Inspection Photos

Location Name: CAERUS PICEANCE LLC, N.PARACHUTE-65S95W/30SESW

Location ID: 335670

Date: 10/8/2024

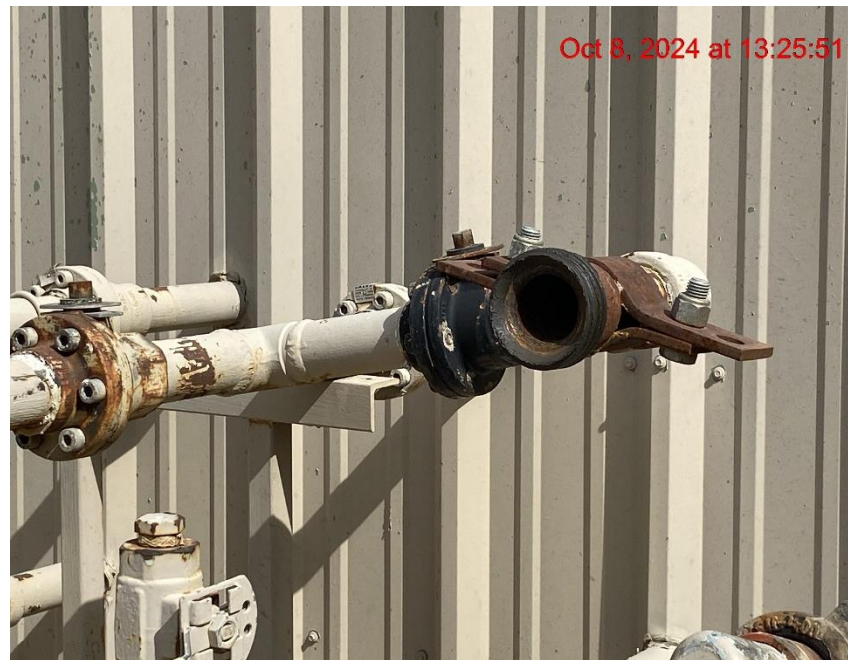
Open-Ended Line – Photo #04032

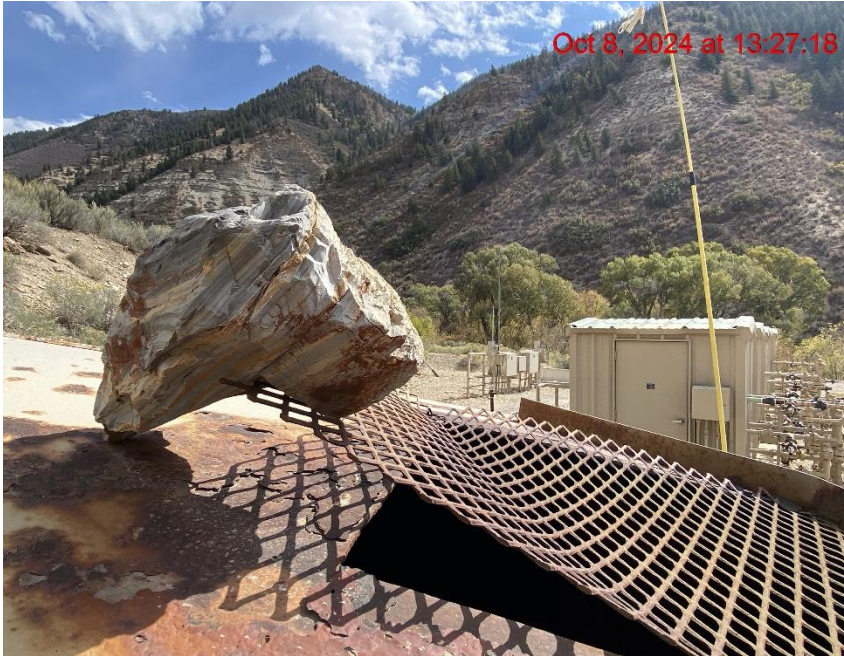
Unserviceable Wildlife Screen – Photo #04035

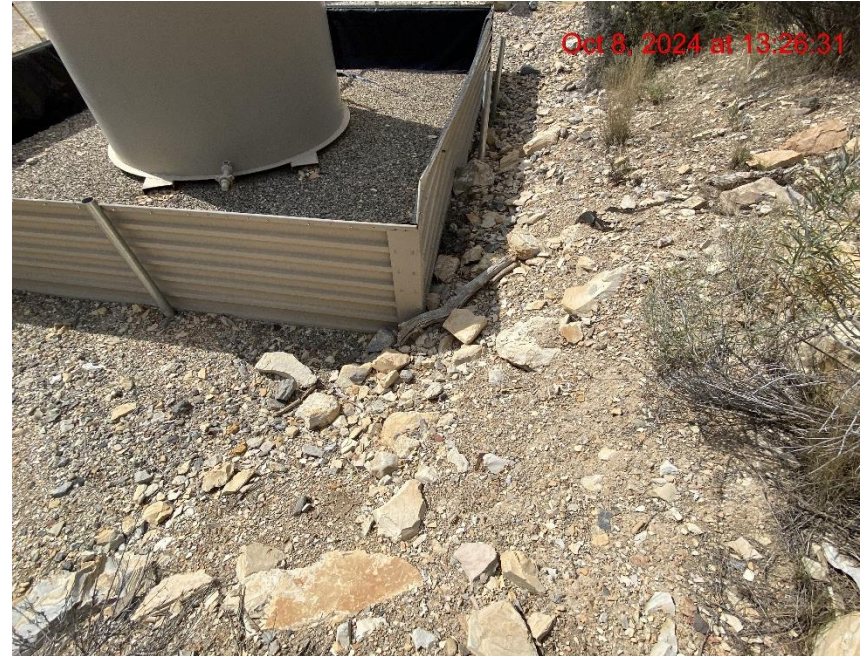
Insufficient Erosion Control – Photo #04033

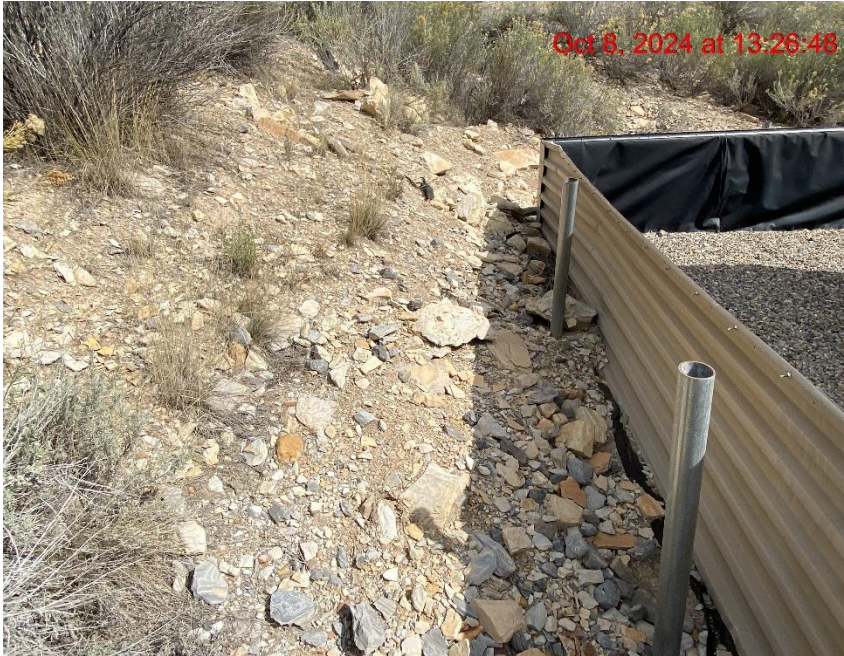
Insufficient Erosion Control – Photo #04034
