WELL NAME: DEER 23-17, API #: 071-06565, INSP. # 716300102

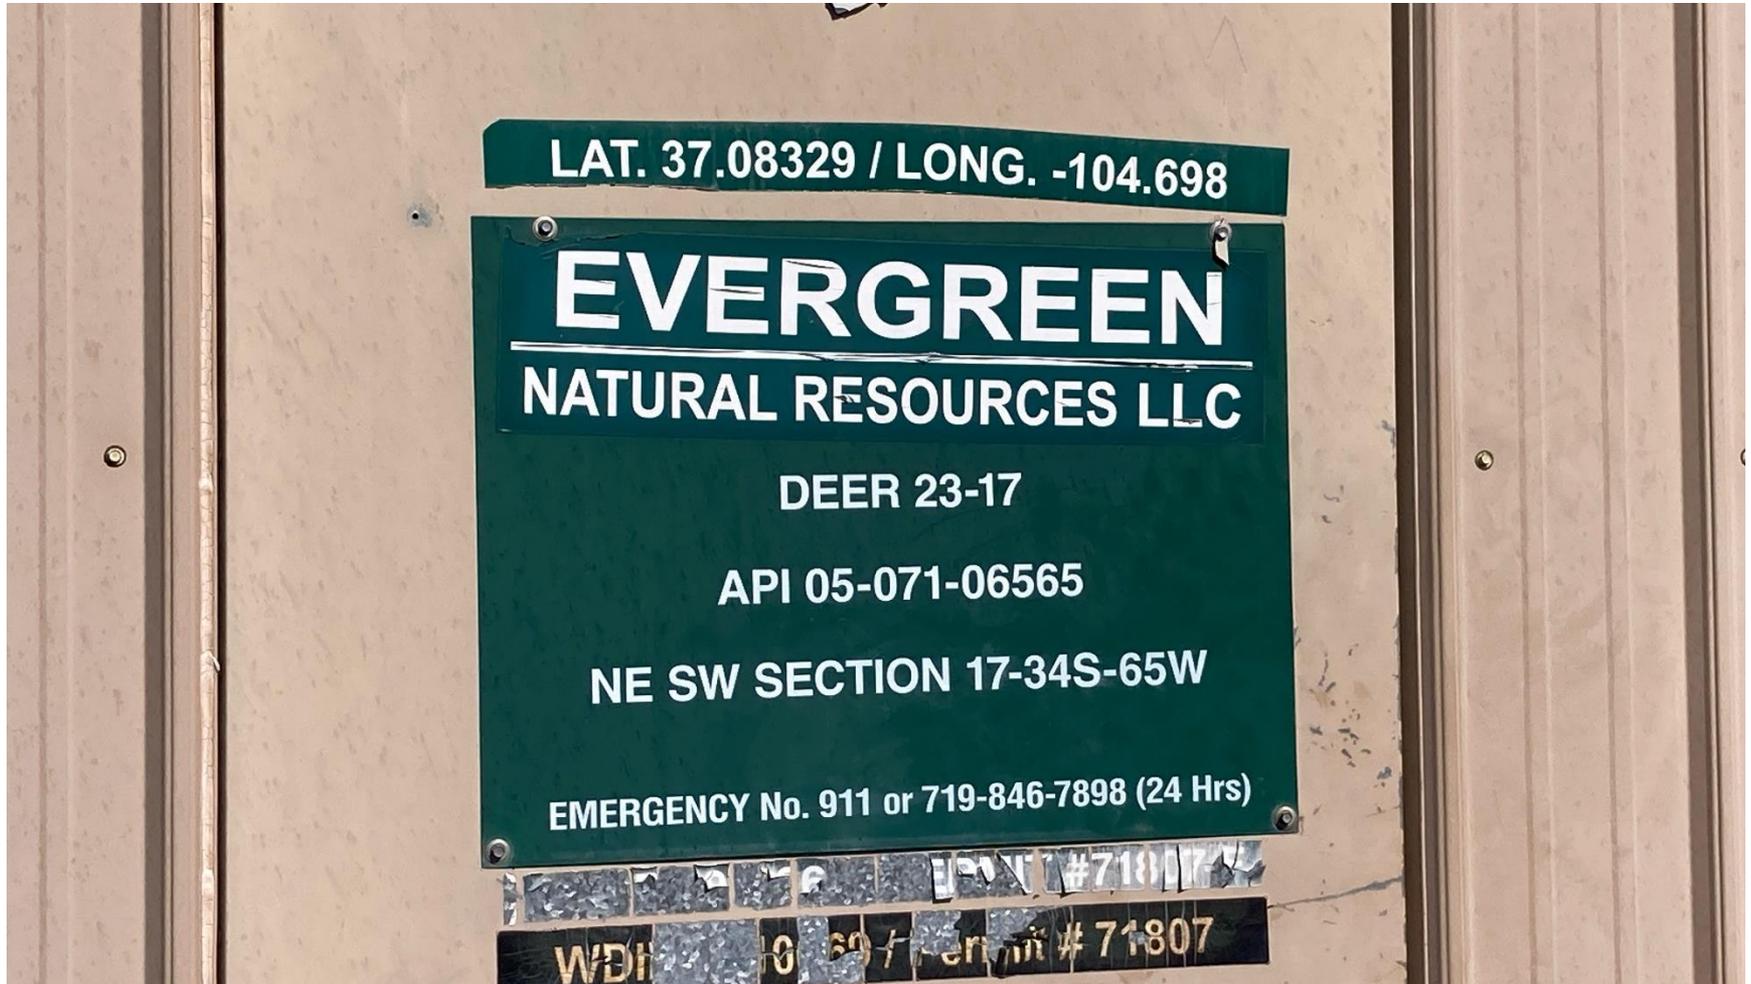
PHOTO 1: WELL SIGN

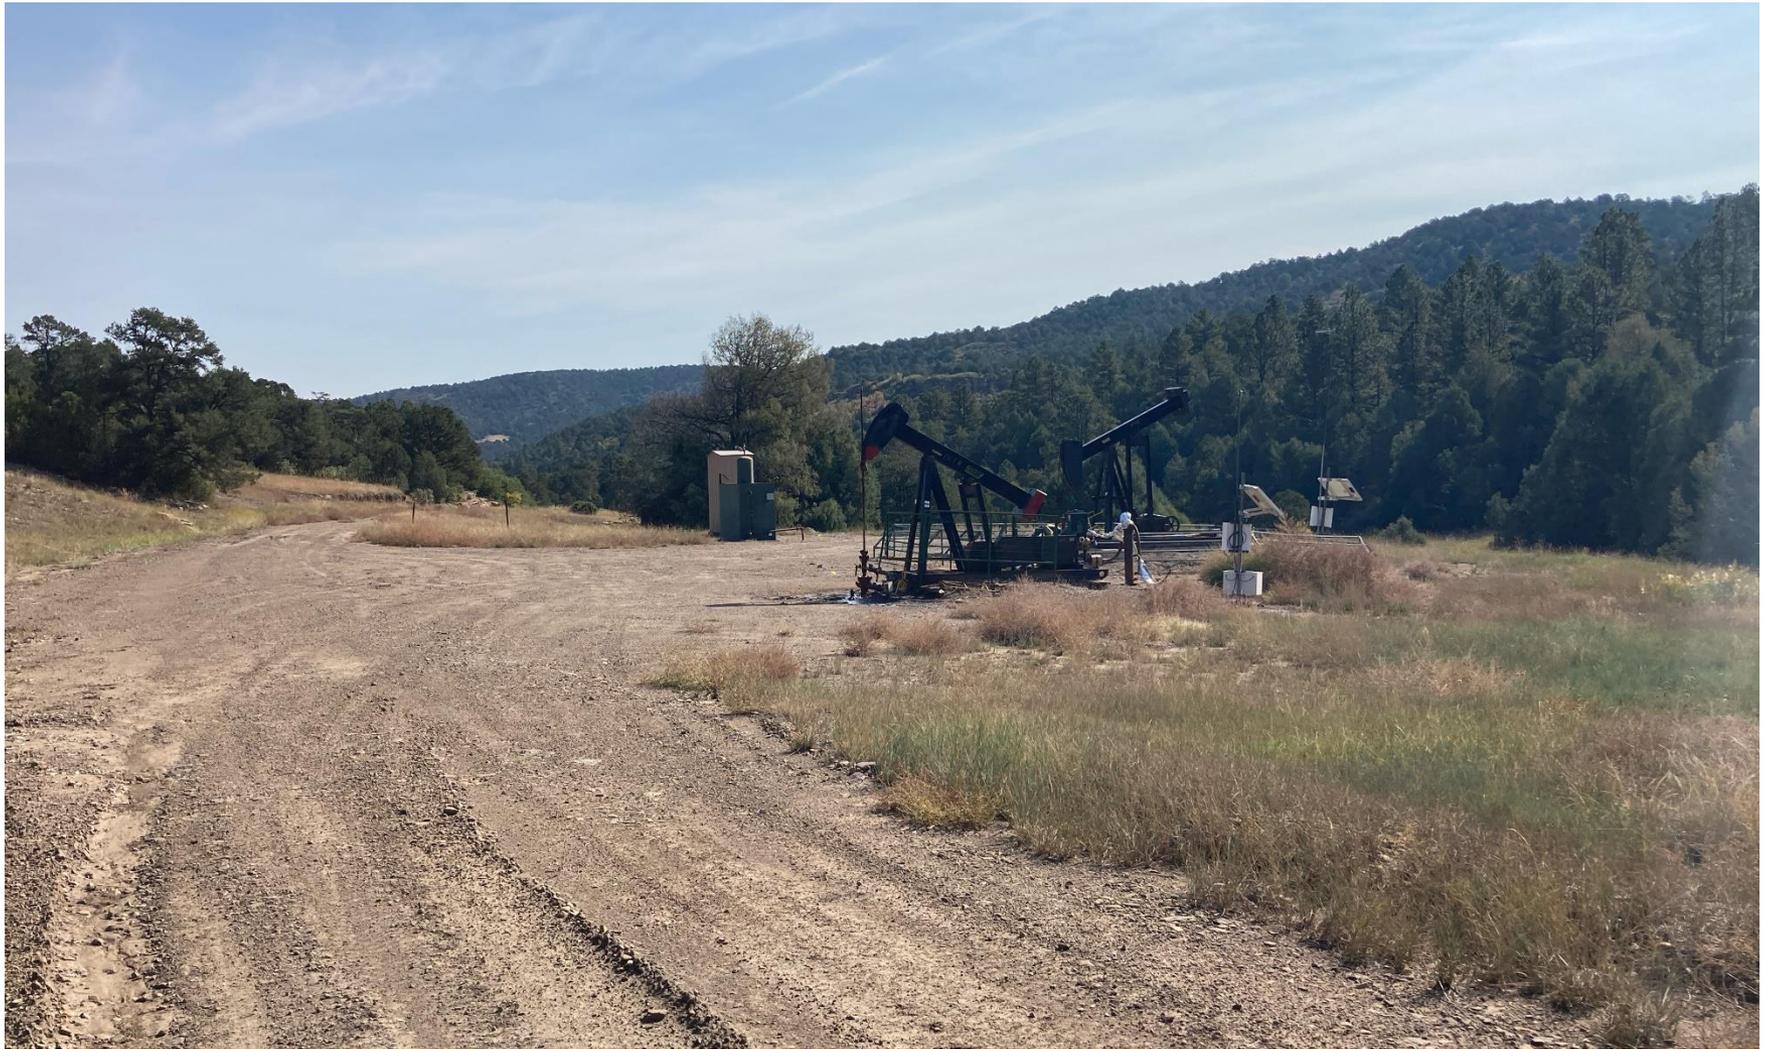
PHOTO 2: LOCATION.

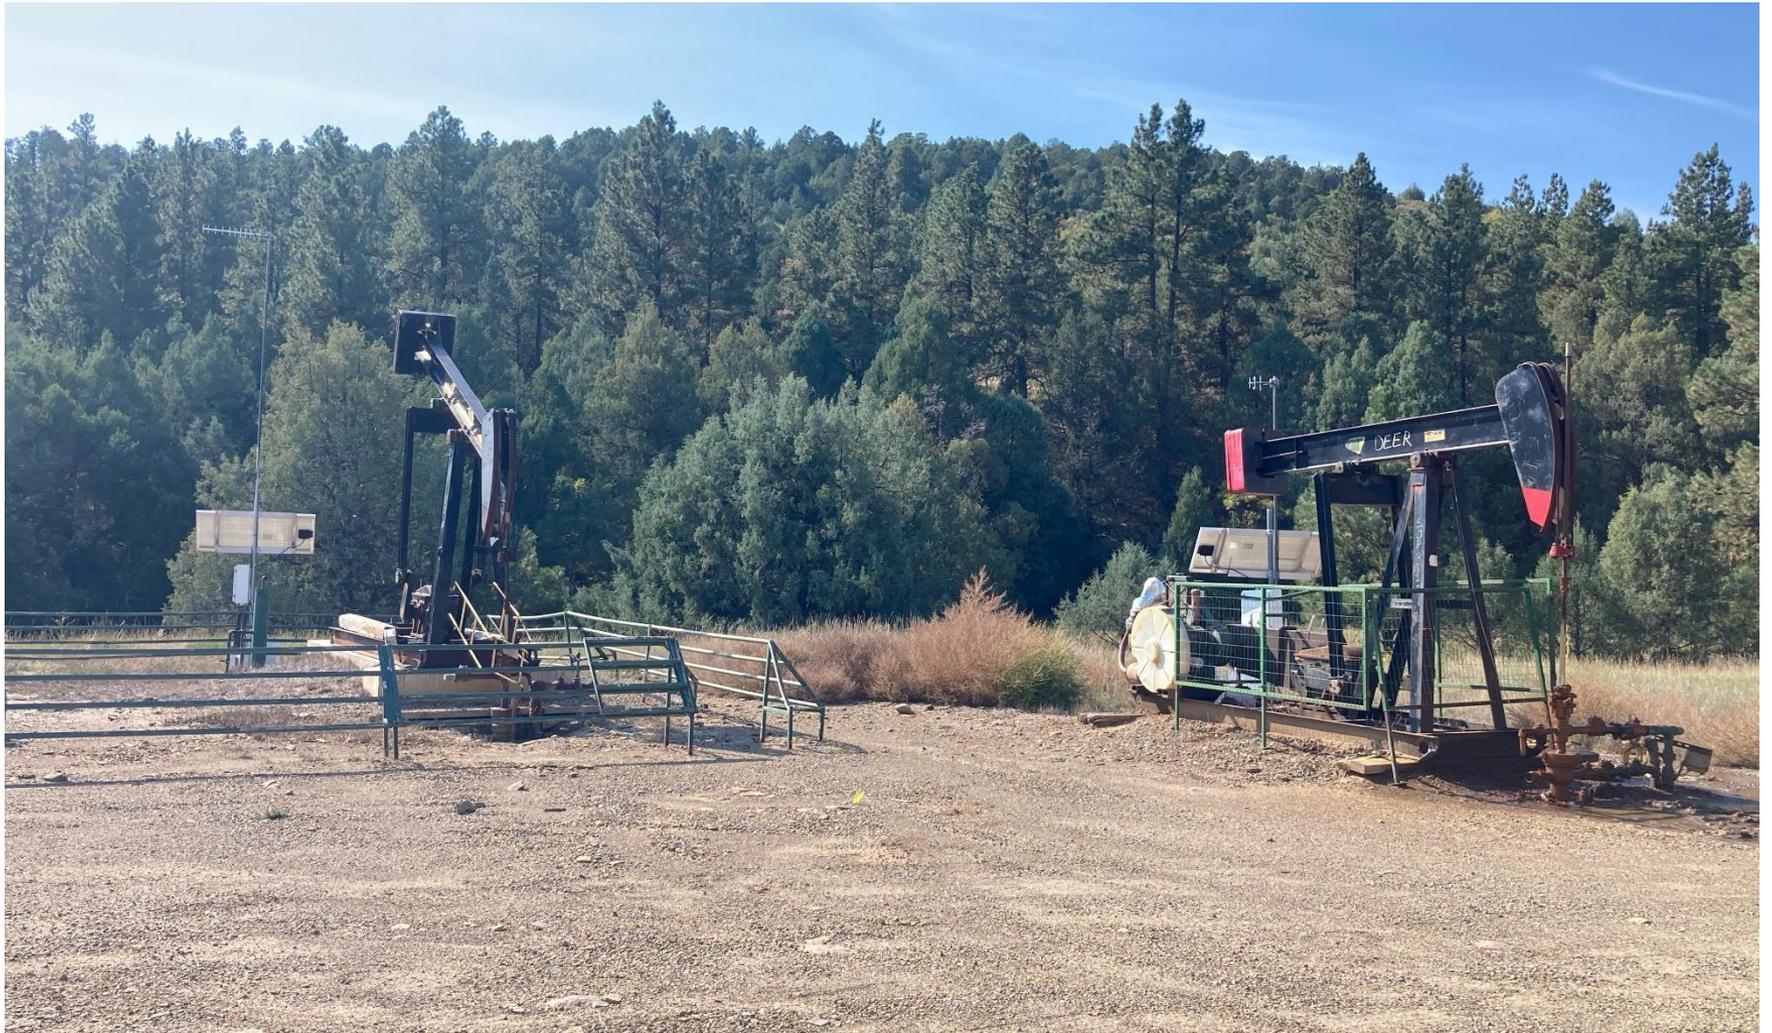
PHOTO 3: WELLHEAD AND EQUIPMENT.

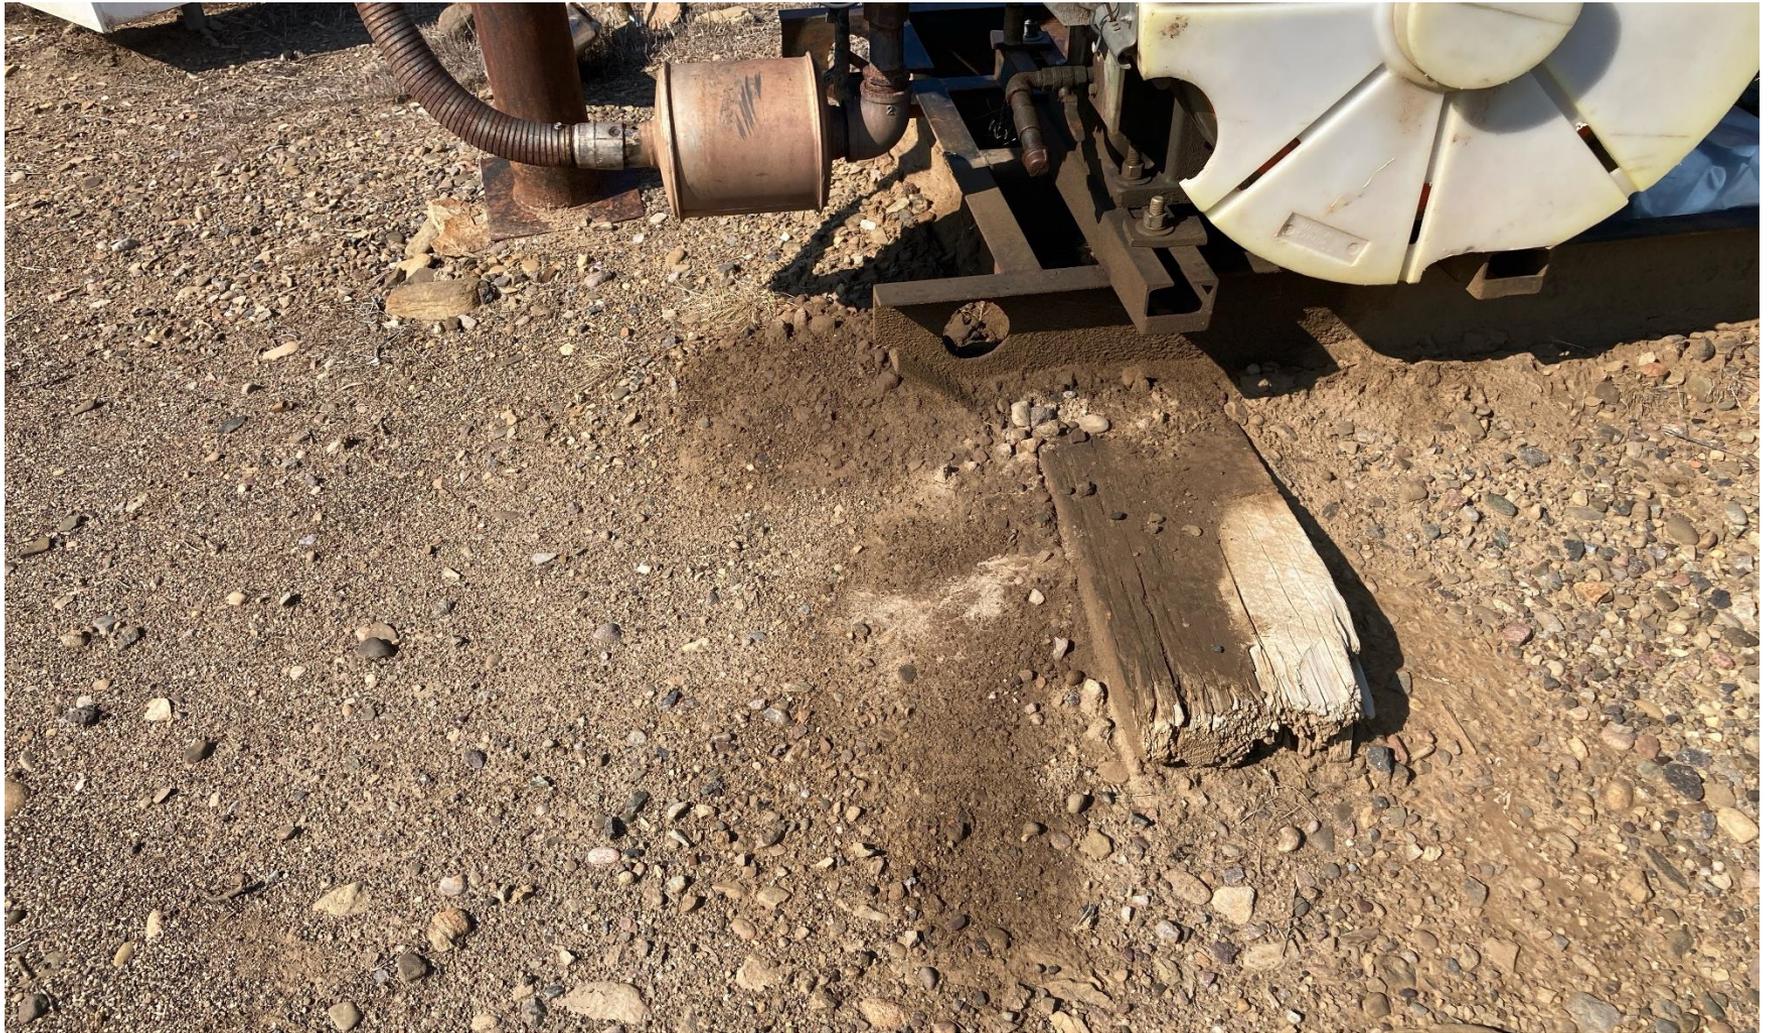
PHOTO 4: AREA OF IMPACTED SOIL AROUND THE DEER 23-17 PUMPJACK PRIME MOVER. Conduct maintenance on equipment, cleanup stained material and review self inspection processes. COMPLY WITH RULE 1002,(2).D CA DATE 11/08/2024.

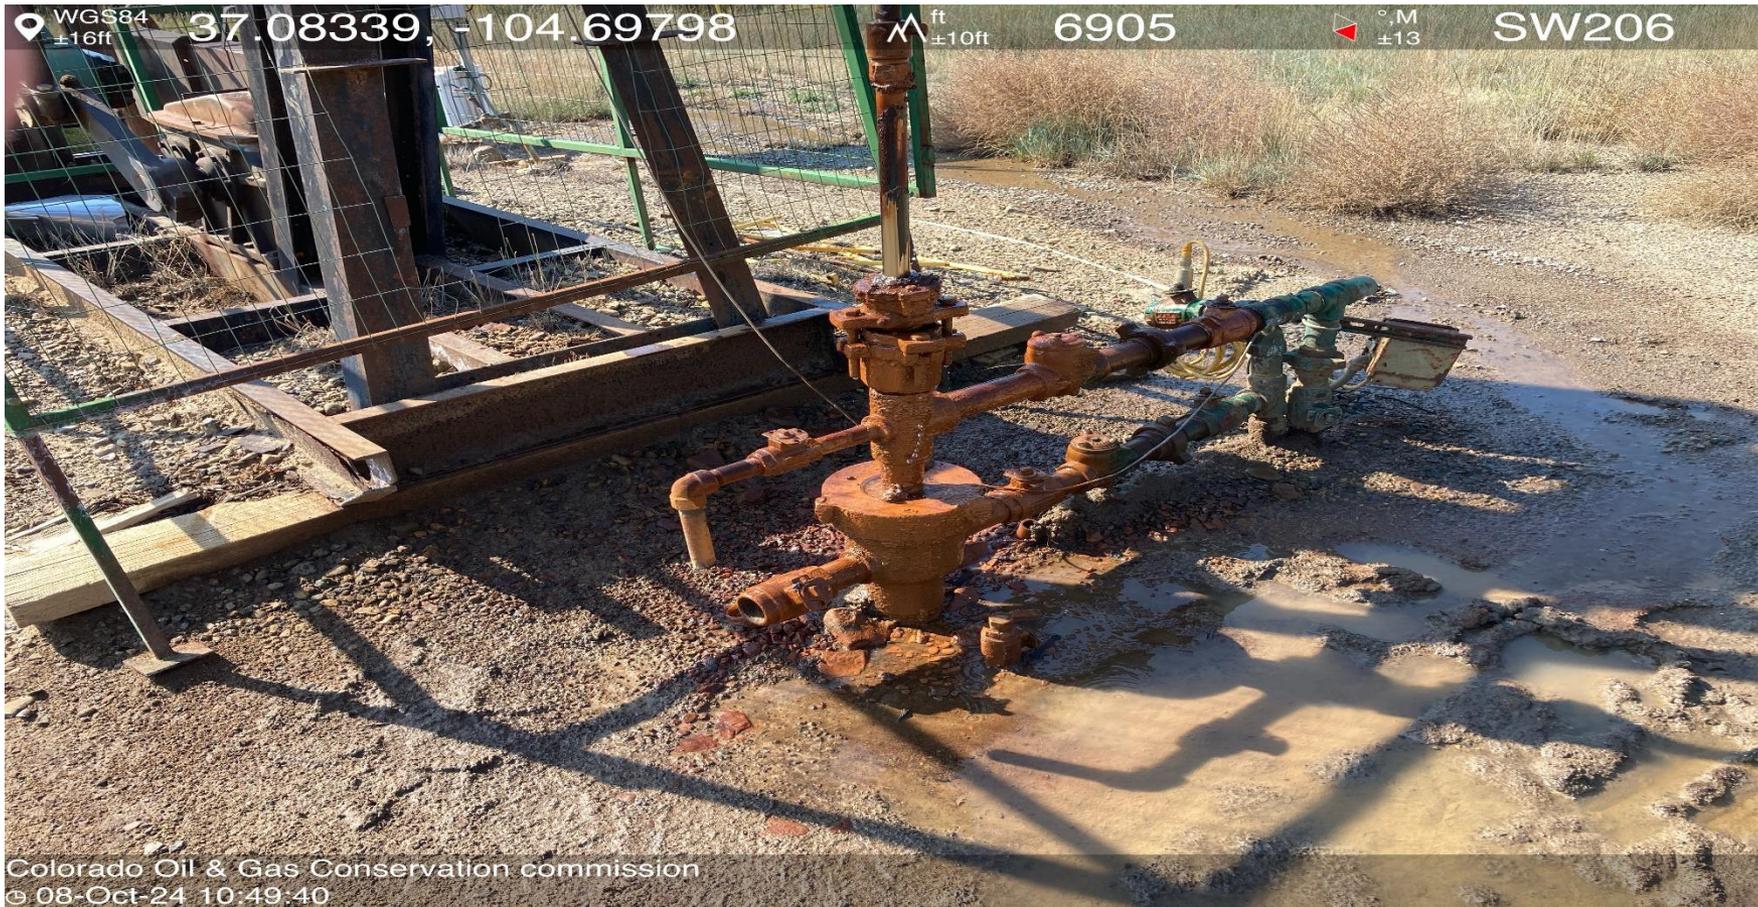
PHOTO 5: THE PACKING ON THE DEER 23-17 HAS BEEN LEAKING, PRODUCED WATER FROM THE LEAKING PACKING HAS TRAVELED SOUTH FROM WELLHEAD TO THE STORMWATER DITCH THEN EAST TO APPROX. 35' FROM STATE WATERS (APPROX 220' FROM WELLHEAD). **Securely fasten all valves, pipes, fittings, and Production Facilities to ensure good mechanical condition, inspect at regular intervals and maintain in good mechanical condition per Rule 608.e. CONTACT AREA EPS FOR DIRECTION ON SPILL. 24 HOURS TO FIX LEAK, 48 HOURS TO CONTACT AREA EPS.**

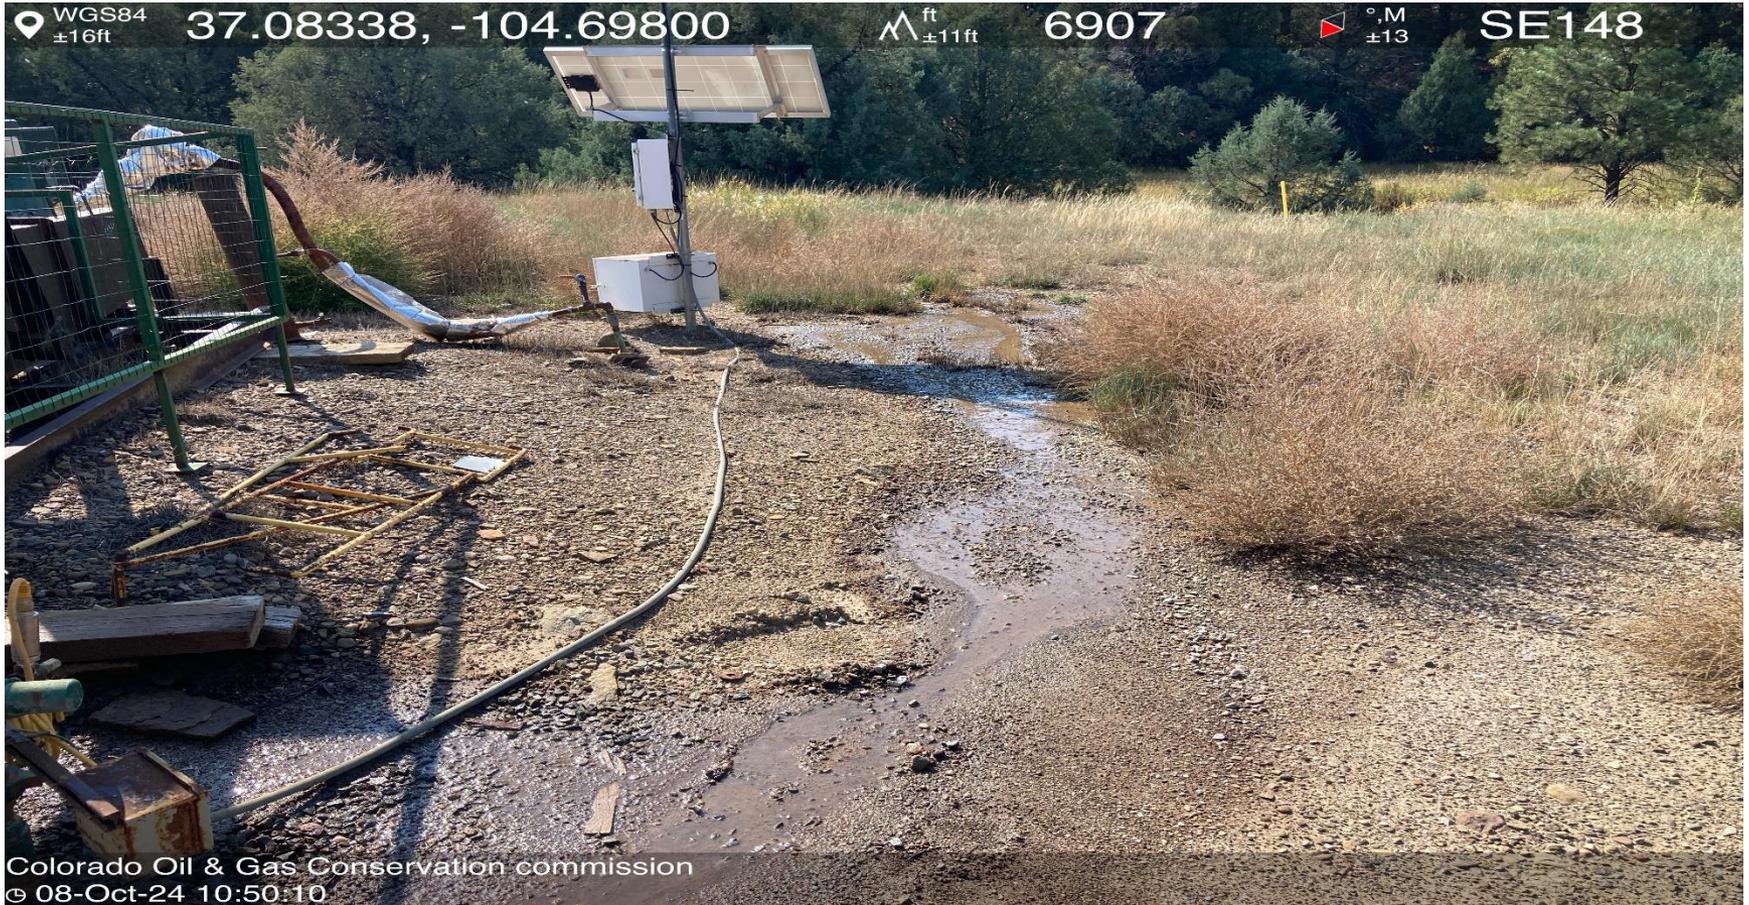
PHOTO 5: THE PACKING ON THE DEER 23-17 HAS BEEN LEAKING, PRODUCED WATER FROM THE LEAKING PACKING HAS TRAVELED SOUTH FROM WELLHEAD TO THE STORMWATER DITCH THEN EAST TO APPROX. 35' FROM STATE WATERS (APPROX 220' FROM WELLHEAD). Securely fasten all valves, pipes, fittings, and Production Facilities to ensure good mechanical condition, inspect at regular intervals and maintain in good mechanical condition per Rule 608.e. CONTACT AREA EPS FOR DIRECTION ON SPILL. 24 HOURS TO FIX LEAK, 48 HOURS TO CONTACT AREA EPS.

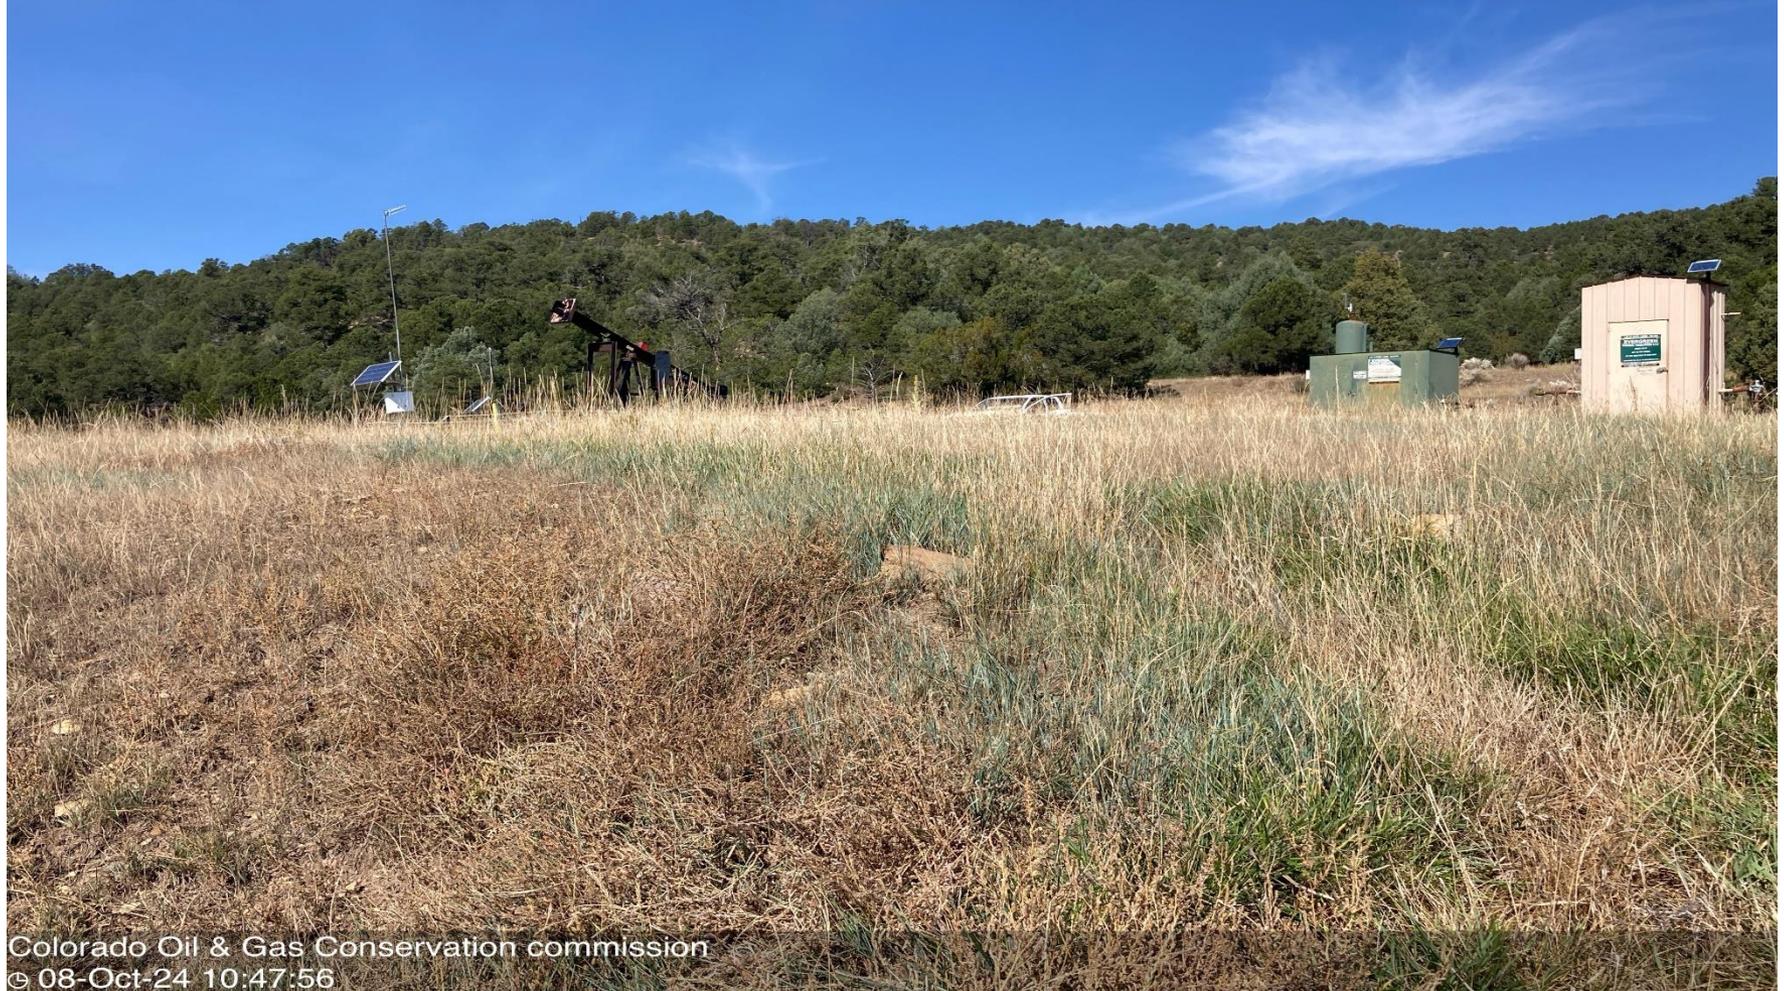
PHOTO 7: PHOTO TAKEN FROM THE EDGE OF THE PRODUCED WATER FLOW APPROX. 220' FROM WELHEAD.

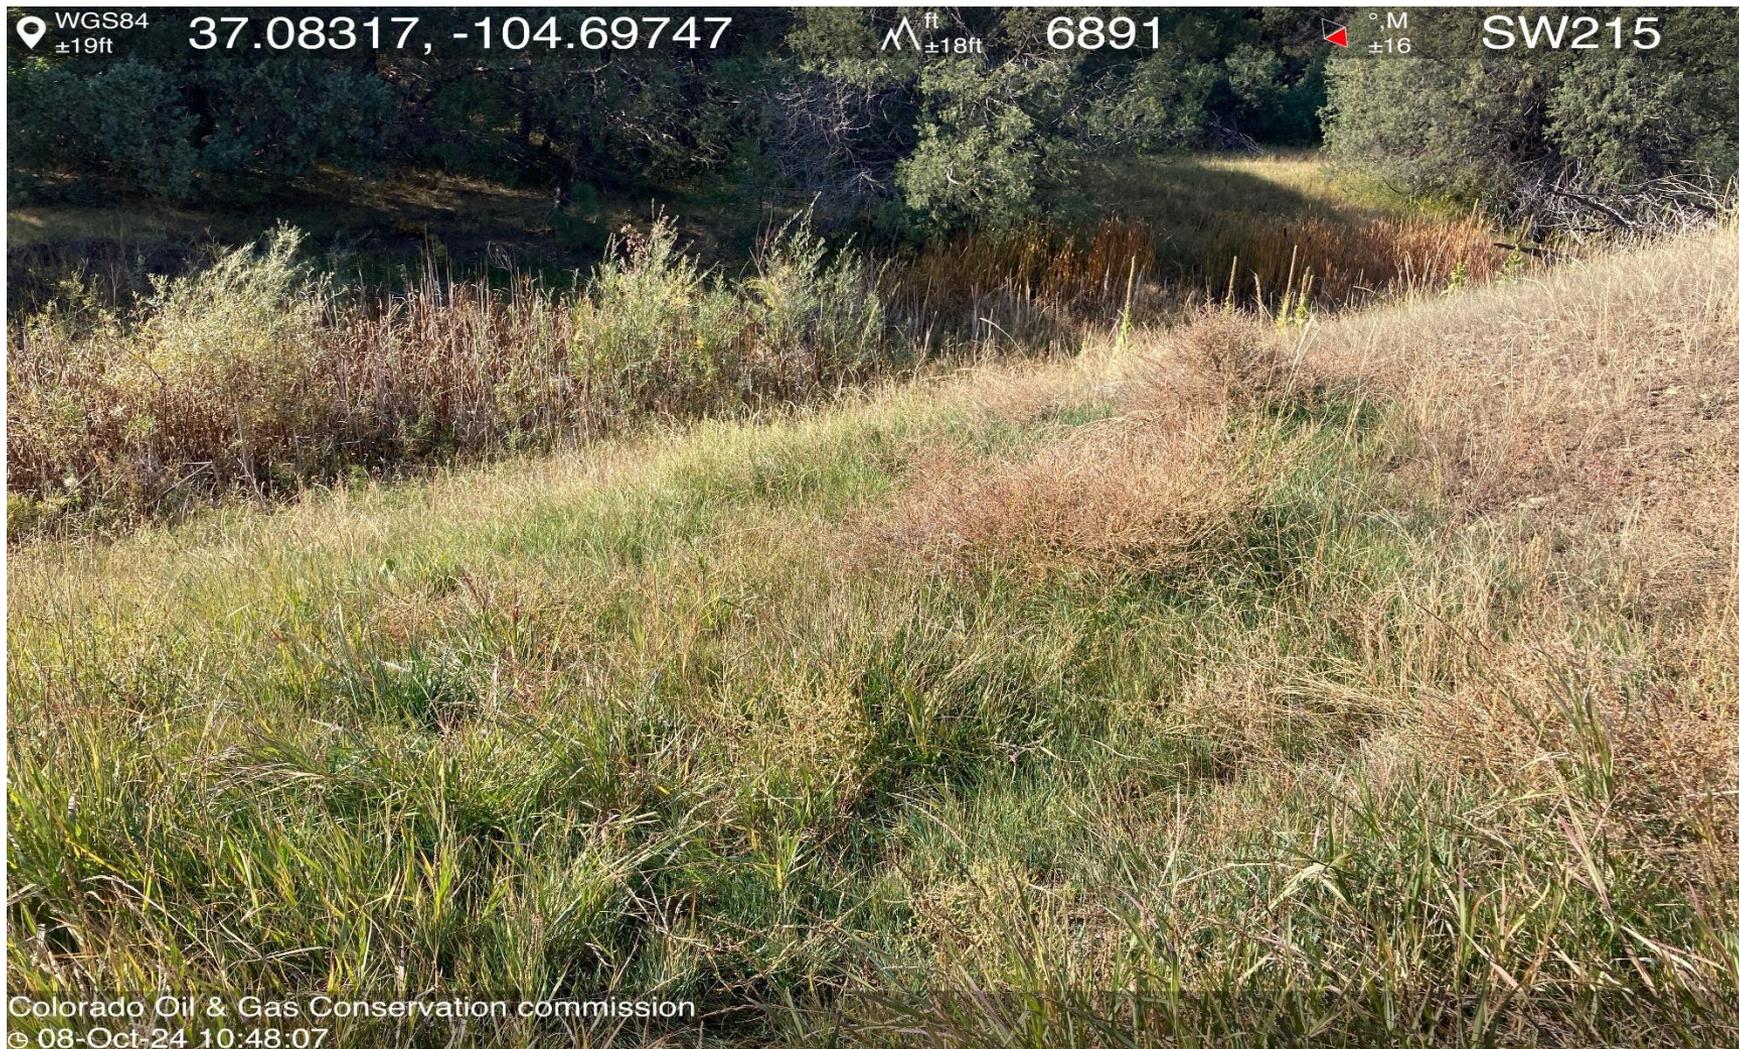
PHOTO 8: PHOTO TAKEN FROM THE EDGE OF THE PRODUCED WATER FLOW APPROX. 35' FROM STATE WATERS.
