Inspection Photos

Location Name: TEP ROCKY MOUNTAIN LLC FEDERAL RMV 132-18 Pad

Location ID: 335412

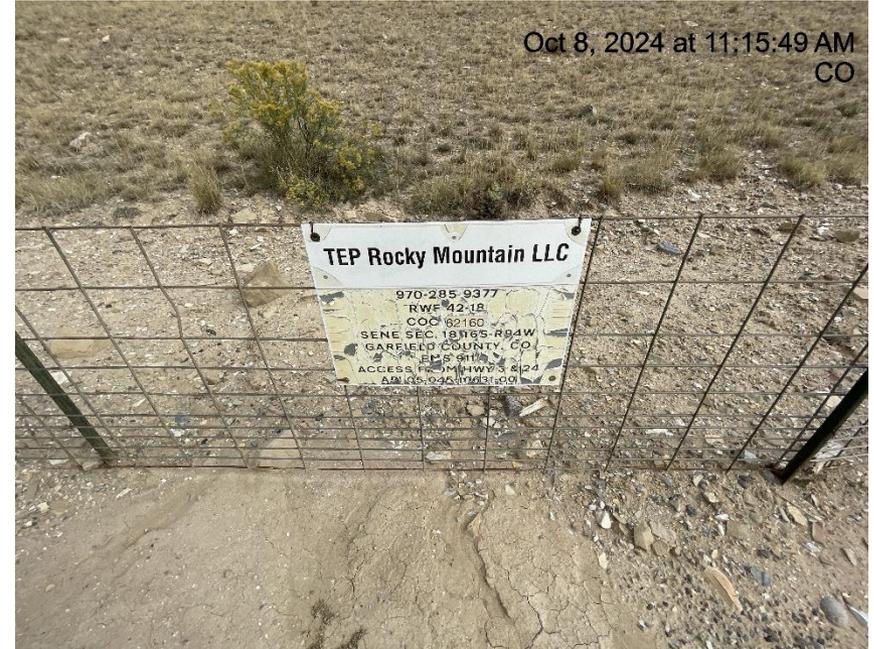
Photo # 3853 RWF 42-18 wellhead sign peeling & some info starting to become illegible

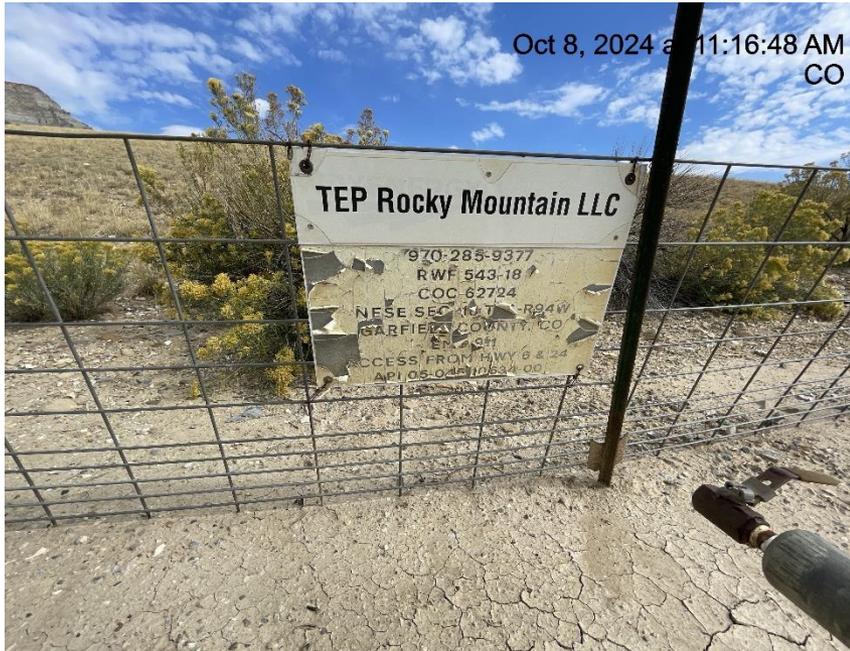
Photo # 3854 RWF 543-18 wellhead sign peeling & some info starting to become illegible

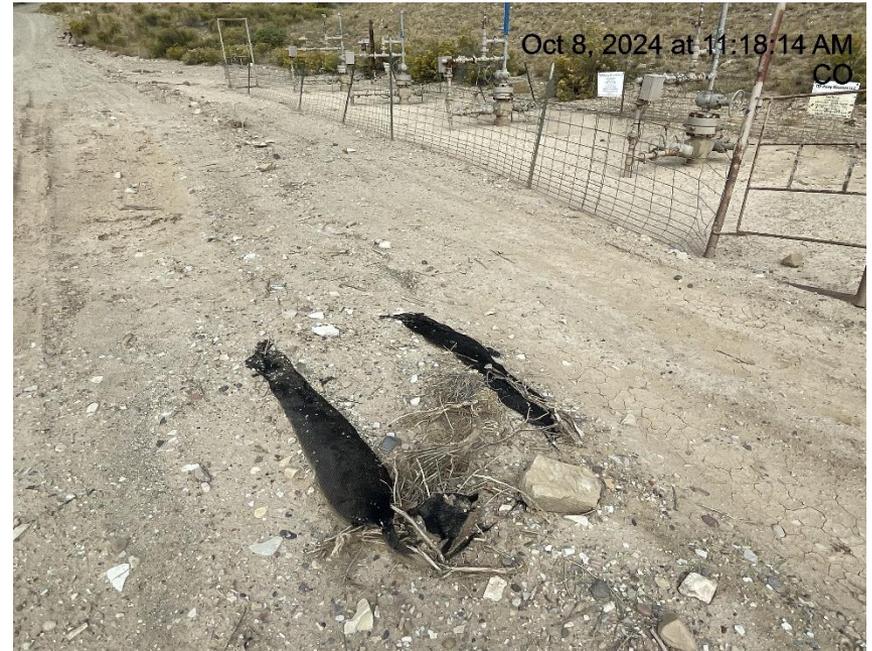
Photo # 3855 Debris

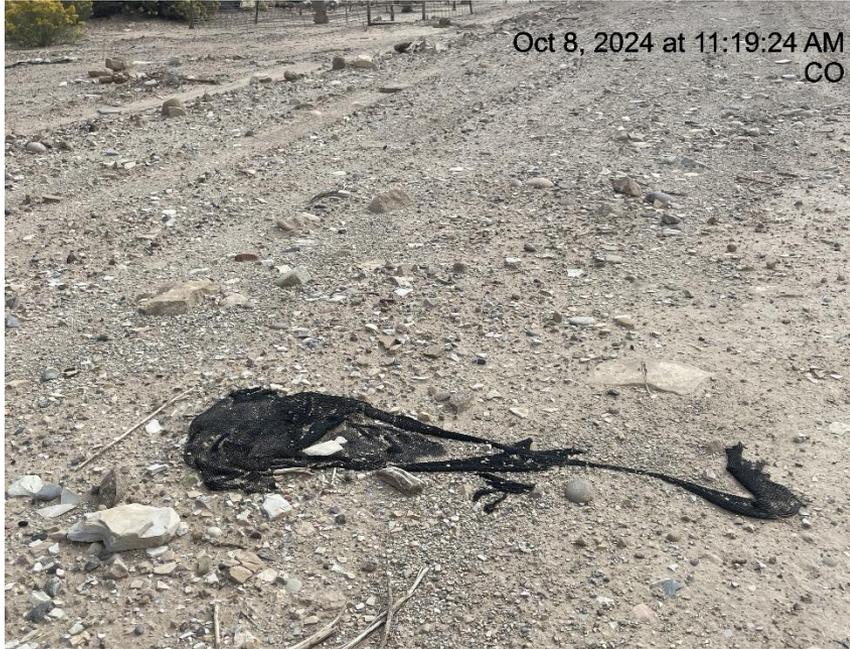
Photo # 3856 Debris

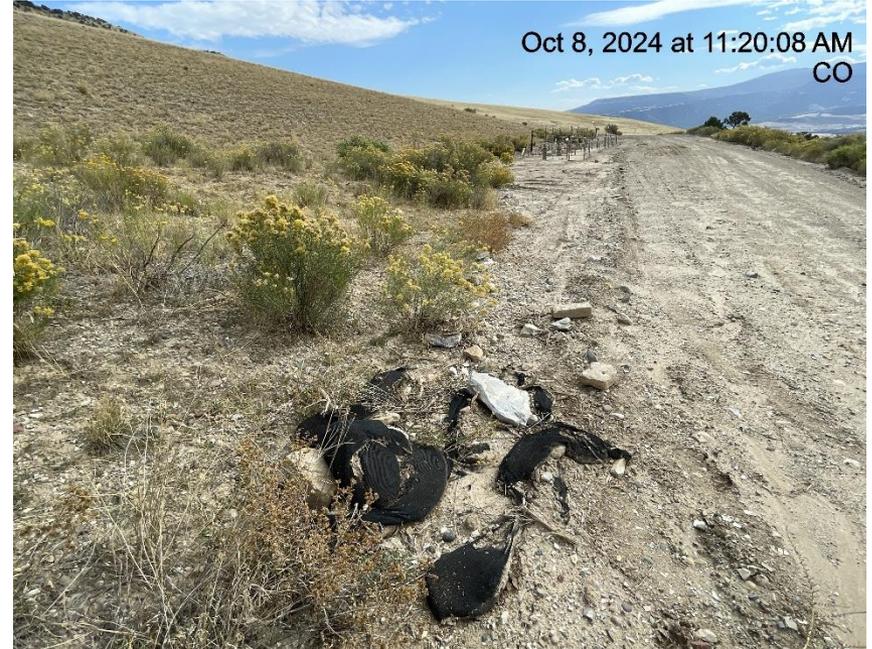
Photo # 3857 Debris

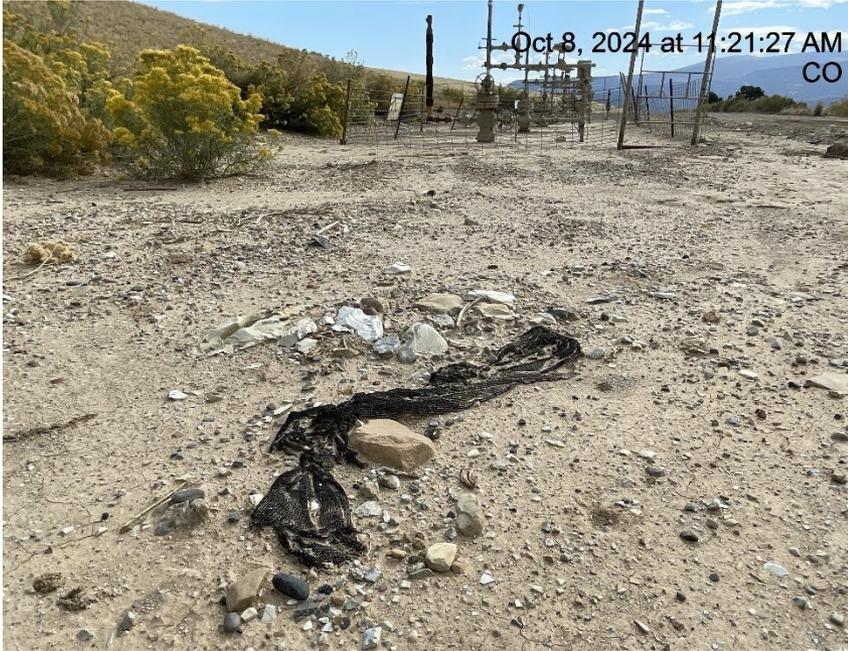
Photo # 3858 Debris

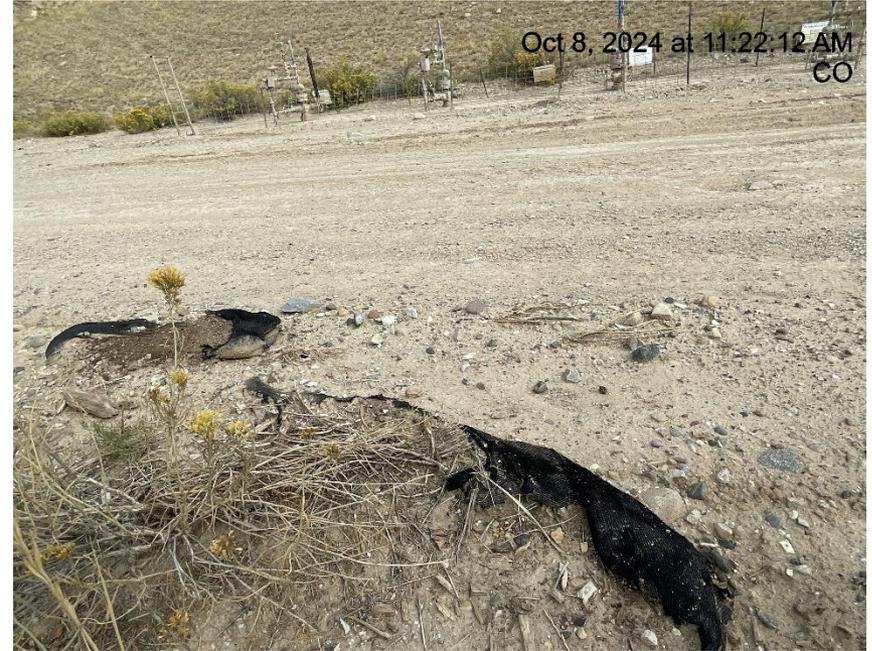
Photo # 3859 Debris

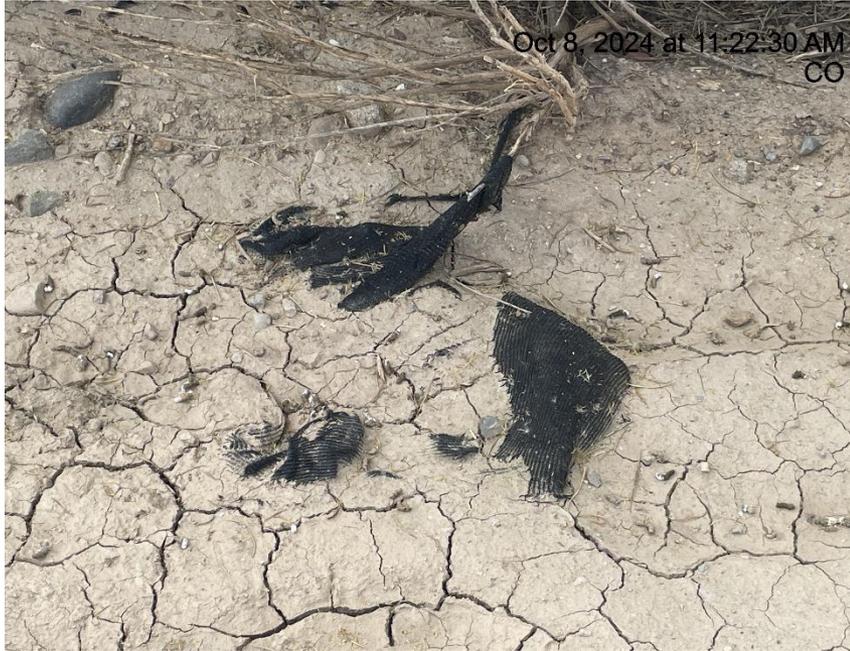
Photo # 3860 Debris

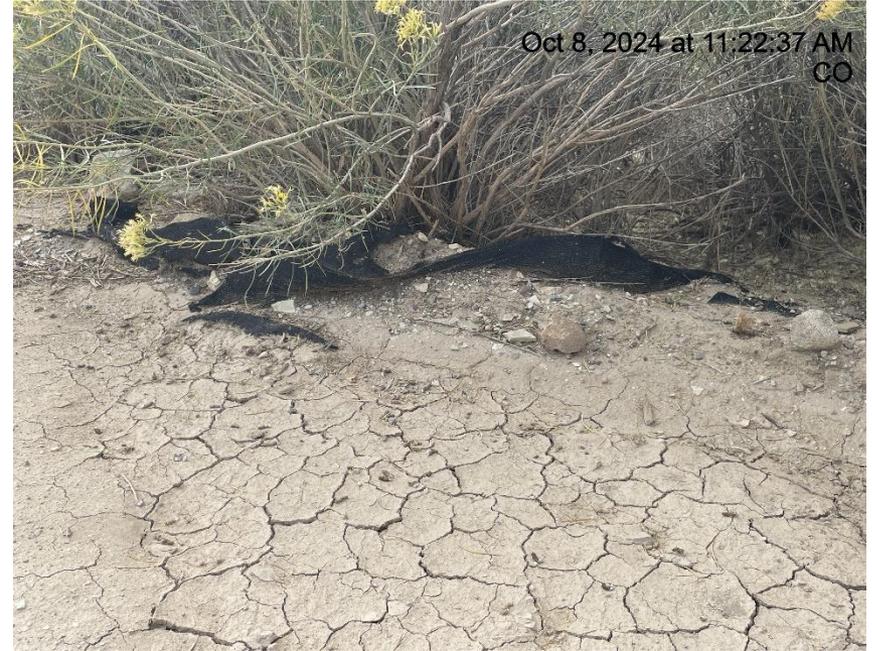
Photo # 3861 Debris

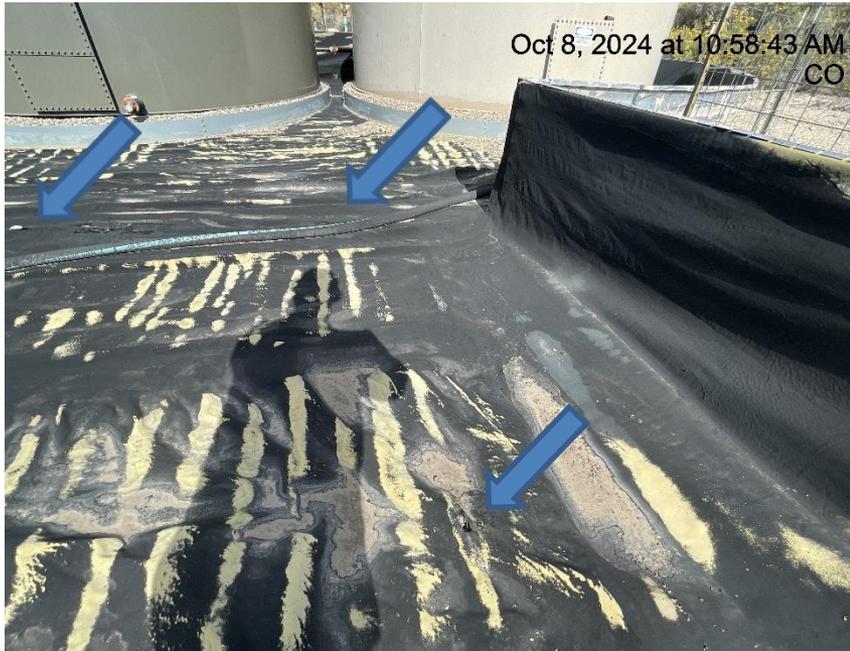
Photo # 3862 Holes in secondary containment liner/liner needs maintenance

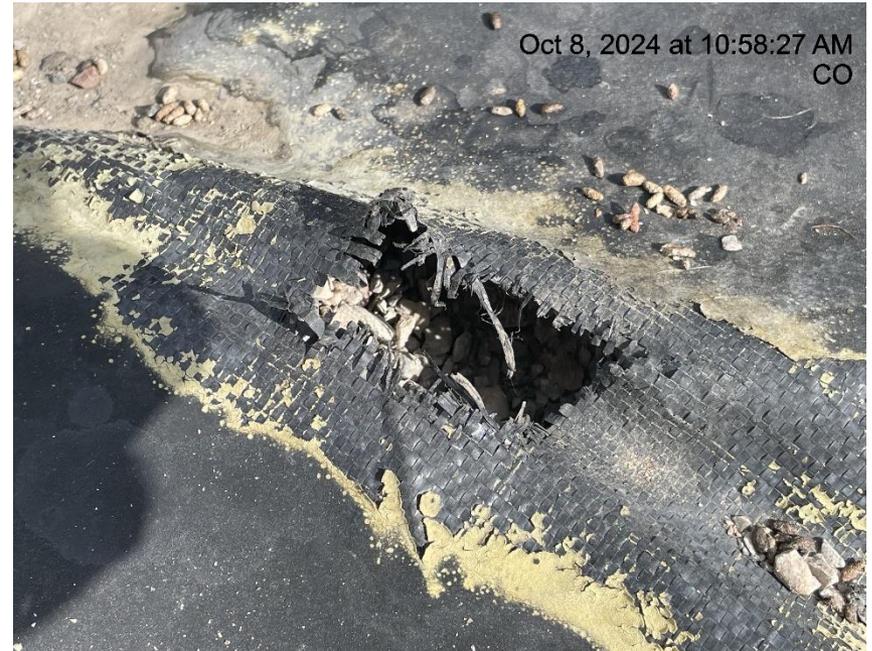
Photo # 3863 Hole in secondary containment liner/liner needs maintenance

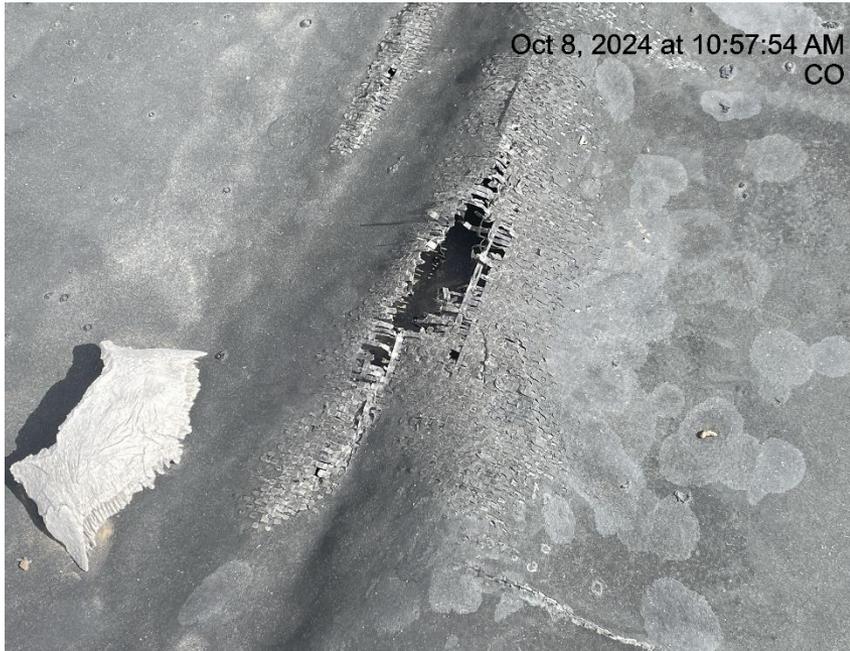
Photo # 3864 Hole in secondary containment liner/liner needs maintenance

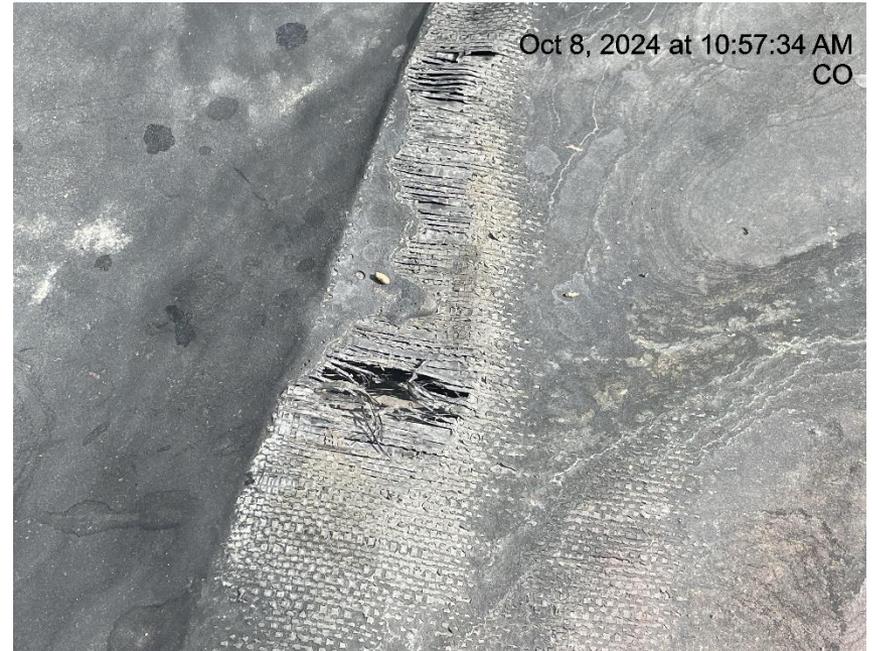
Photo # 3865 Hole in secondary containment liner/liner needs maintenance

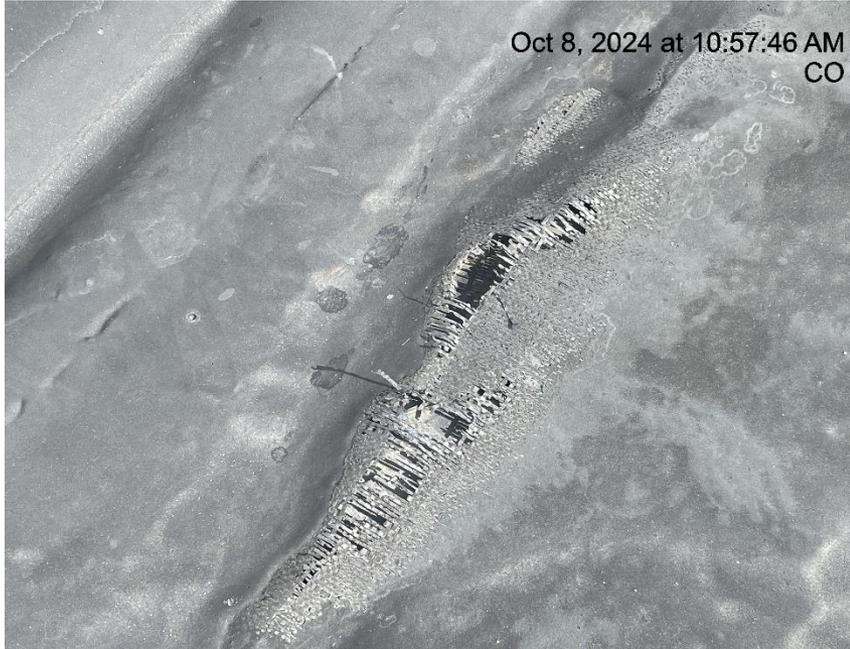
**Photo # 3866 Hole in secondary containment liner/liner
needs maintenance**
