**Inspection Photos**  
**Location Name: Cass 11-9H**  
**Location ID: 420717**

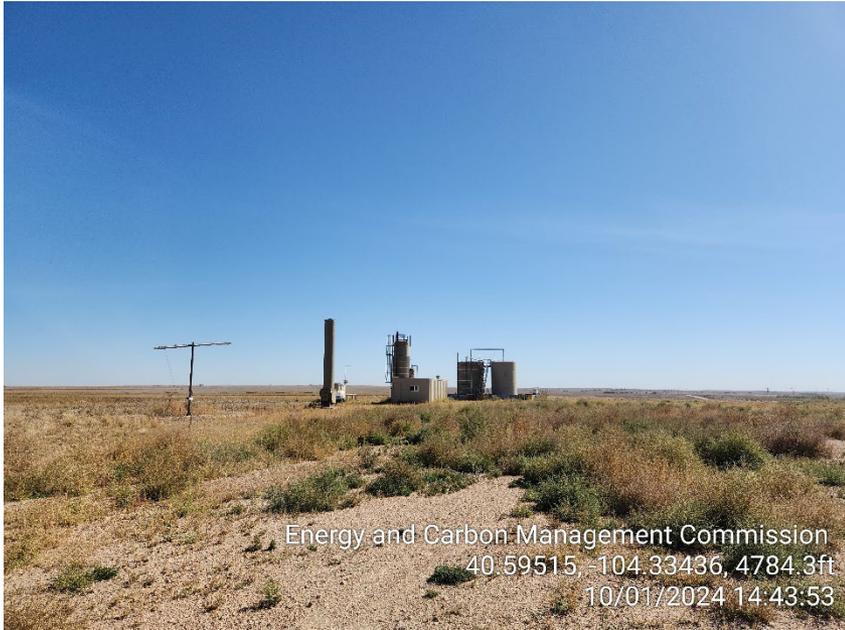
**Photo 1 – Location Overview – Weeds**

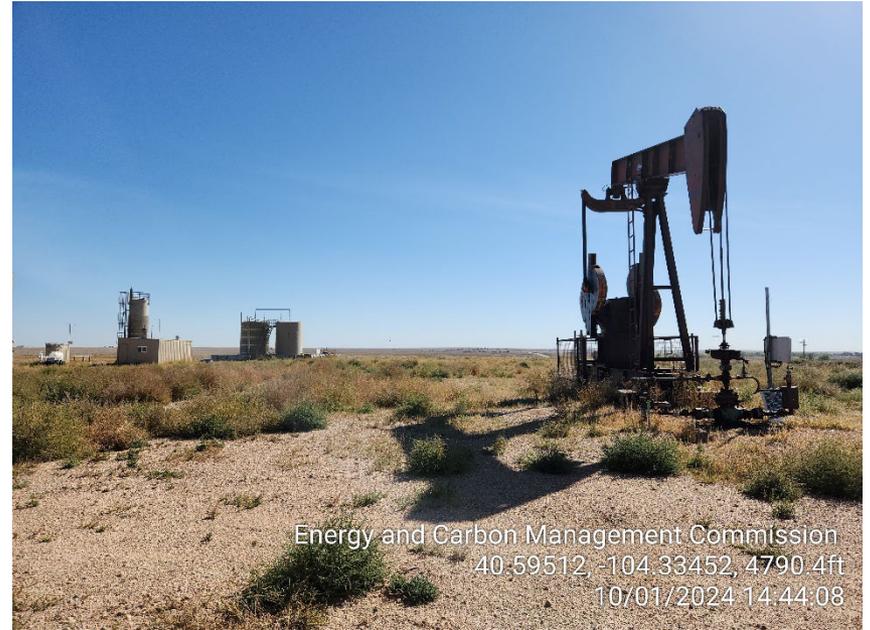
**Photo 2 – Pumping Unit – Weeds**

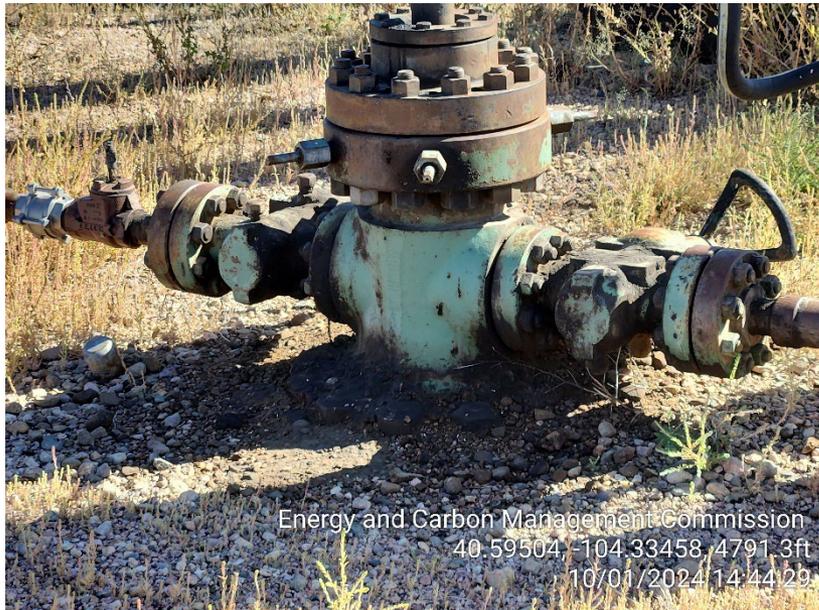
Photo 4 – Wellhead – Stained Soil

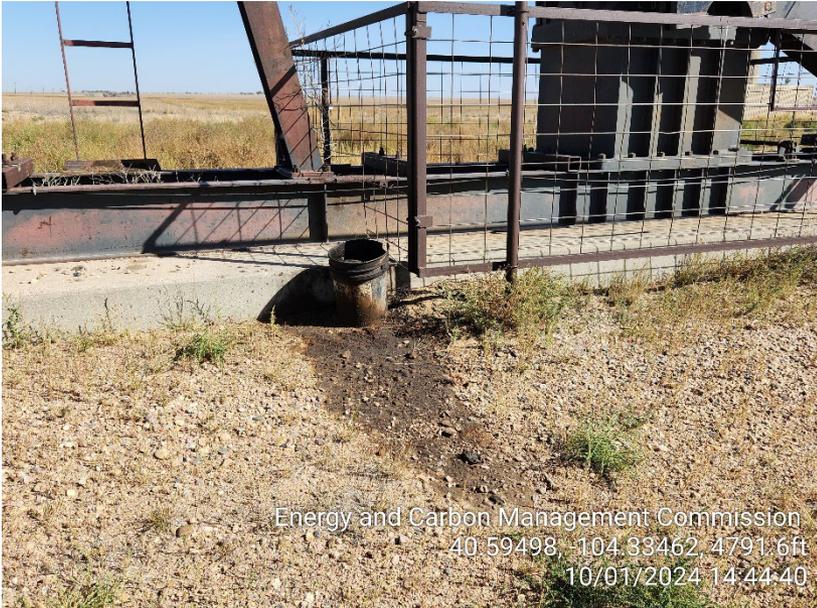
**Photo 5 – Oily Waste and Stained Soil at Pumping Unit**

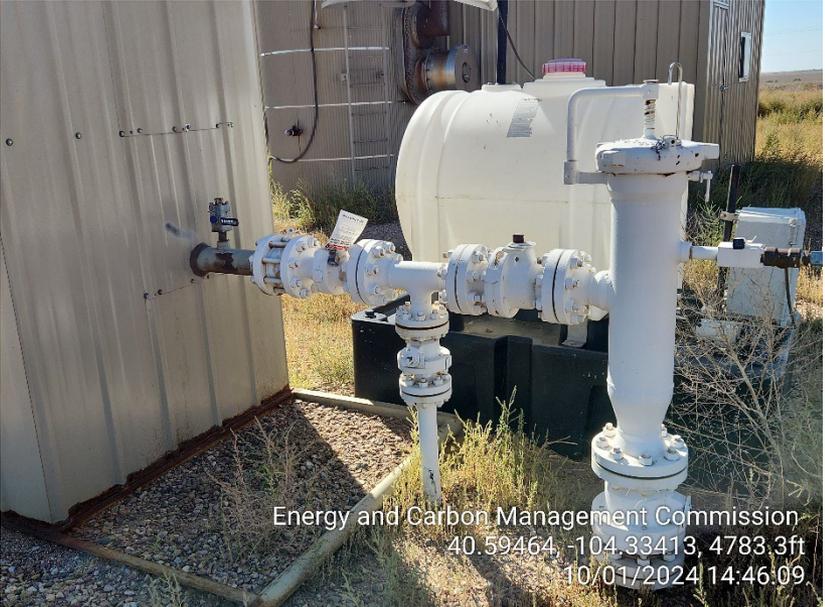
**Photo 7 – Gas Sales Line LOTO Downstream of Meter**

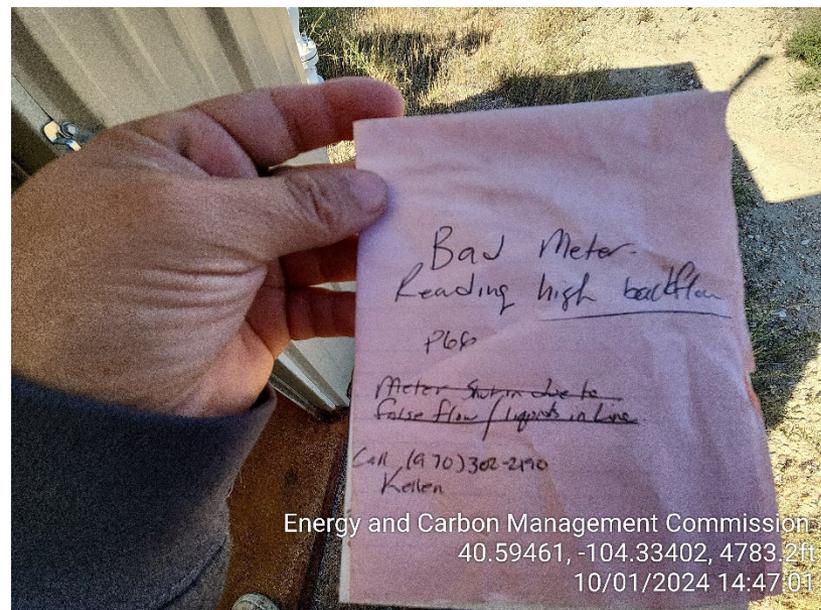
Photo 10 – Gas Sales Meter not from Gas Operating Company

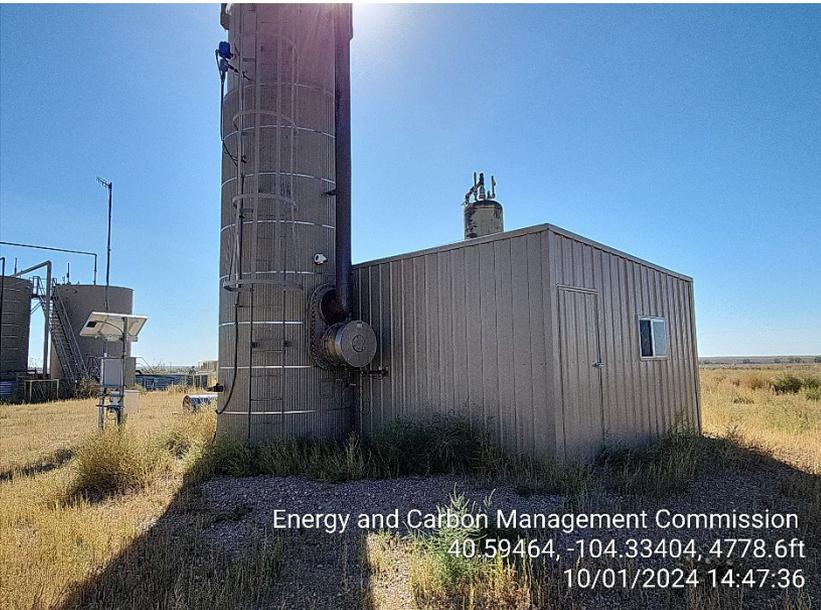
**Photo 11 – Heater Treater – Weeds**

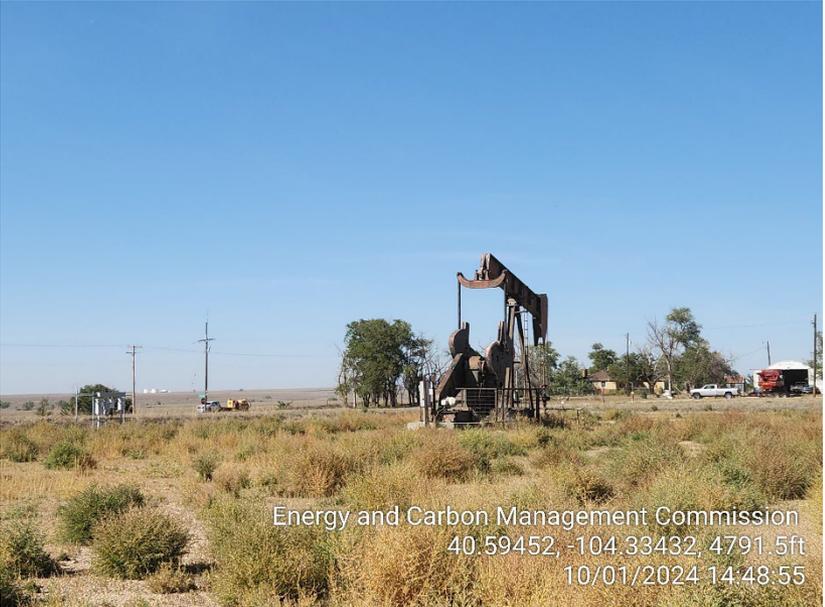
Photo 13 – Pumping Unit looking North – Weeds

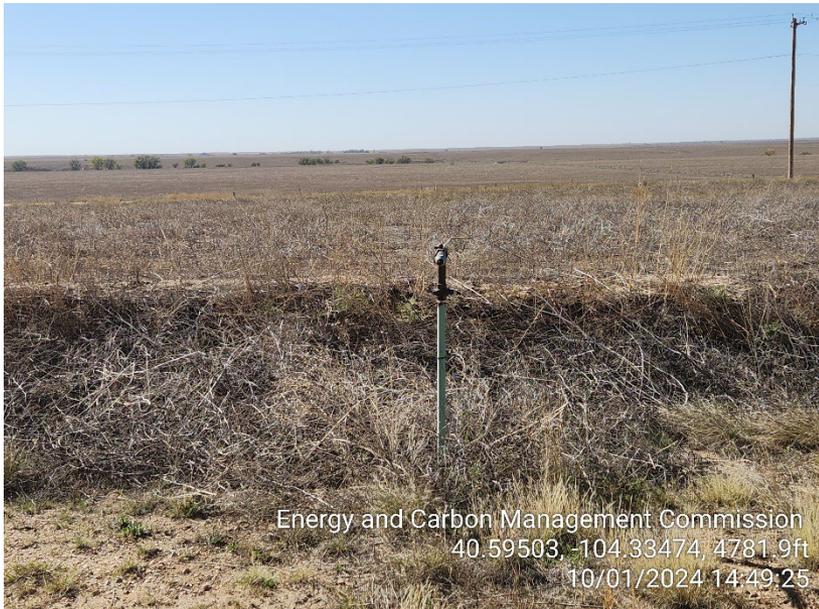
**Photo 17 – Unmarked Riser at Electrical Panel**
