Interim Reclamation and Stormwater Inspection

Date: 09/30/2024

Operator: MDS ENERGY DEVELOPMENT LLC - 10814

Location ID: 471039

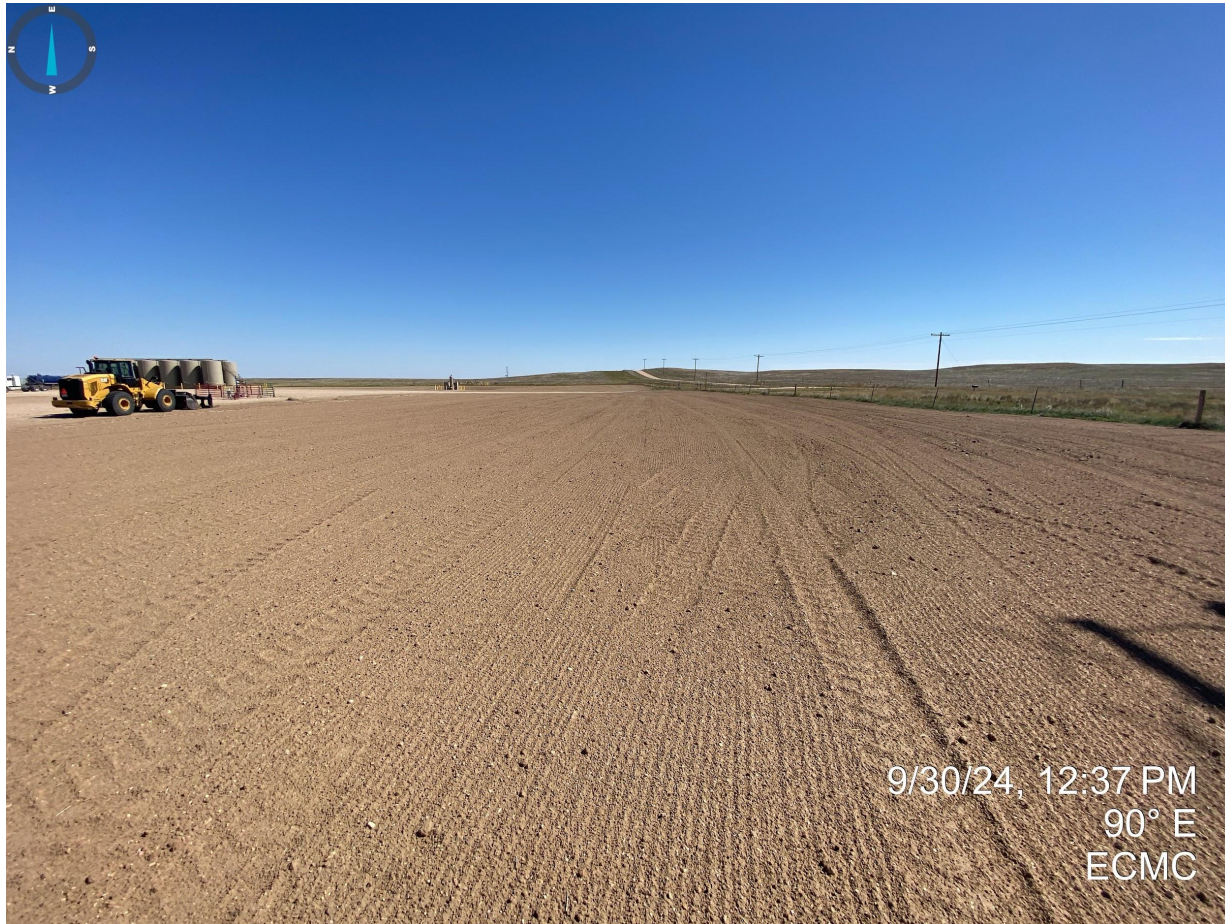
Photo 1. Southwestern interim areas; it appears that topsoil has been imported and spread throughout the interim areas which appear to have been recontoured. No perimeter stormwater controls observed.

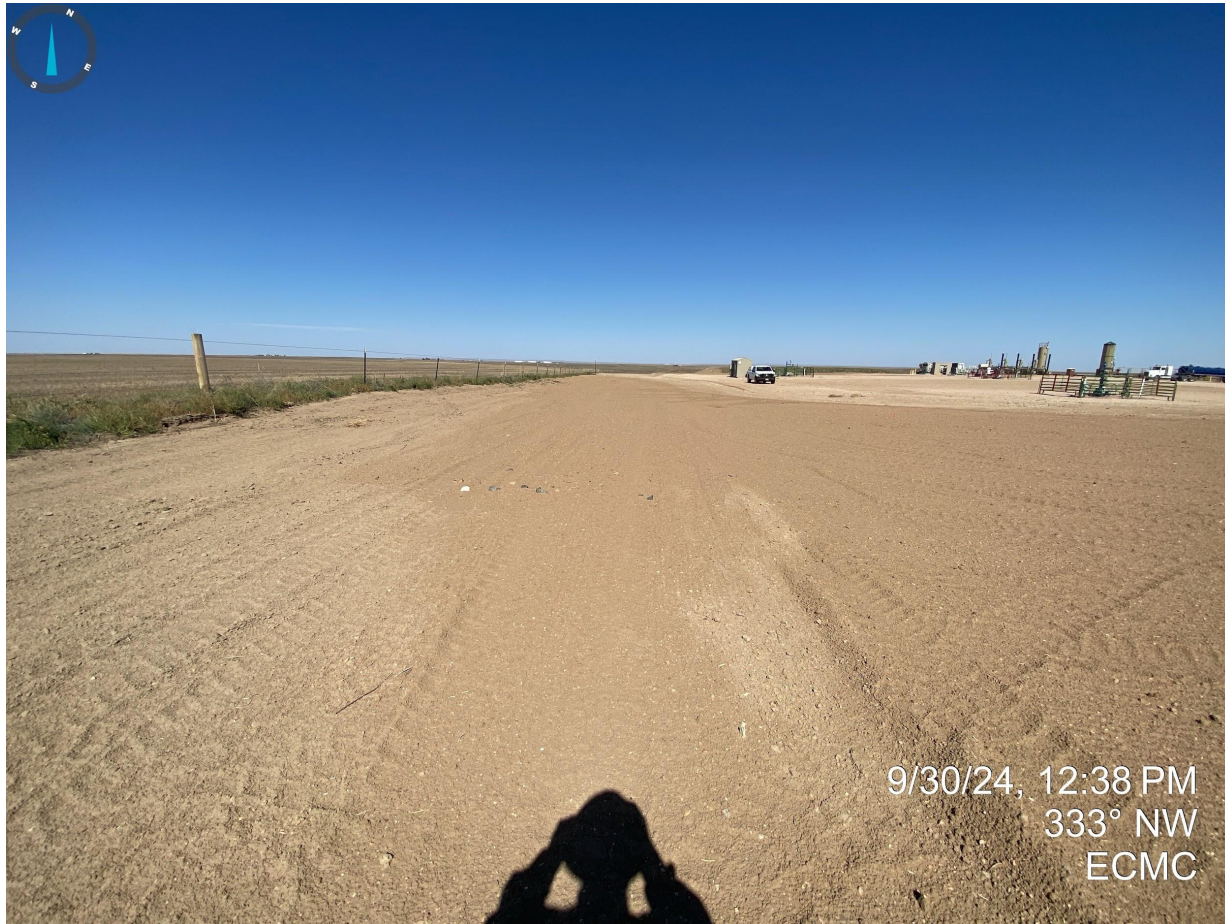
Photo 2. Continued from Photo 1, facing northwest. See comments in Photo 1.

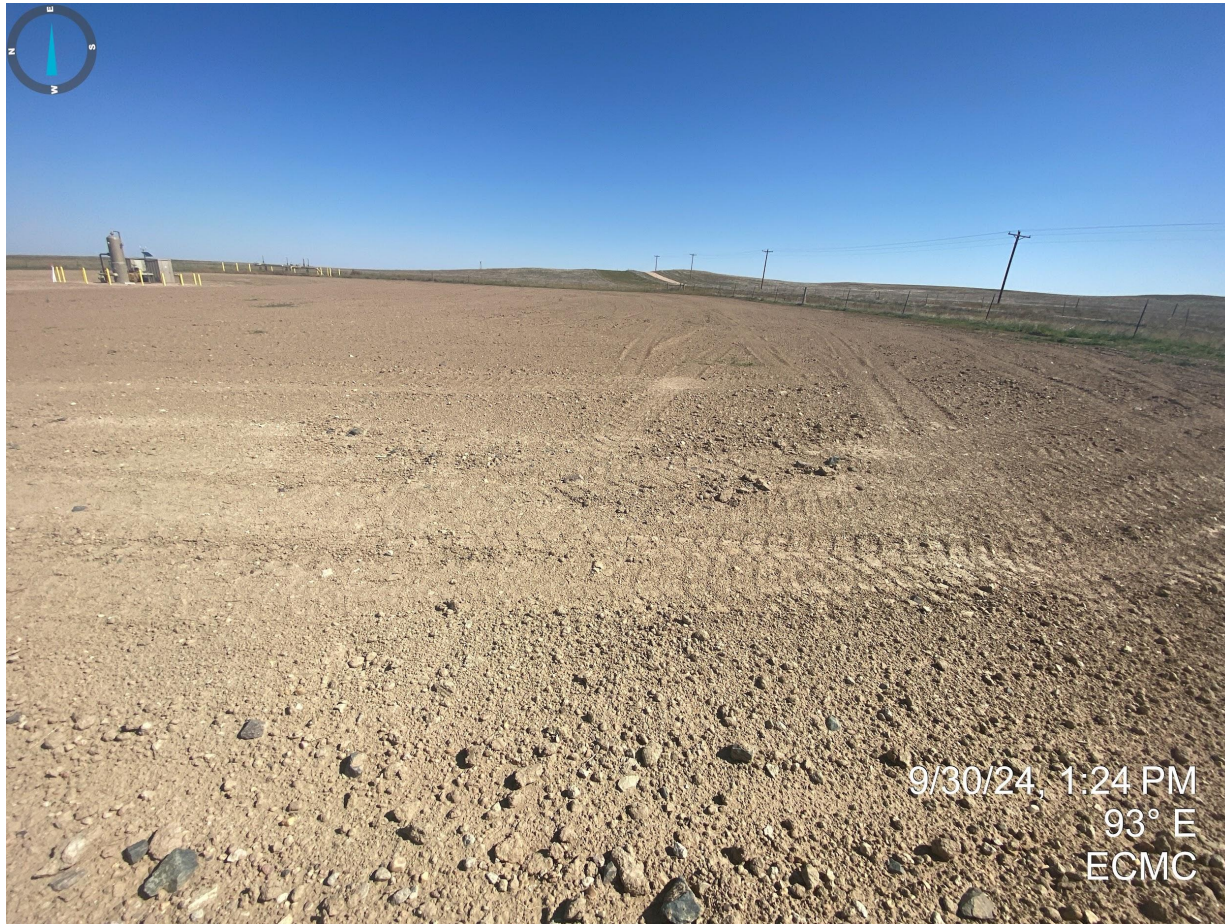
Photo 3. Southeastern interim areas; it appears that topsoil has been imported and spread throughout the interim areas which appear to have been recontoured. No perimeter stormwater controls observed.

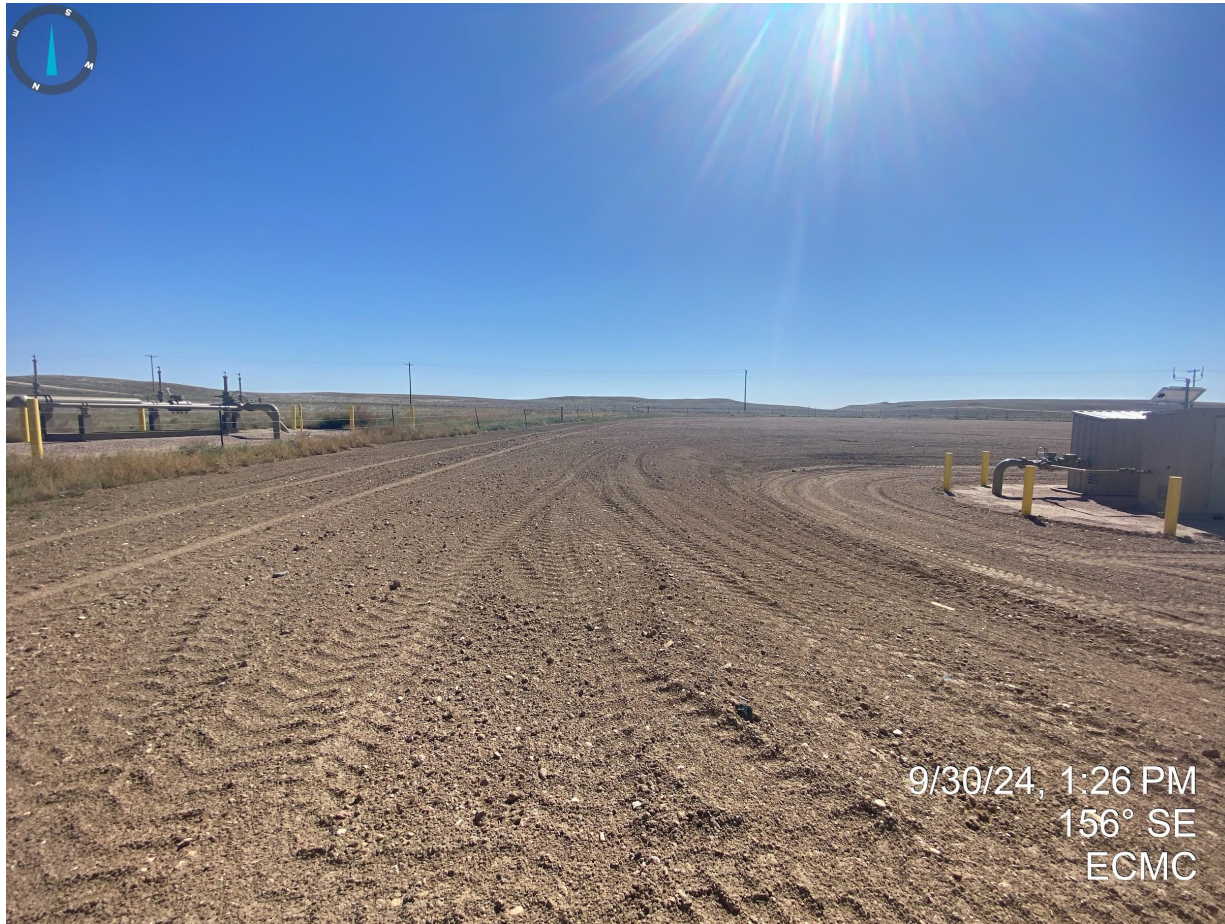
Photo 4. Continued from Photo 3, facing southeast. See comments in Photo 3.

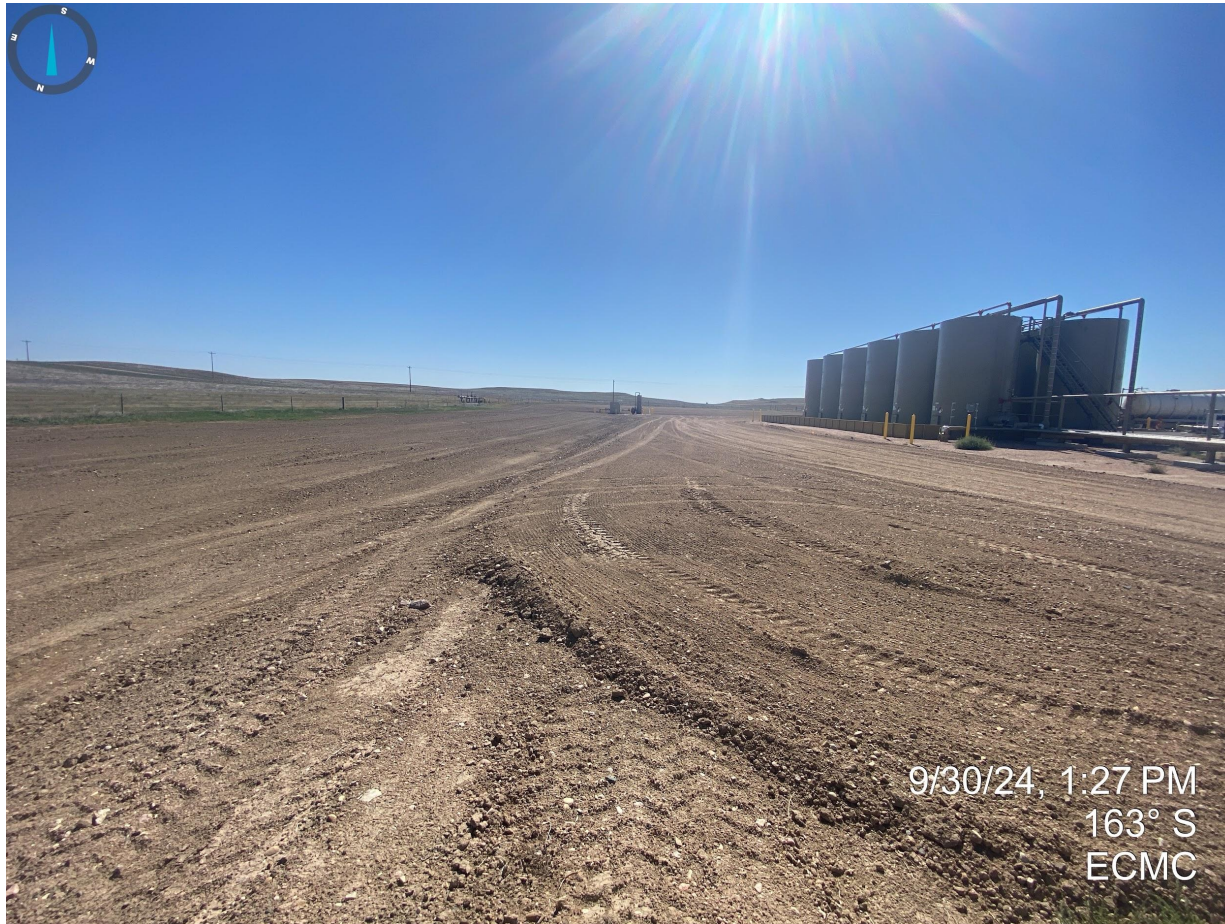
Photo 5. Eastern interim areas; it appears that topsoil has been imported and spread throughout the interim areas which appear to have been recontoured. No perimeter stormwater controls observed.

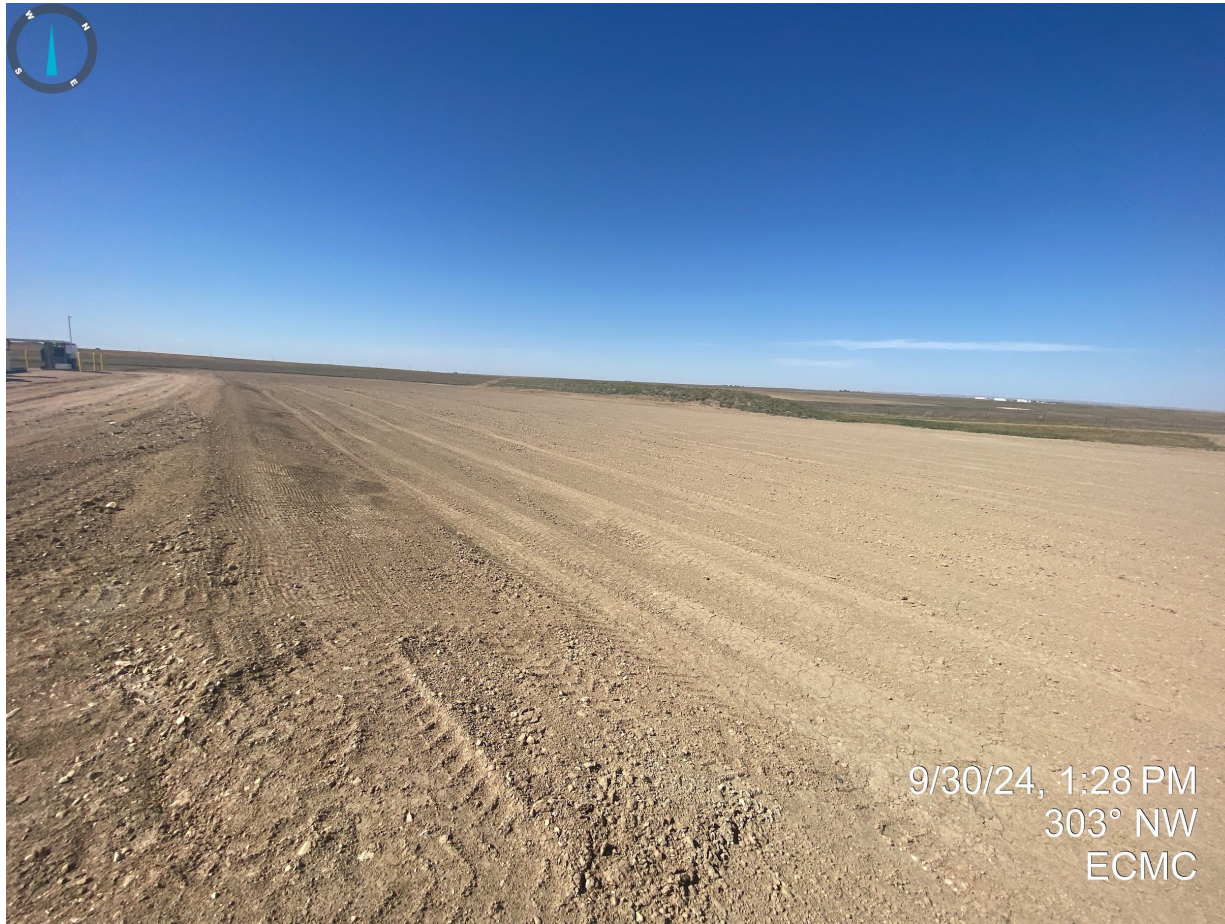
Photo 6. Northern interim areas between production areas and existing topsoil stockpile; it appears that topsoil has been imported and spread throughout the interim areas which appear to have been recontoured.

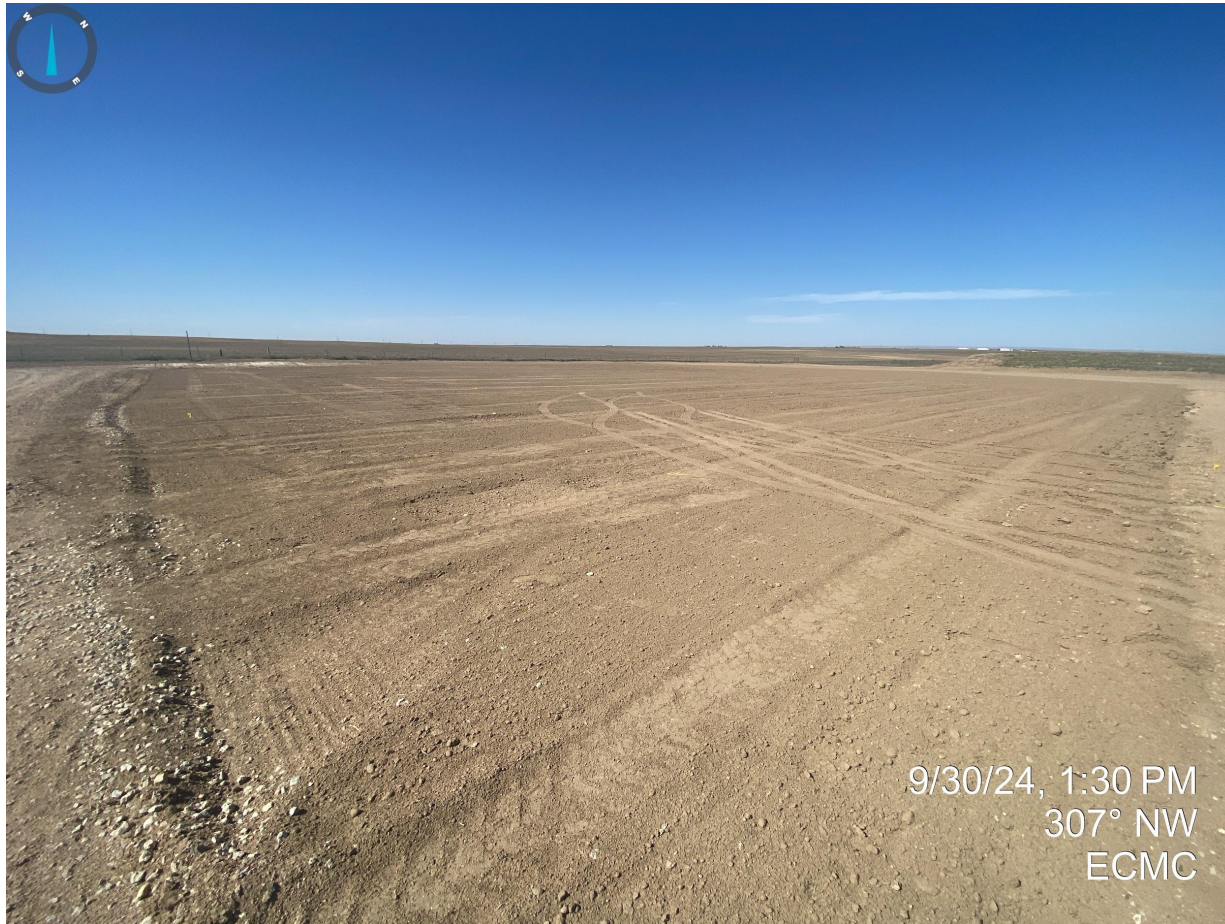
Photo 7. Western interim areas north of the well locations; it appears that topsoil has been imported and spread throughout the interim areas which appear to have been recontoured.

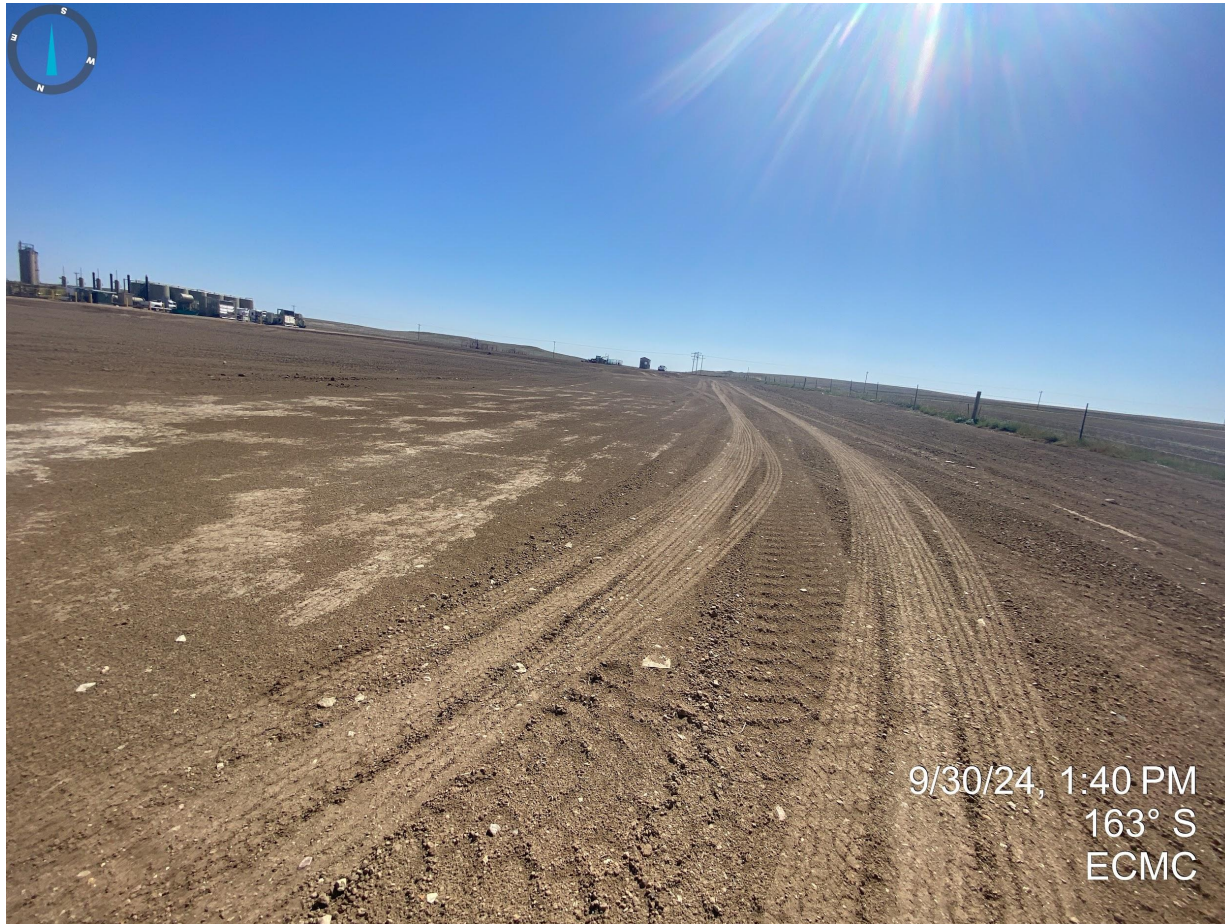
Photo 8. Western interim areas; it appears that topsoil has been imported and spread throughout the interim areas which appear to have been recontoured. No perimeter stormwater controls observed.

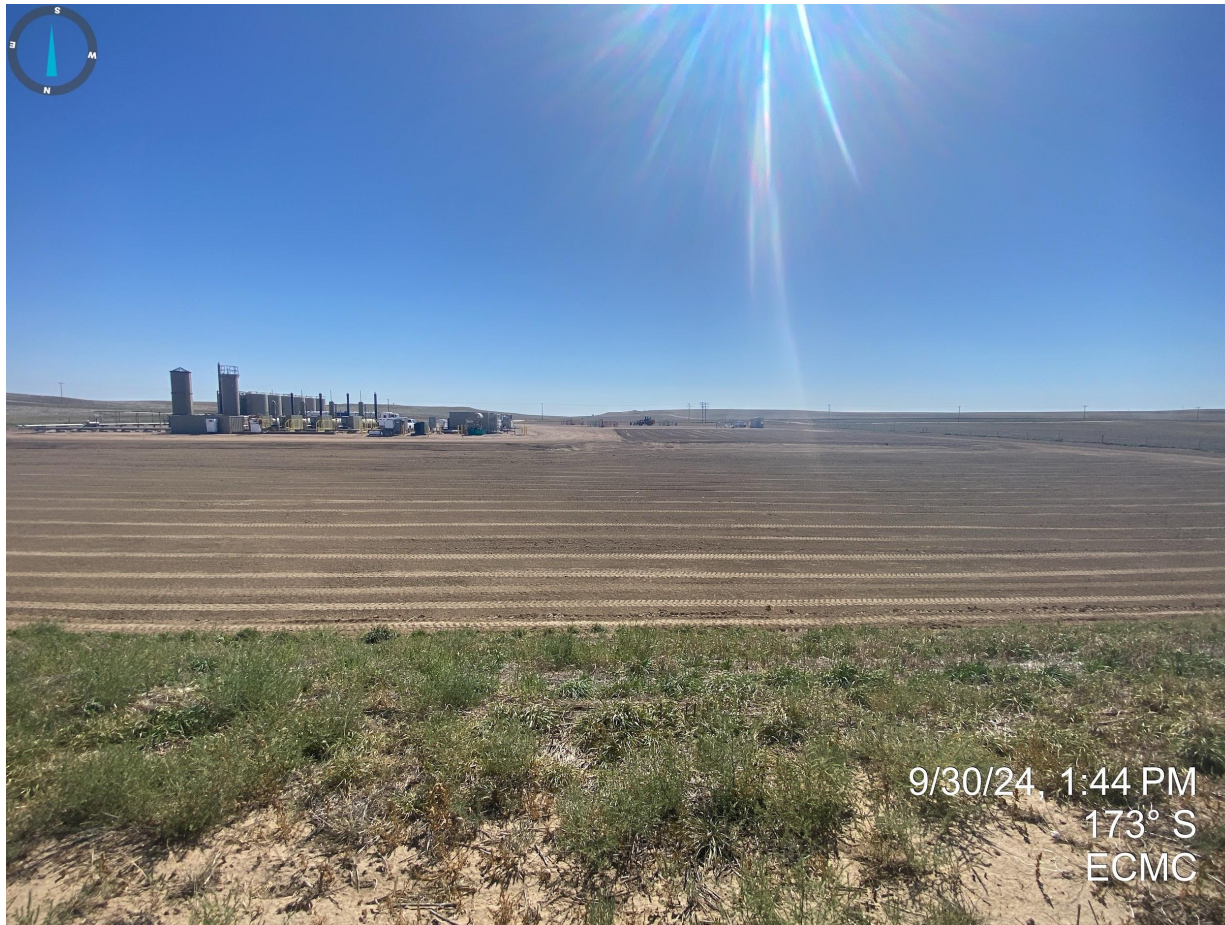
Photo 9. Overview of northern interim areas, facing south from the top of the existing topsoil stockpile.

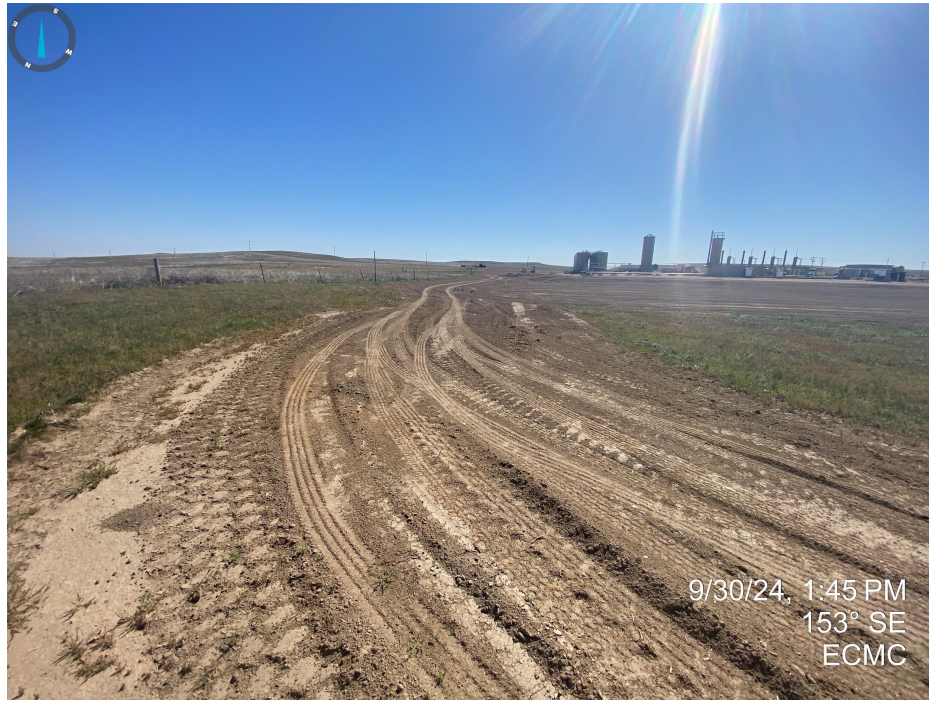
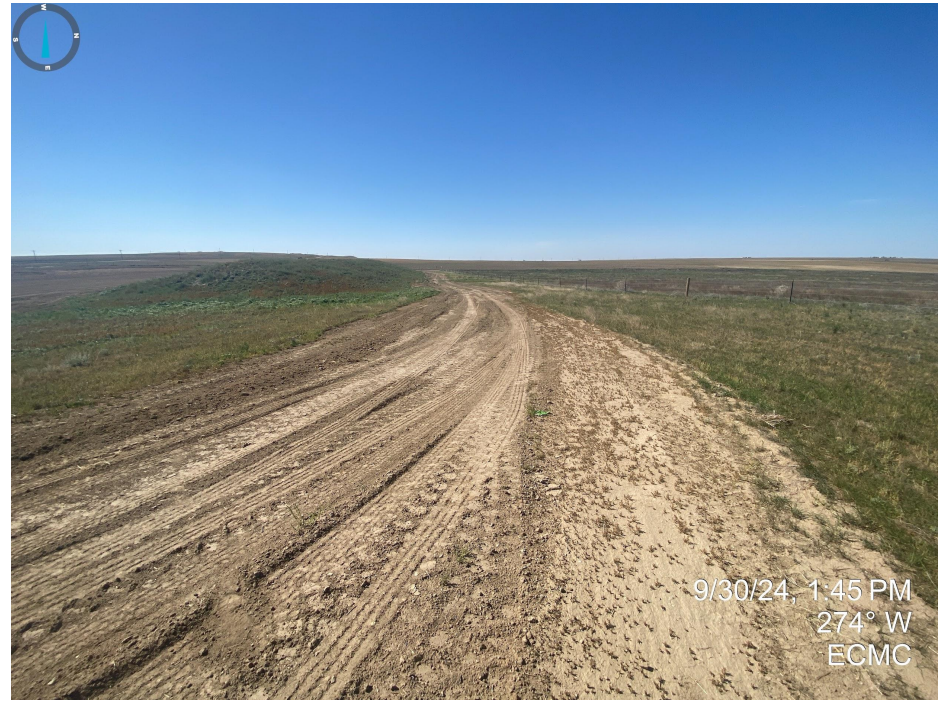
Photos 10 & 11. Taken near the northeastern portion of the location. Perimeter stormwater control measures appear to have been removed with no apparent control measures/BMPs installed since the previous inspection.

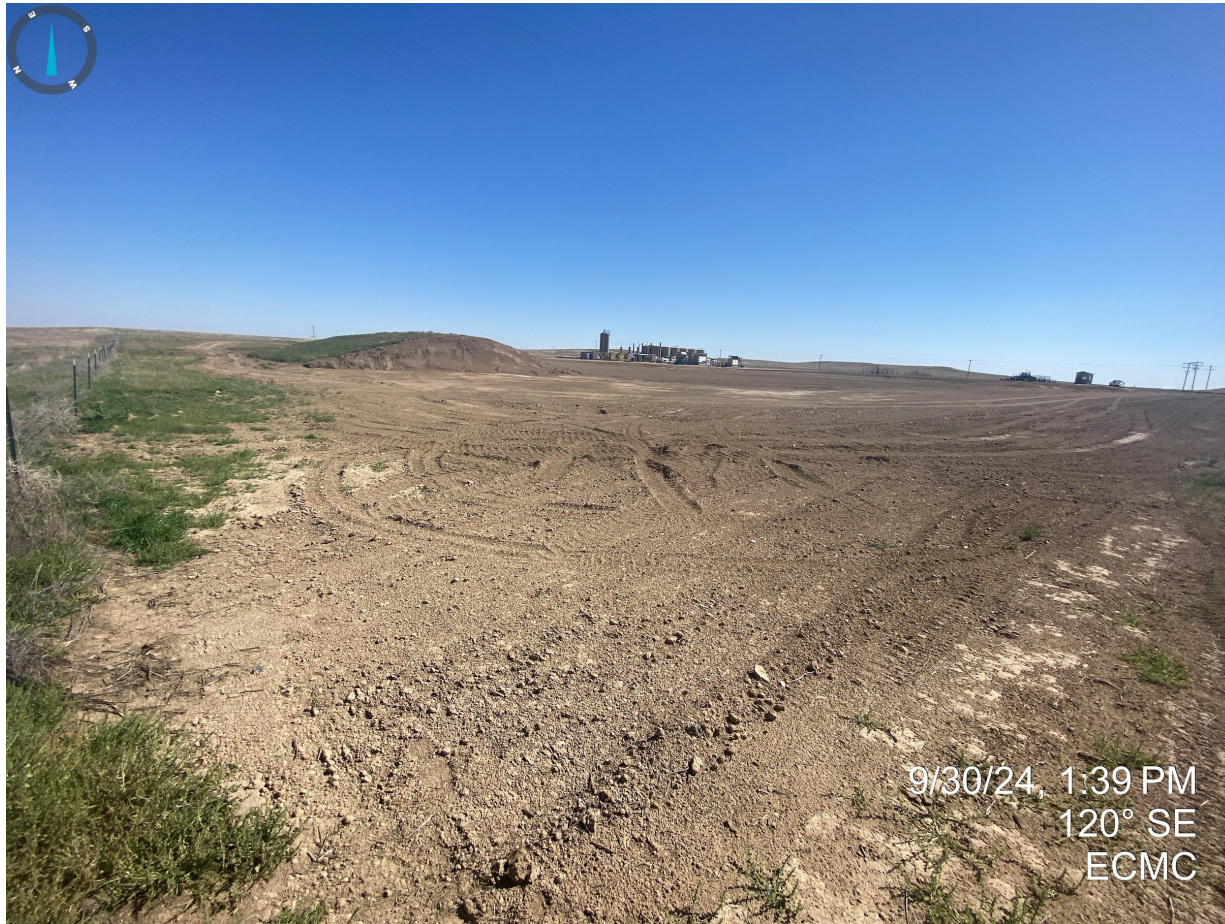
Photo 12. Taken near the northwest corner of the location. Perimeter stormwater control measures appear to have been removed with no apparent control measures/BMPs installed since the previous inspection.

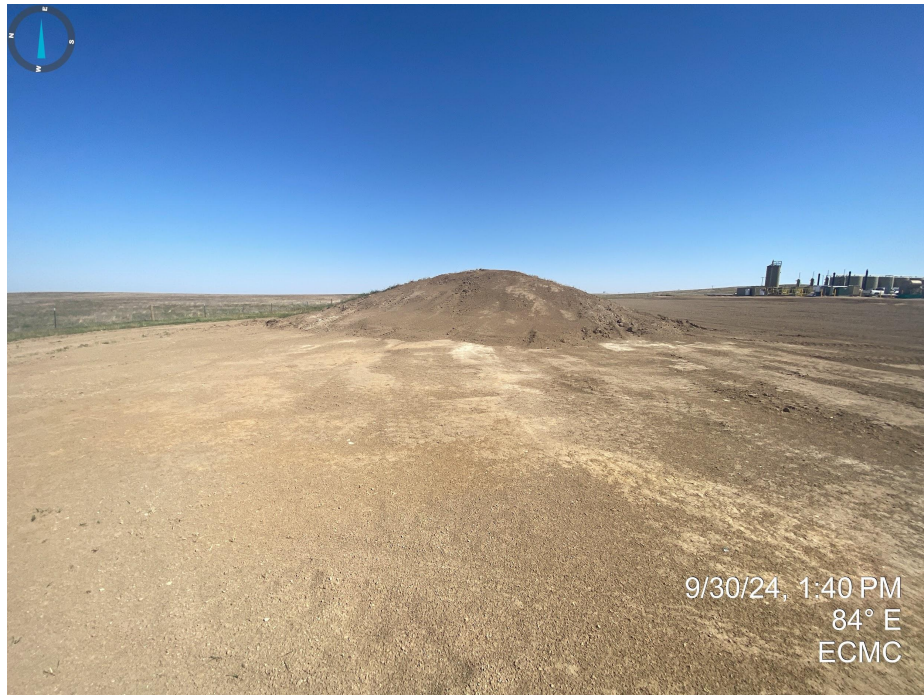
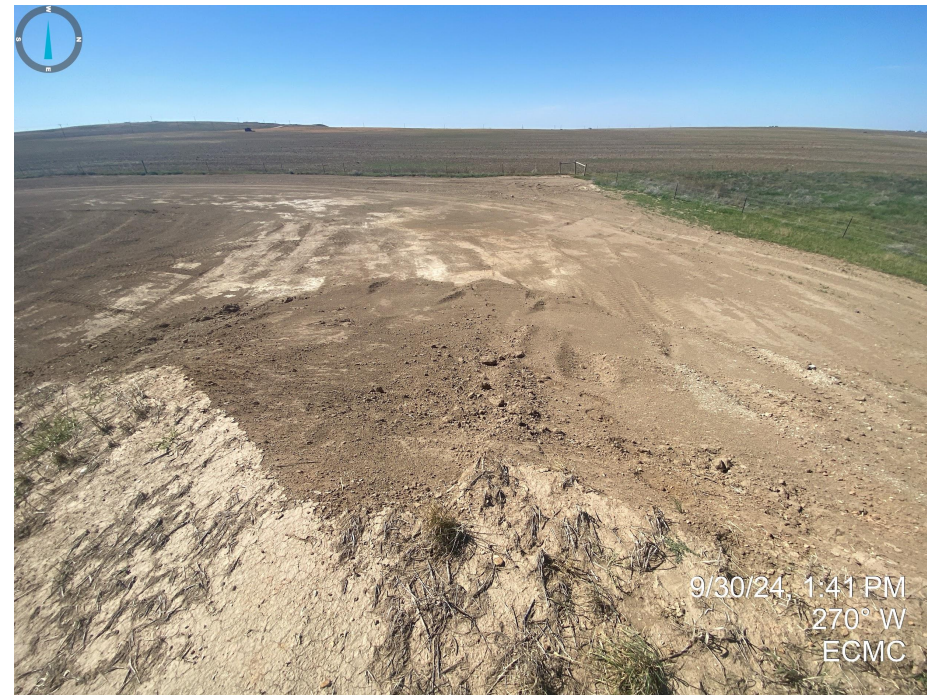
Photos 13 & 14. It appears that topsoil has been removed from the existing stockpile area (western side).

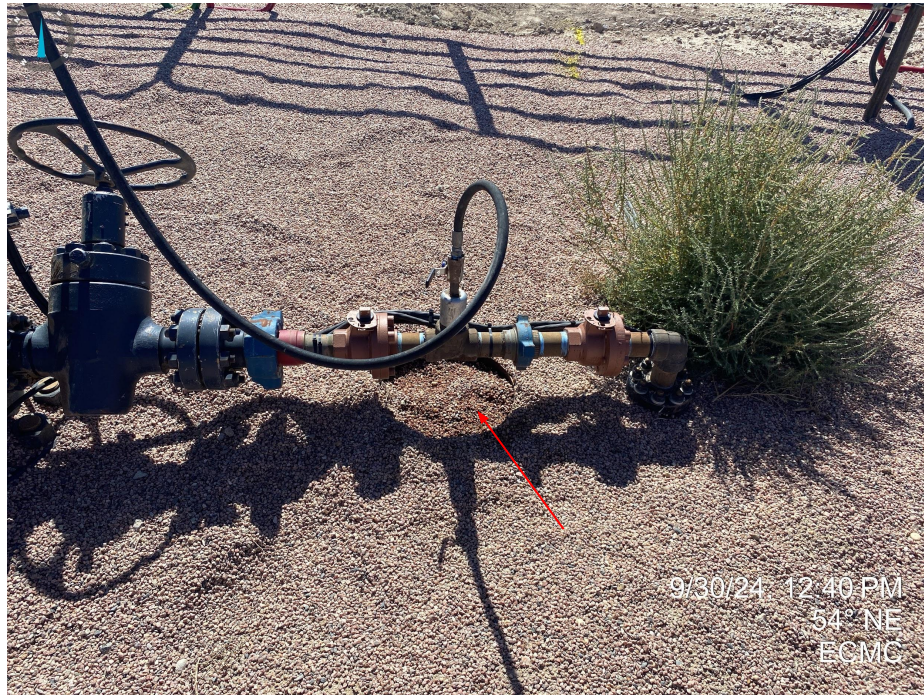
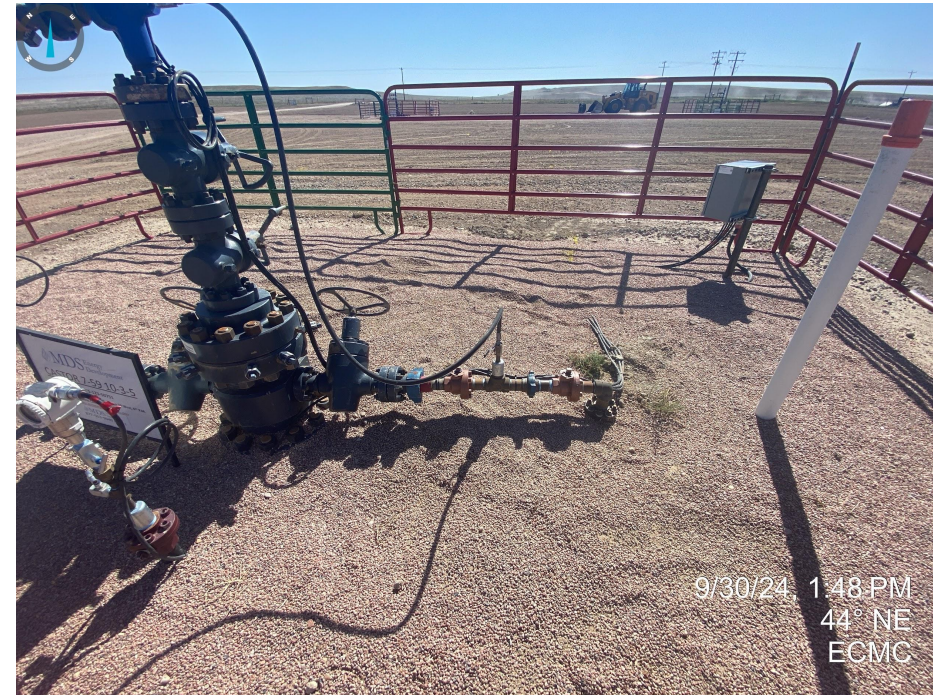
Photos 15 & 16. Staff observed that stained soil/gravel remained at the rat hole near the wellhead (left photo). While on site, Staff showed/explained the stained soil to on-site Lease Operator (Alec) who advised Staff that it would be cleaned up that same day. Before leaving the location, Staff re-inspected the rat hole and it appeared that the stained soil was removed and backfilled with fresh gravel (right photo).

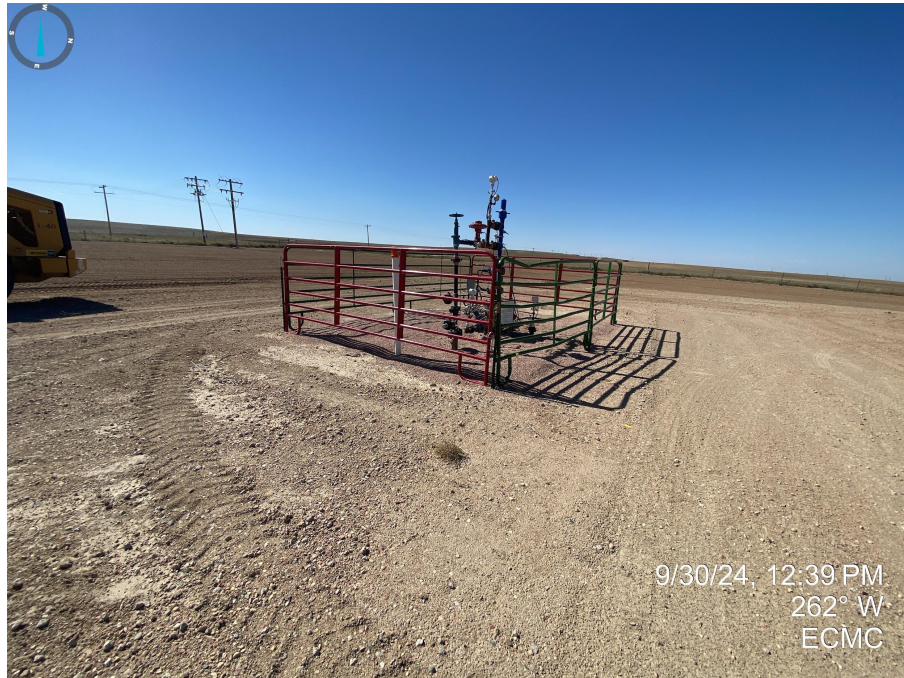
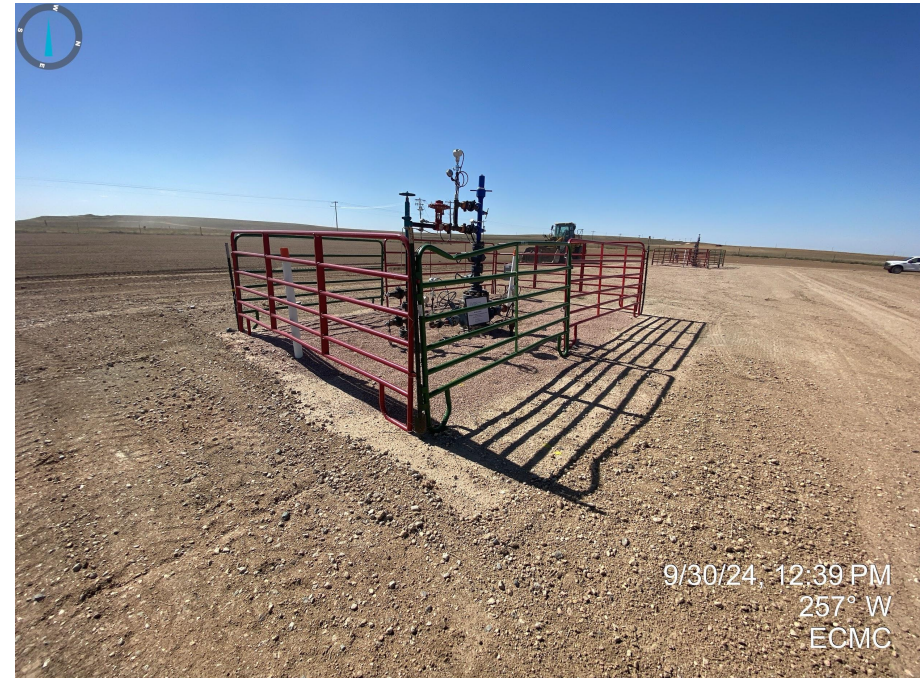
Photos 17 & 18. Subsidence previously observed around wellheads appears to have been backfilled.

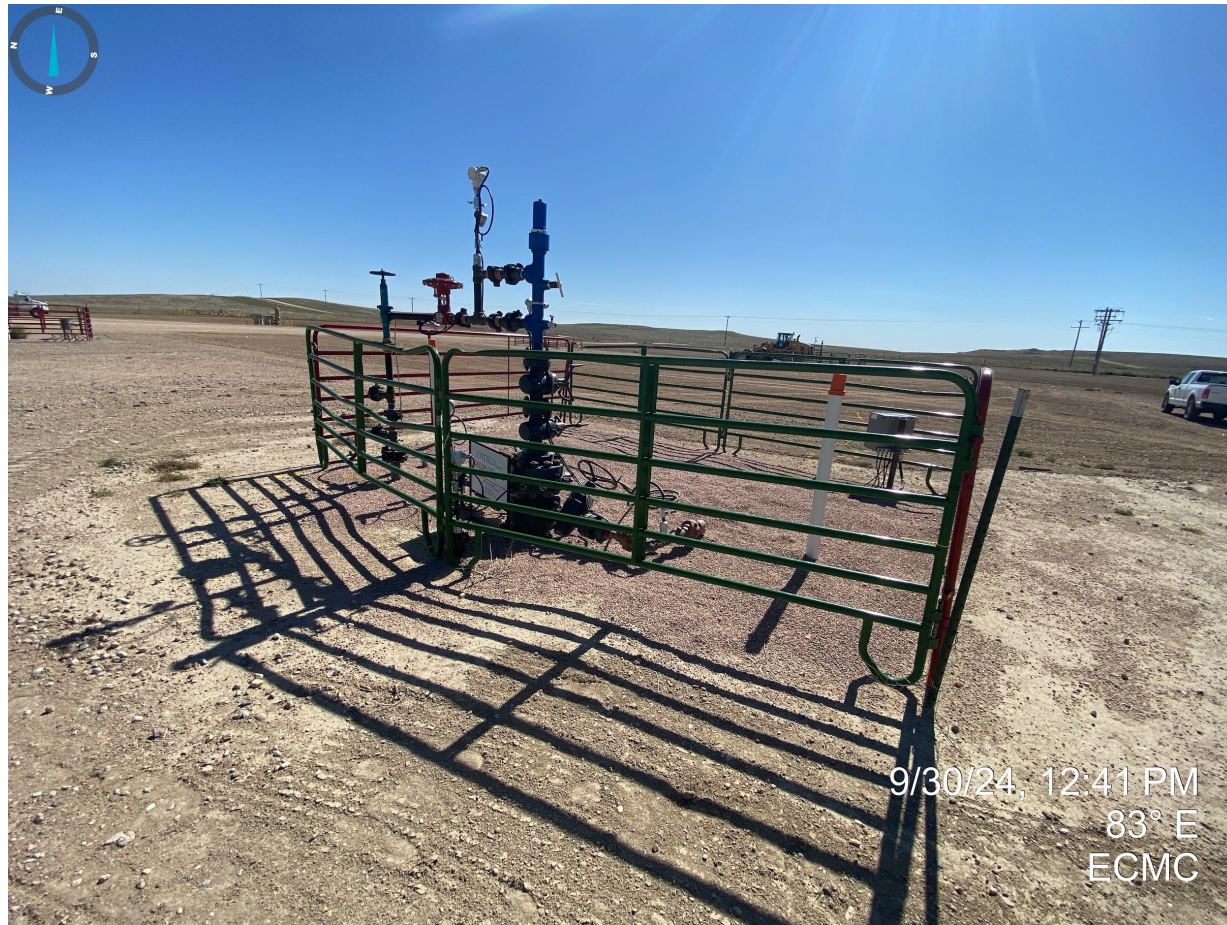
Photo 19. Subsidence previously observed around wellheads appears to have been backfilled.

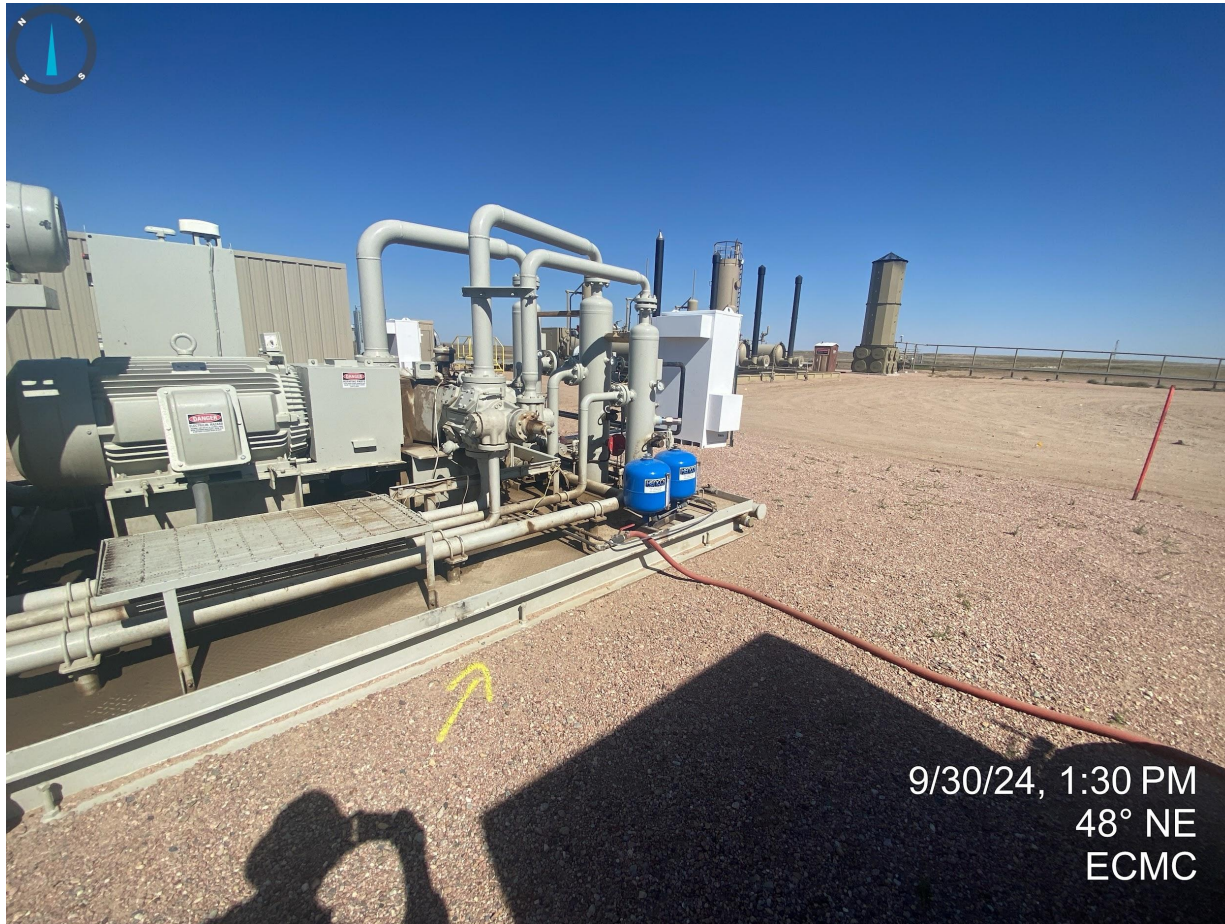
Photo 20. 5 gallon bucket appears to have been removed from the location.

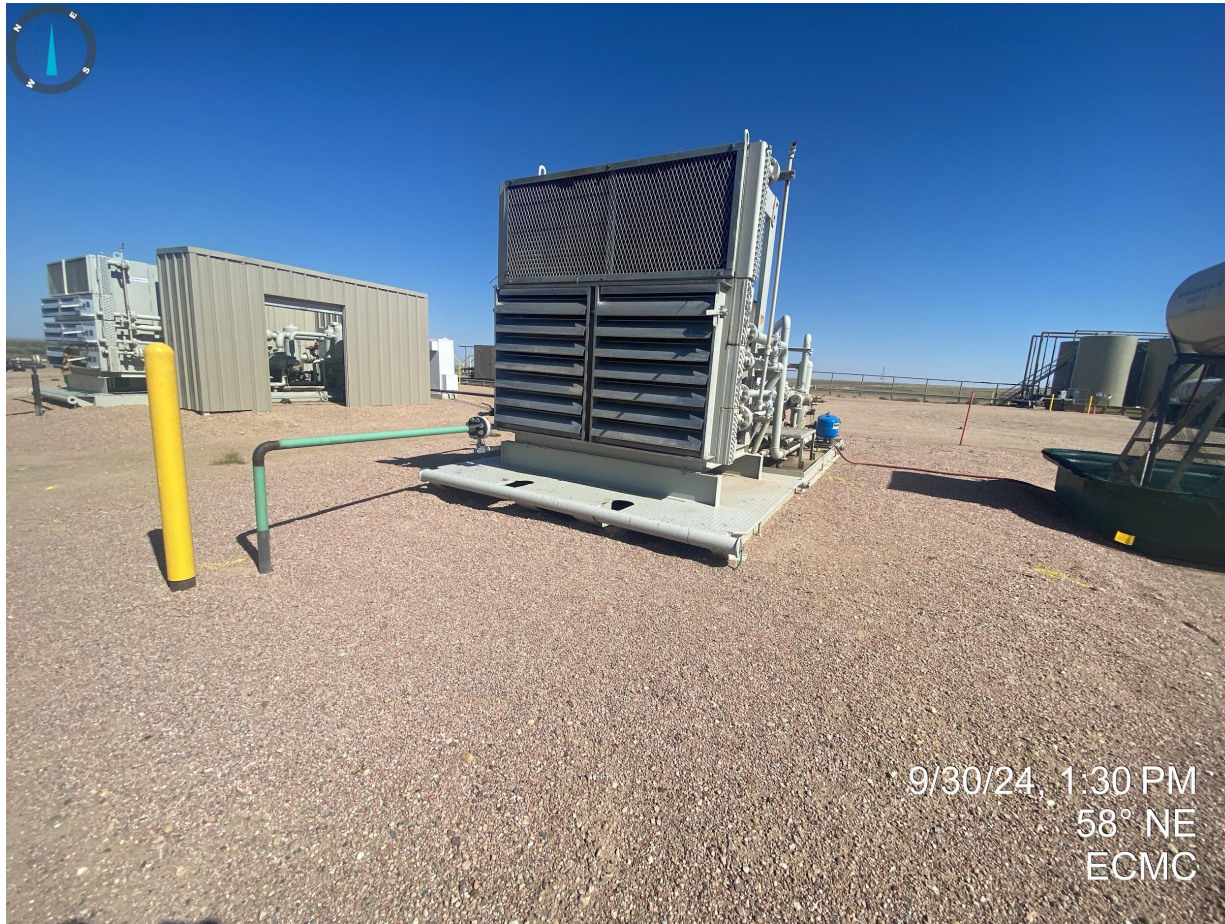
Photo 21. Stained soil previously documented around compressor appears to have been removed.

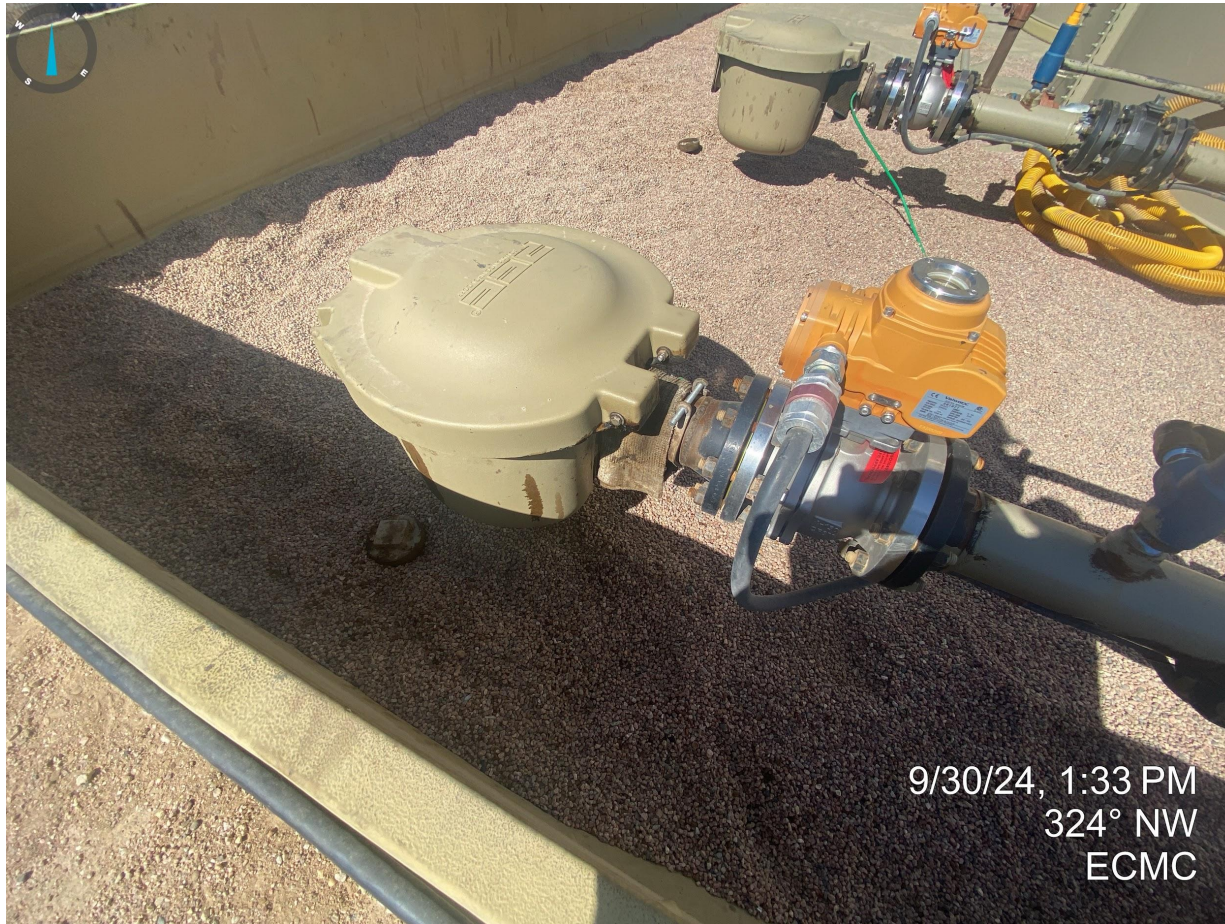
Photo 22. Stained soil previously documented near loadout lines appears to have been removed; trace amounts of stained pea gravel still remains. Operator shall continue to monitor and mague the location for stained soils and implement appropriate BMPs where necessary.
