Inspection Photos

Location Name: FLETCHER GULCH 34-41

Location ID: 316606

Inspection Date: September 24, 2024

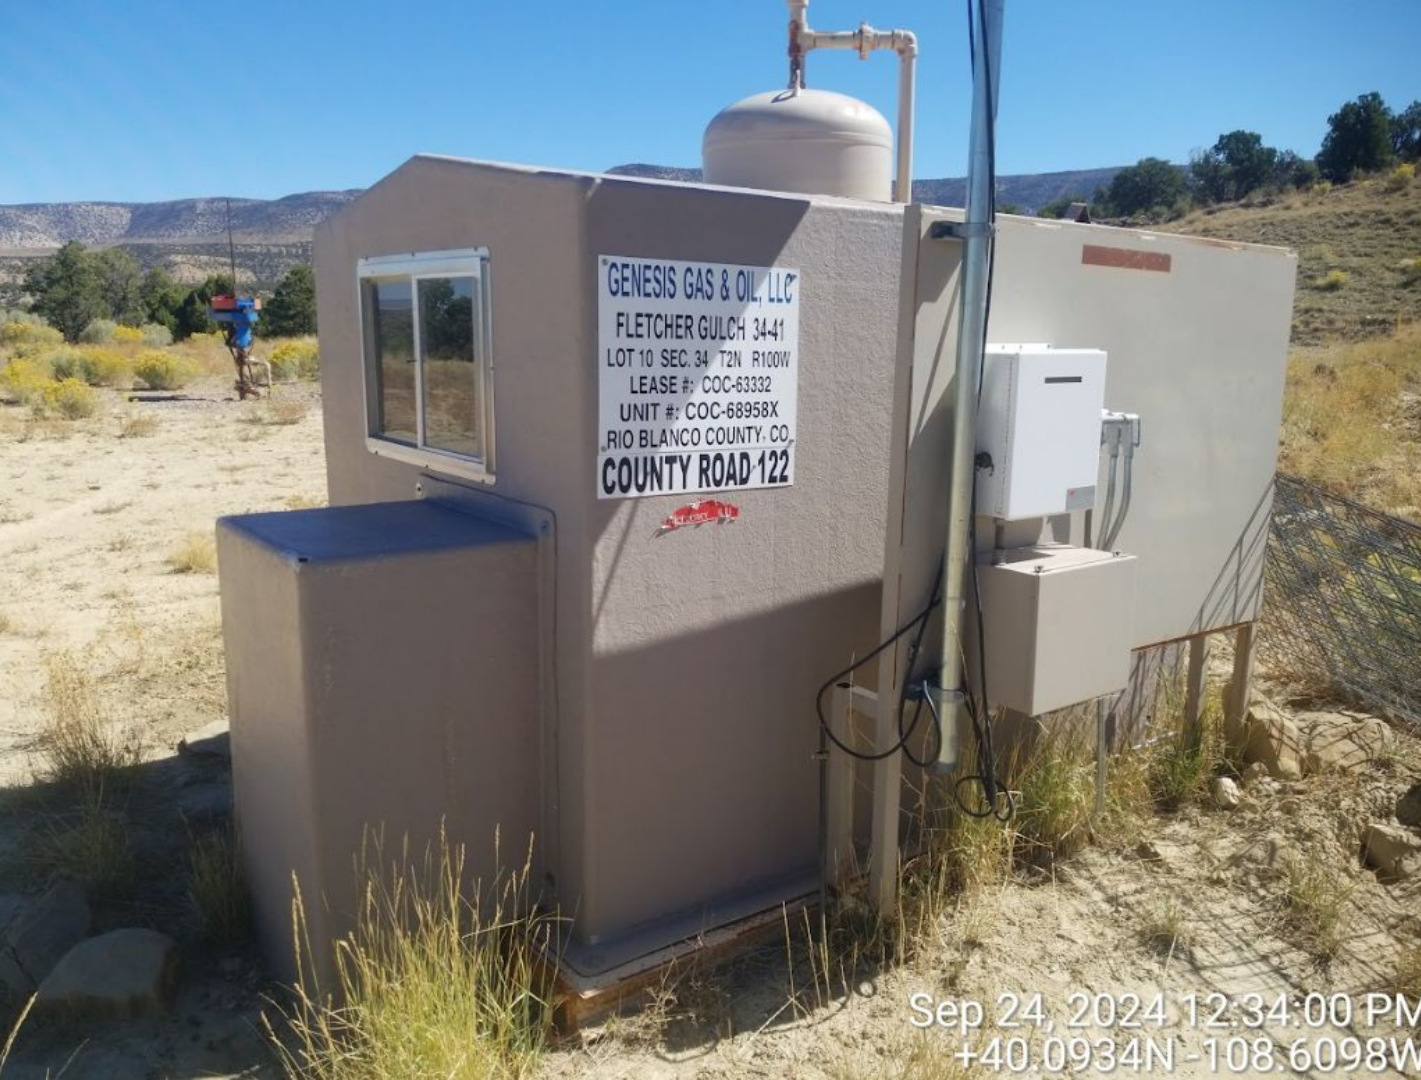
Location sign, meter  
house.

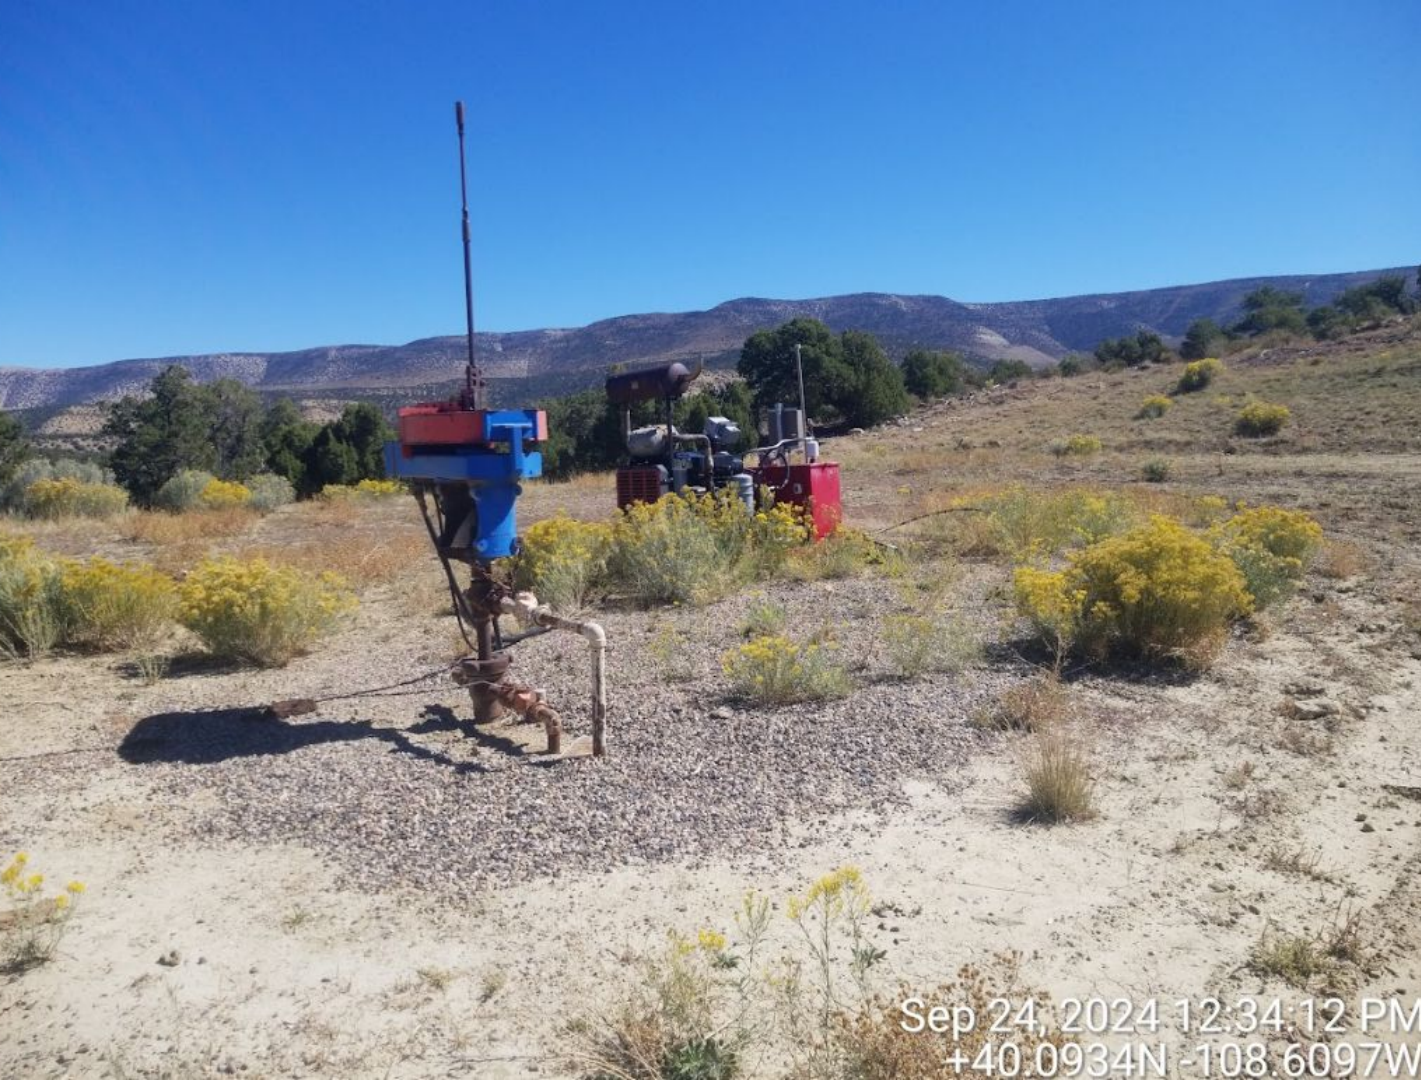
Wellhead and  
compressor.

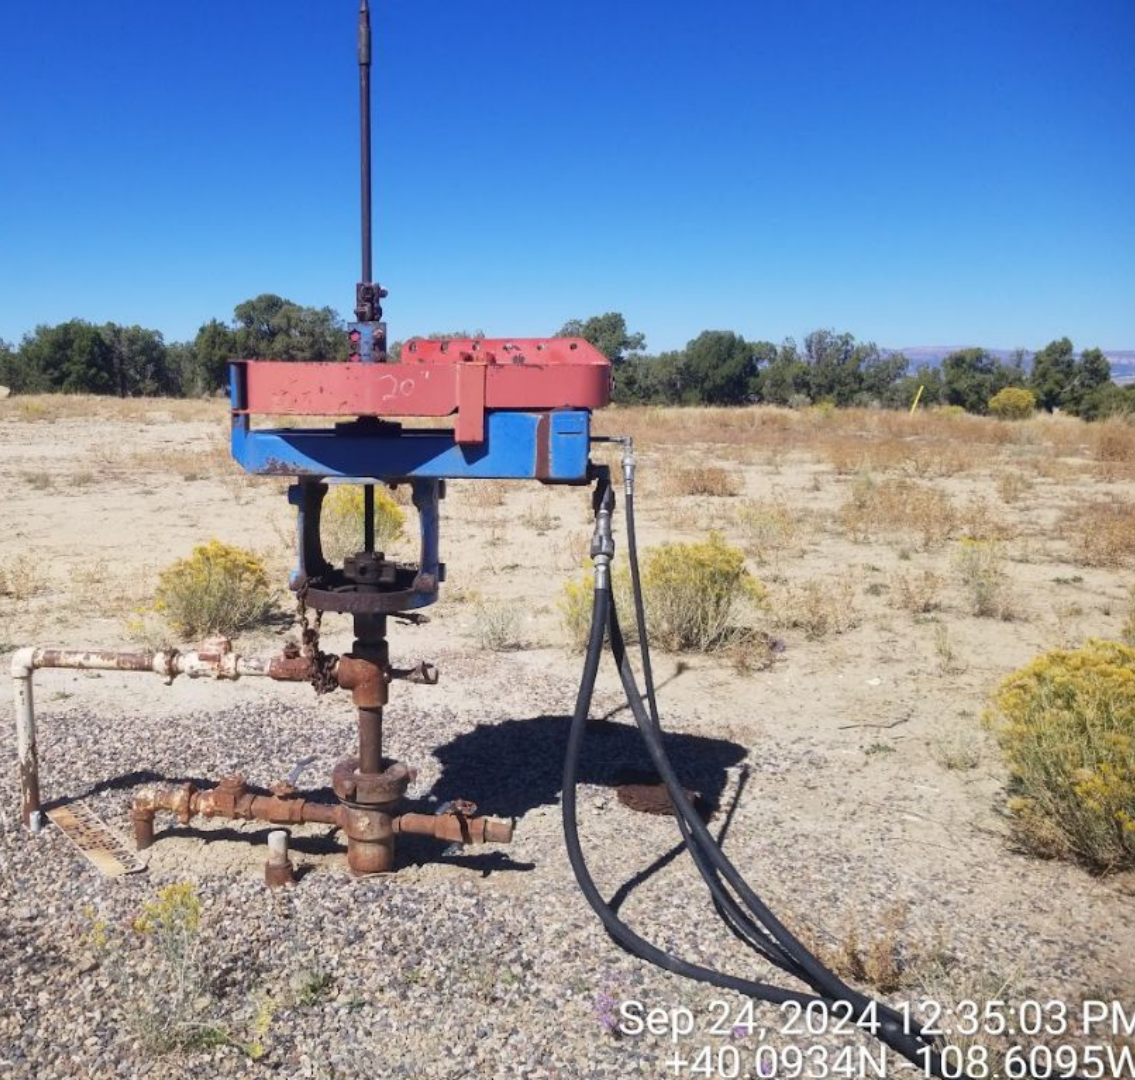
Wellhead.

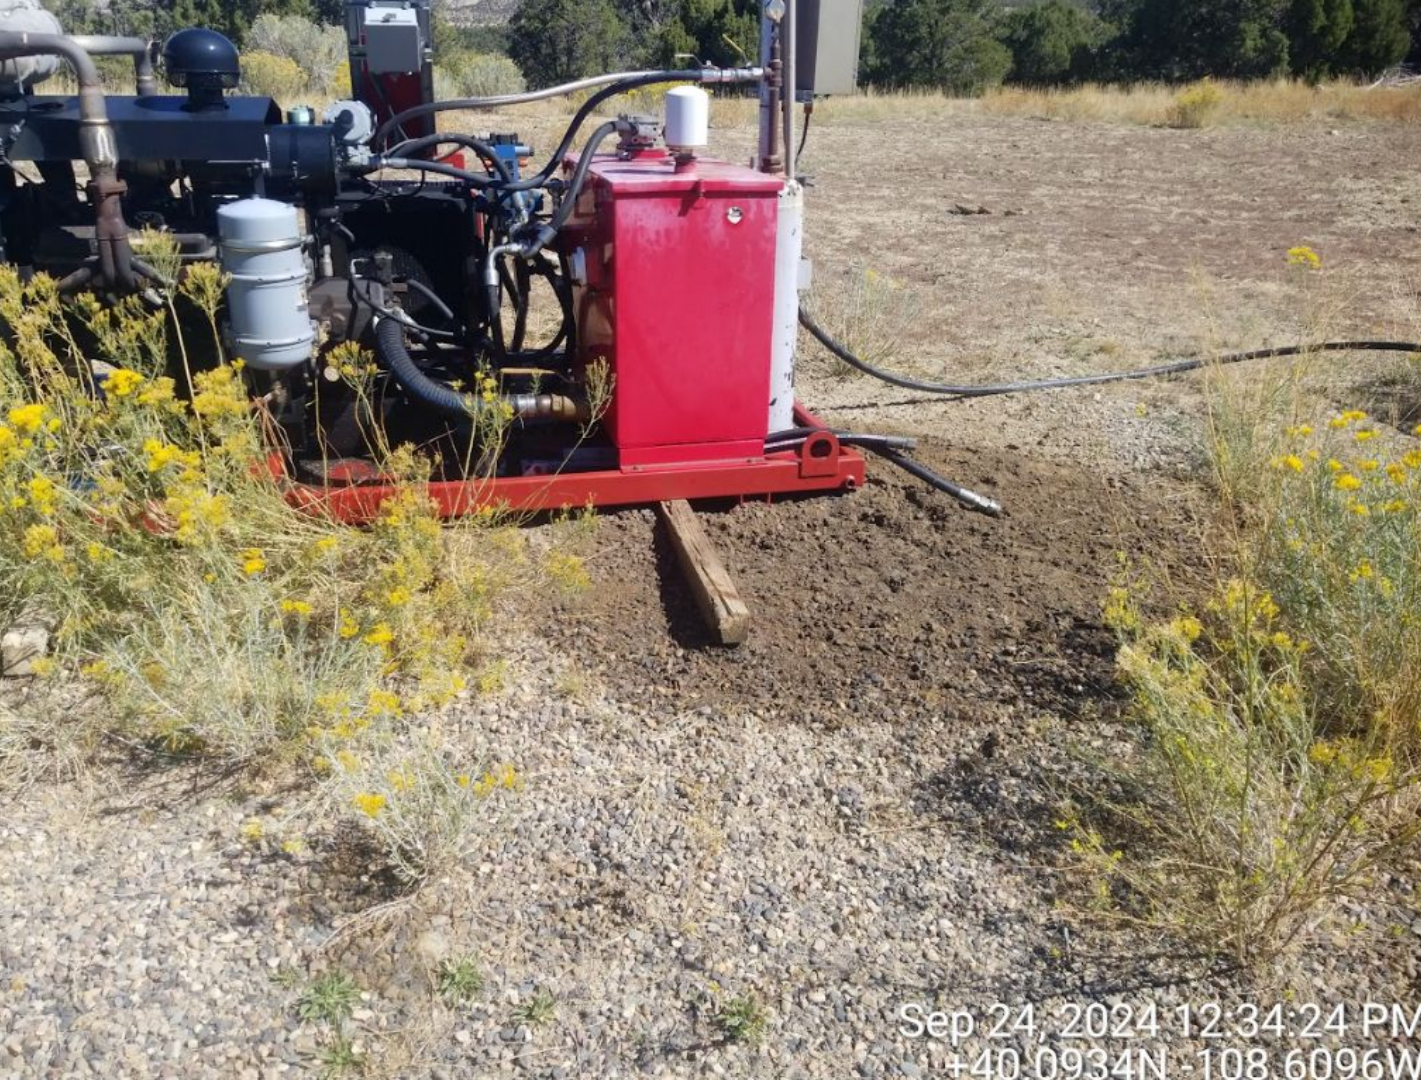
Potentially impacted  
material adjacent to the  
compressor.

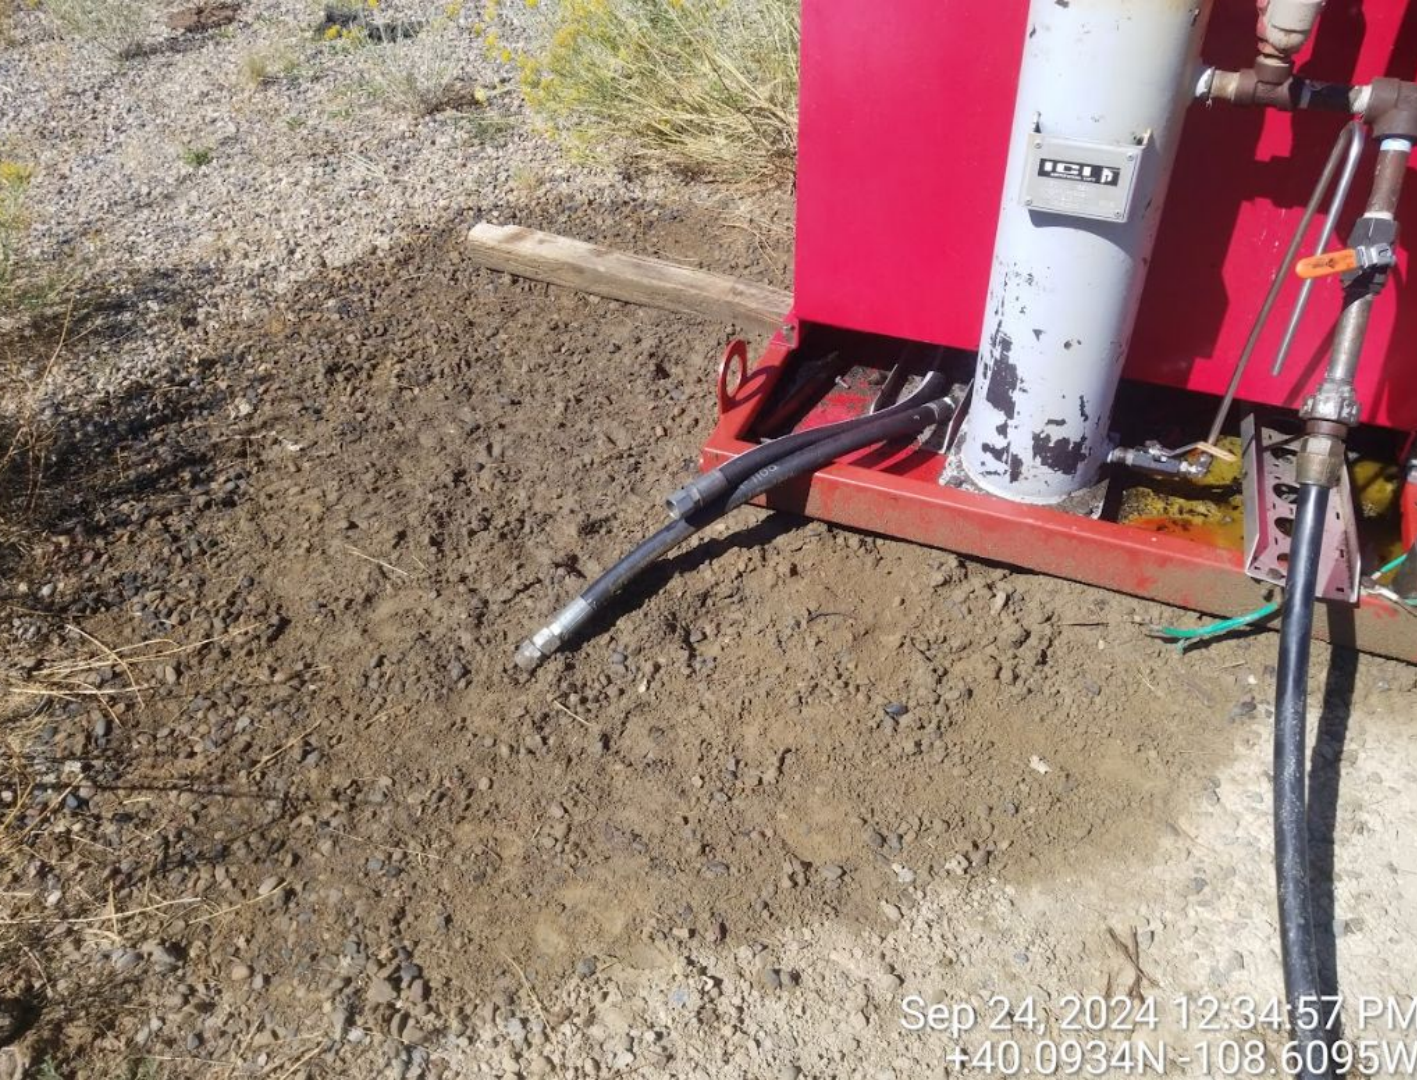
Potentially impacted  
material adjacent to the  
compressor.

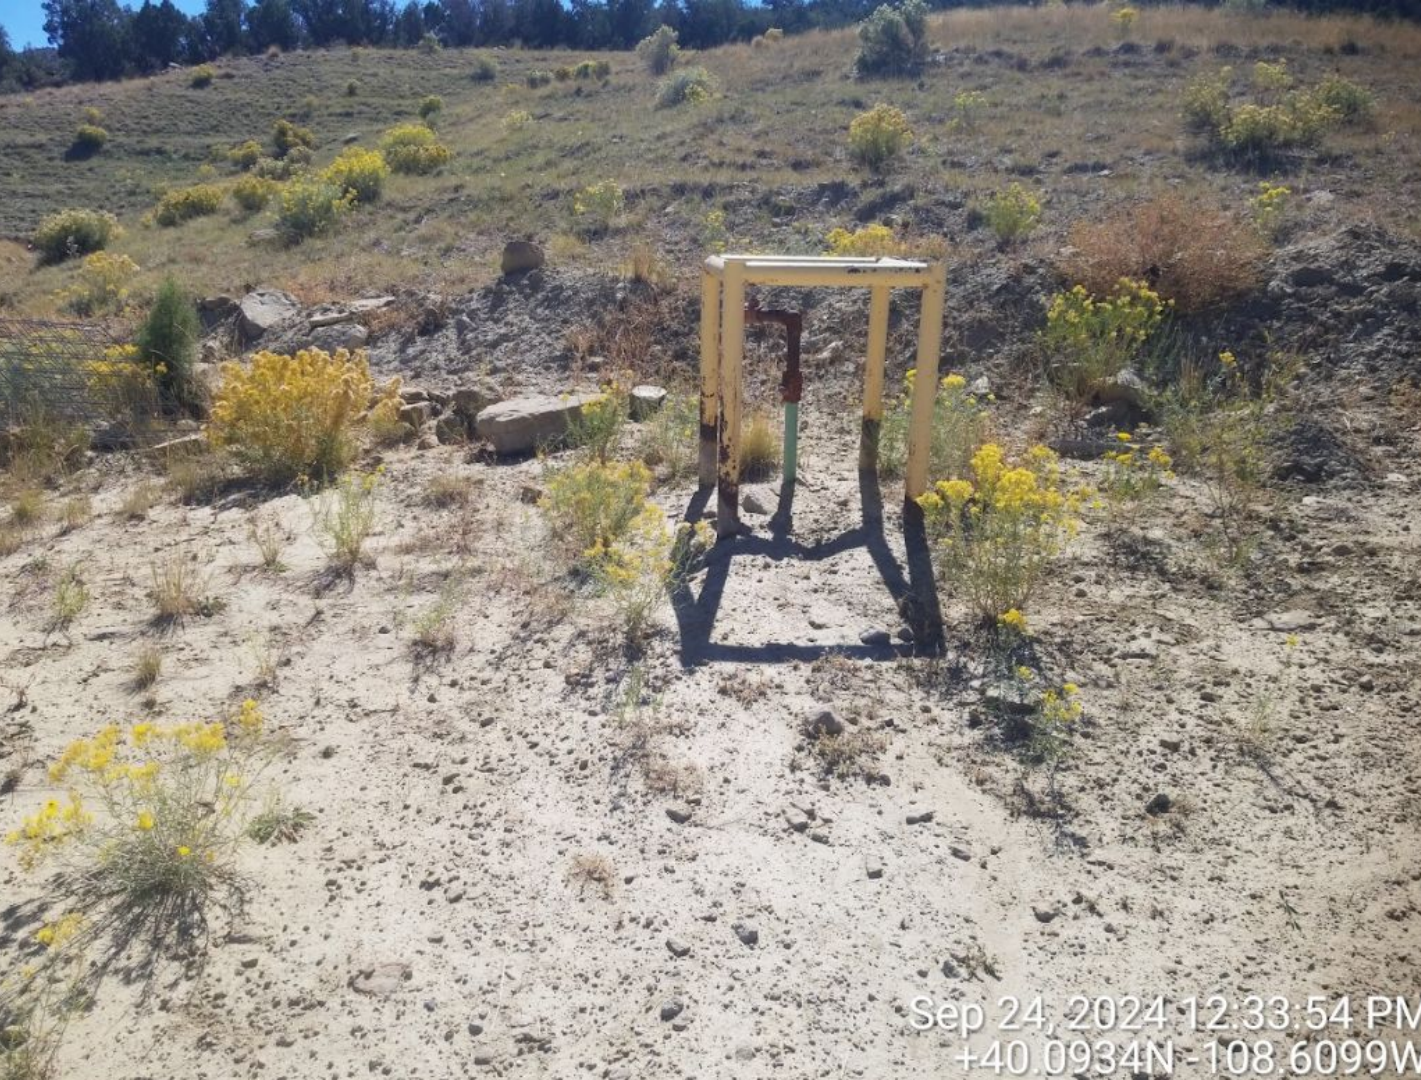
Improper abandonment of flowline or crude oil transfer line (not purged, depressurized, risers cut 3' below grade, ends sealed, equipment removed) per 1105.
