Inspection Photos

Loc: 322234

Operator: **INCREMENTAL OIL & GAS (FLORENCE) LLC**

Inspection Date: 10/9/2024

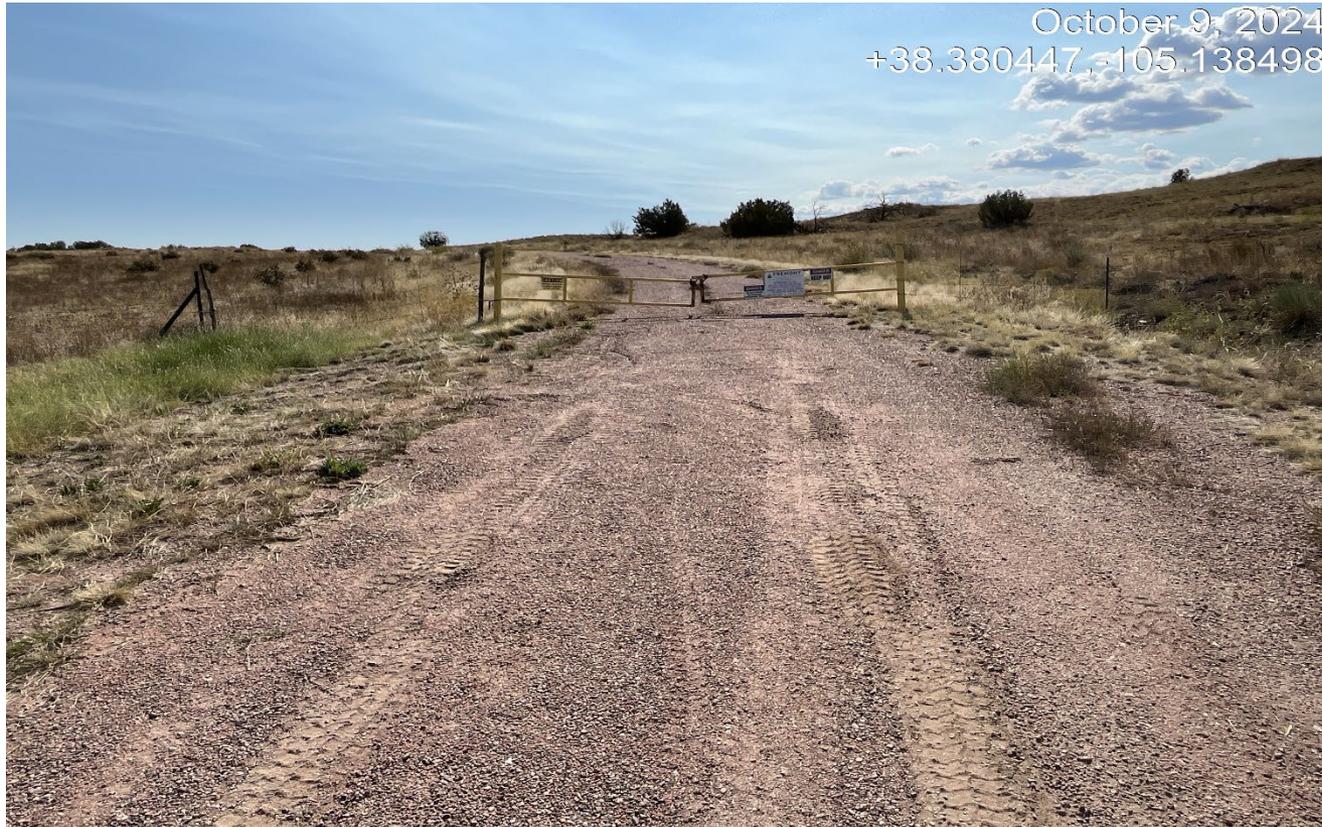
Photo 1. Facing southeast at the beginning of the access road. The access road has not been reclaimed.

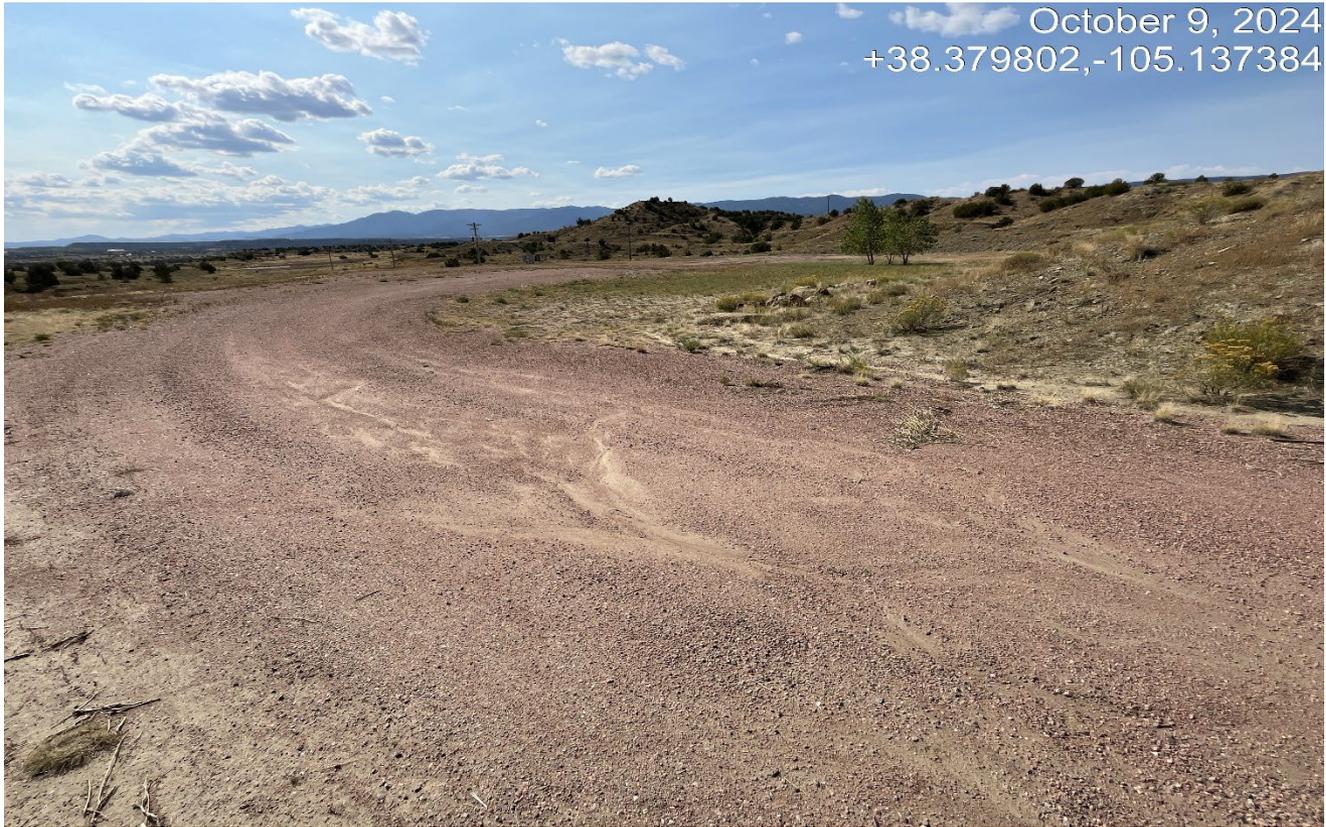
Photo 2. Facing south toward the location. The well has been plugged and abandoned however final reclamation has not yet been completed.

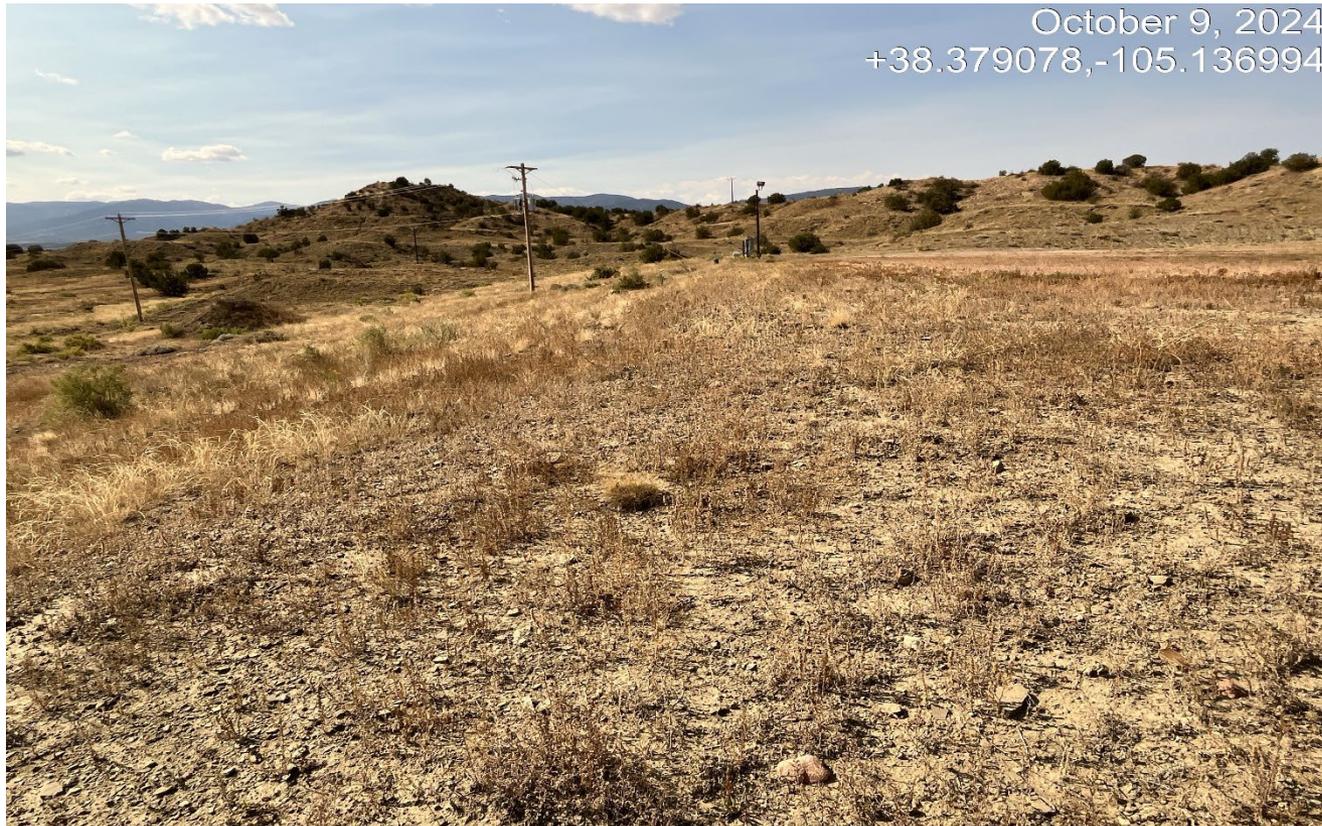
Photo 3. Facing southwest along the fill slope. The location will need to be recontoured back to the original slopes

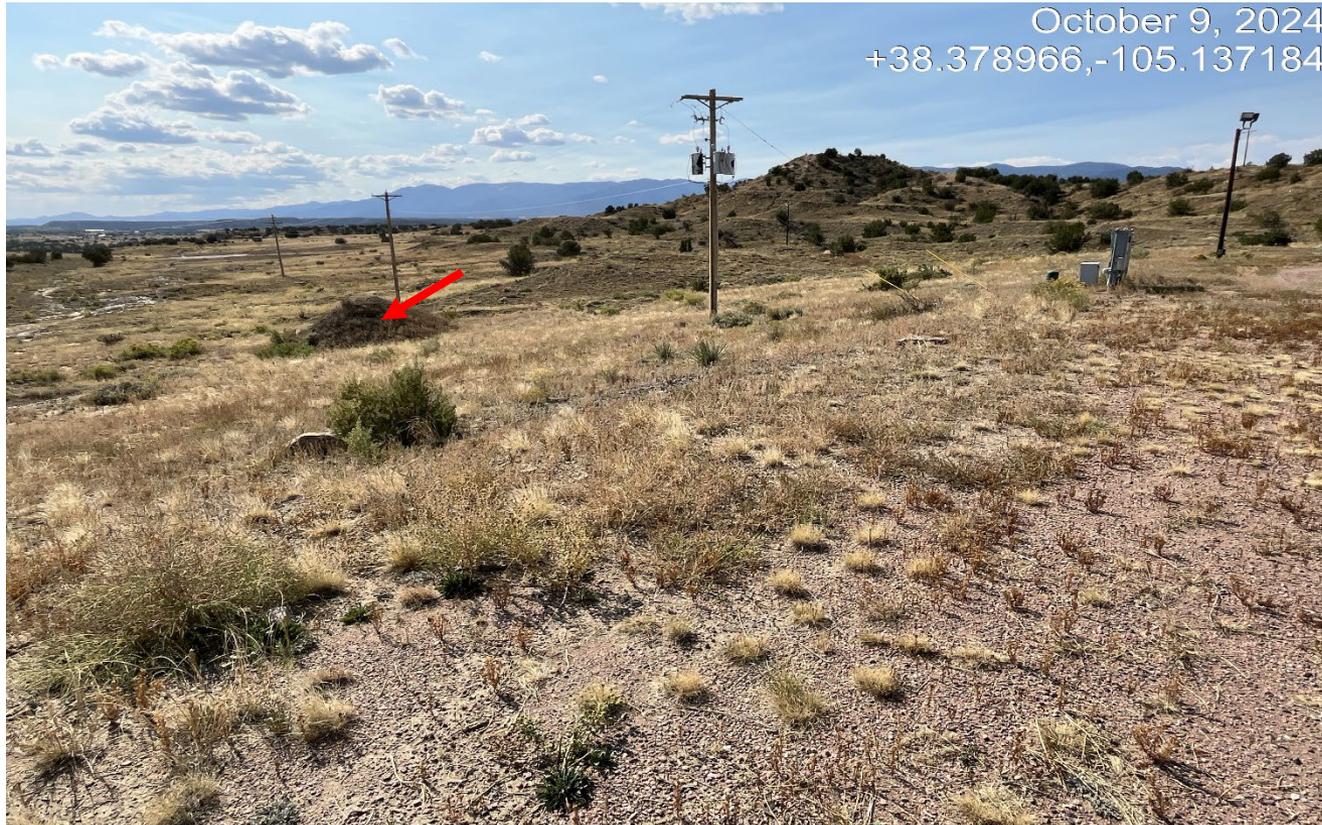
Photo 4. The electric utilities remain at the location and should have been removed with 3 months of abandonment. The entire powerline and poles servicing this location must be removed. There is a topsoil pile shown at red arrow.

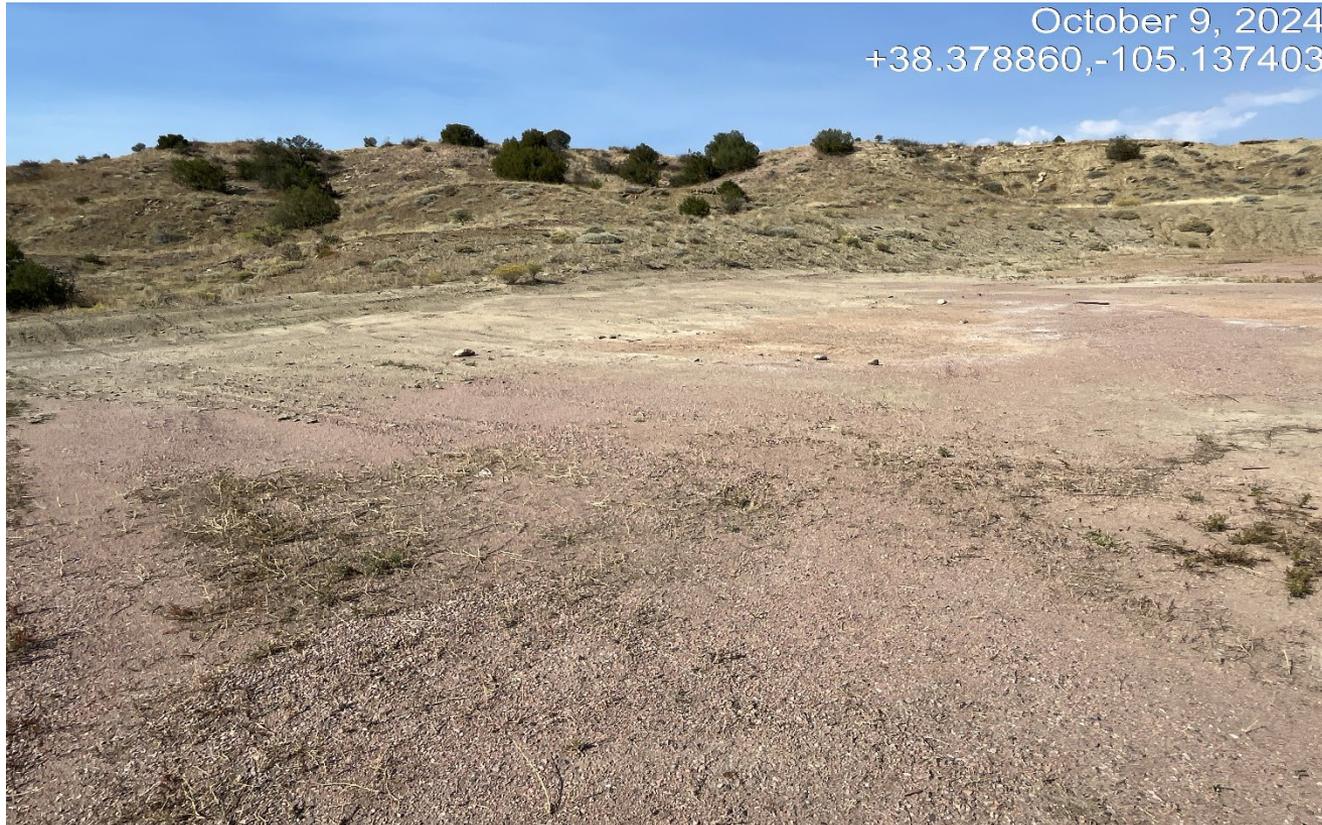
Photo 5. Facing toward the south side of the location. The tanks have been removed since the previous inspection.

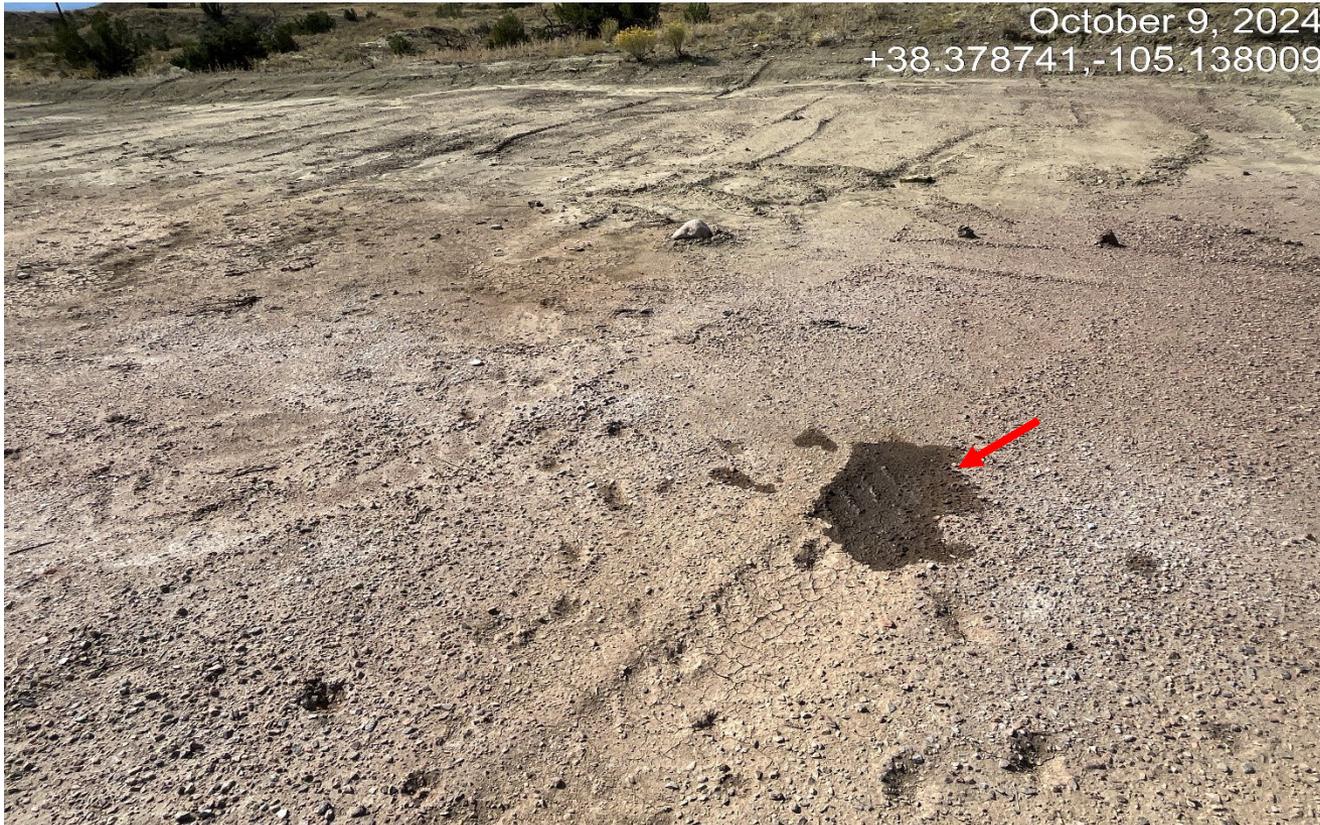
Photo 6. There was previous impacts observed and there is oil stained soil shown at red arrow. The area of the tank battery and abandoned well need to be sample per form 27 decommissioning of the well.

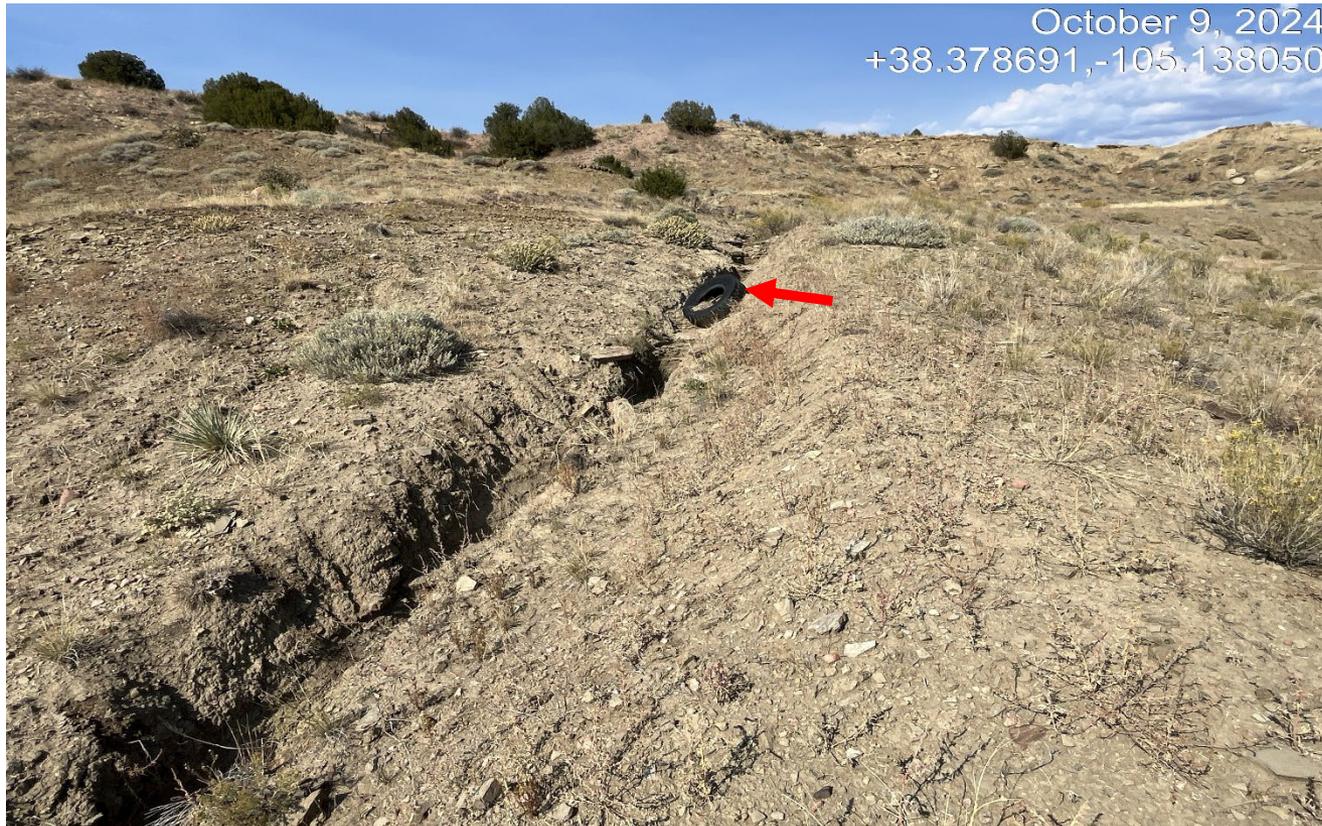
Photo 7. Facing southwest at the south side of the location. There is an erosion channel shown at red arrow which will need to be repaired and stabilized.

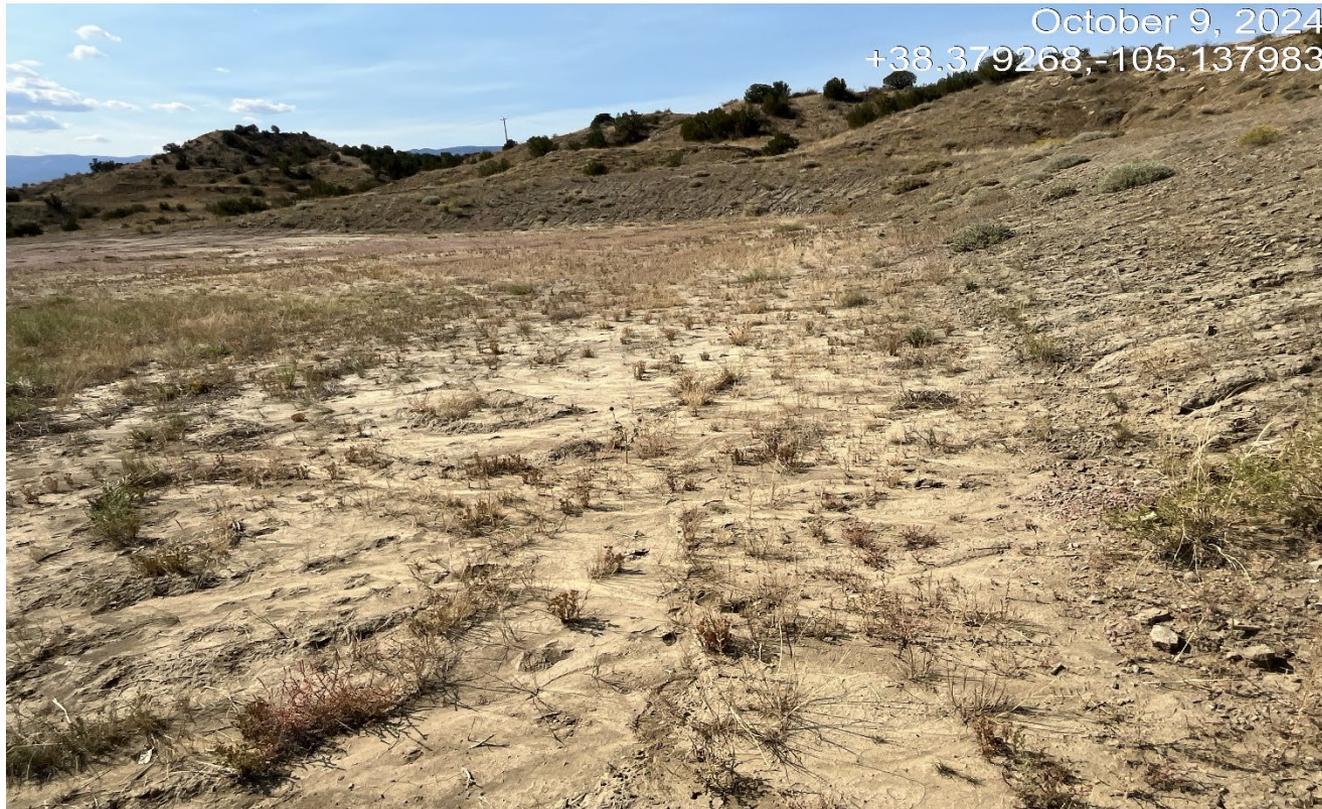
Photo 8. Facing south along the cut slope. There are rilling erosion along the cut slope which is not stabilized.

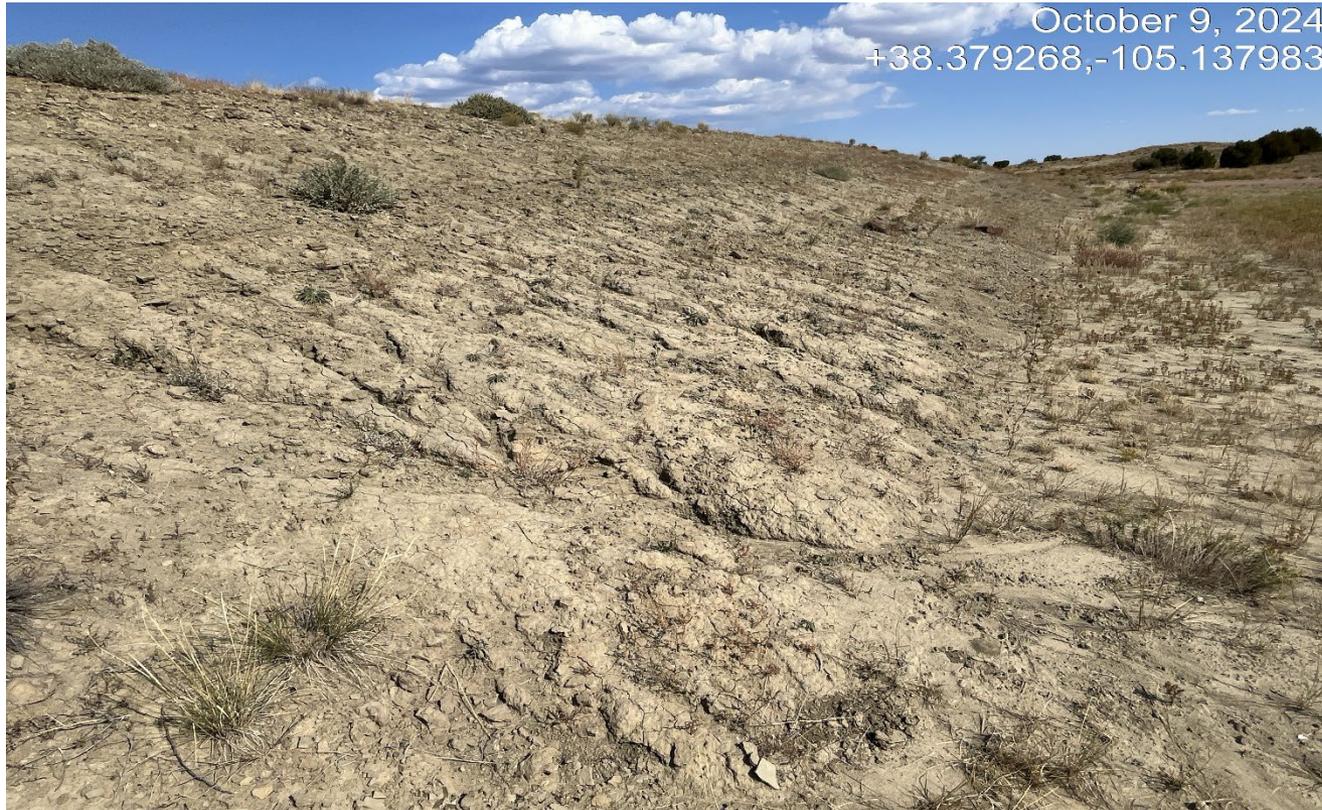
Photo 9. Facing northwest along the cut slope. There cut slope is not stabilized.

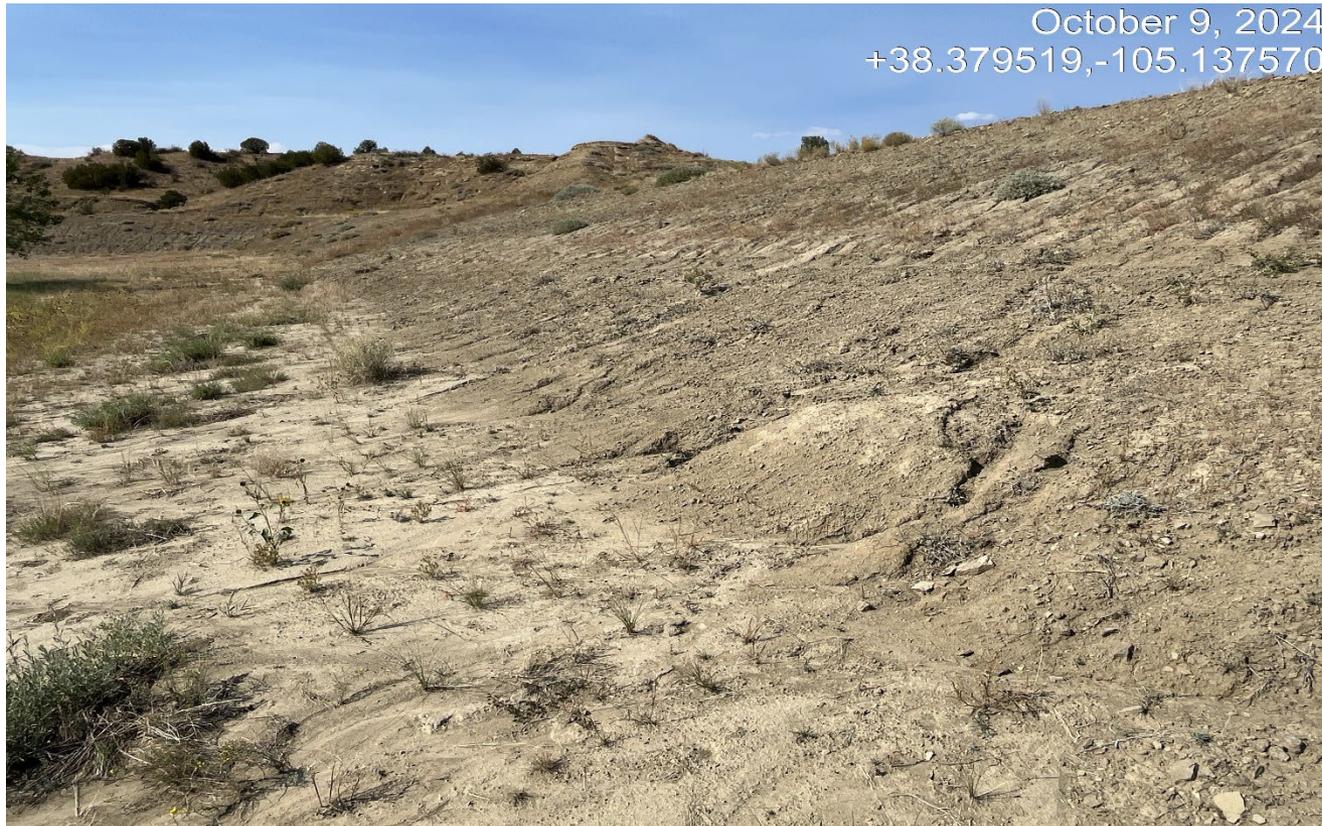
Photo 11. Facing south at the location standing from base of the cut slope.
