Inspection Photos

Loc: 322227

Operator: **JAVERNICK OIL**

Inspection Date: 10/9/2024

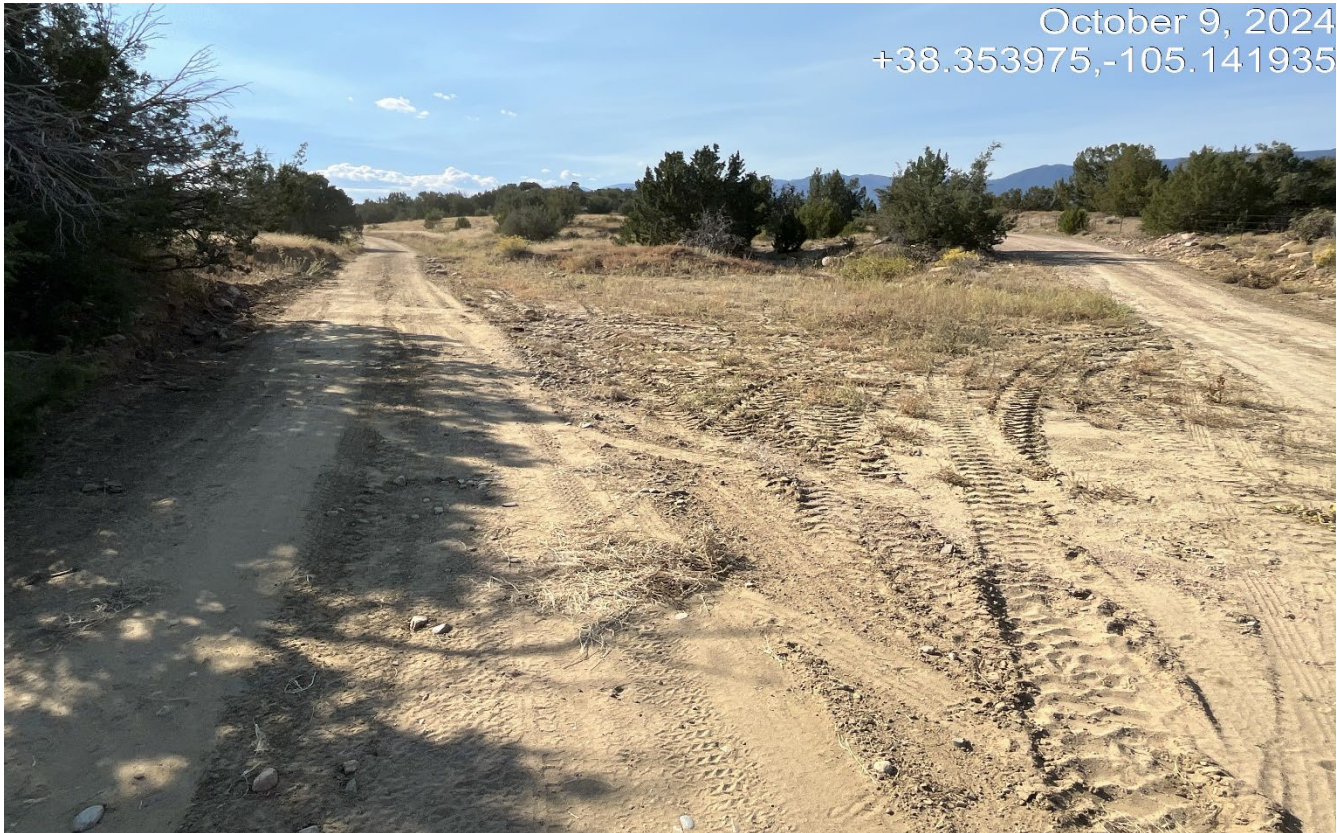
Photo 1. Facing southeast along the access road.

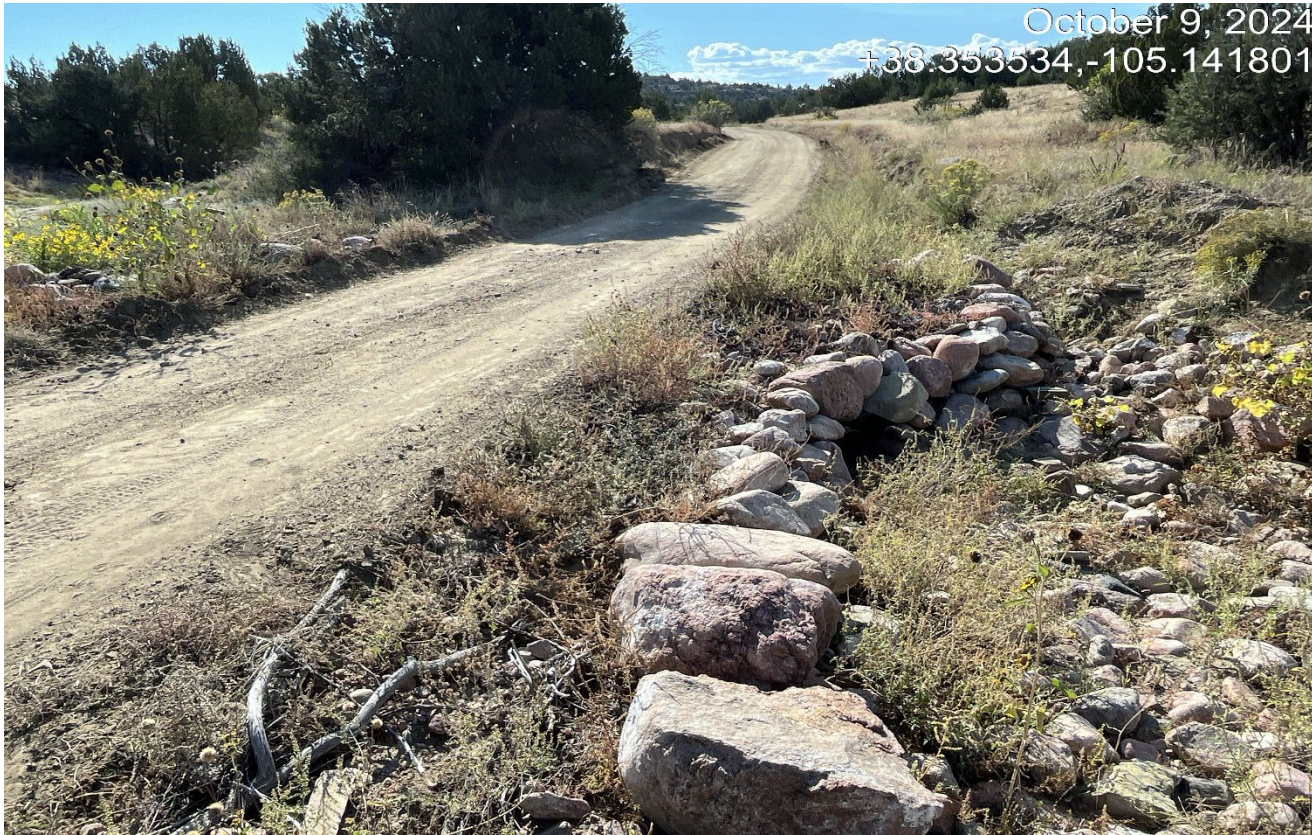
Photo 2. Facing toward the intermittent drainage that had washed out the road. There are two 1' culverts installed which may not be adequately sized for heavy storm events. The road rock used for outlet protection could become easily displaced.

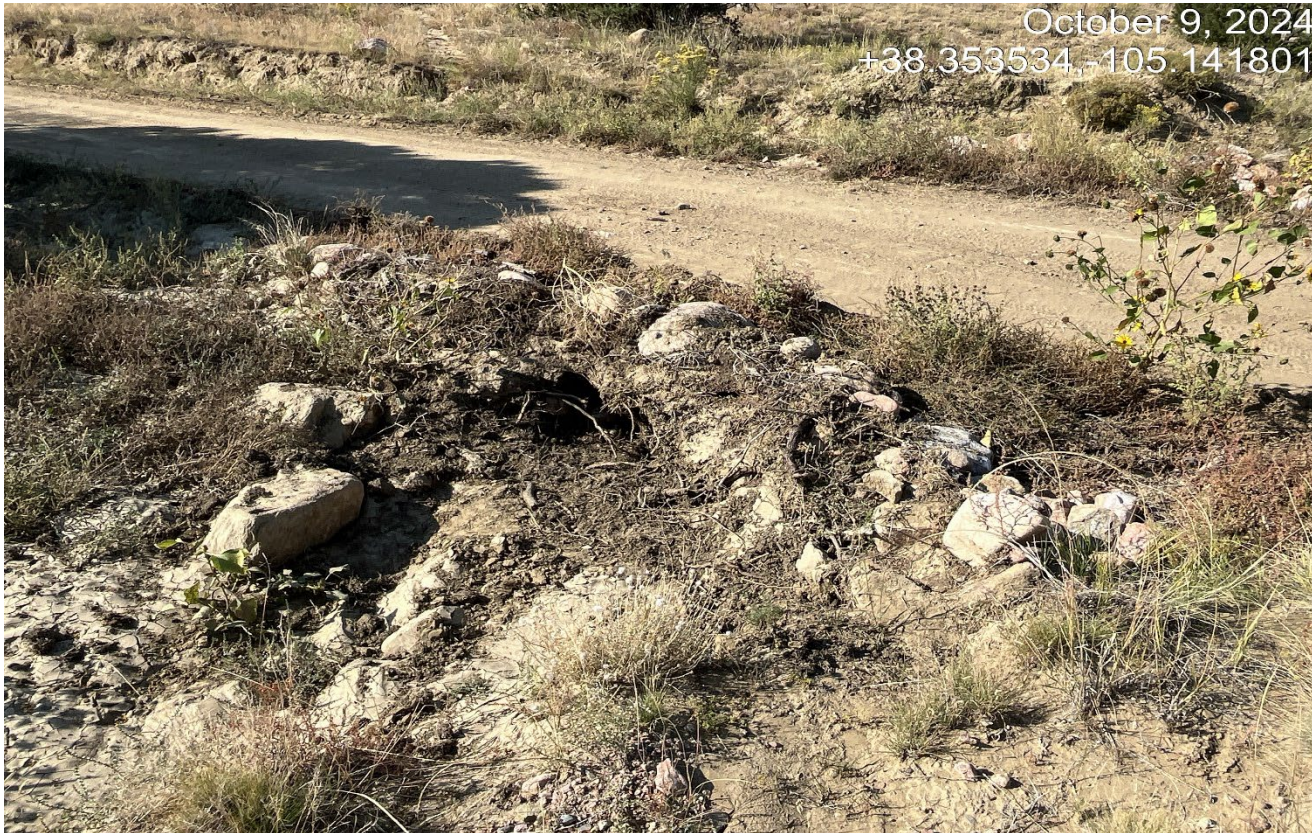
Photo 3. Facing toward the intermittent drainage that had washed out the road. There are two 1' culverts installed which may not be adequately sized for heavy storm events. The culvert has already filled up with debris and it appears debris was washed over the road. The culverts are insufficiently sized.

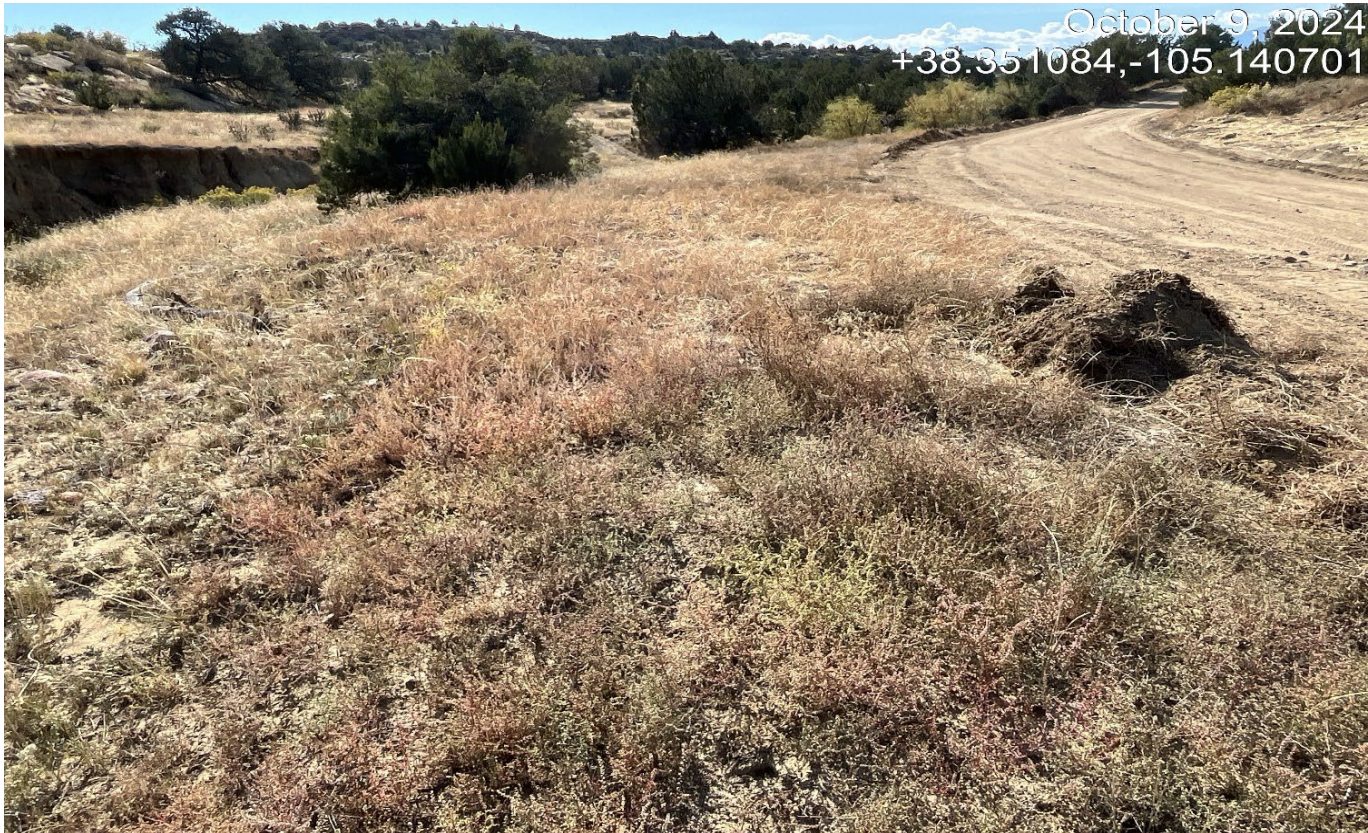
Photo 4. Facing southeast at the tank battery site. The disturbed area along the road side needs to be reclaimed and stabilized. Previous corrective action was not completed. There are undesirable weeds (Kochia) within this area.

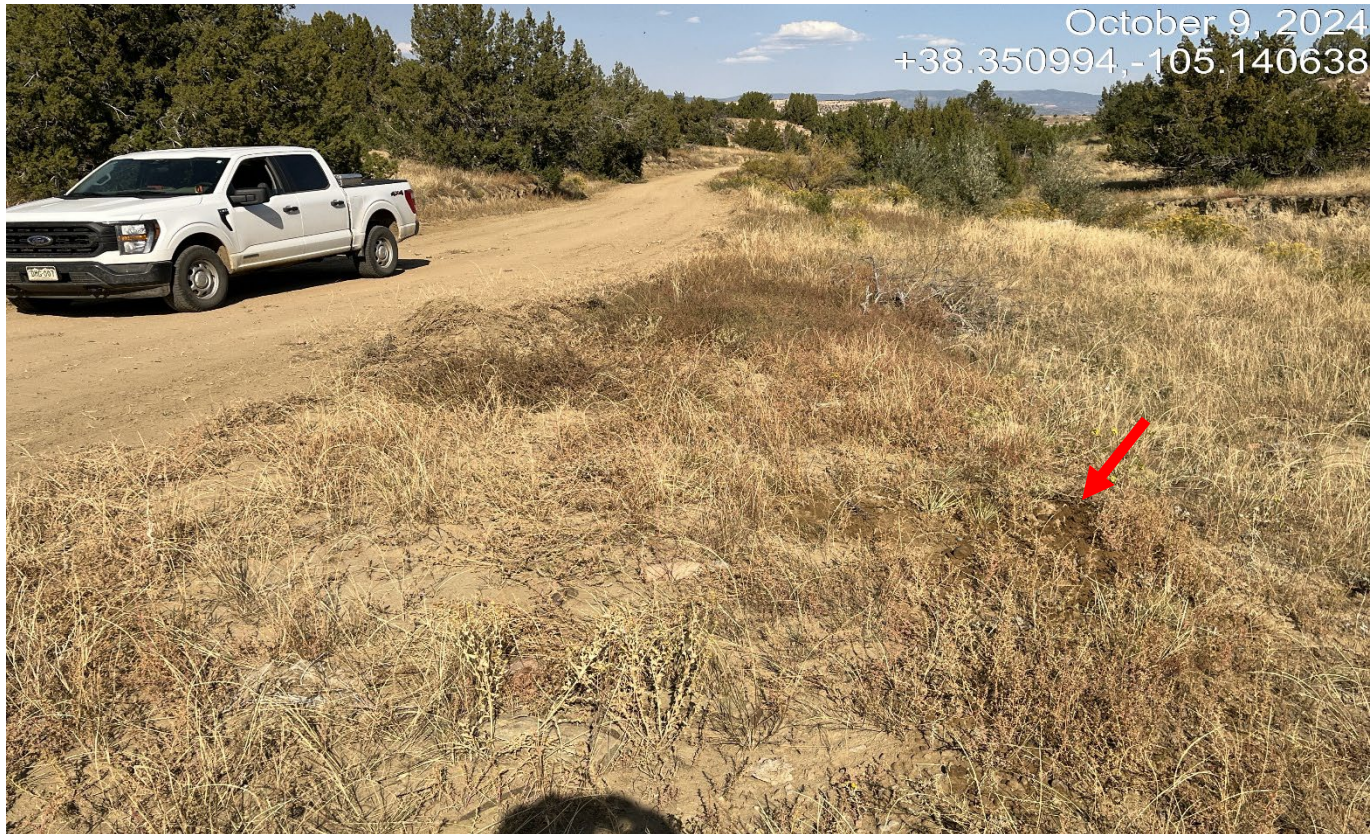
Photo 5. Facing back northwest along the side of the road disturbance. There are blackened soils that have a diesel odor from a spill.

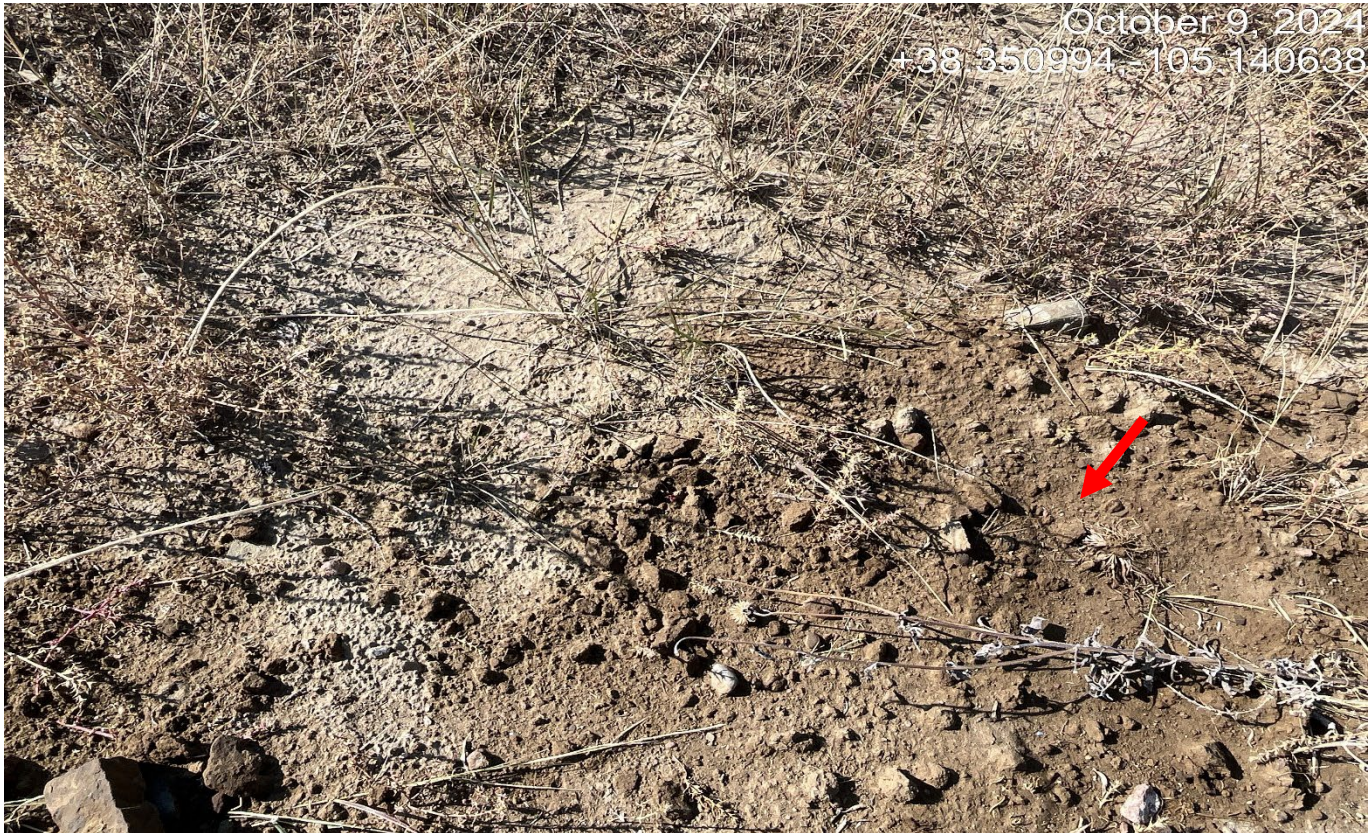
Photo 6. Discolored soils shown in previous photo have a diesel fuel odor. This must be cleaned up.

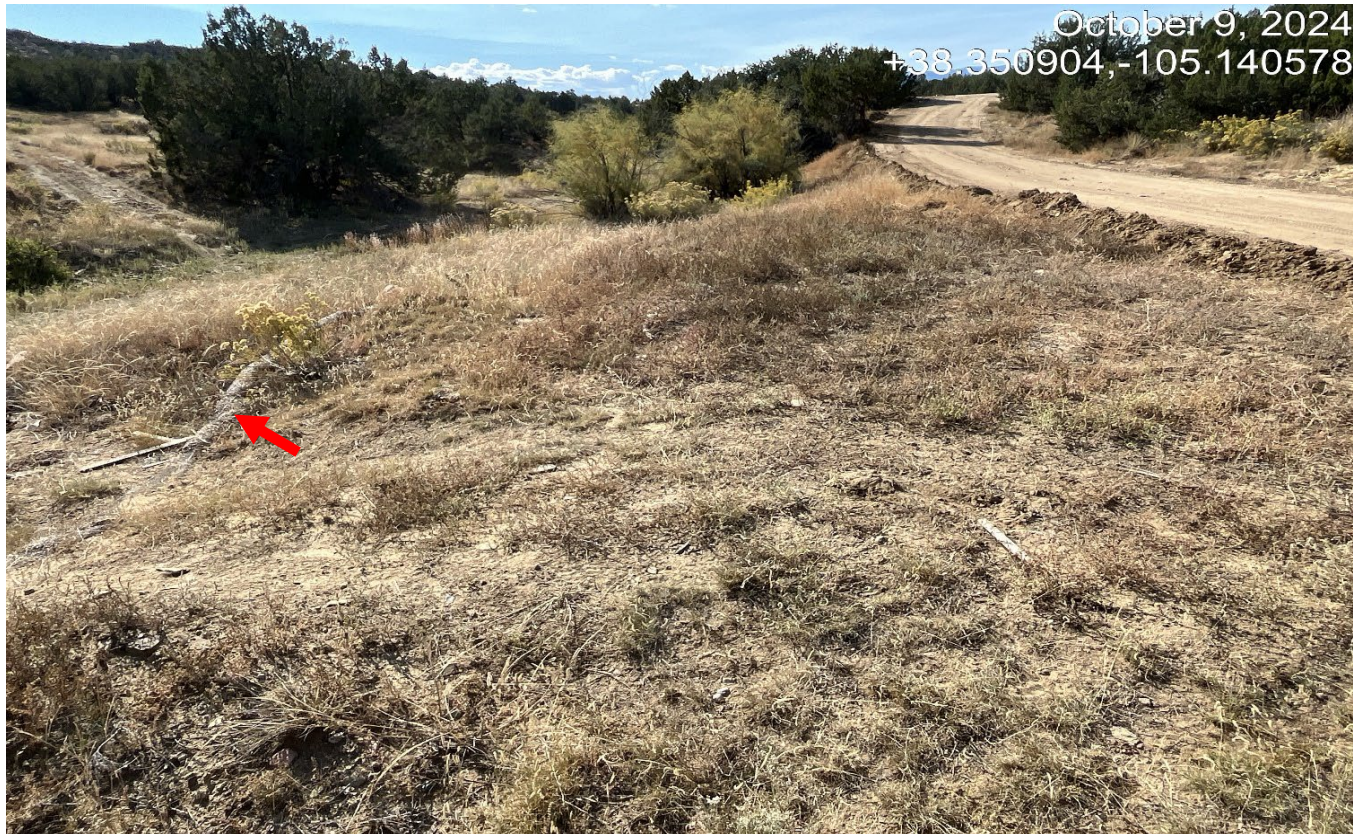
Photo 7. Facing south where soils were pushed out along the road side. This area needs to be reclaimed and perimeter wattles need maintenance shown at red arrow.

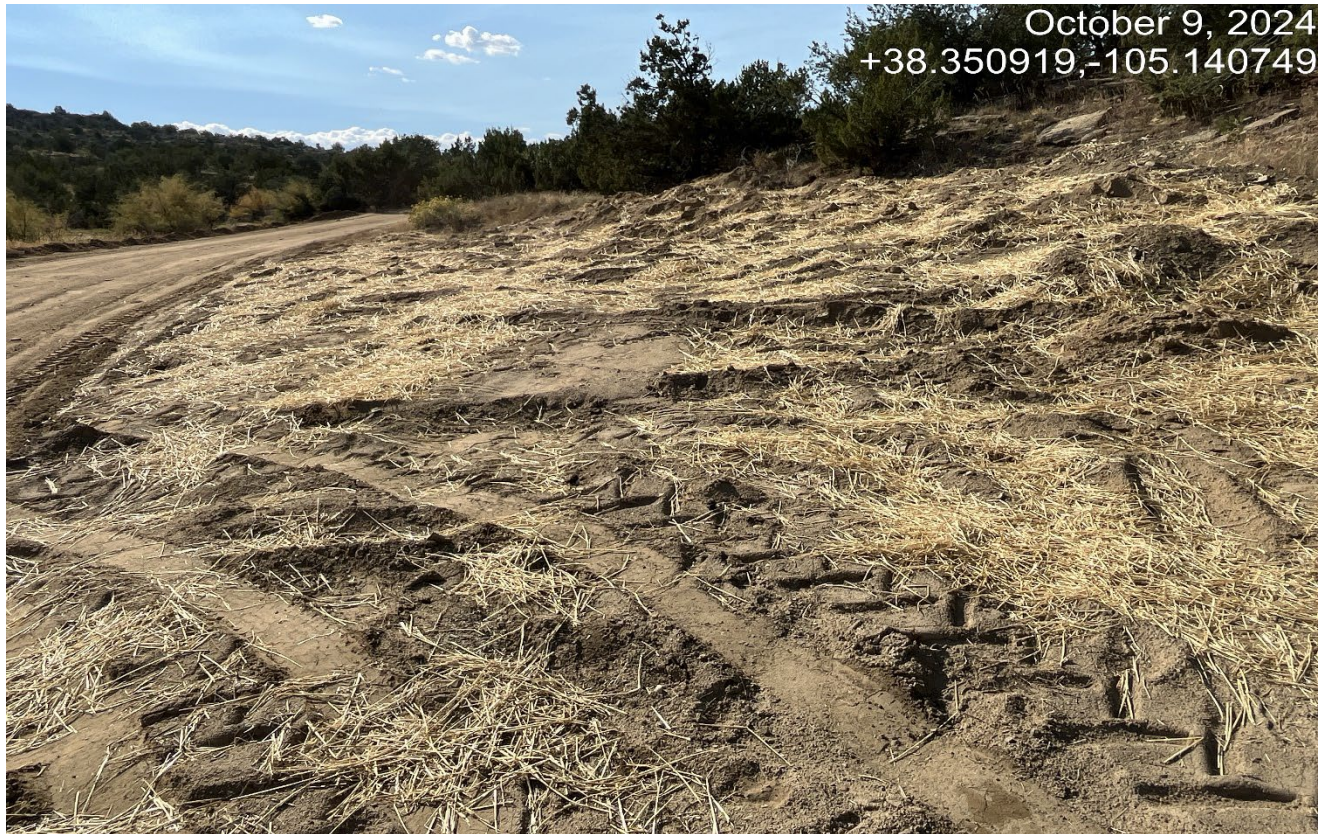
Photo 8. Facing south toward the tank battery site. The tanks have been removed and soils have been contoured. The soils were not leveled and remain loose and susceptible to erosion.

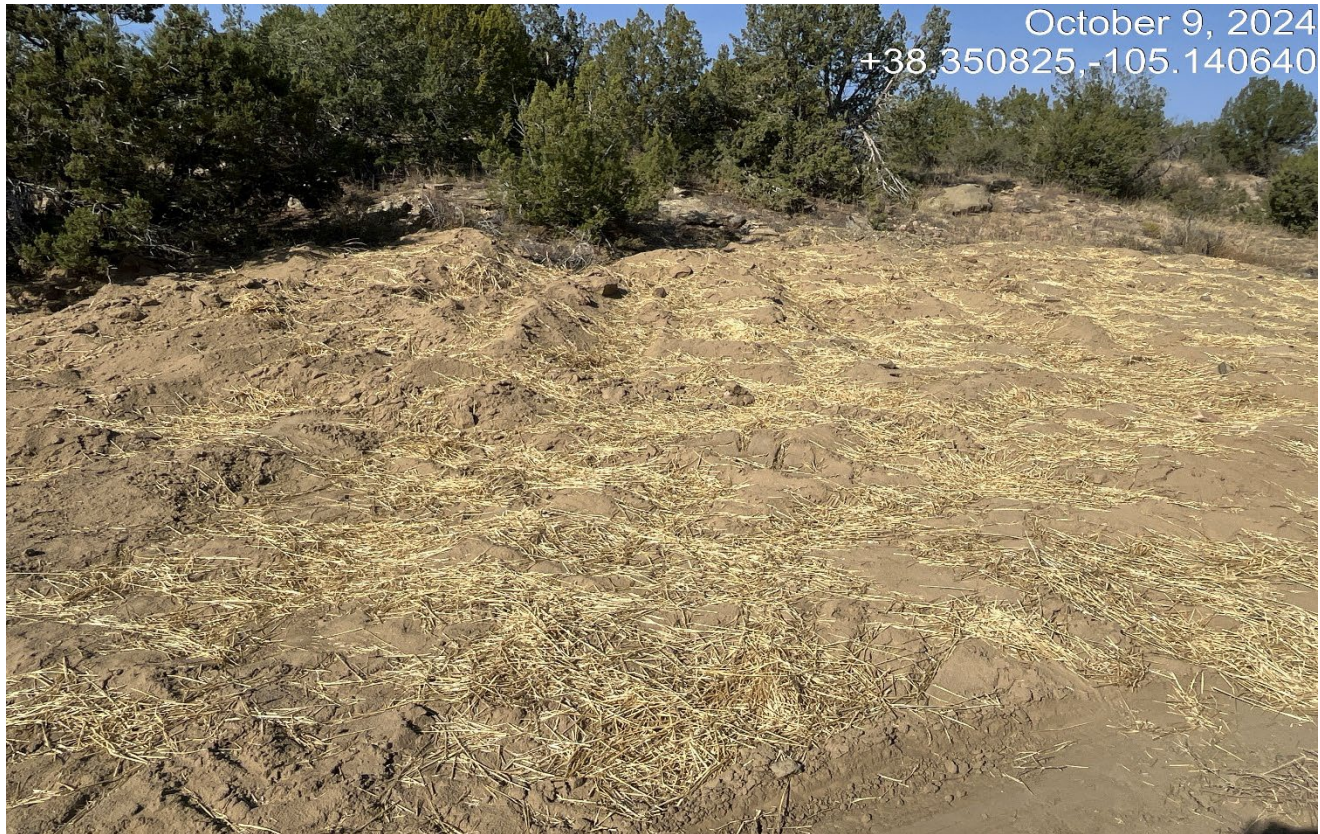
Photo 9. The soils were not leveled and remain loose and susceptible to erosion. The straw mulch is not crimped into the soils and can blow away.

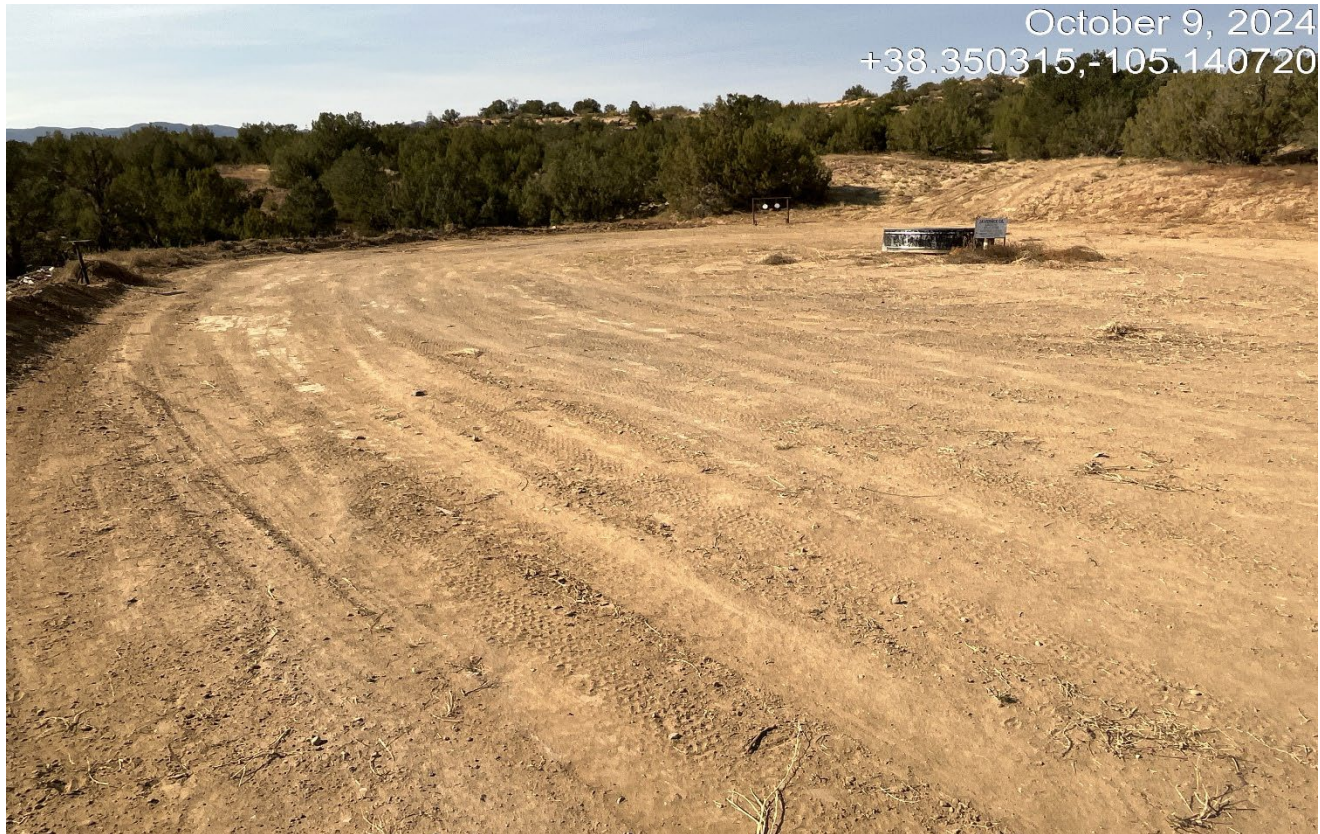
Photo 10. Facing southwest toward the well site. The conex containers and cuttings pile have been removed.

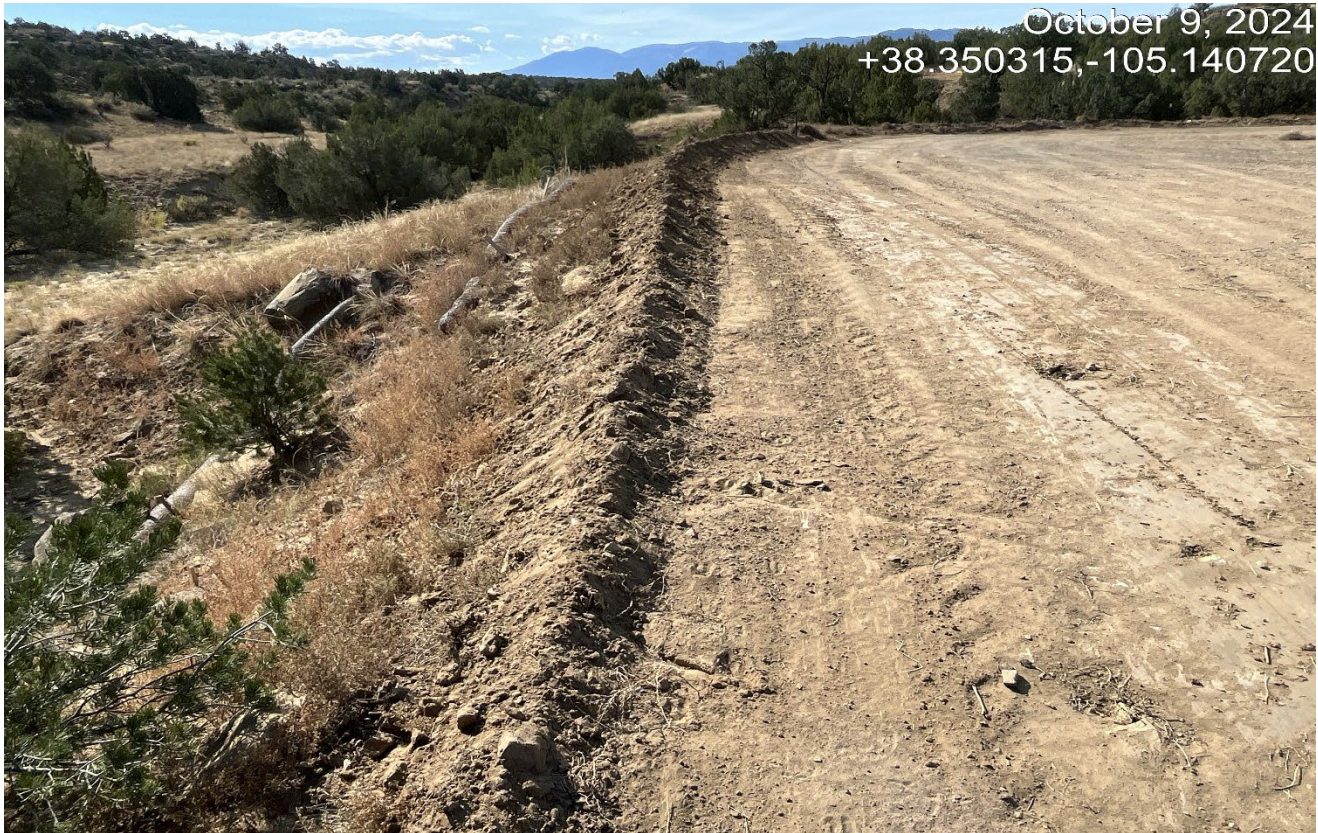
Photo 11. Facing southwest toward the fill slope of the location. There are loose soils pushed out along the edge of the pad that can erode offsite.

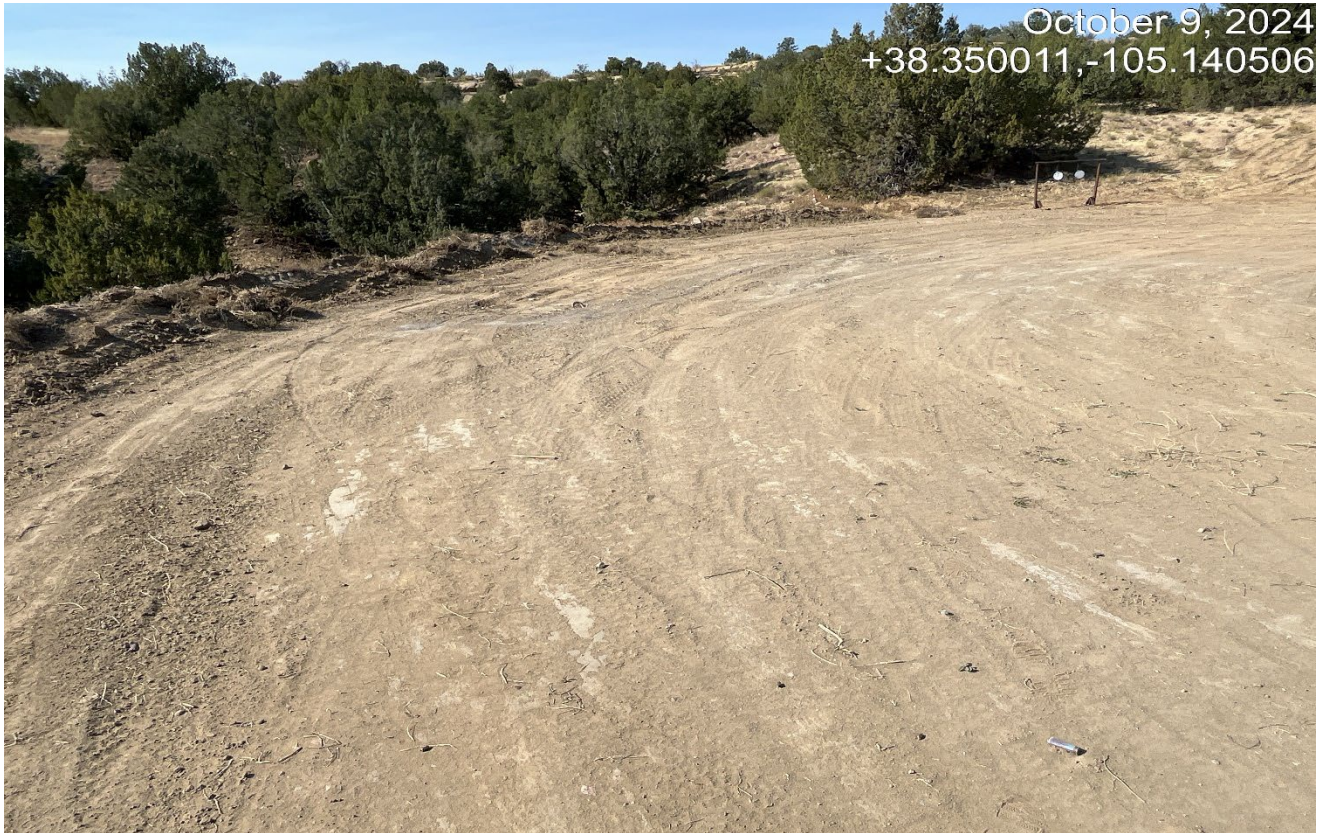
Photo 12. The drill cutting pile has been removed but there is still grey material present since the cuttings were not stored in a liner.

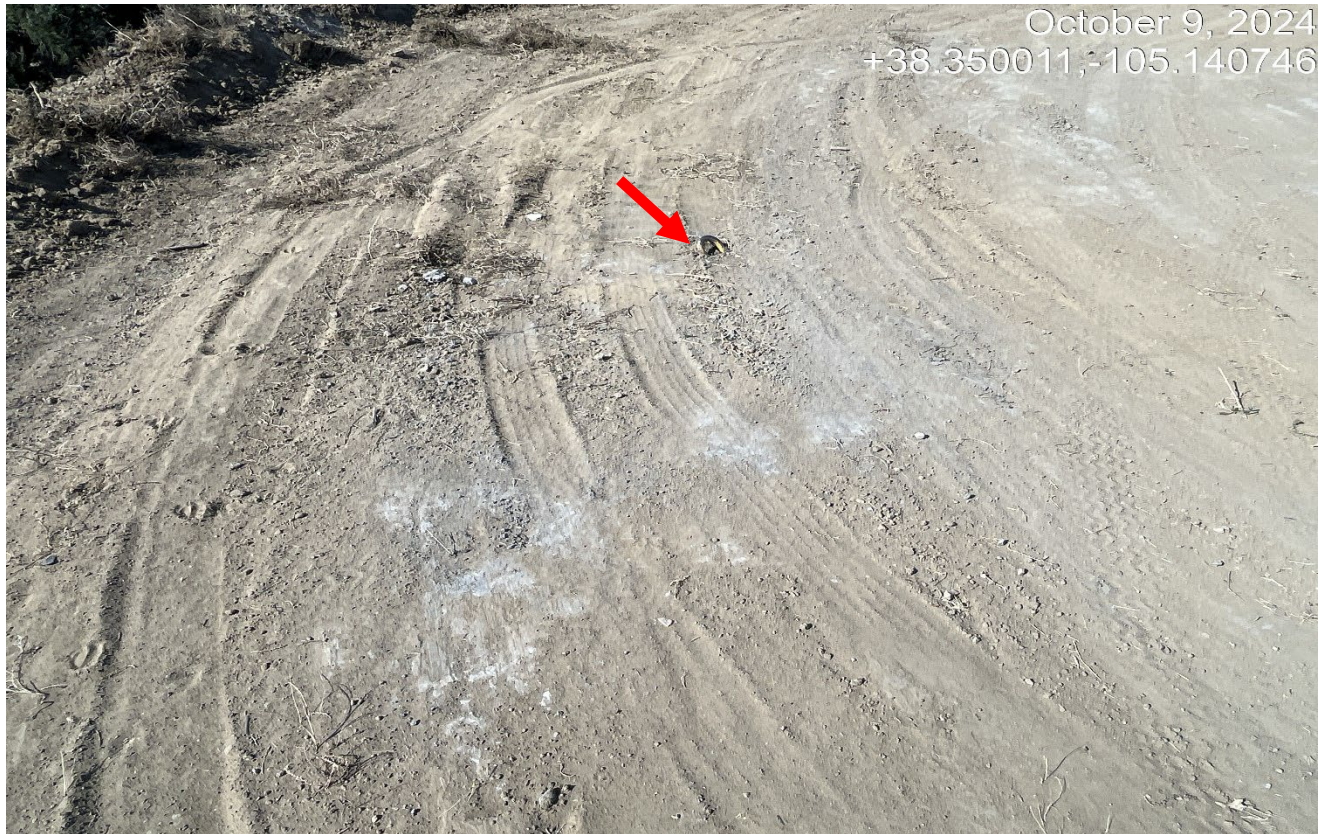
Photo 13. View of grey cuttings observed on the surface. The guyline anchor is not marked at red arrow.

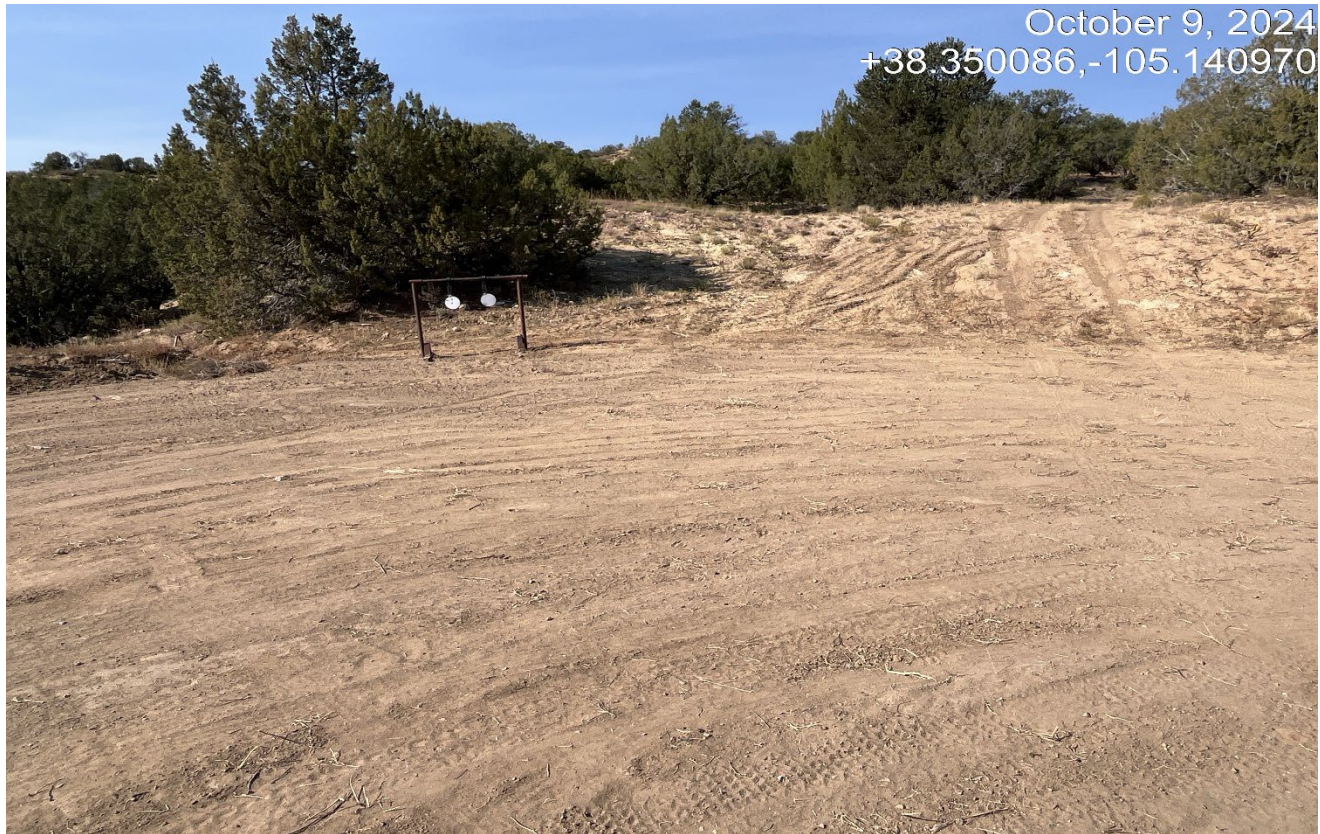
Photo 14. Facing southwest at the south side of the location. There is a shooting target on location that needs to be removed. Discharge of firearms is a safety concern on the wellsite.

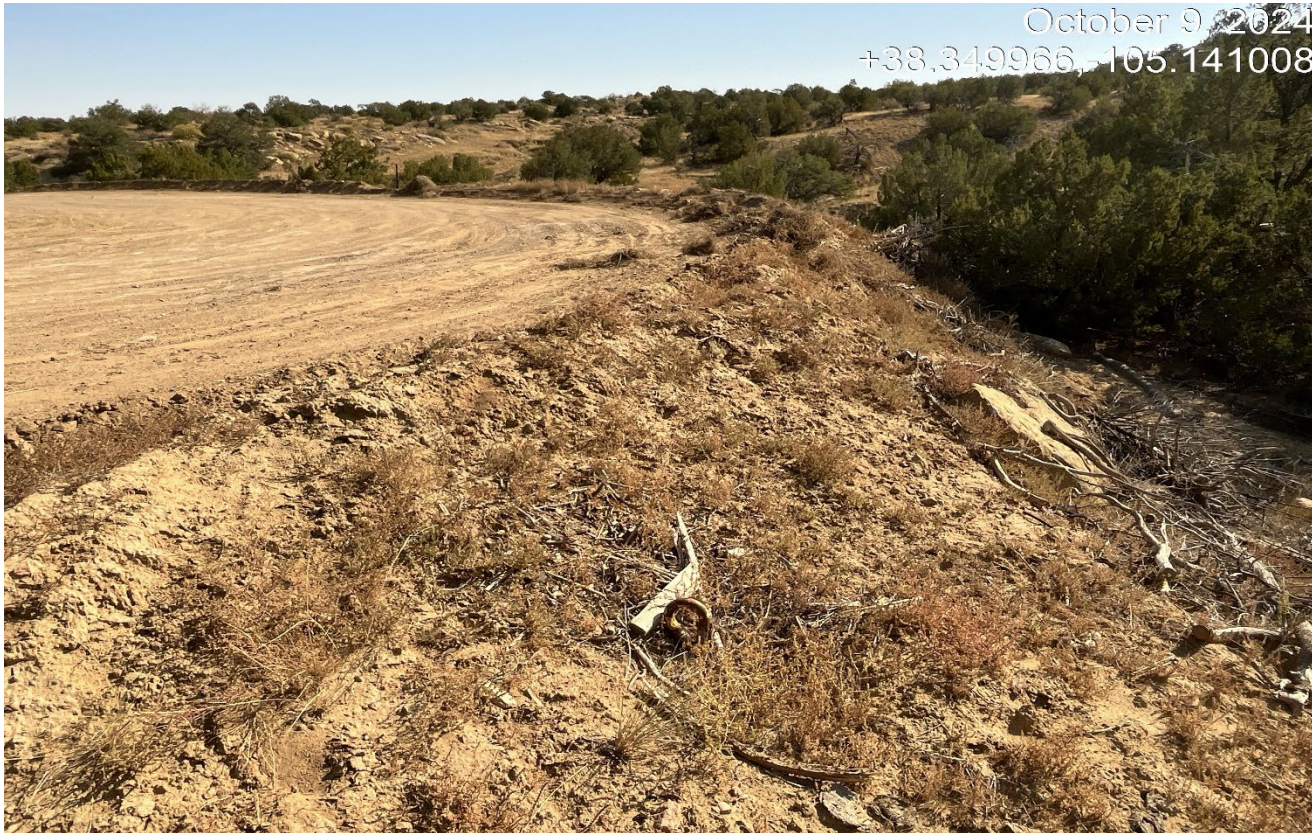
Photo 15. Facing toward the fill slope at the south side of the location which consists of weeds and is not stabilized.

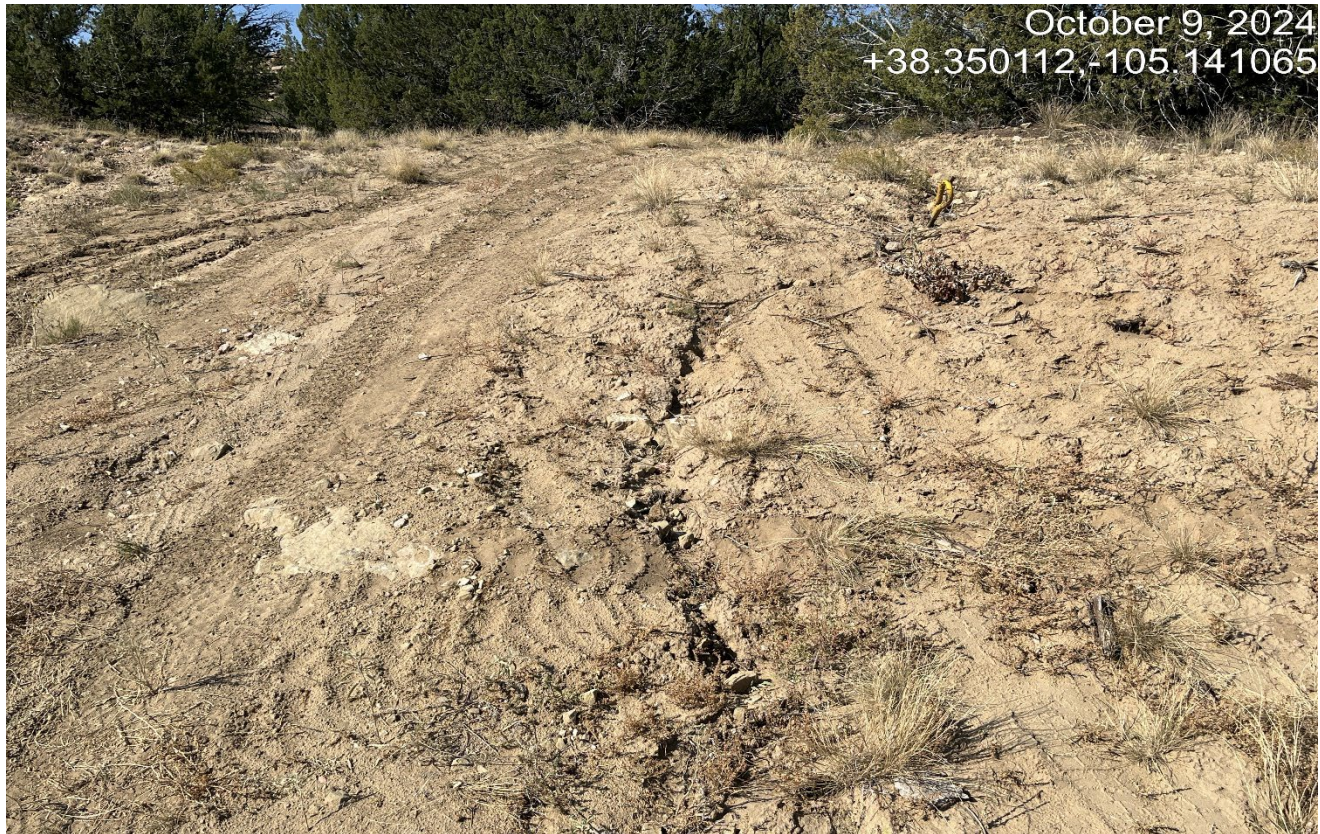
Photo 16. Facing toward the cut slope at the southwest side of the location. There are signs of erosion and the cut slope is not stabilized with vegetation.

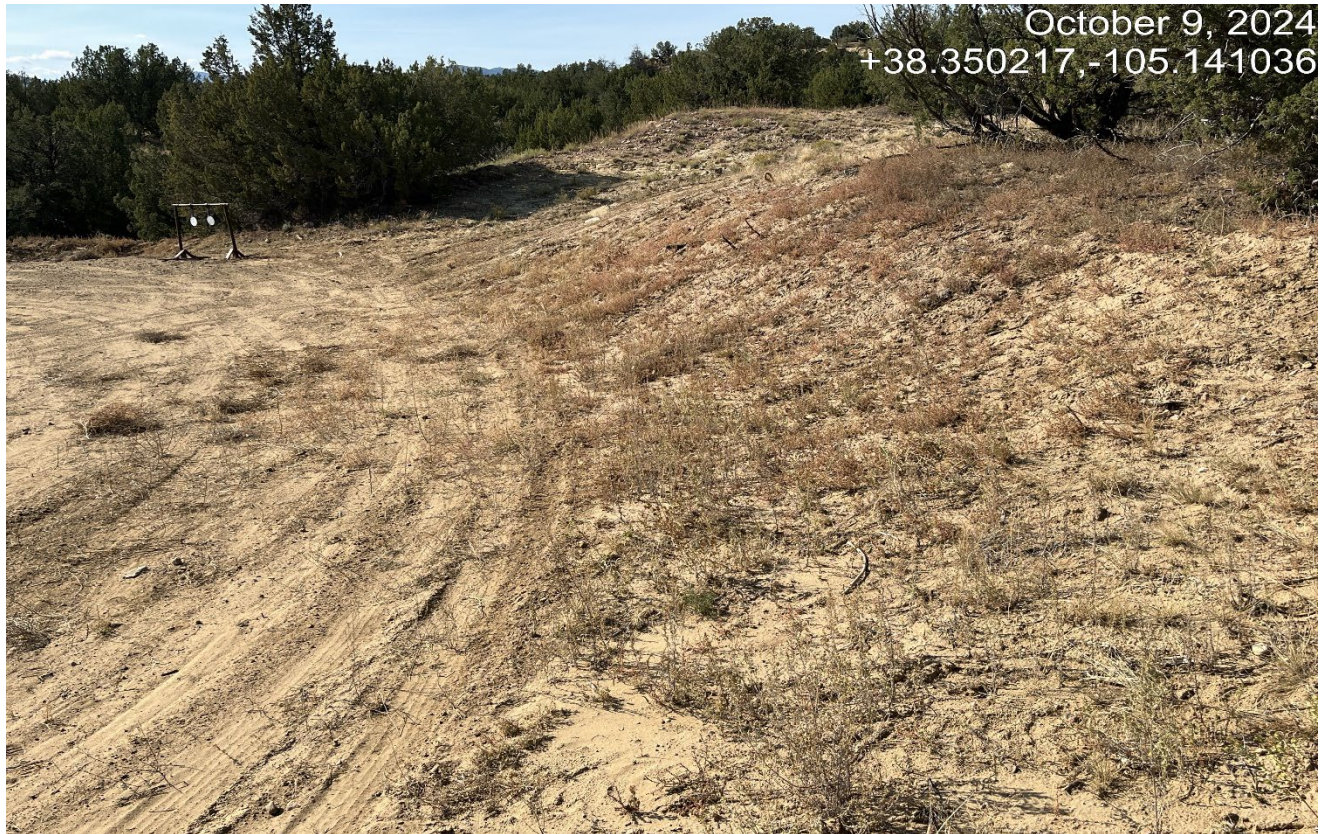
Photo 17. Facing southwest at the location. The cut slope of the location is not stabilized and there are insufficient stormwater run-on controls.

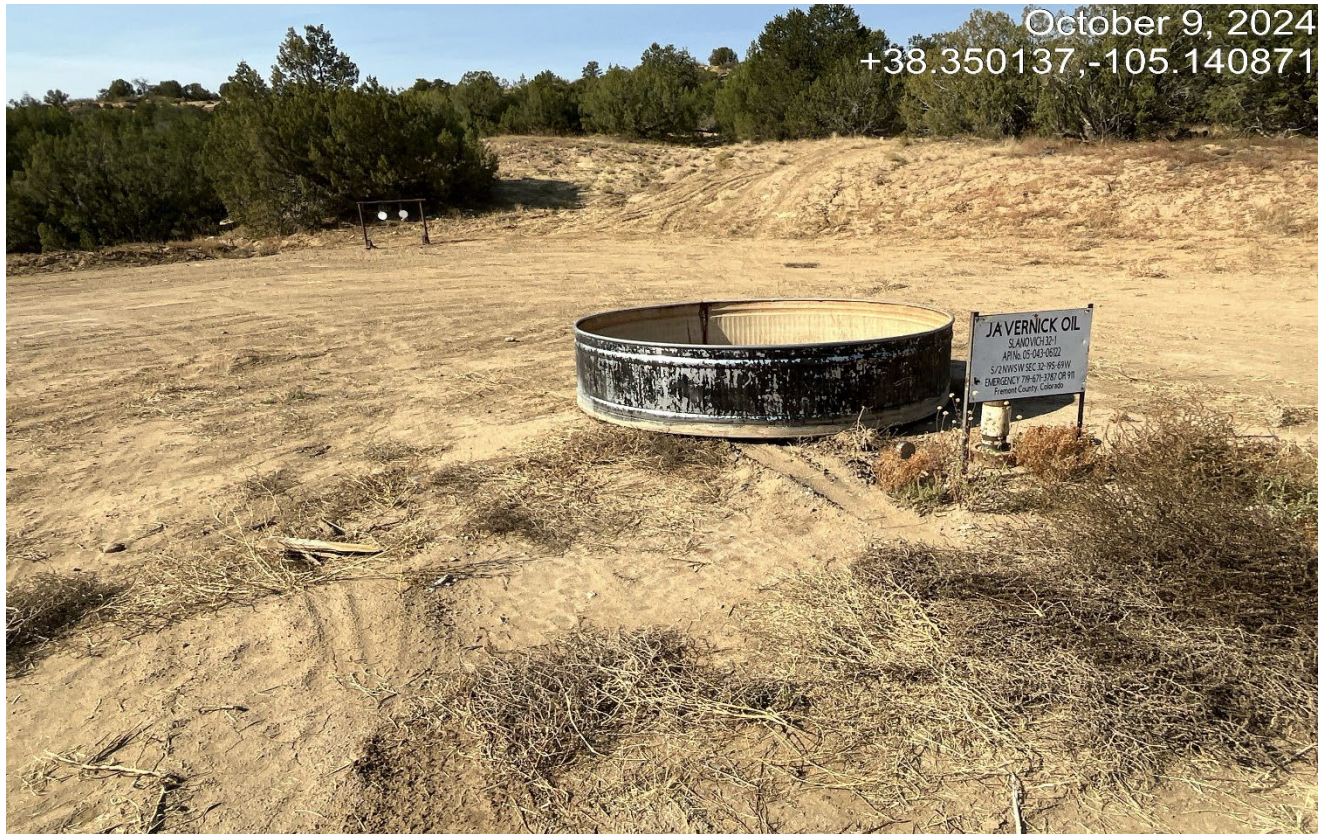
Photo 18. here is a stock tank at the well that needs to be removed.

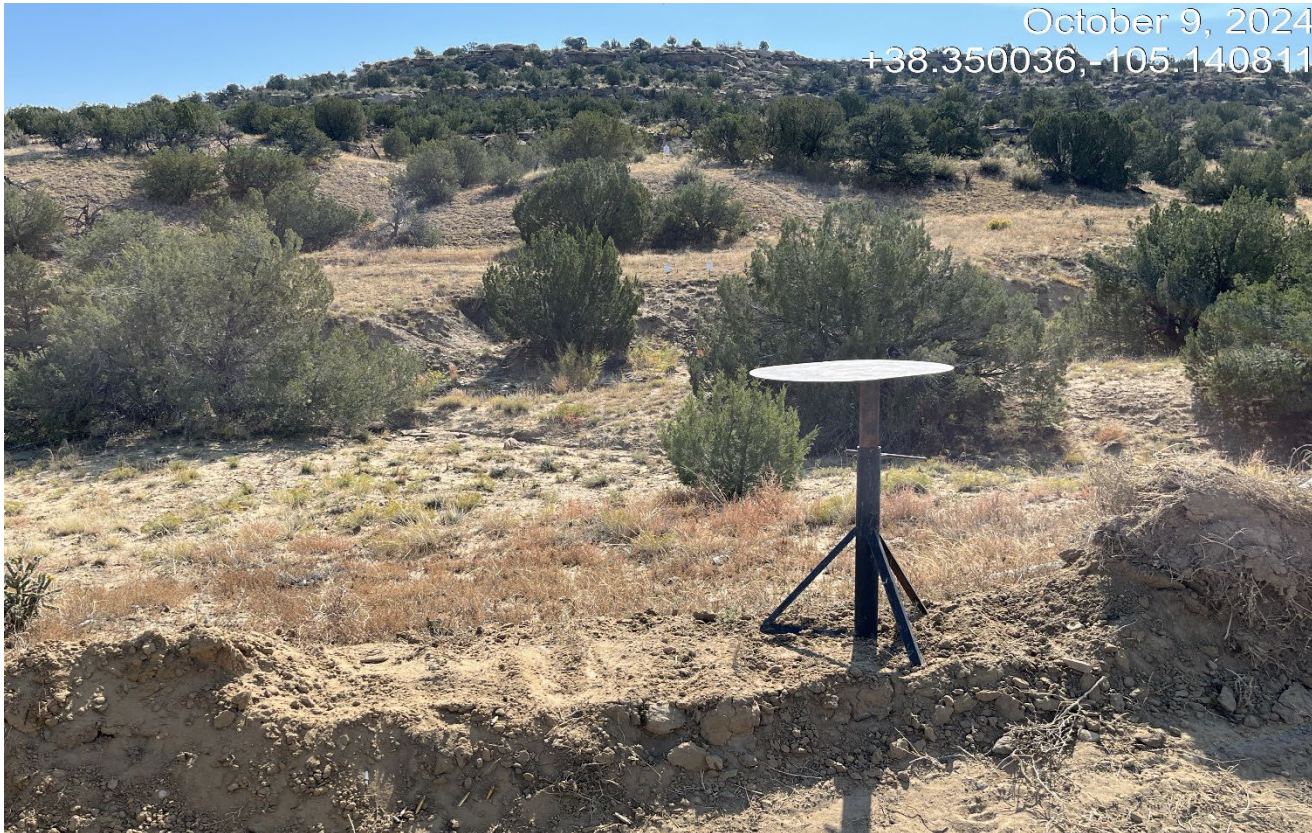
Photo 19. There appears to be a firearm shooting rest at the east side of the well pad and additional targets in the background. Discharge of firearms is a safety concern on the wellsite.
