Inspection Photos
Location Name: QB Energy Mamm Creek J6SEB Pad
Location #: 432265

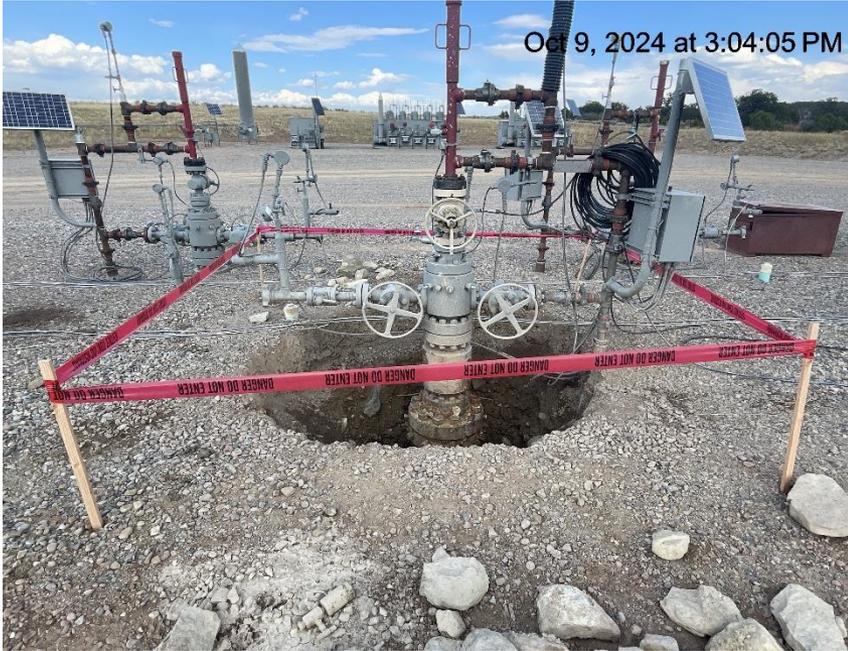
Photo # 4322 Insufficient wildlife protection for hole around wellhead/wildlife hazard

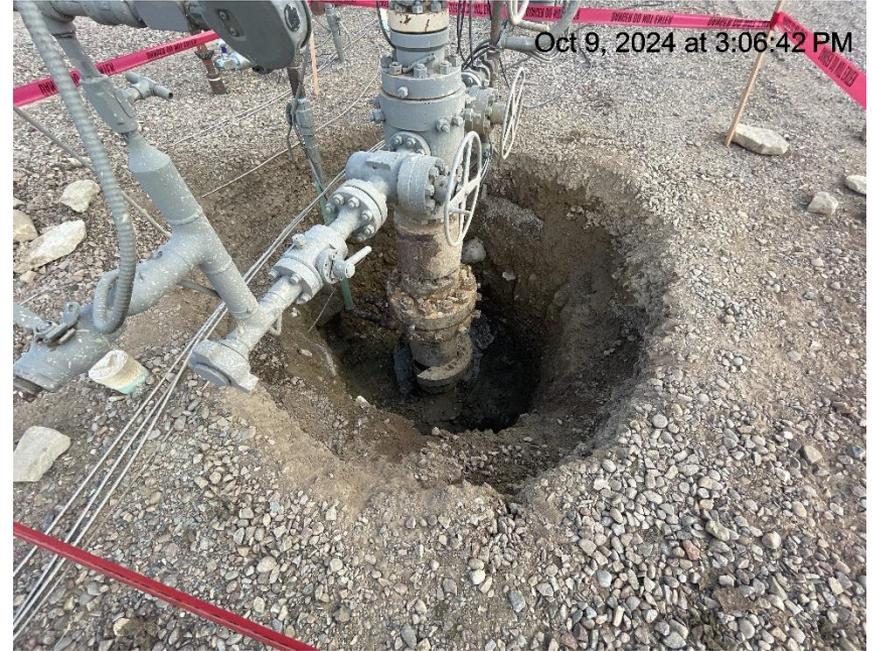
Photo # 4323 Insufficient wildlife protection for hole around wellhead/wildlife hazard

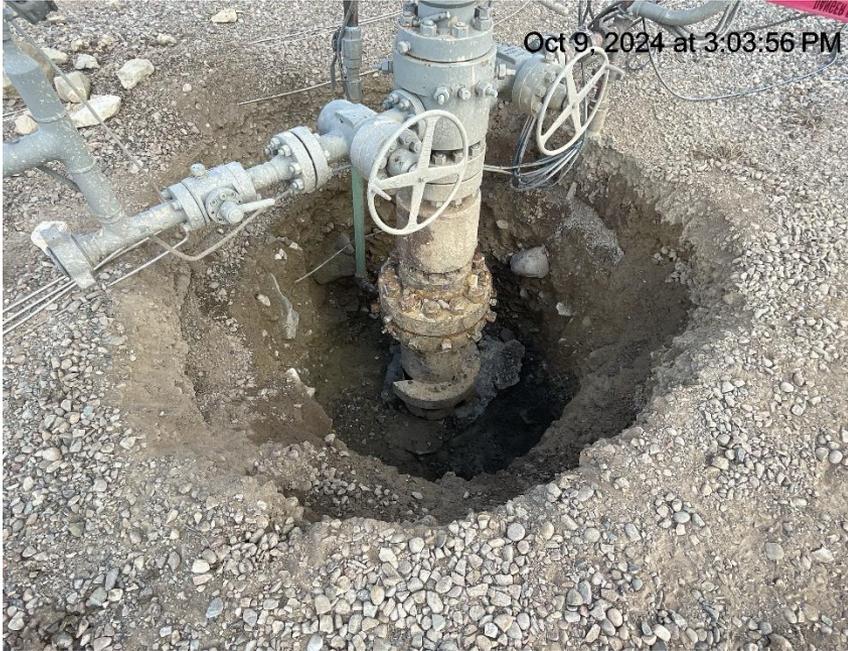
Photo # 4324 Insufficient wildlife protection for hole around wellhead/wildlife hazard

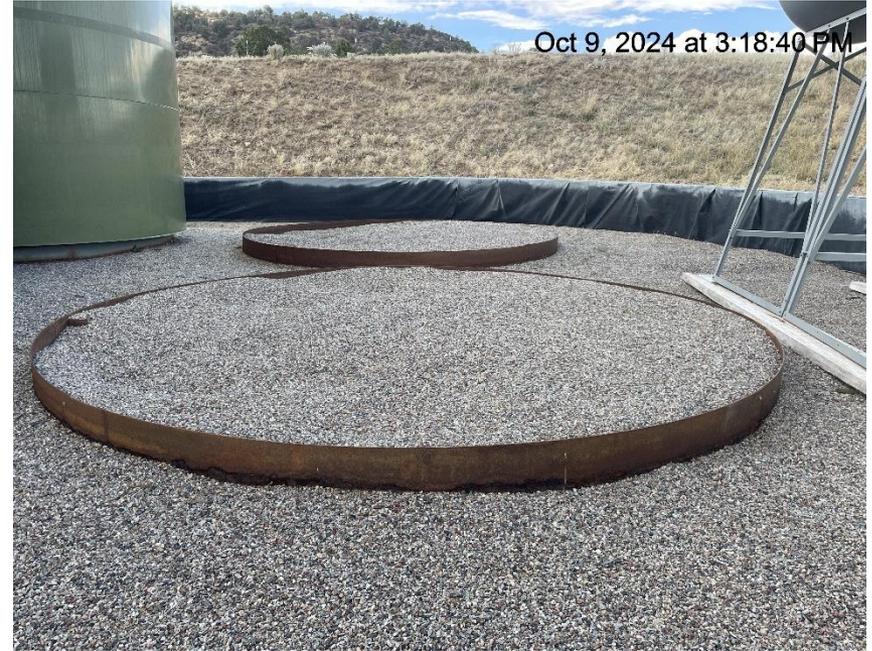
Photo # 4325 Unused tank rings in secondary containment
