# Inspection Photos

**Operator:** CAERUS PICEANCE LLC #10456

**Location ID:** 335781

**Inspection Doc:** 696206367

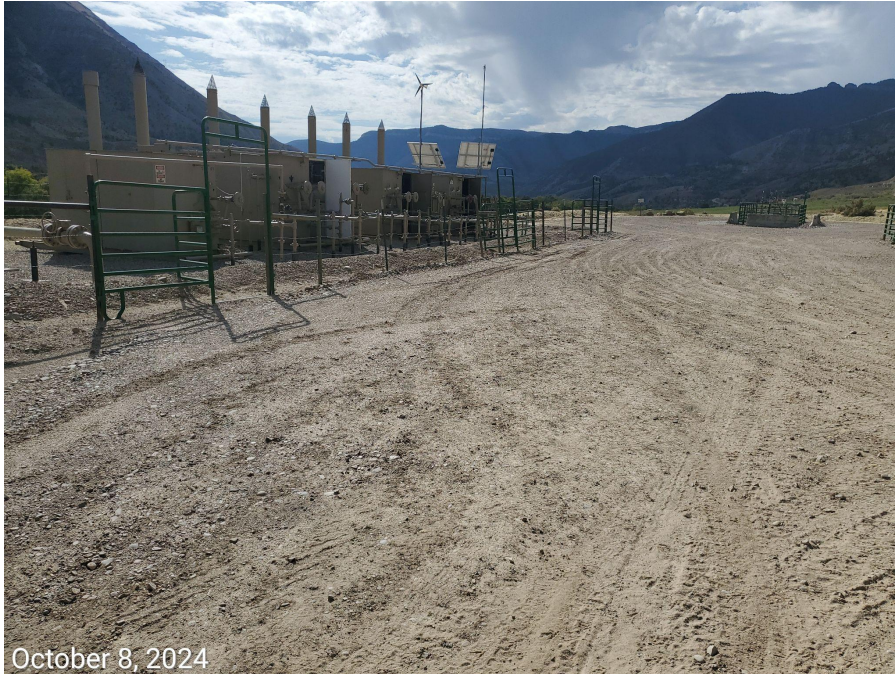
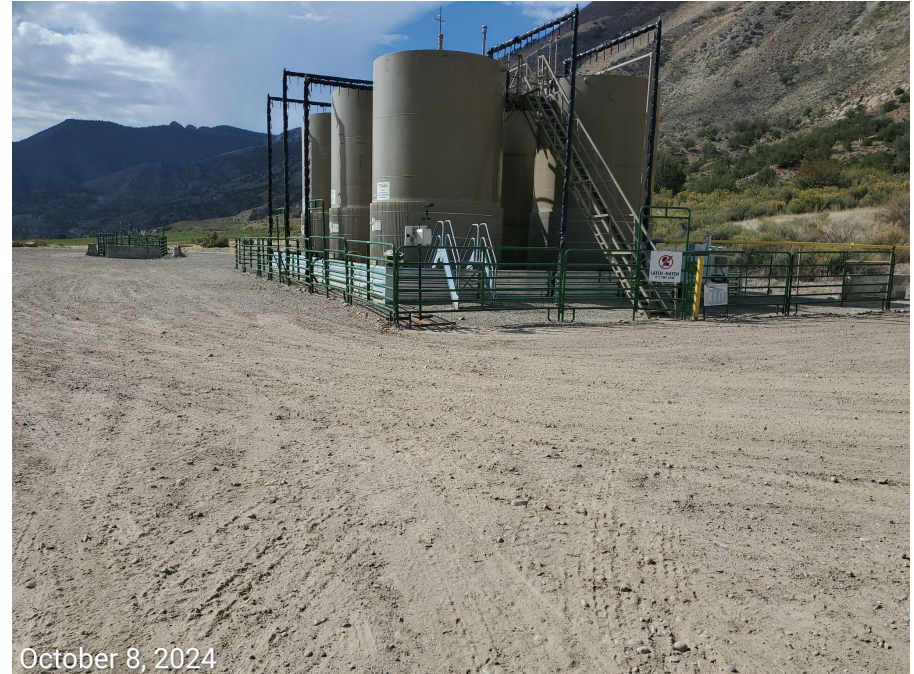
**Photo 1:** Photos taken from the north end of the western working pad surface, facing south. Operator appears to have performed grading operations to address tracking and stabilization concerns observed during the 3/15/2024 inspection. Unclear if additional controls were implemented to address the tracking and stabilization concerns; BMPs to stabilize the working pad surface, as well as to minimize tracking during wet conditions show sign of disrepair and/or do not appear sufficient; gravel is thin throughout the western pad; tracking is becoming evident. Maintenance advised.

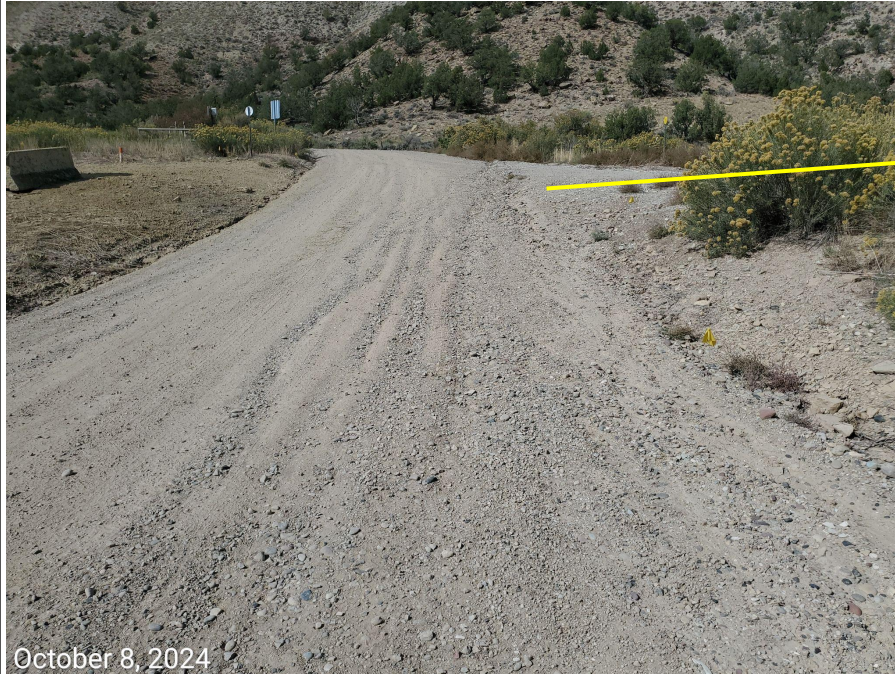
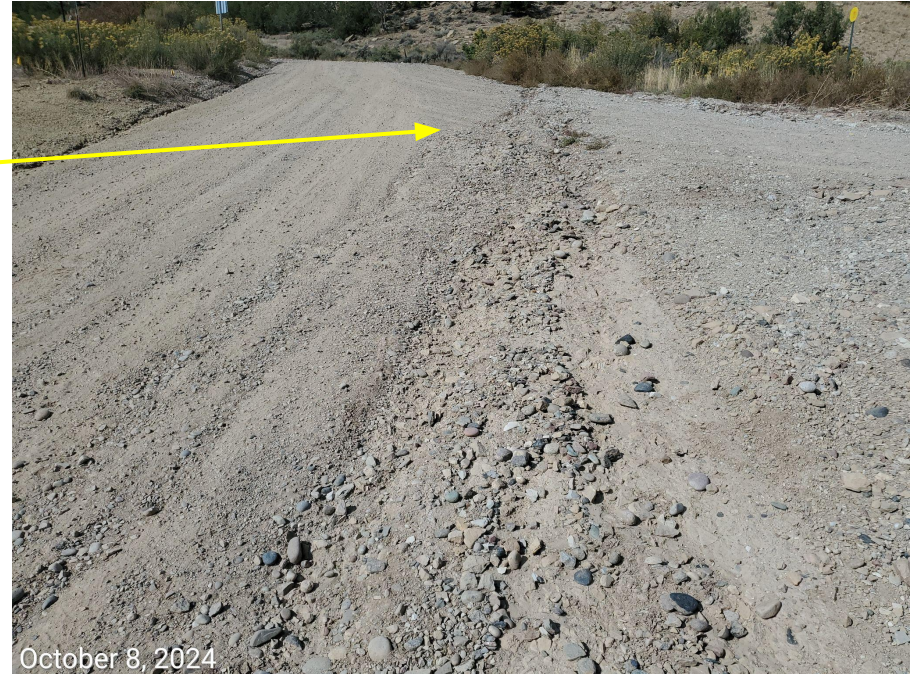
**Photo 2:** Photos taken from the access road, facing west. Photo shows erosion degradation due to stormwater runoff from the main lease road.

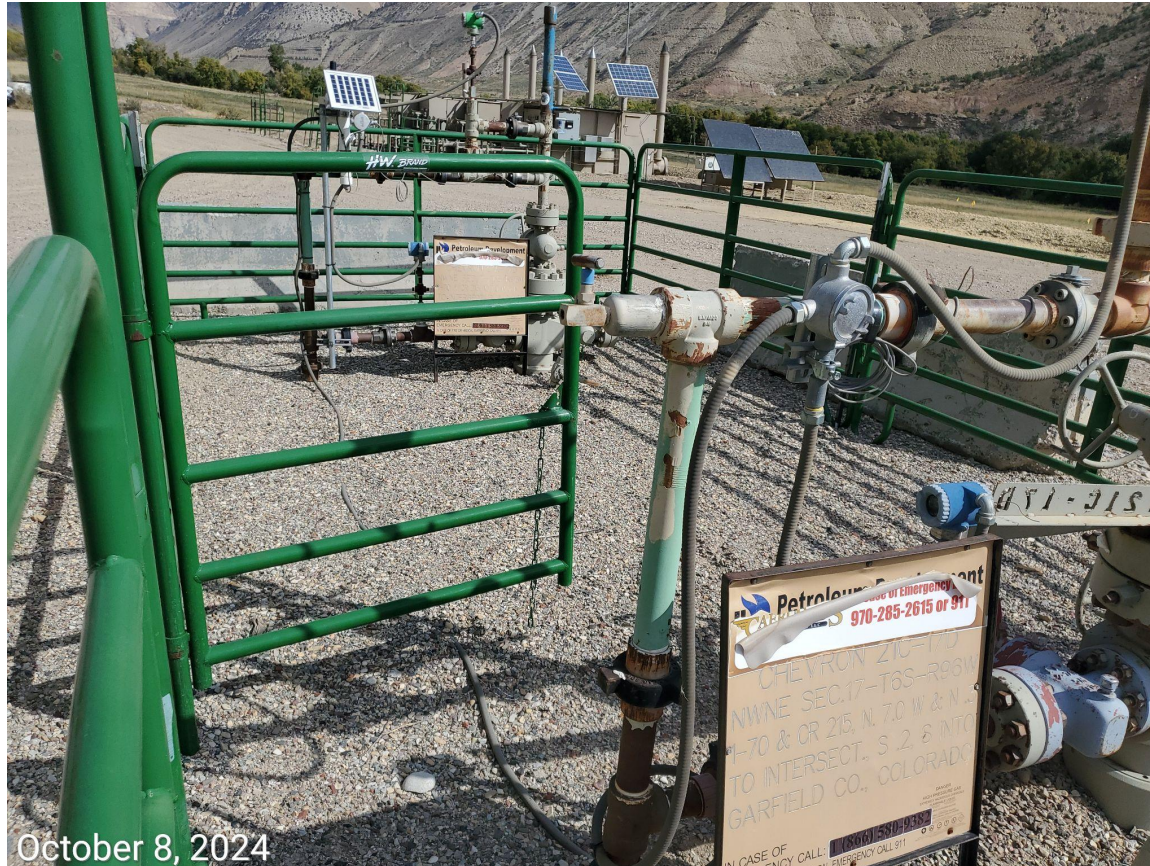
**Photo 3:** Photo example showing information on signs are peeling.

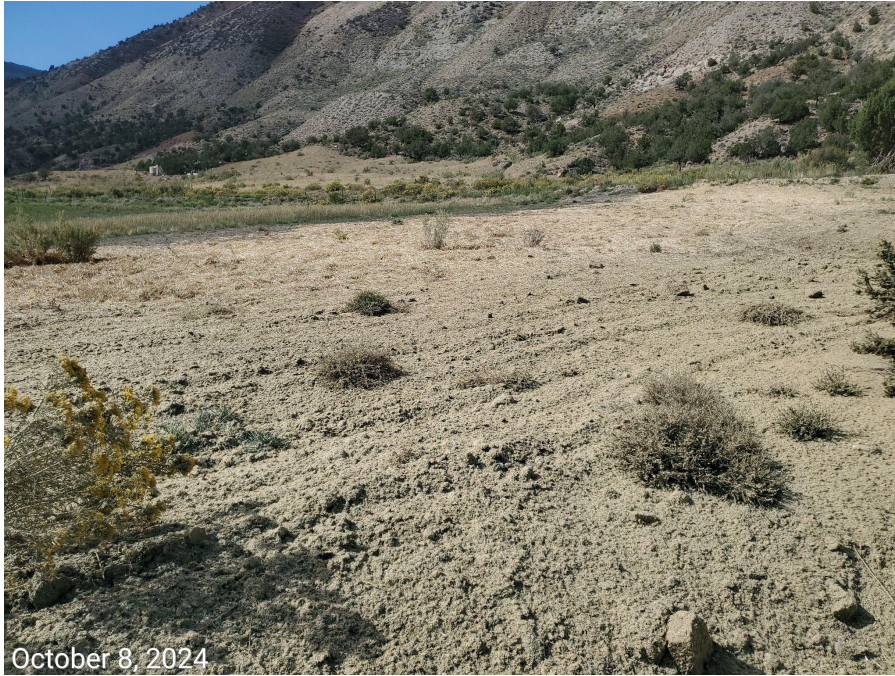
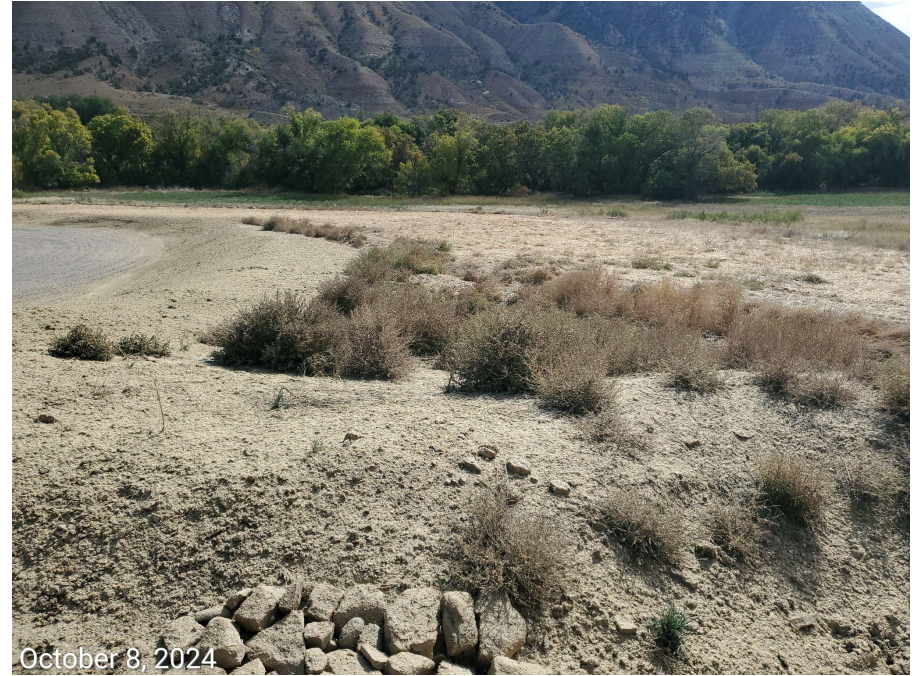
**Photo 4:** Photos taken from the south end of the western pad, facing southwest and southeast. Photos examples showing additional reclamation efforts have been performed.

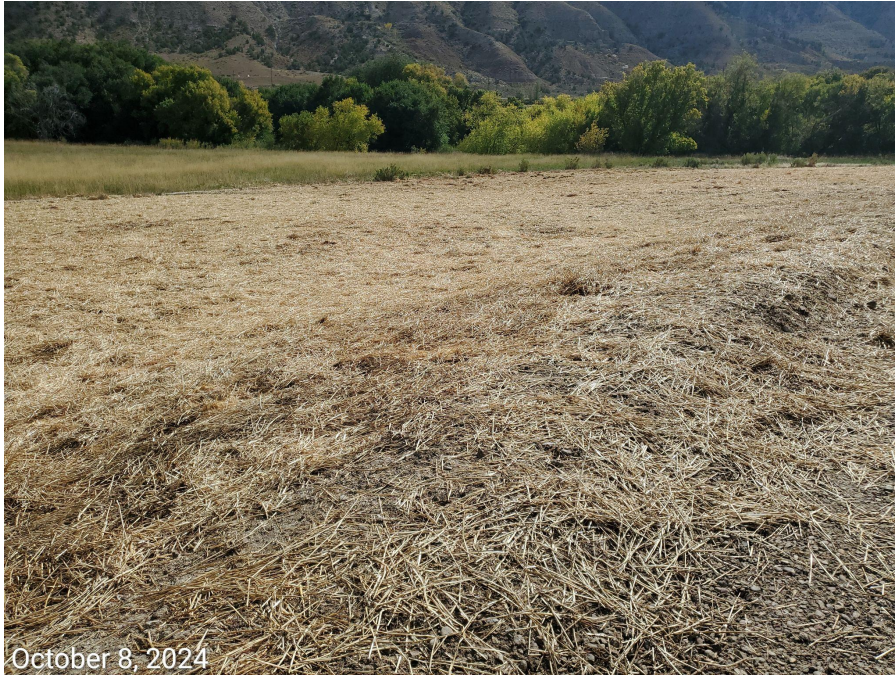
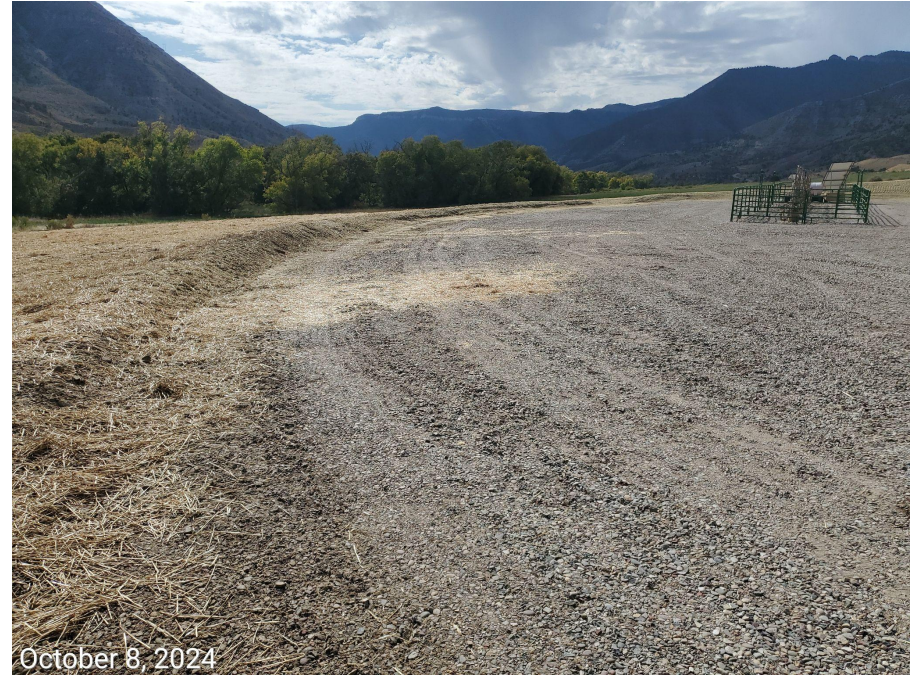
**Photo 5:** Photos 5-6 taken from the north end of the eastern pad. Photos provide an overview from east, southeast, southwest to west. Photo shows additional reclamation and contour work to address stormwater ponding issues have been performed.

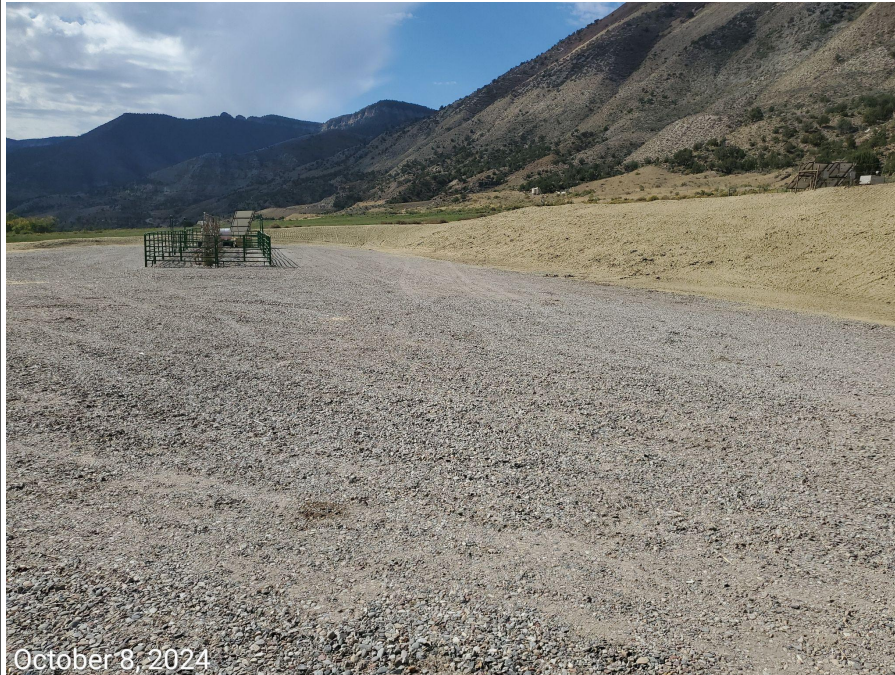
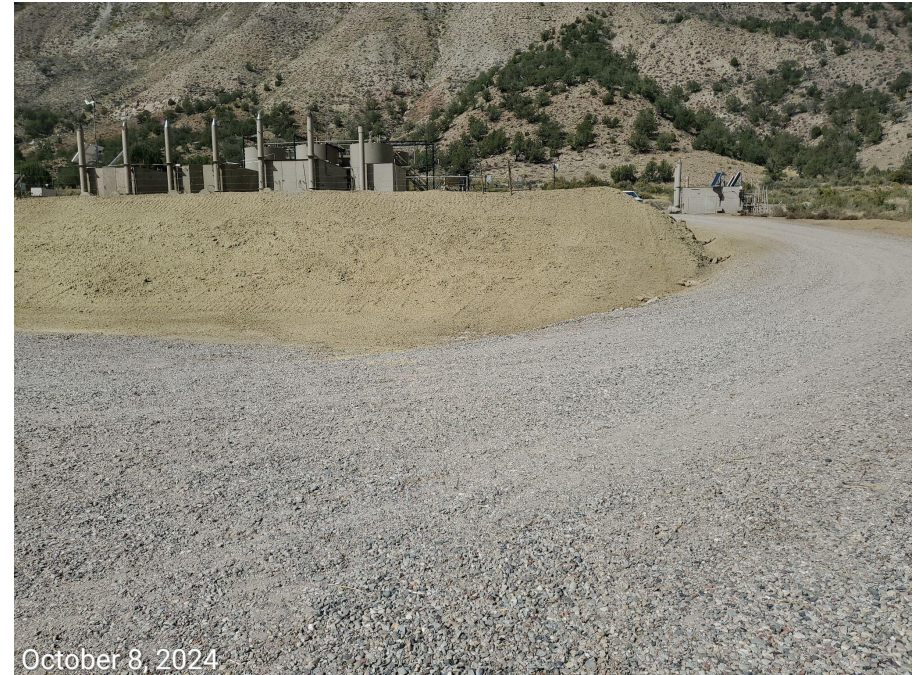
**Photo 6:** See comments under photo 5.

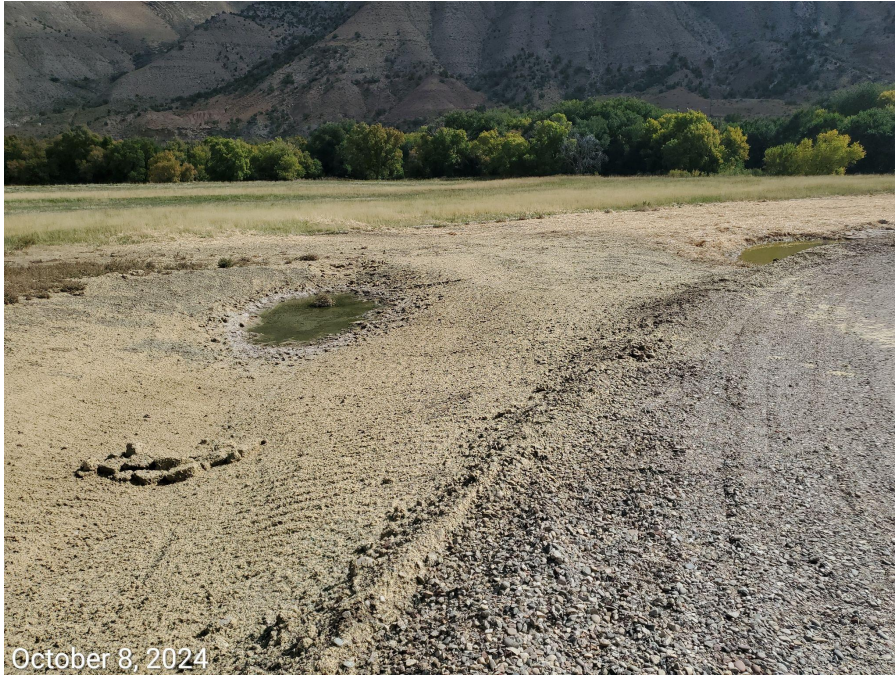
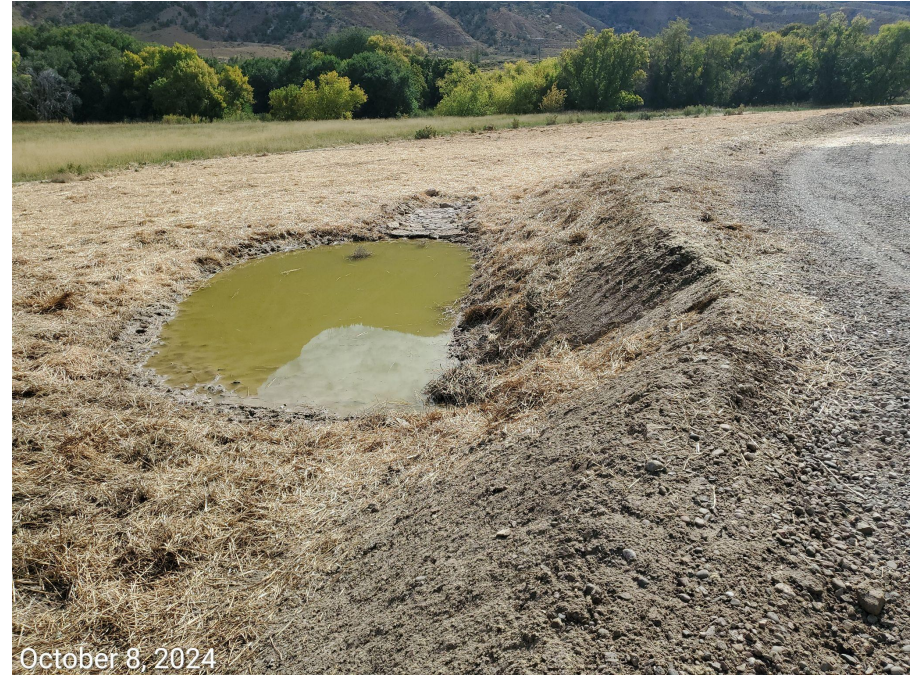
**Photo 7:** Examples of additional sediment traps implemented along the east end of the Location.

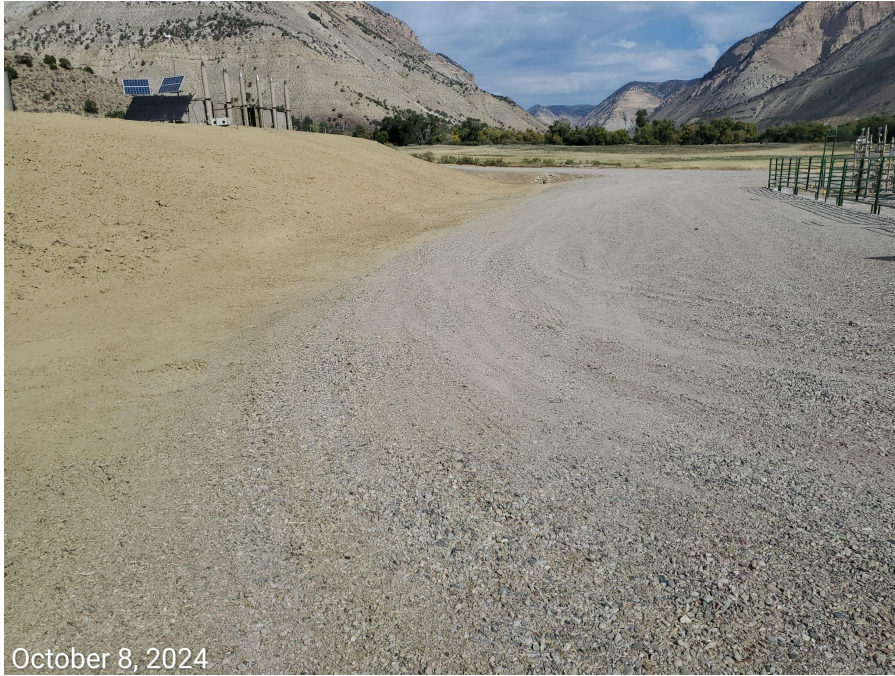
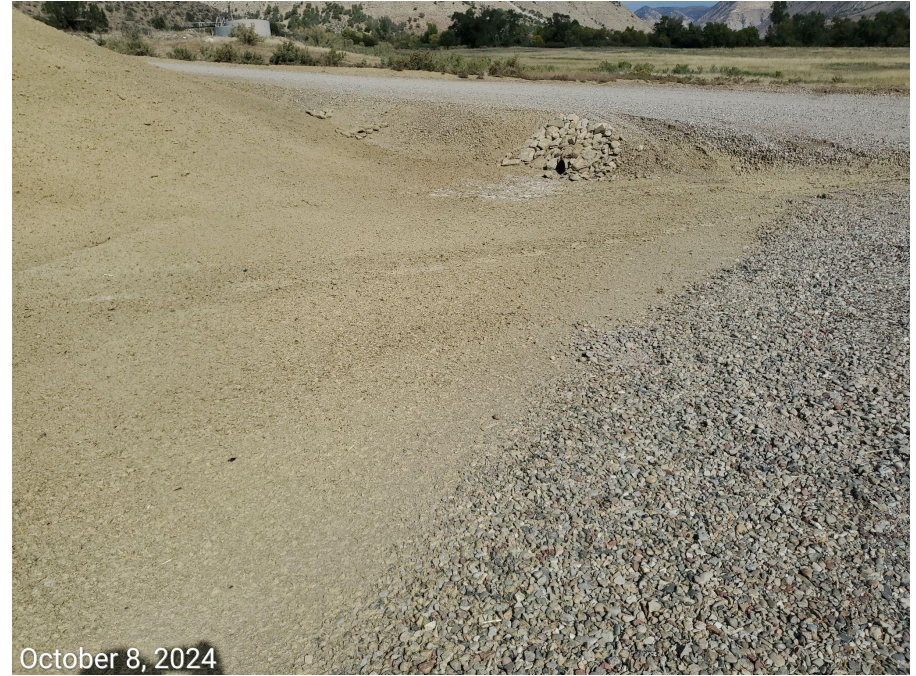
**Photo 8:** Photos taken from west end of the eastern pad, facing north. Photo shows additional reclamation and contour work to address stormwater ponding issues have been performed.
