Interim Reclamation and Stormwater Inspection

September 10, 2024

Operator: FULCRUM ENERGY OPERATING # 10805

Location ID: 416625

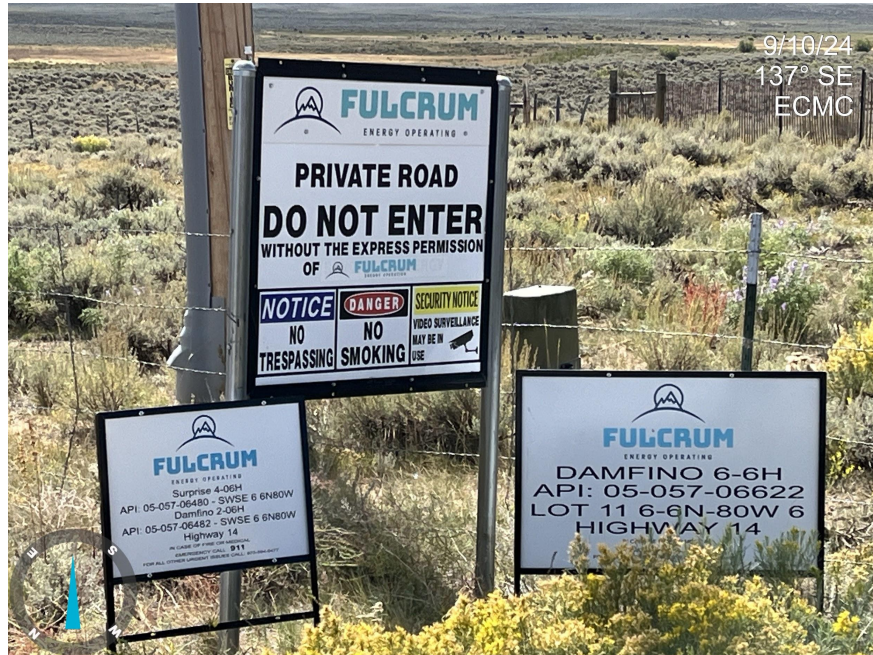
Photo 1. Photo taken from the entrance of Location, illustrating Operator's sign.

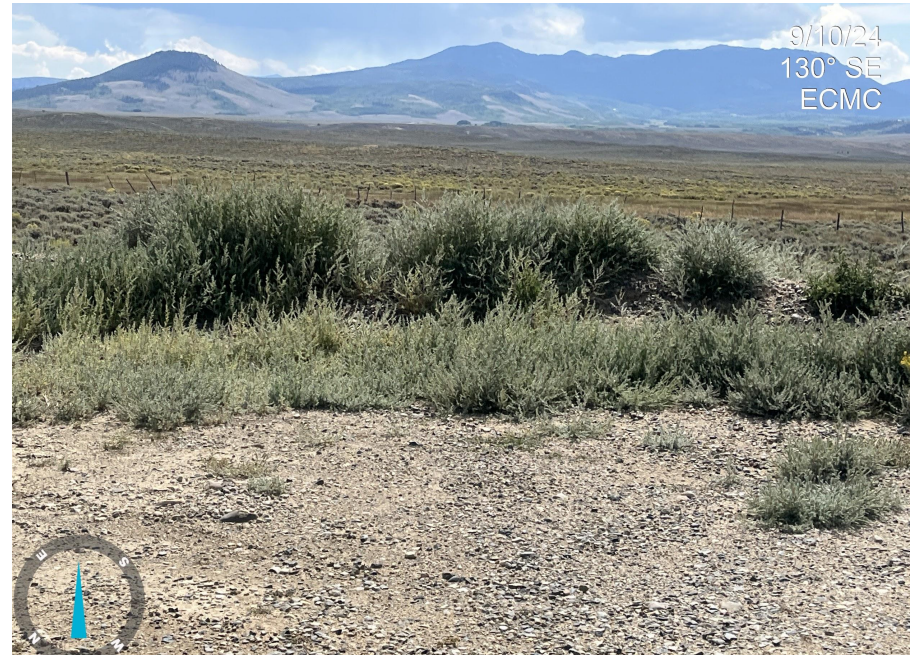
Photo 2. Photo taken at the SE portion of the Location, facing SE. Weeds observed growing on the berms and along other portions of the perimeter.

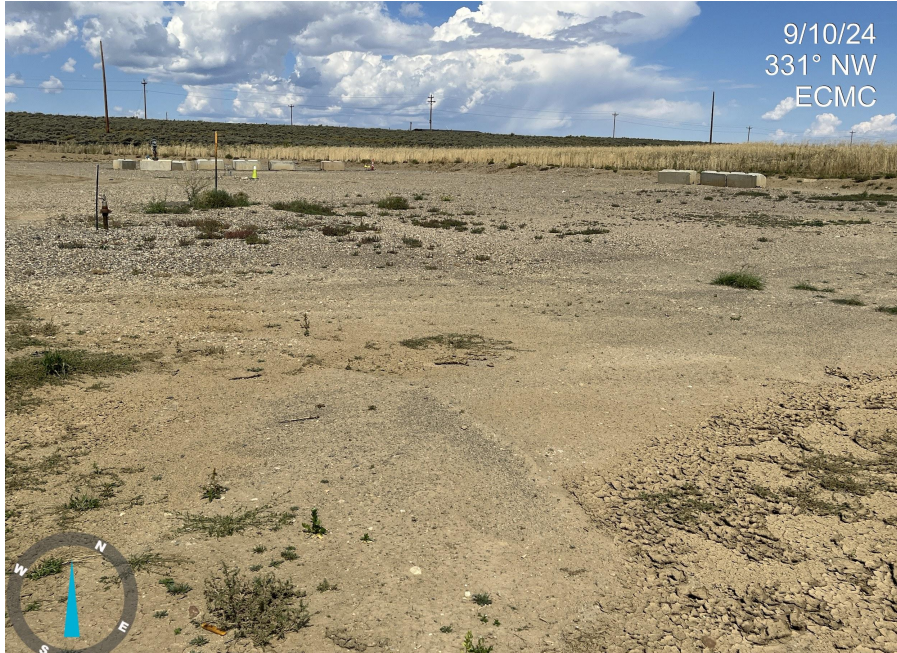
Photo 3. Photo taken from the eastern working pad surface, facing NW. Photo illustrates that some unused equipment was removed. Areas not used for production need to be reclaimed per 1003 Rules.

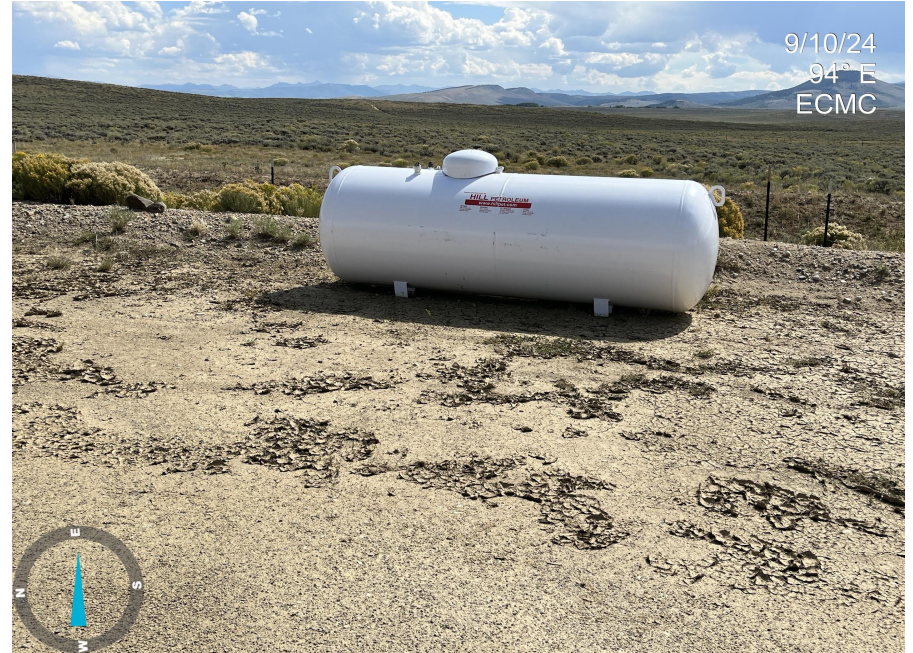
Photo 4. Photo taken from the eastern working pad surface, facing east. Photo illustrates an unused tank.

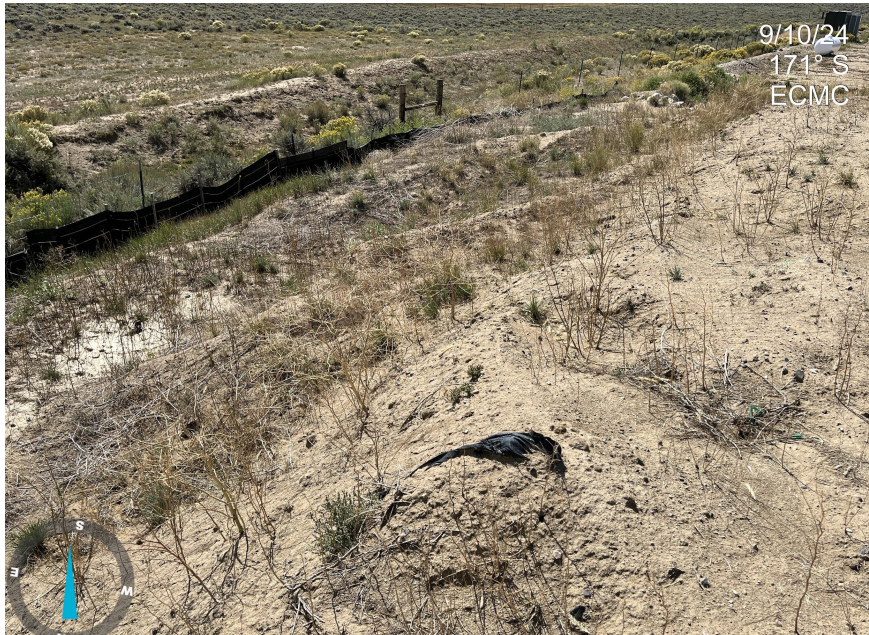
Photo 7. Photo taken from the top of the topsoil pile. Topsoil conditions remain the same as the last inspection. Operator plans to seed and implement stabilization in the fall.

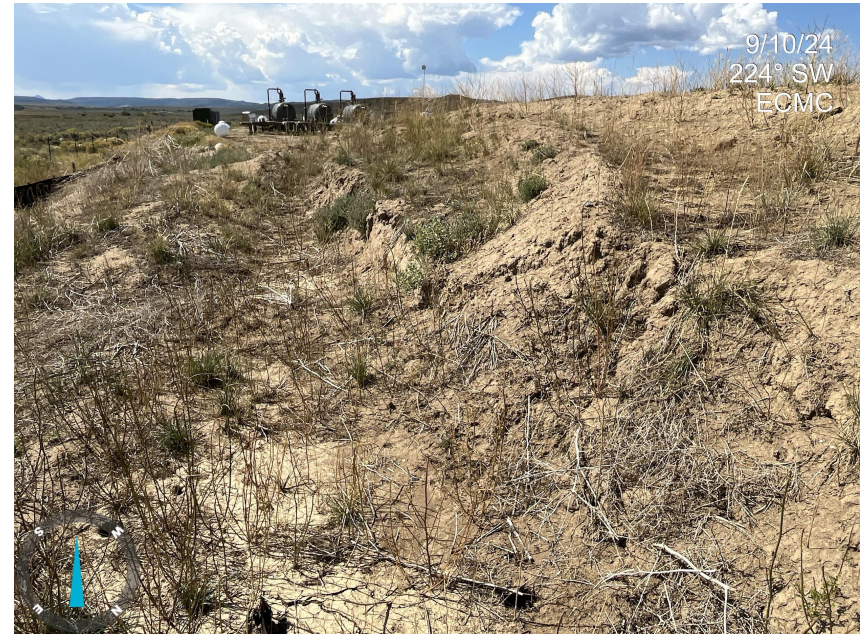
Photo 8. Photo taken from the northeastern edge of the topsoil stockpile, facing SW. Photo illustrates erosion along the topsoil sides. Comply with Rule 1002.c. to implement long-term BMP stabilization and to help prevent weed establishment.

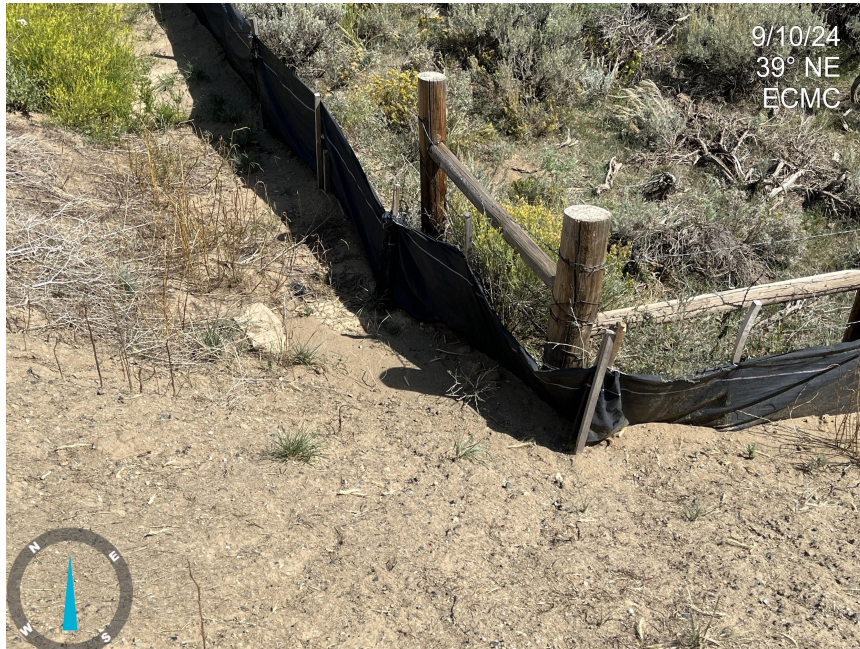
Photo 9. Photo taken from the top of the topsoil stockpile, facing northeast. Photo illustrates the silt fence is inadequate and does not appear to be an appropriate BMP given the snow accumulation in the winter months.

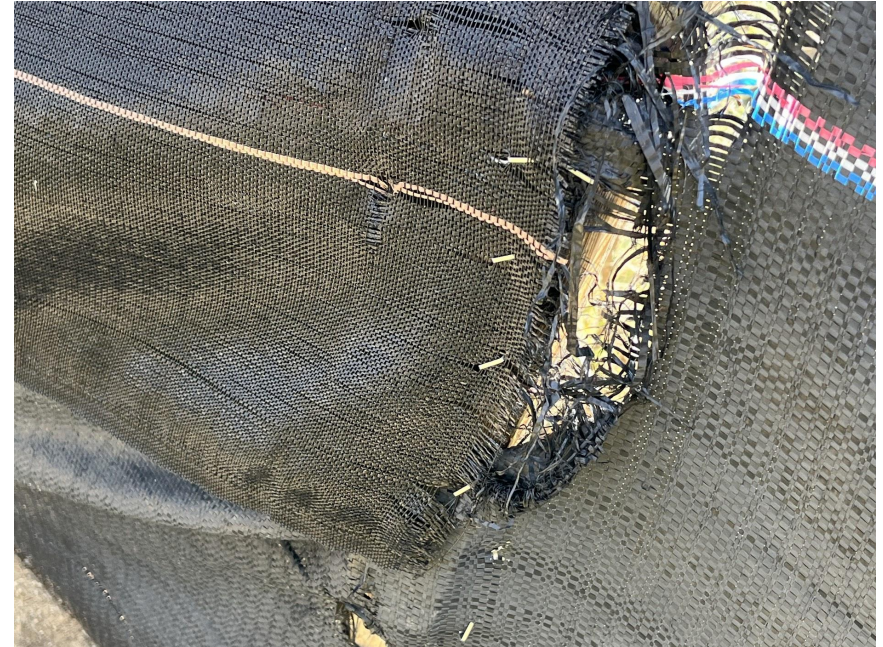
Photo 10. Photo taken of the silt fence, which attempted to be repaired but does not appear to be functioning properly per good engineering practices.

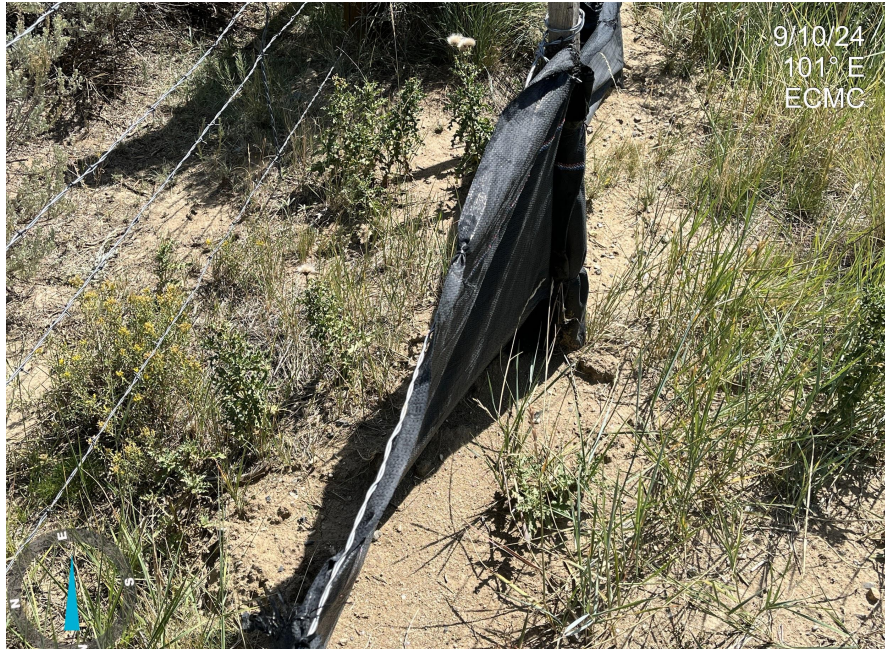
Photo 11. Photo taken from the northwestern edge of topsoil, facing east. Photo illustrates inadequate erosion control BMPs.

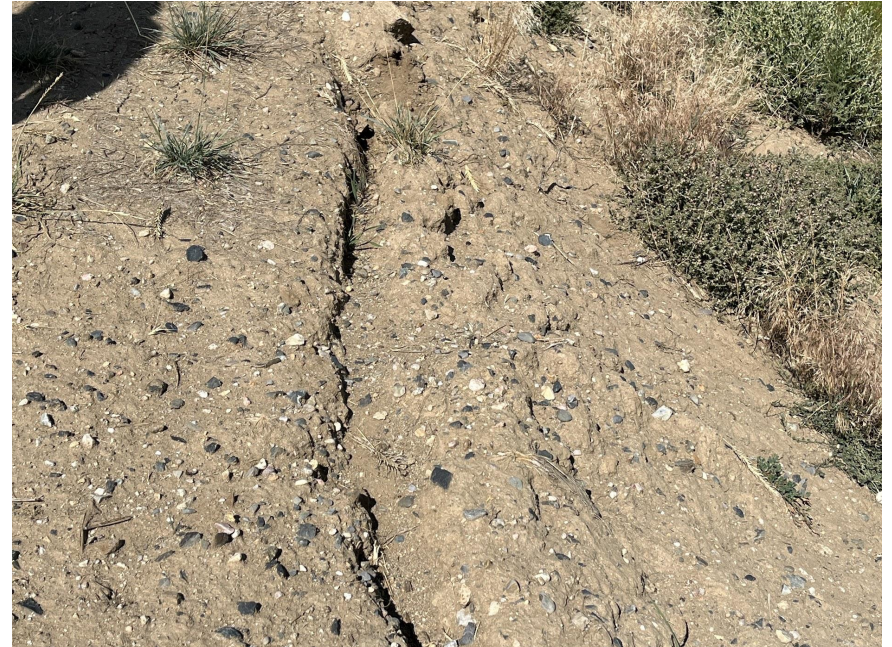
Photo 12. Photo taken from the top of the stockpile topsoil. Photo illustrates erosion occurring along the topsoil pile. Operator shall comply with 1002 rules.

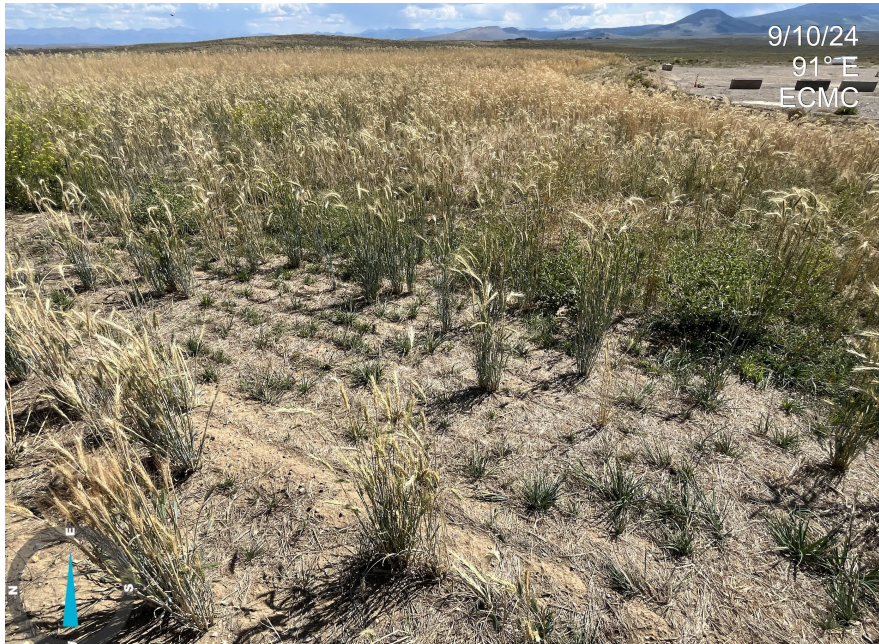
Photo 13. Photo taken from the western interim reclamation area, facing east. Photo illustrates that the seed mix is predominantly introduced species not reflective of reference area vegetation.

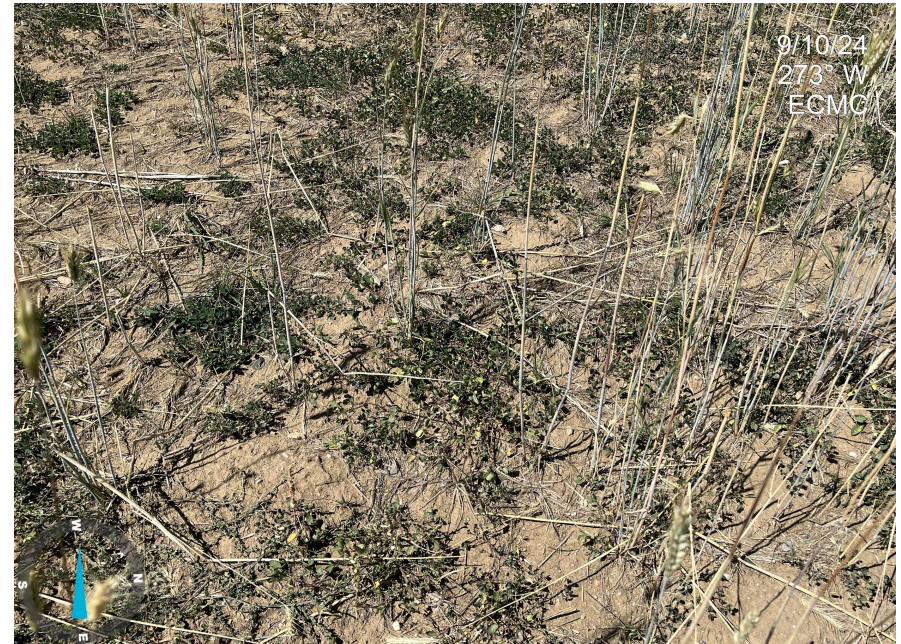
Photo 14. Photo taken from the western interim reclamation area, facing west. Photo illustrates weeds within the interim area.
