New Construction and Stormwater Inspection

Operator: FULCRUM ENERGY OPERATING # 10805

Location ID: 436642

Location Name: Ray Ranch North 0880 S32 Pad

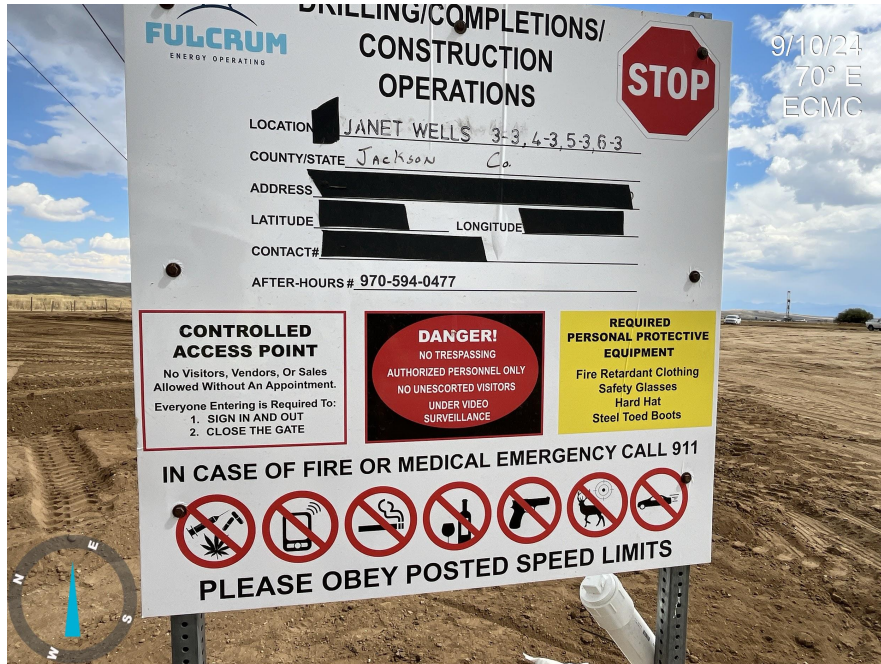
Photo 1. Photo taken from the entrance of Location. Signage of Ray Ranch North is not on site. This Location shares access road with Janet 0780 S5 Pad. Photo illustrates the drilling is occurring at the Janet Pad.

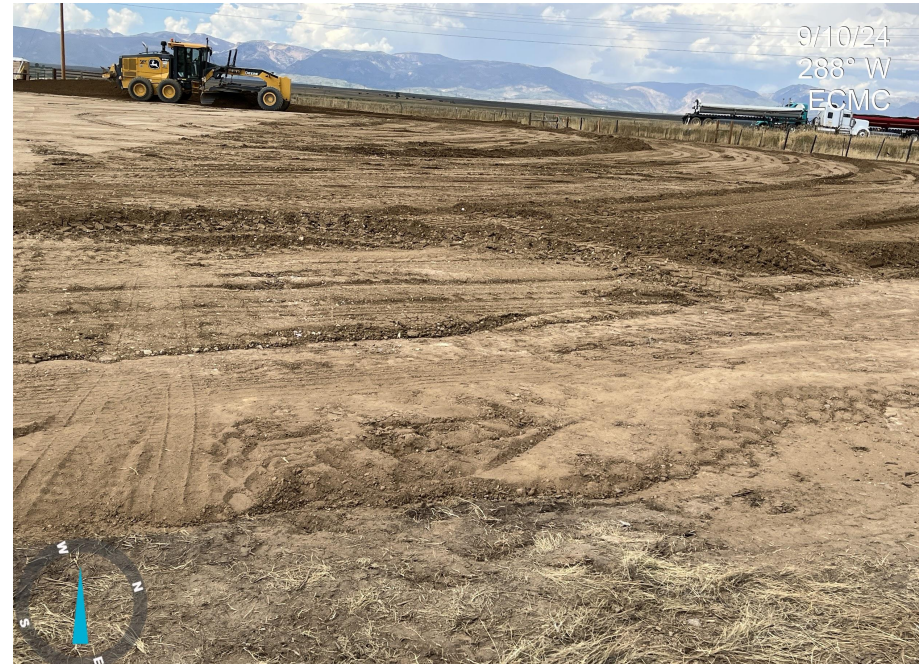
Photo 2. Photo taken from the eastern edge of Location facing west. Photo illustrates construction grading without perimeter stormwater BMPs

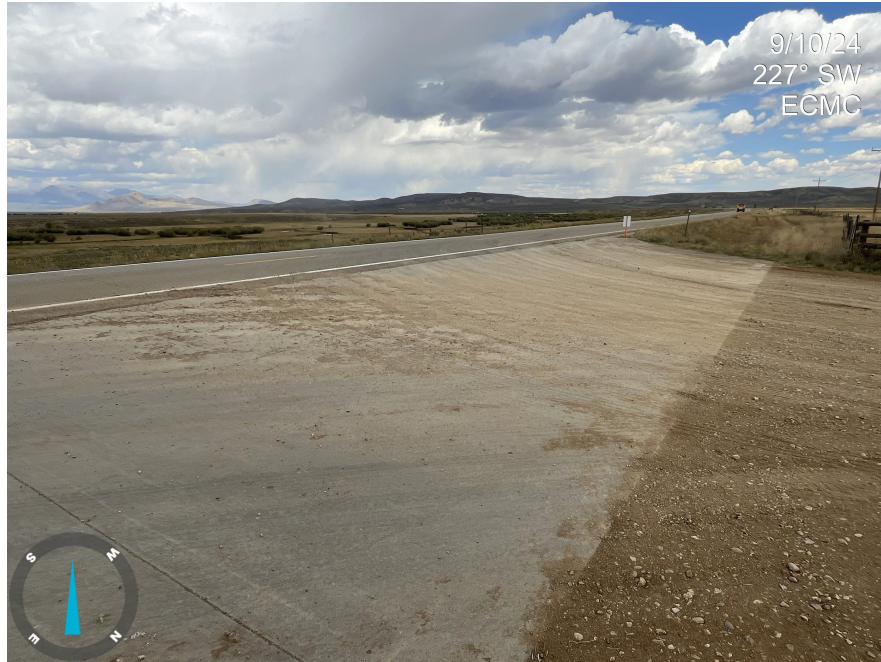
Photo 3. Photo taken from the entrance of Location facing Highway 14. Photo illustrates sediment track-out offsite. Sediment transport was not observed at longer distances away from entrance.

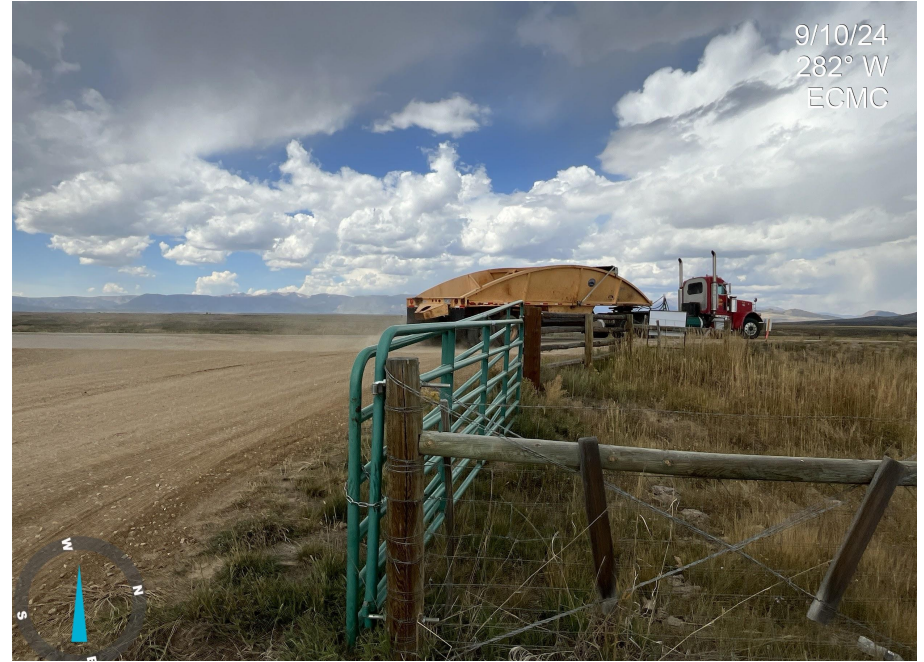
Photo 4. Photo taken from the entrance of Location facing Highway 14. Tracking pad not installed to prevent track of material off site. Discussion with Operator that street sweeper was employed to clean sediment tracked off-site.

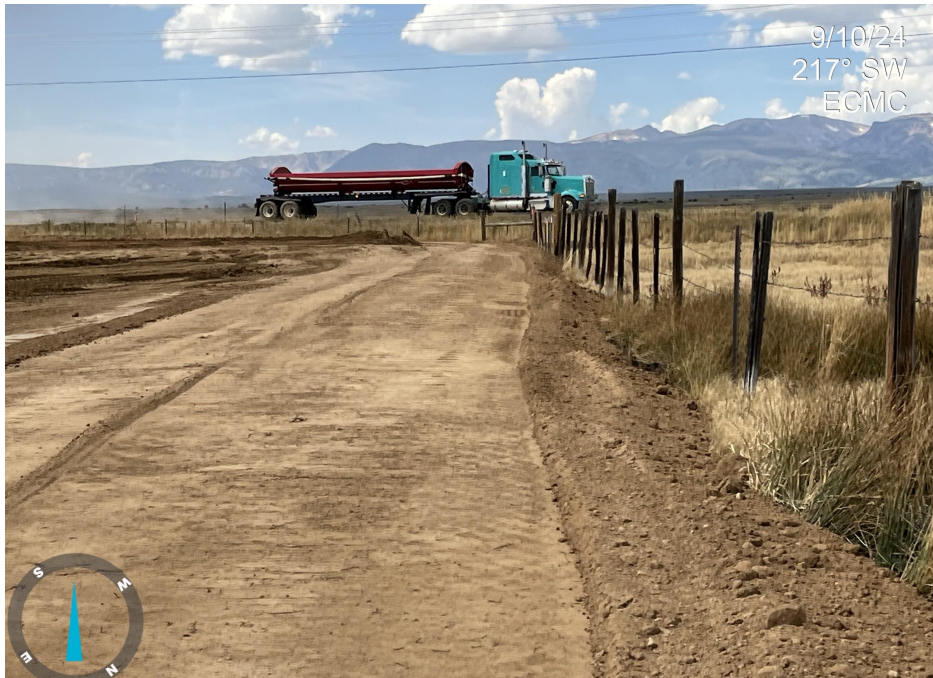
Photo 5. Photo taken from the northeastern edge of Location, facing southwest. Photo illustrates Location perimeter. No stormwater perimeter BMPs installed prior to construction, per Rule 1002.f.(2) .

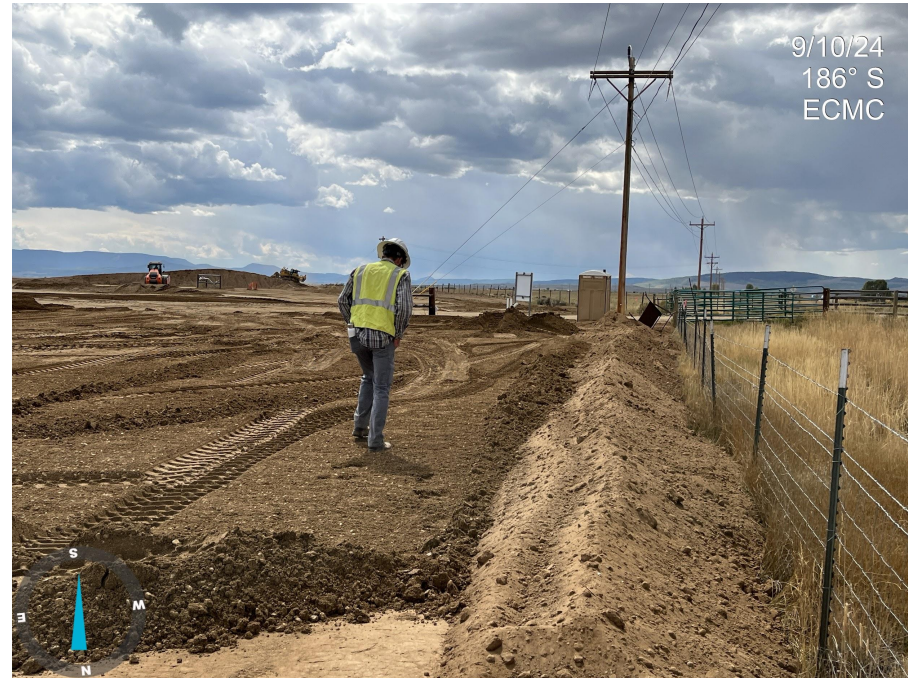
Photo 6. Photo taken from the northwestern edge of Location, facing south. Photo illustrates Location perimeter. No stormwater perimeter BMPs installed at time of inspection.

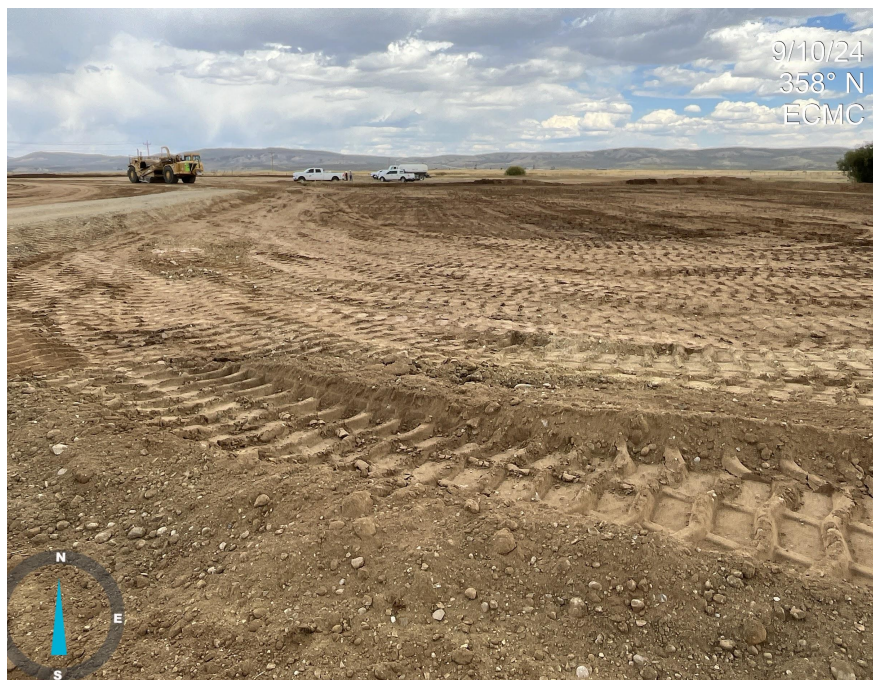
Photo 7. Photo taken from the eastern edge of Location, facing north. Photo illustrates Location perimeter. No stormwater perimeter BMPs installed at time of inspection.

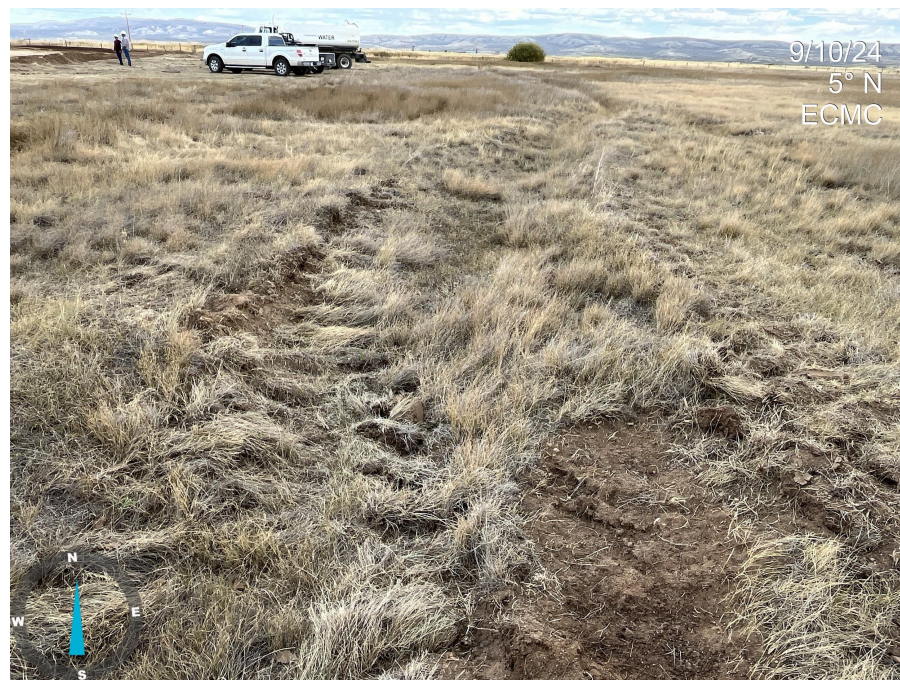
Photo 8. Photo taken from the eastern edge of Location, facing north. Photo illustrates an area not constructed at time of inspection. Based on Operator plans, this area may be part of disturbance. If so, salvage topsoil and install perimeter BMPs.

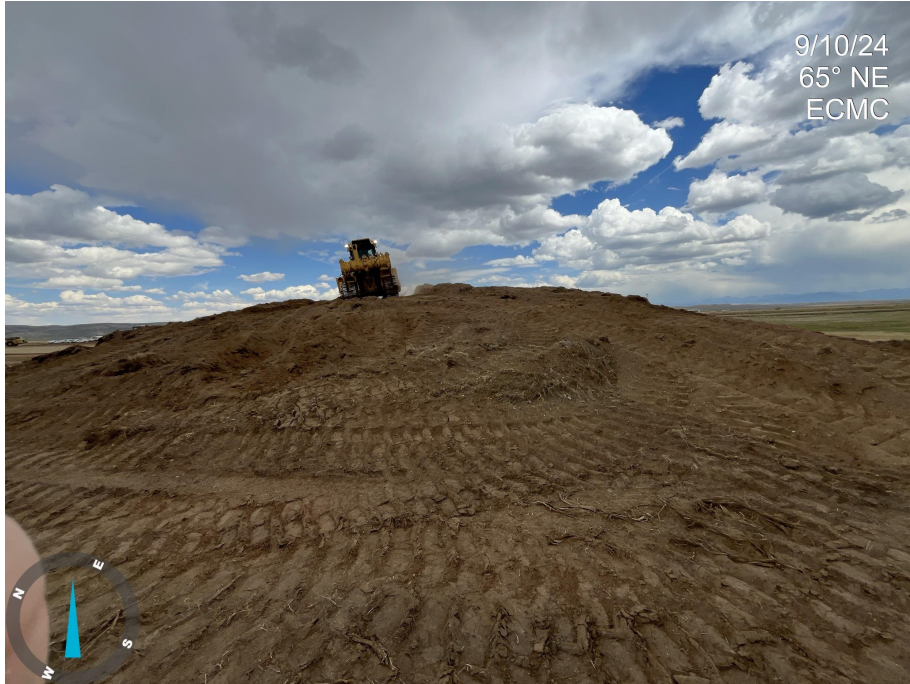
Photo 9. Photo taken from western edge of Location, facing NE. Photo illustrates topsoil stockpile and temporary stabilization is in process.

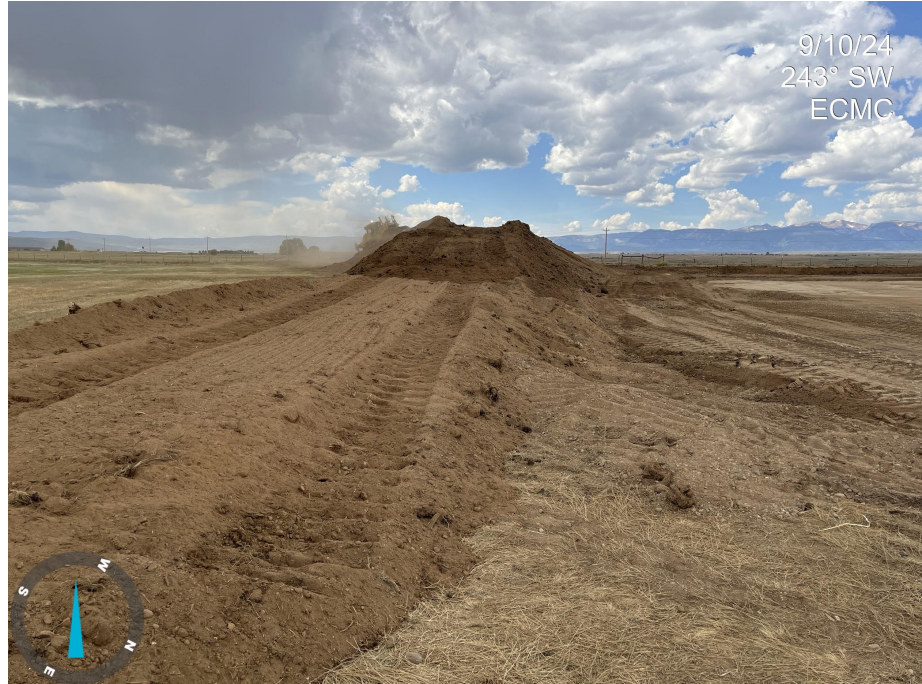
Photo 10. Photo taken from southeastern edge of Location, facing SW. Photo illustrates topsoil stockpile.

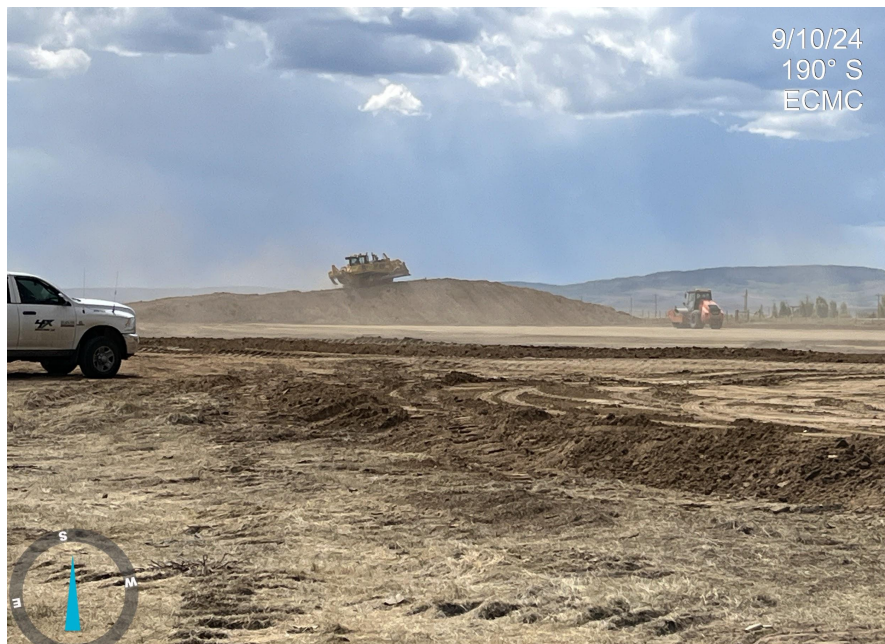
Photo 11. Photo taken from the eastern edge of Location. Photo illustrates topsoil stockpiling in process.

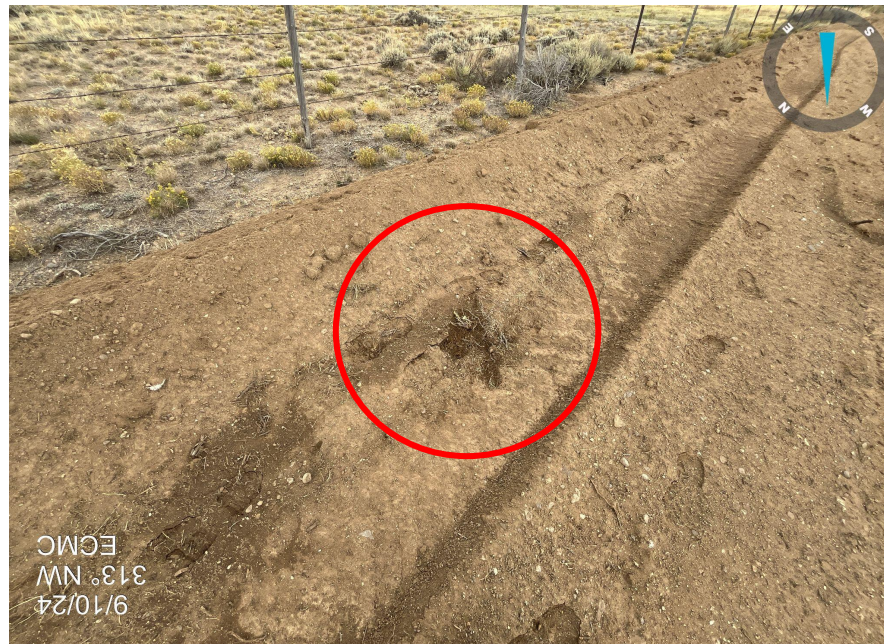
Photo 12. Photo taken from the western edge of Location. Photo illustrates topsoil observed on perimeter.

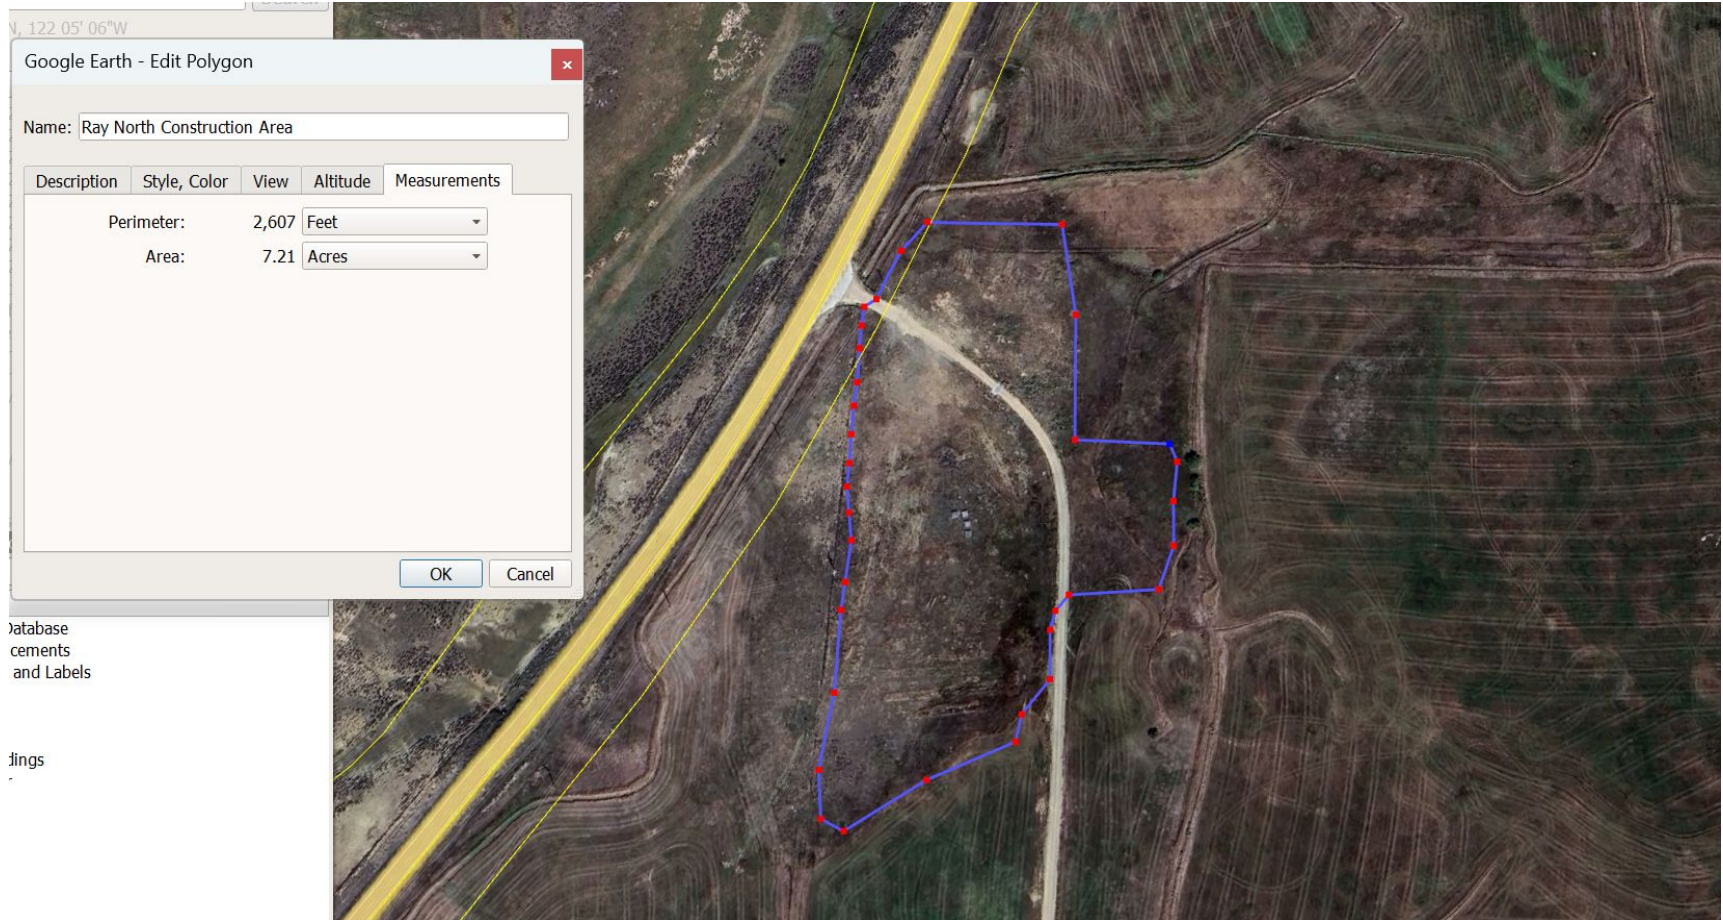
Photo 13. Satellite imagery and perimeter of Location during construction. The Location is approximately 7.2 acres. At the time of construction, not all areas had been excavated.
