# Interim Reclamation and Stormwater Inspection

September 10, 2024

Operator: FULCRUM ENERGY OPERATING # 10805

Location ID: 436801

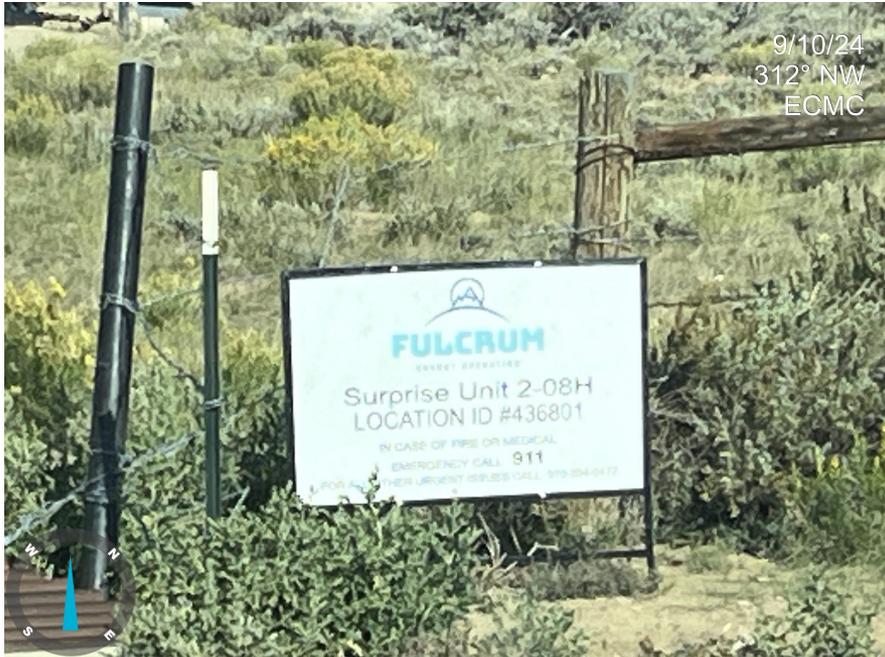
**Photo 1.** Photo taken from the entrance of Location. Photo illustrates the Location Operator sign.

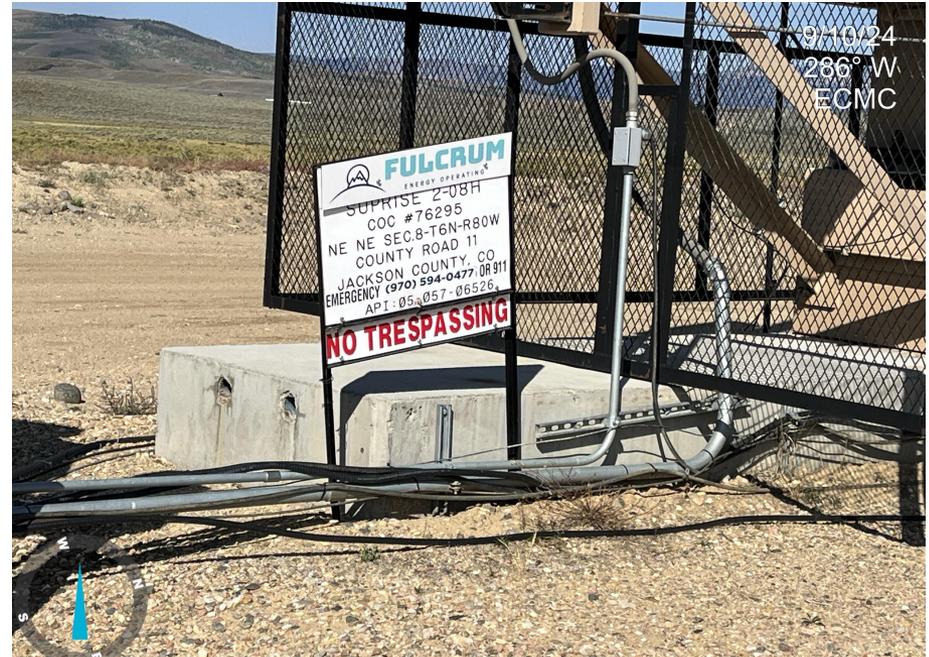
**Photo 2.** Photo taken from the wellhead. Photo illustrates that API was added to well signage.

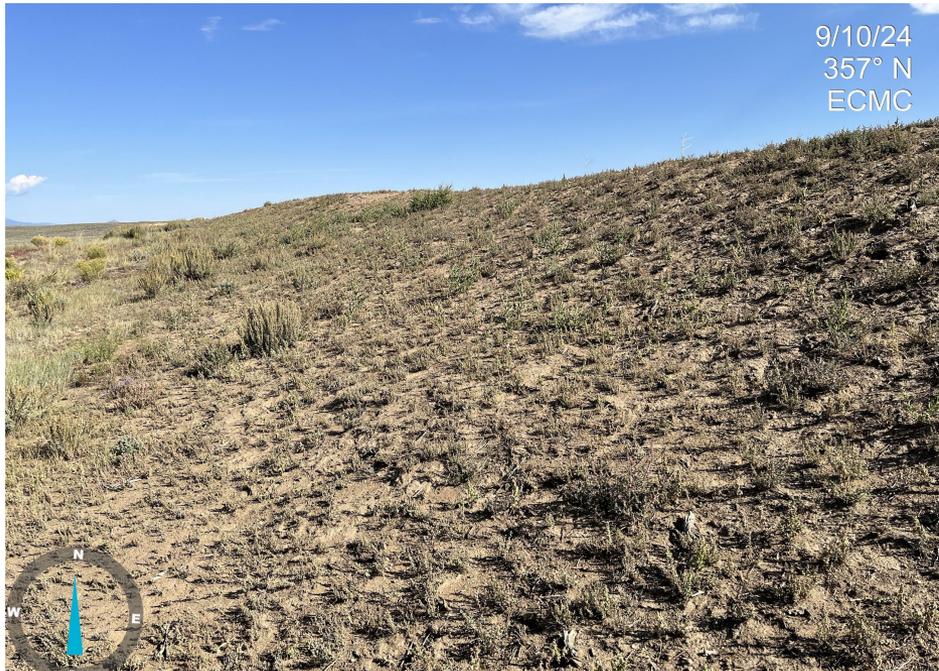
**Photo 3.** Photo taken from the eastern interim reclamation area, facing north. Photo illustrates topsoil stockpile, with weed growth (e.g., Russian Thistle) present and little to no perennial vegetation established. Silt fence was removed. Comply with 1002 Rules.

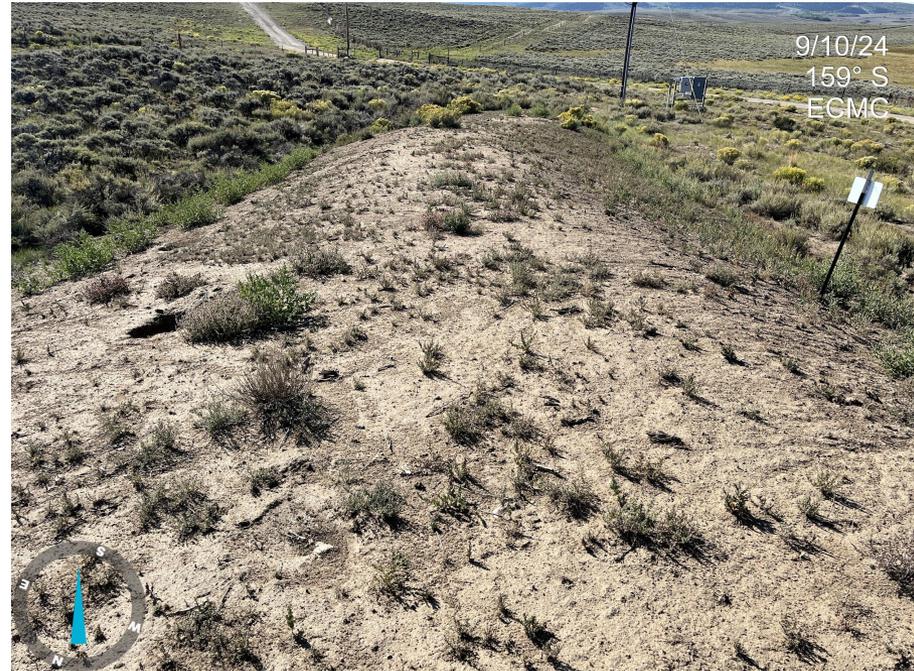
**Photo 4.** Photo taken from the eastern topsoil stockpile, facing south. Photo illustrates topsoil stockpile, with weed growth (e.g., Russian Thistle) present and little to no perennial vegetation established. Silt fence was removed.

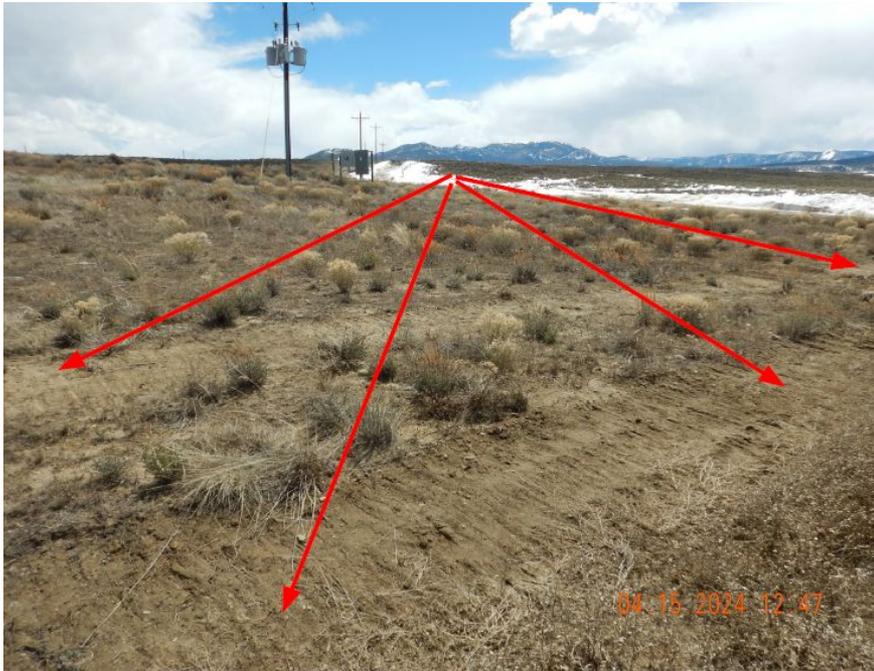
**Photo 5.** Photo taken 4/15/24 from the eastern interim reclamation area, facing southeast. Photo illustrates disturbances related to remediation project.

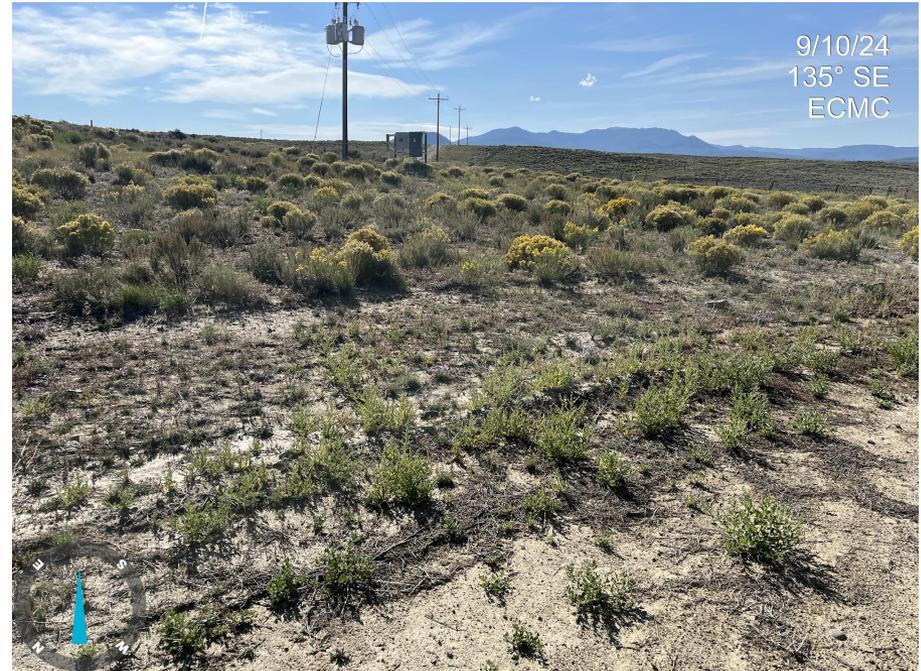
**Photo 6.** Photo taken from the eastern interim reclamation area, facing southeast. Photo illustrates that interim reclamation has not occurred along this portion of the pad. Comply with Rule 1003.

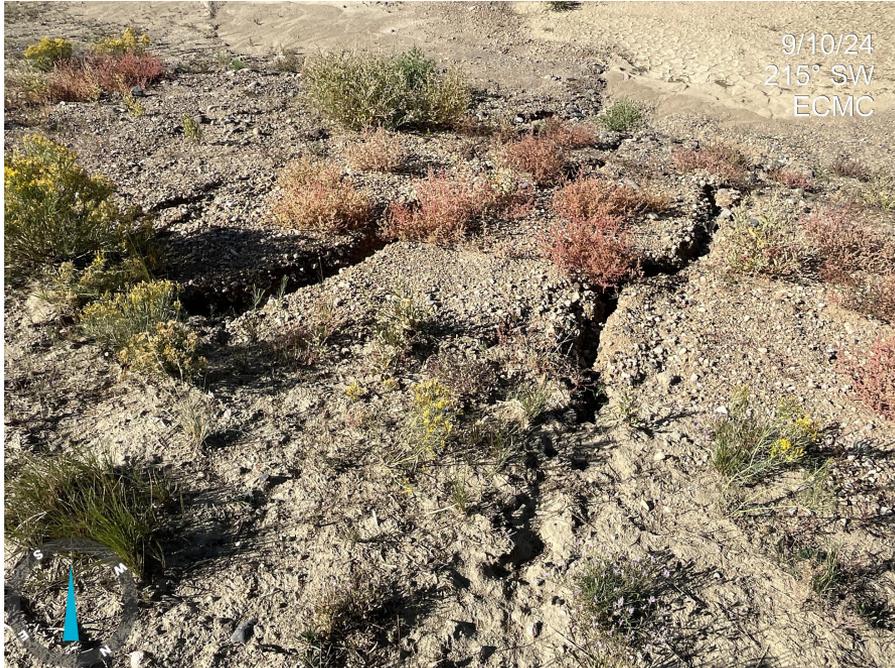
**Photo 7.** Photo taken from the top of the topsoil stockpile, facing SW. Photo illustrates topsoil stockpile is not properly stabilized, with evidence of erosion. Comply with 1002.c.

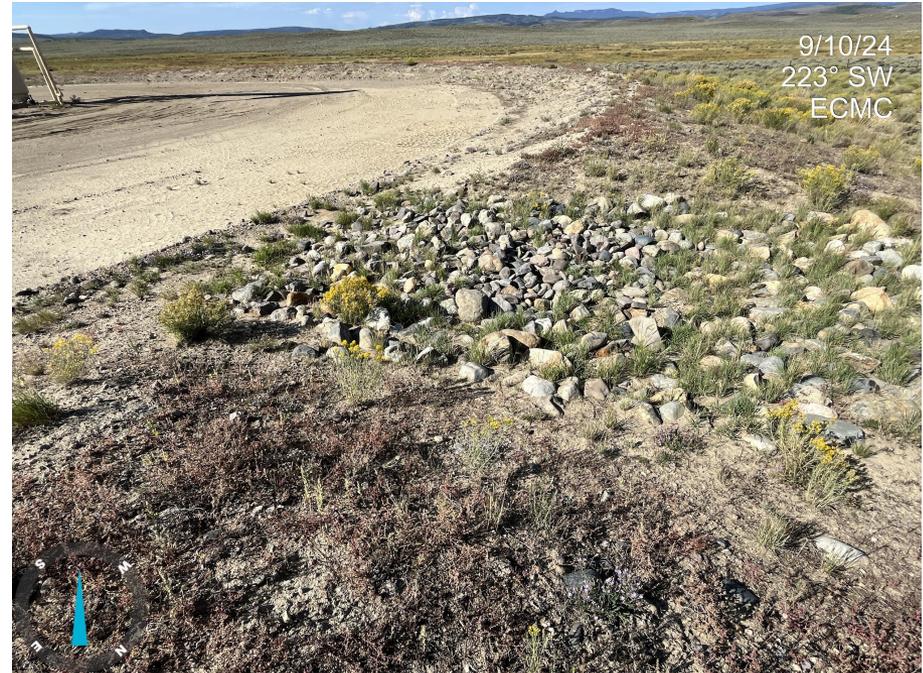
**Photo 8.** Photo taken from the eastern portion of working pad surface area, facing SW. Photo illustrates that the sediment trap is not functioning properly. Comply with Rule 1002.f.

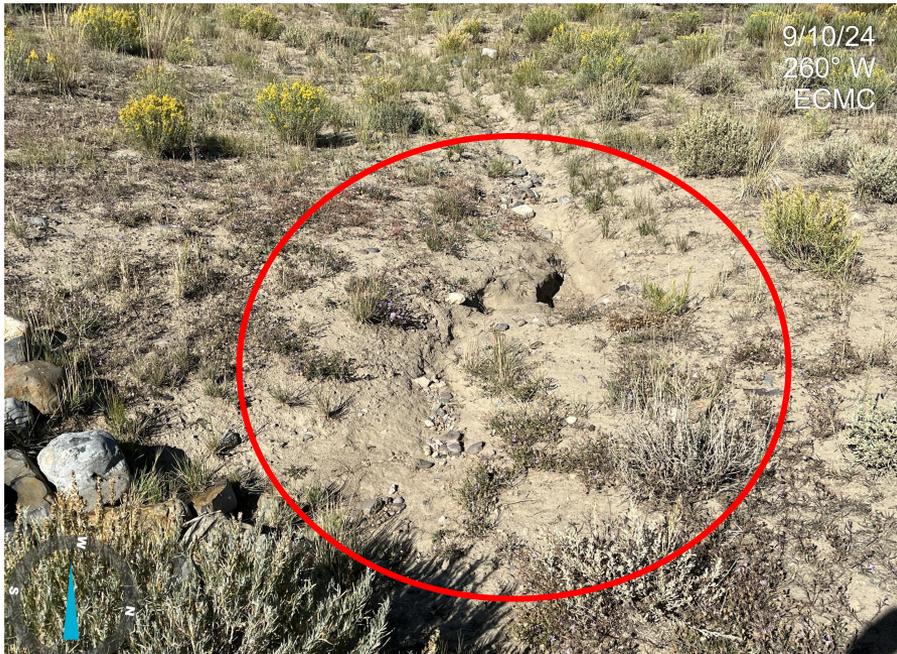
**Photo 9.** Photo taken from the eastern working pad surface, facing west. Photo illustrates erosion downhill from sediment trap revegetation of the fill slopes are in process. Operator shall continue to monitor and manage until Location reaches 1003 standards.

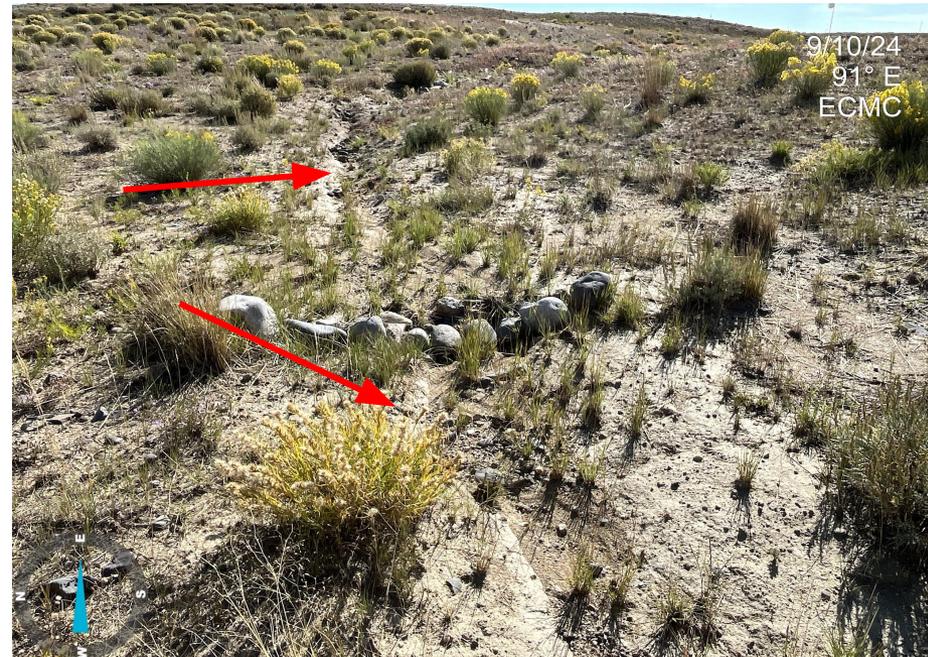
**Photo 10.** Photo taken from the northern portion of interim area, facing east. Photo illustrates check dams are not functioning properly. It was observed that erosion (red arrows) and downhill sedimentation were occurring.

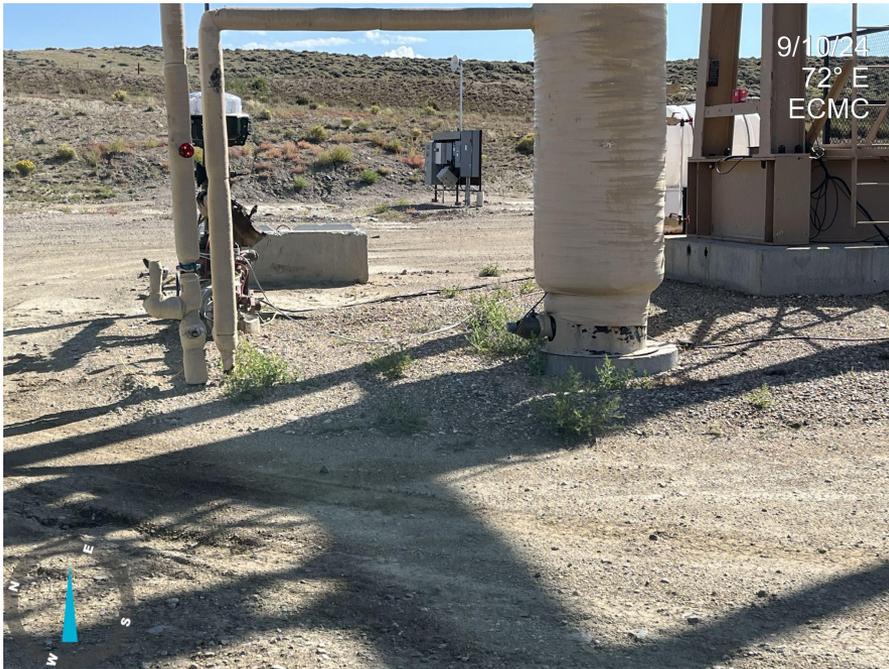
**Photo 11.** Photo taken from the western working pad surface, facing east. Photo illustrates weeds at the wellhead.

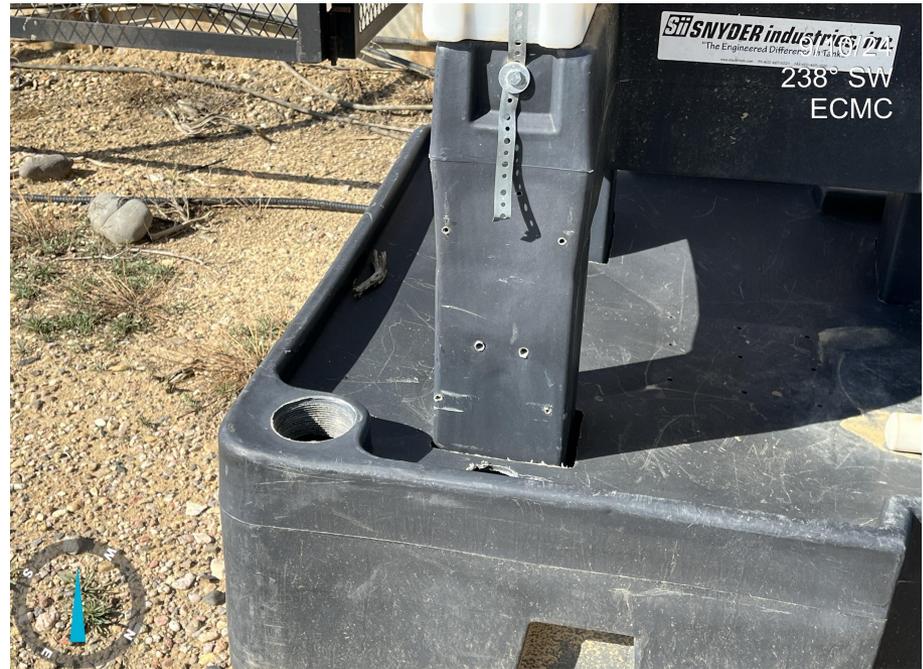
**Photo 12.** Photo taken at the wellhead, facing southwest. Photo illustrates wildlife protection devices were missing from equipment. Comply with Rule 902.b.
