Interim Reclamation and Stormwater Inspection

September 10, 2024

Operator: WOODBURY RESOURCES LLC #10761

Inspection Photos
Location Name: Fuqua 18-15 Pad
Location ID: 324766

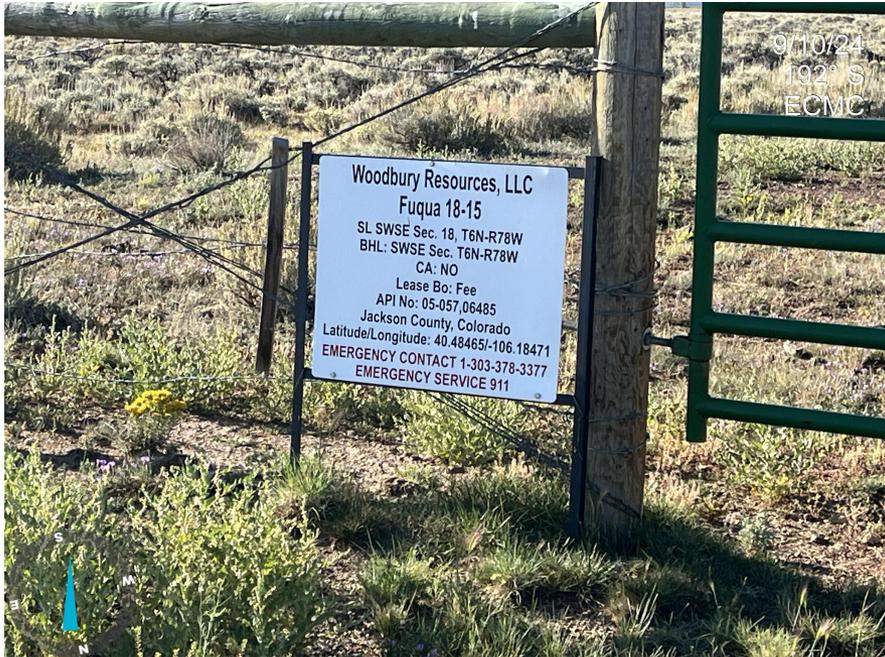
Photo 1. Photo taken from the entrance of Location, illustrating Operator's sign, which needs to be corrected due to an inaccurate Well API #.

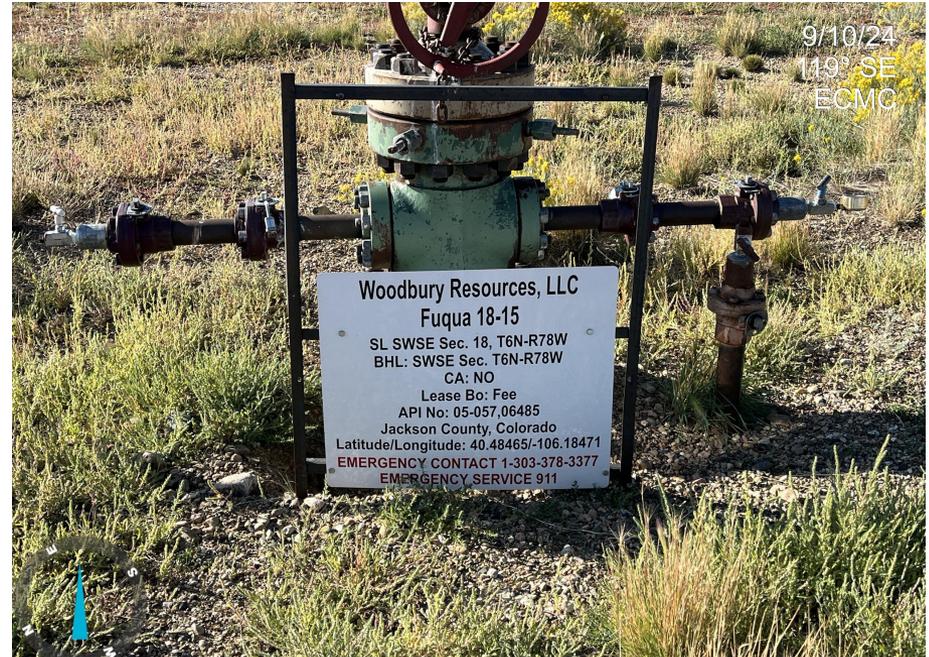
Photo 2. Photo taken the wellhead of the Location, illustrating the Operator's sign, which needs to be corrected due to an inaccurate Well API #.

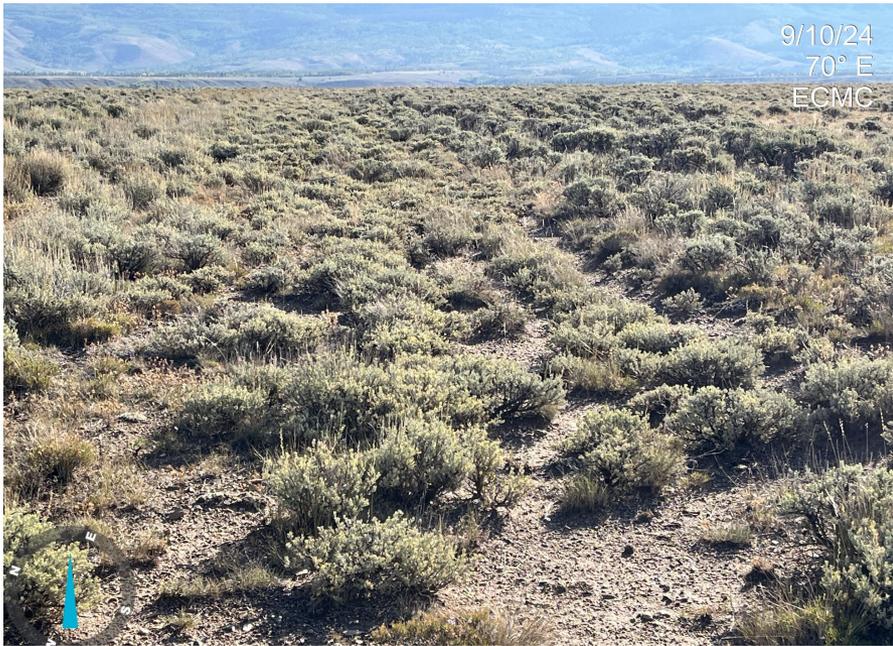
Photo 3. Photo taken from the eastern edge of pad, facing east. Photo illustrates the Operator bulldozed the disturbance feature in response to a 2012 E&P waste release for a proposed controlled burn. The disturbance feature has reclaimed back to reference area conditions.

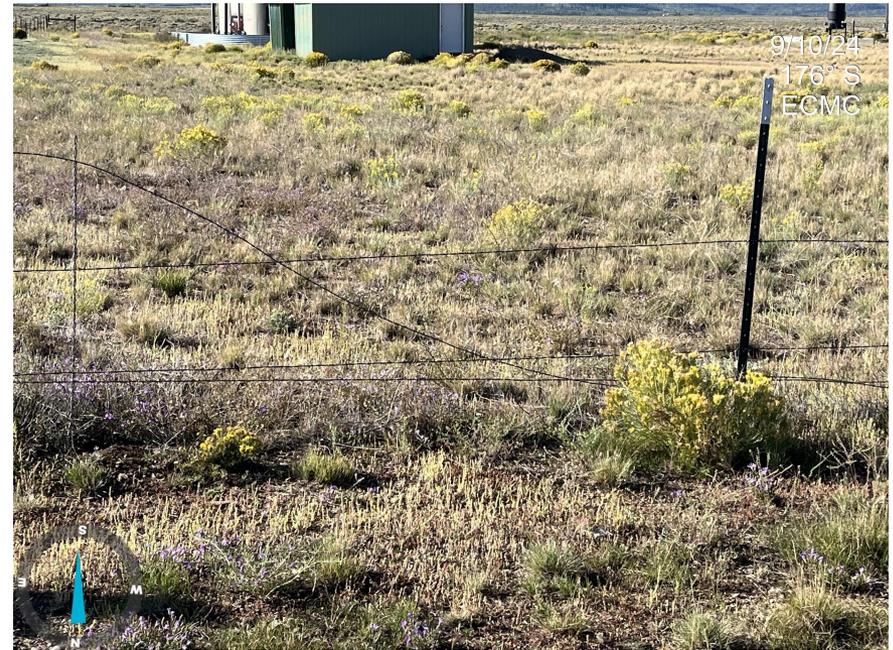
Photo 4. Photo taken from the southeastern working pad, facing North. Photo illustrates broken fence.

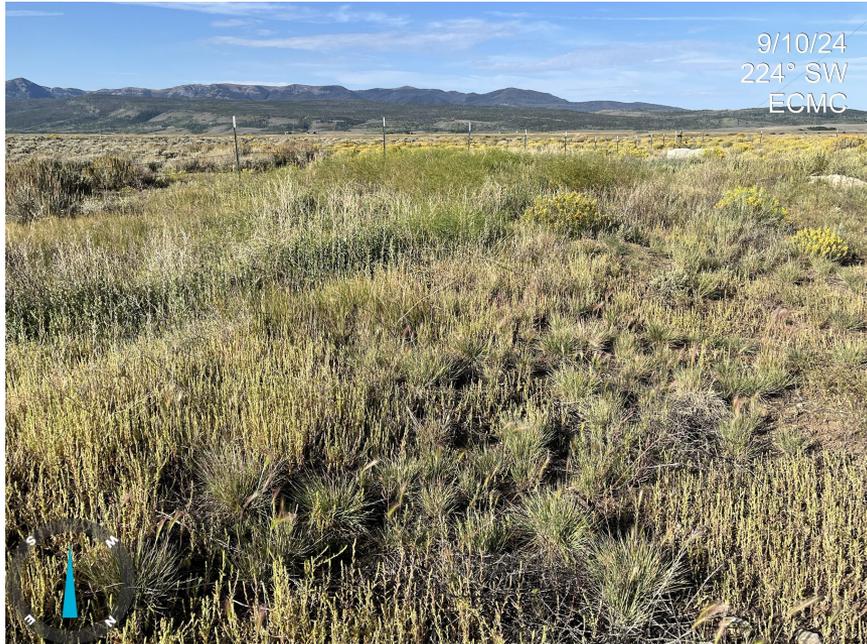
Photo 5. Photo taken from the northern interim reclamation area, facing southwest. Photo illustrates the area consists mostly of annual vegetation, which is not reflective of reference area conditions.

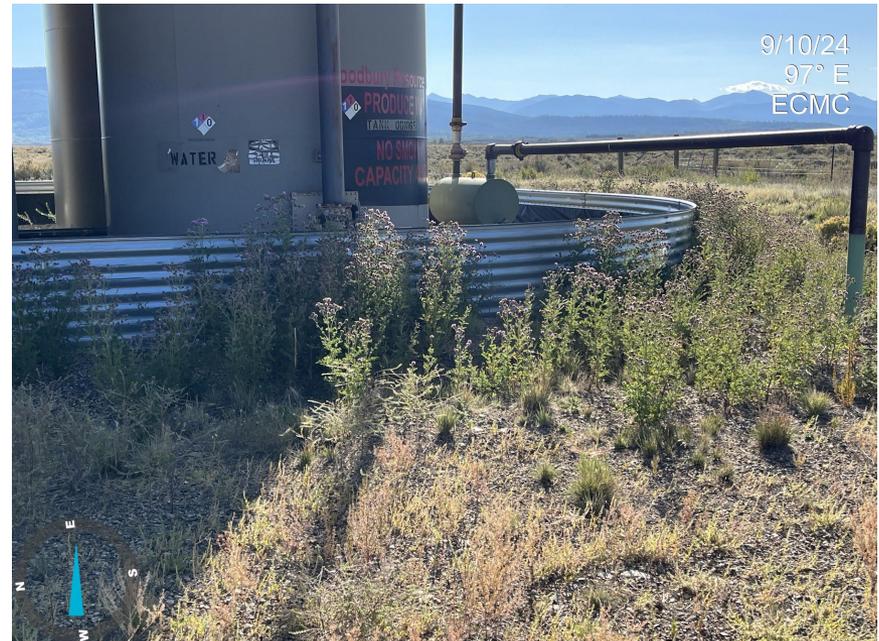
Photo 6. Photo taken near the tank battery. Photo illustrates weeds, including Canada Thistle and Russian thistle. Comply with Rules 606.c. and 1003.f.

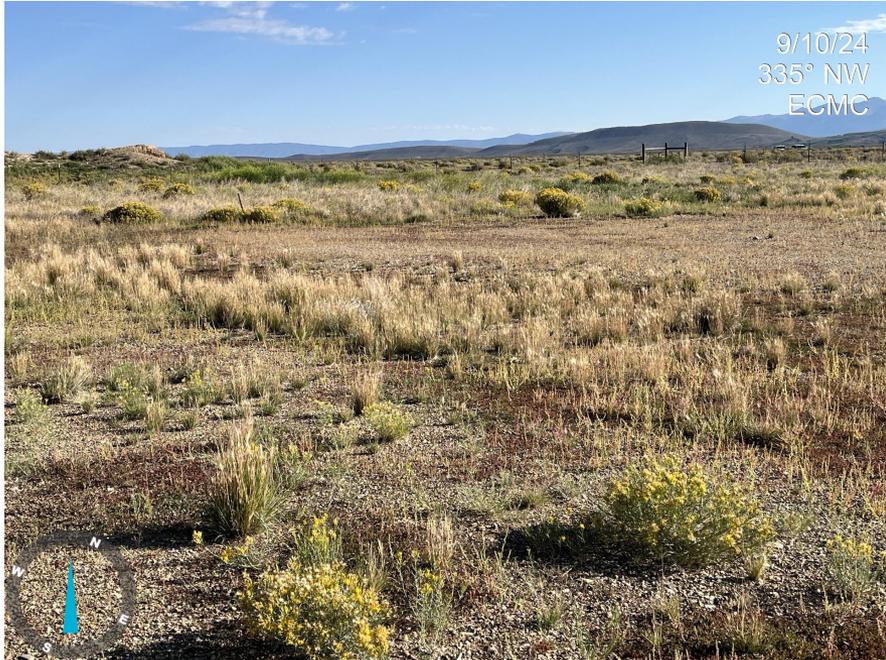
Photo 7. Photo taken from the western interim reclamation area, facing northwest. Photo illustrates the area consists mostly of annual vegetation, which is not reflective of reference area conditions.

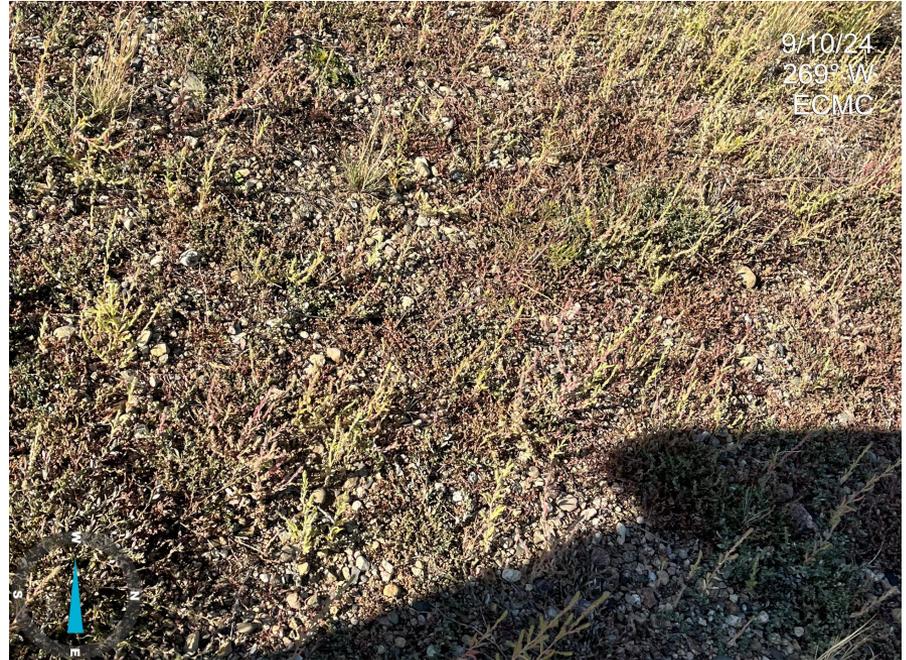
Photo 8. Photo taken from the entrance of the Location, facing south. Photo illustrates the annual vegetation.

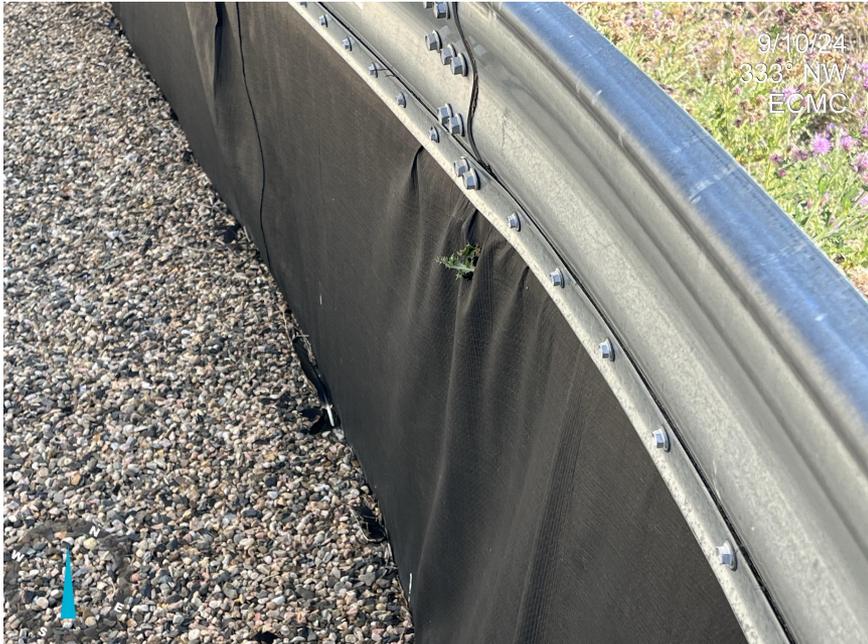
Photo 9. Photo taken from the southeast working pad at tank battery secondary containment. Photo illustrates that the liner is inadequate. Comply with Rule 603.o.

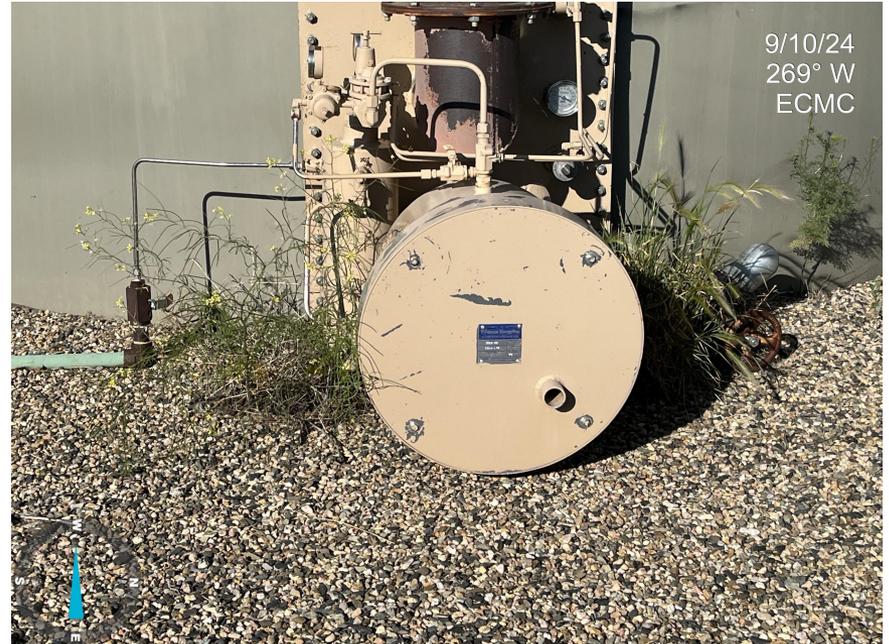
Photo 10. Photo taken from the tank battery. Photo illustrates missing caps/covers on equipment. Operator shall implement wildlife BMPs. Operator shall also manage weeds. Comply with Rule 902.b. and 606.

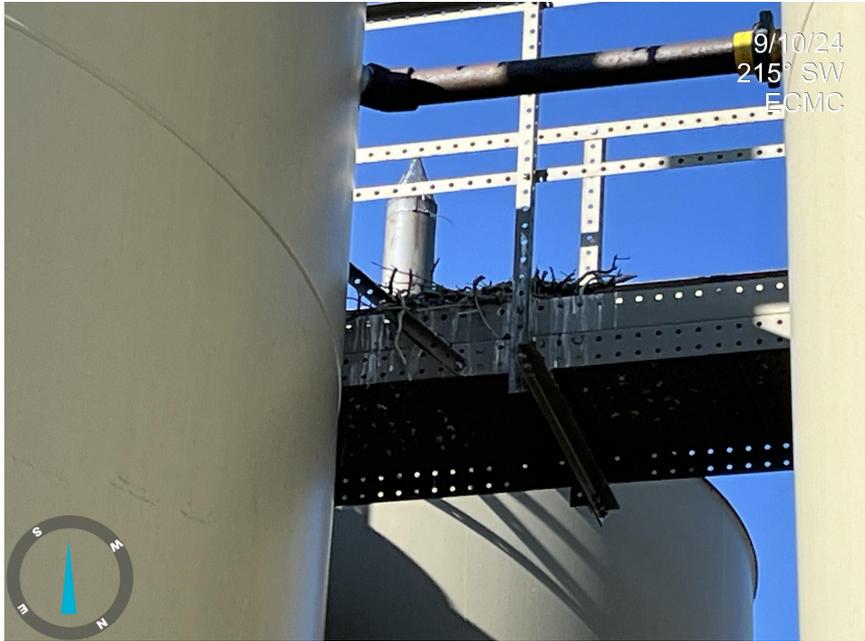
Photo 11. Photo taken at the tank battery. Photo illustrates evidence of a nest (near another nest, see Photo 12). This appears to be an owl's nest based on the surrounding evidence.

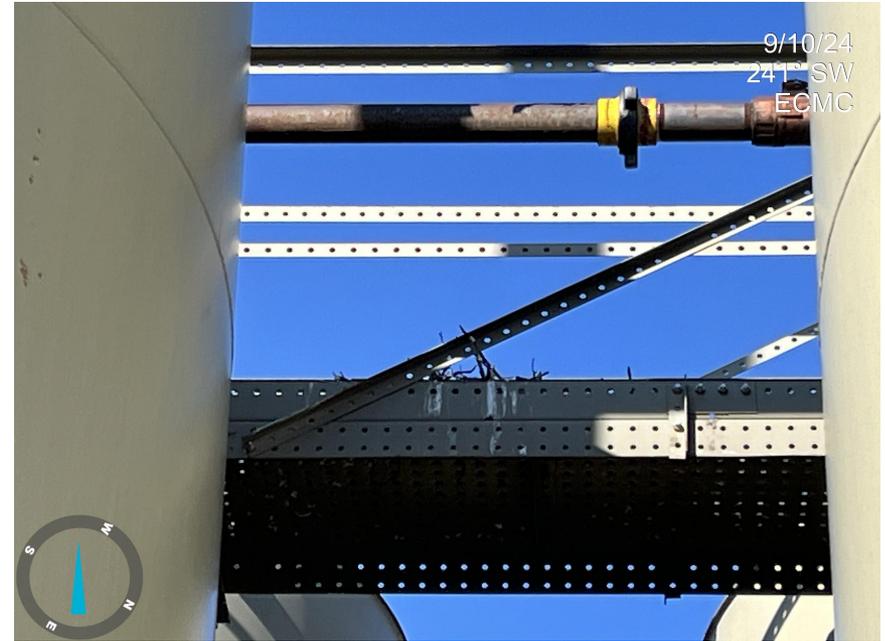
Photo 12. Photo taken at the tank battery. Photo illustrates evidence of a second nest found within a few feet of the first one.
