**Storm Water Management and Erosion control**  
**Location Name: TEP ROCKY MOUNTAIN LLC FEDERAL RWF 32-10 Pad**  
**Location ID: 335659**

**Location Overview: Location is within High Priority/Density Habitat areas & in close proximity to Black Bear Habitat area. Multiple drainages from location contribute to the Colorado River.**

**Section/Township/Range: 11 6S94W**

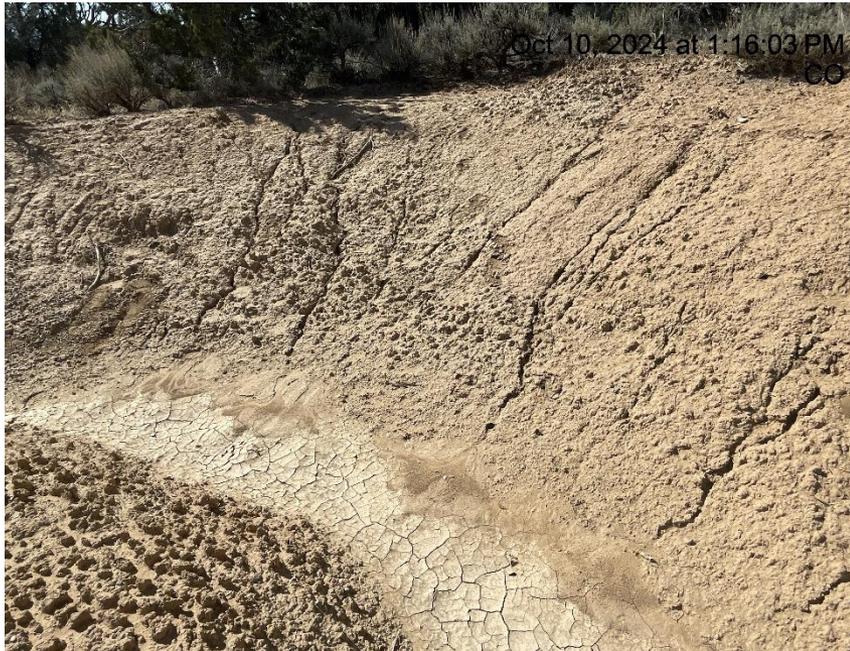
**Photo # 4932 Erosion & transport of sediment on cut slope**

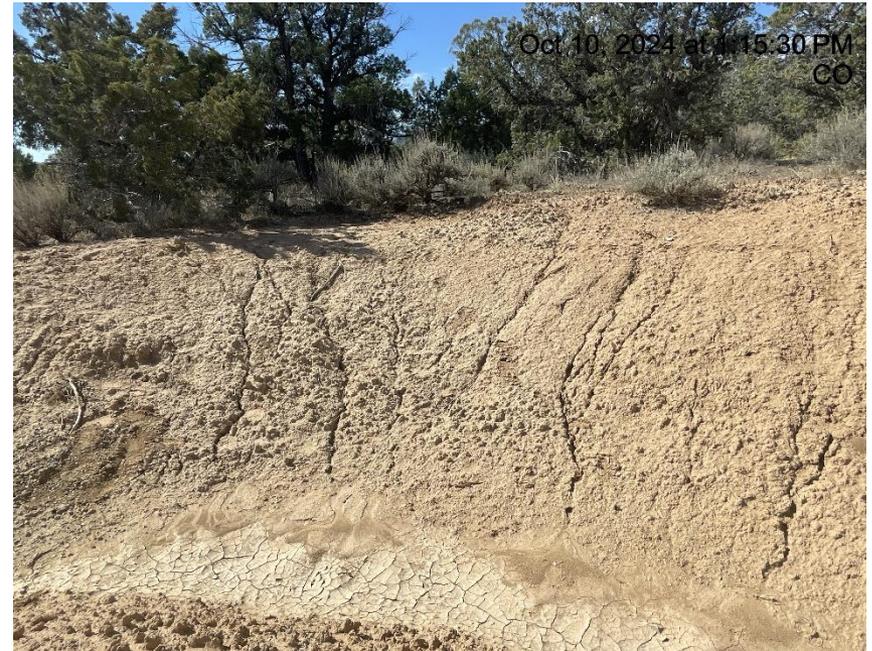
**Photo # 4933 Erosion & transport of sediment on cut slope**

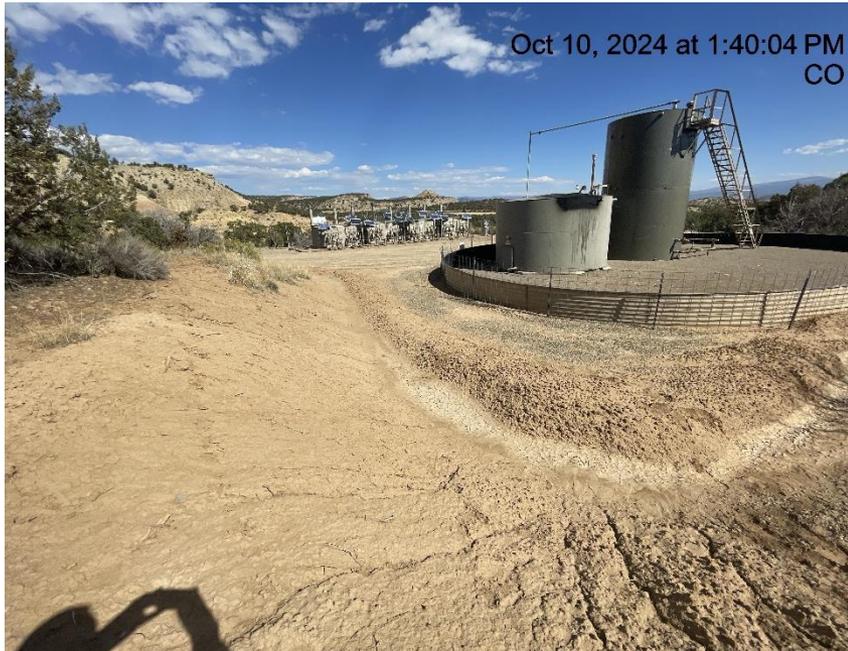
**Photo # 4934 Erosion & transport of sediment on cut slope & insufficient BMP's/runoff controls**

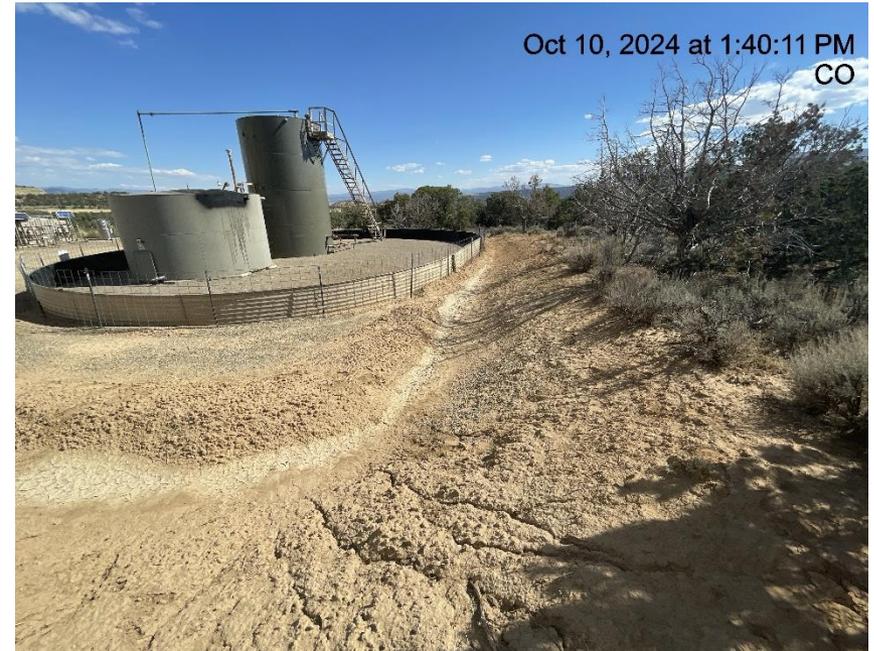
**Photo # 4935 Erosion & transport of sediment on cut slope & insufficient BMP's/runoff controls**

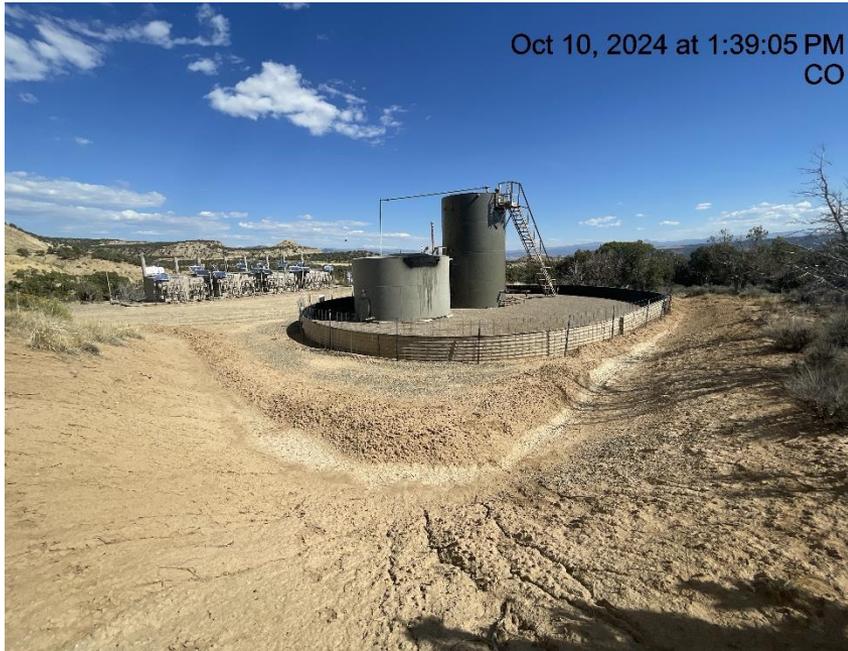
**Photo # 4936 Erosion & transport of sediment on cut slope & insufficient BMP's/runoff controls**

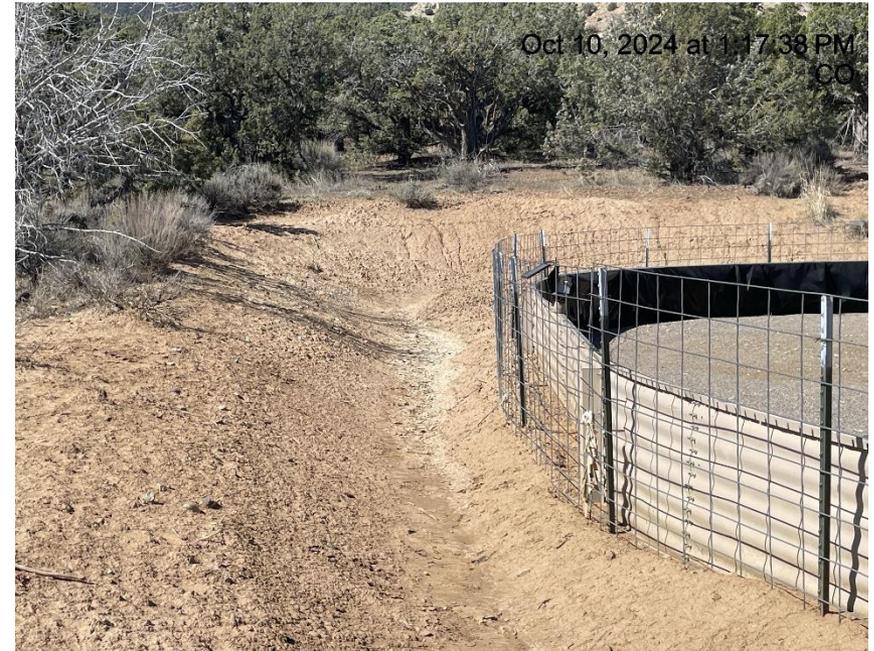
**Photo # 4937 Insufficient BMP's/runoff controls**

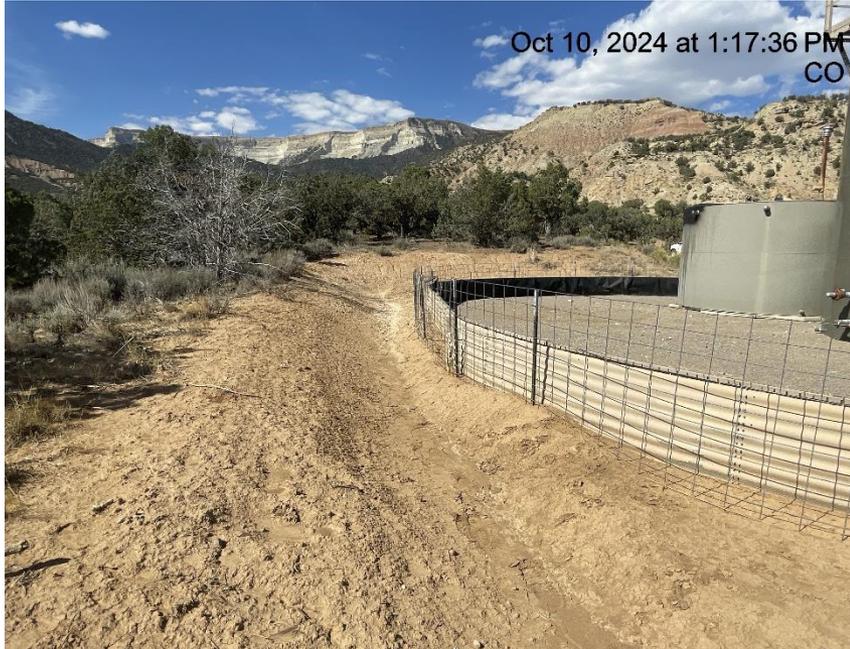
**Photo # 4938 Insufficient BMP's/runoff controls**

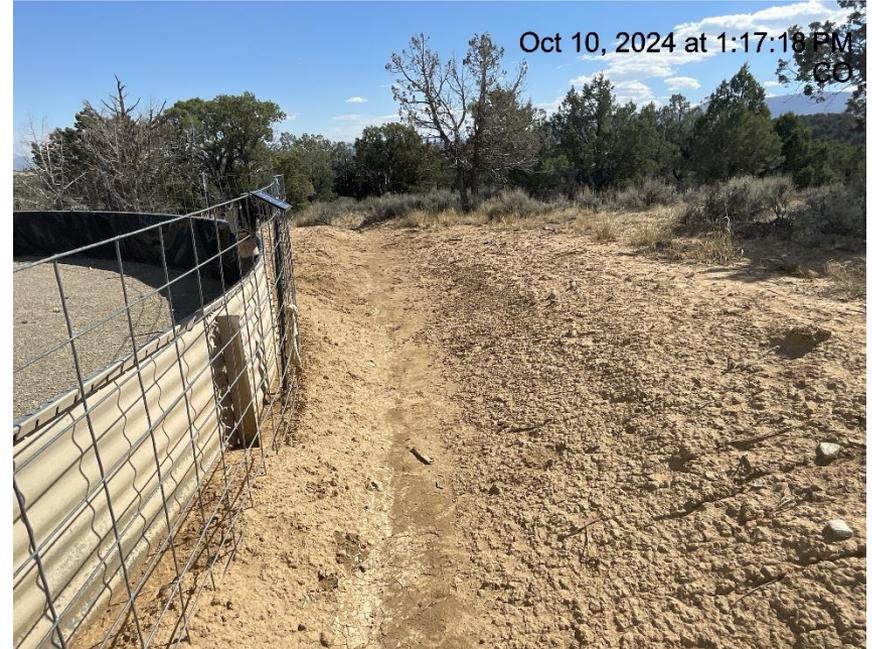
**Photo # 4939 Failure to minimize erosion & transport of sediment off location - sediment laden stormwater is traveling through ditch & migrating off location into a vegetated area - insufficient BMP's/runoff controls.**

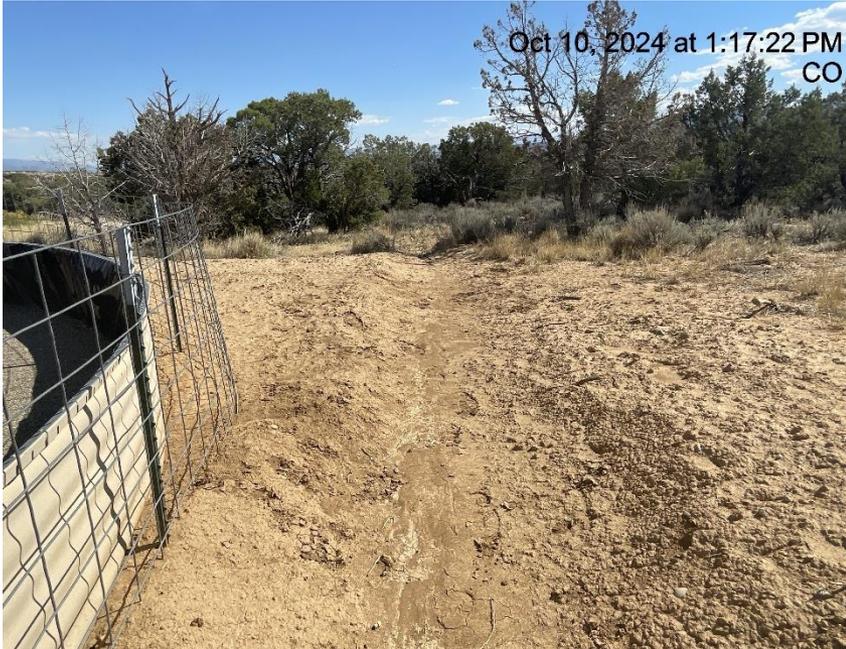
**Photo # 4940 Failure to minimize erosion & transport of sediment off location - sediment laden stormwater is traveling through ditch & migrating off location into a vegetated area - insufficient BMP's/runoff controls.**

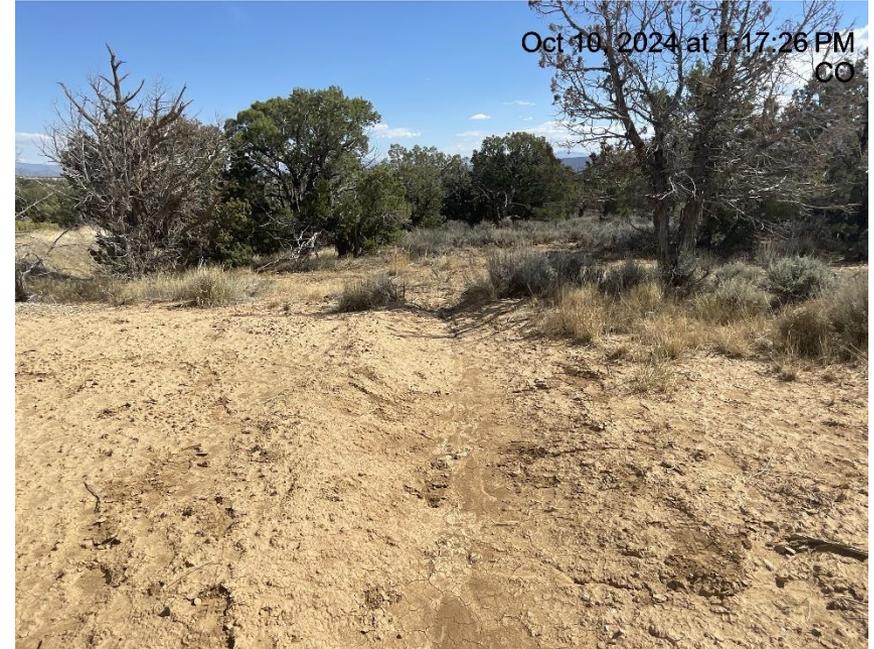
**Photo # 4941 Failure to minimize erosion & transport of sediment off location - sediment laden stormwater is traveling through ditch & migrating off location into a vegetated area - insufficient BMP's/runoff controls.**

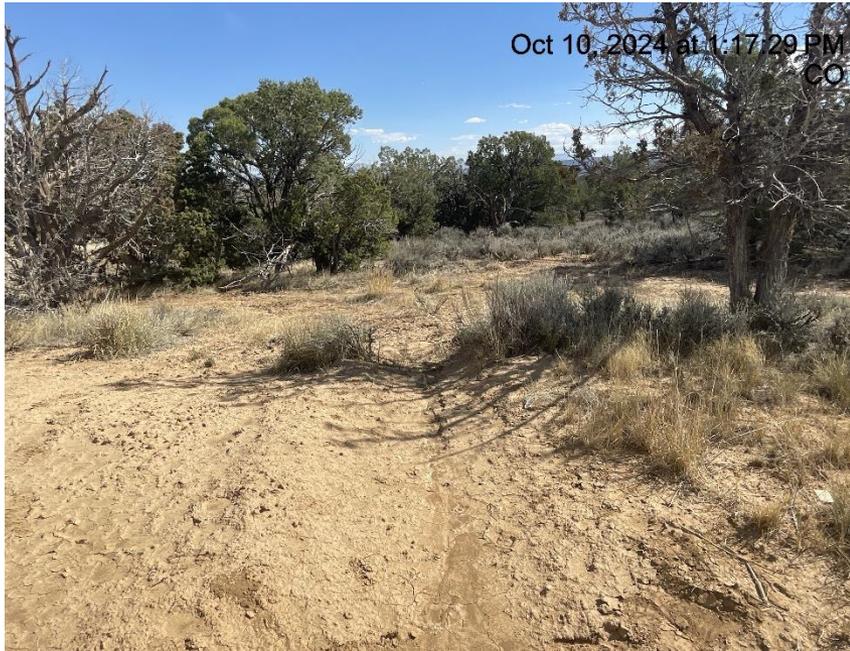
**Photo # 4942 Failure to minimize erosion & transport of sediment off location - sediment laden stormwater is traveling through ditch & migrating off location into a vegetated area - insufficient BMP's/runoff controls.**

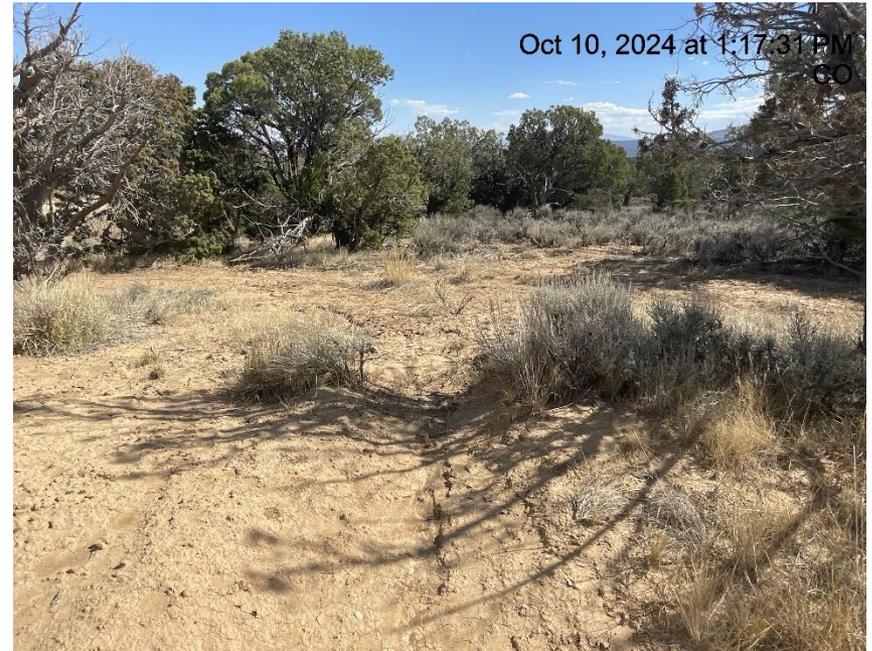
**Photo # 4943 Failure to minimize erosion & transport of sediment off location - sediment laden stormwater is traveling through ditch & migrating off location into a vegetated area - insufficient BMP's/runoff controls.**

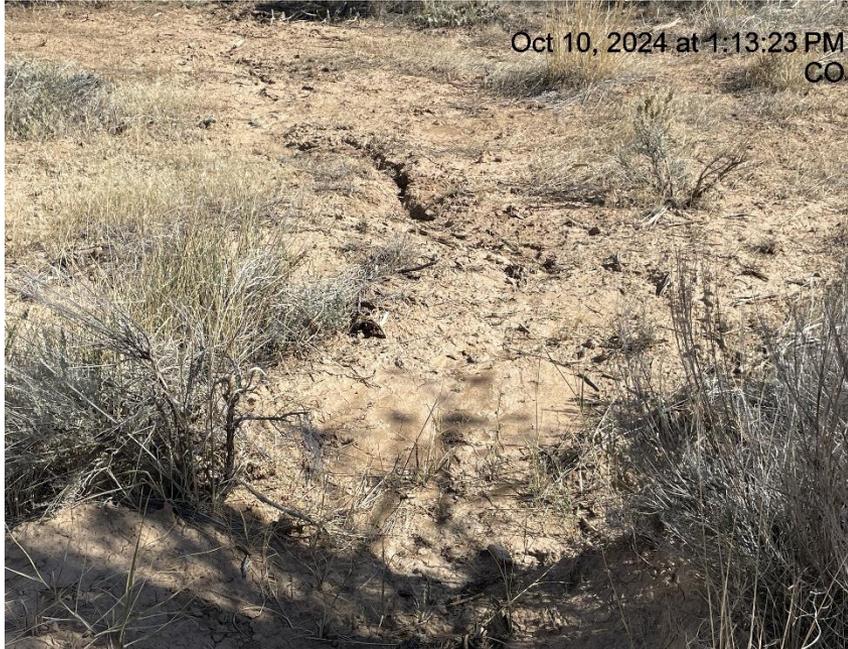
**Photo # 4944 Failure to minimize erosion & transport of sediment off location - sediment laden stormwater is traveling through ditch & migrating off location into a vegetated area - insufficient BMP's/runoff controls.**

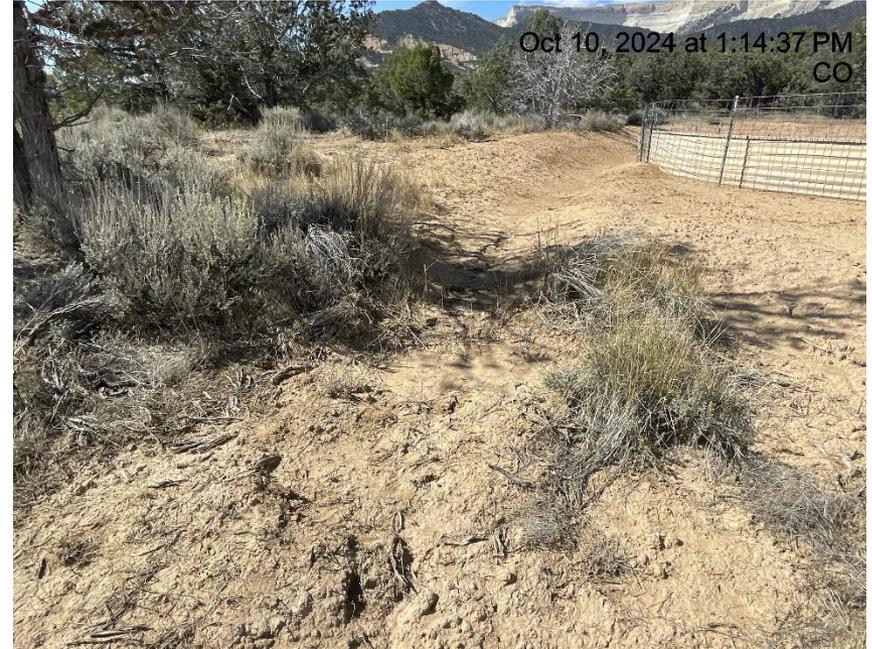
**Photo # 4945 Failure to minimize erosion & transport of sediment off location - sediment laden stormwater is traveling through ditch & migrating off location into a vegetated area - insufficient BMP's/runoff controls.**

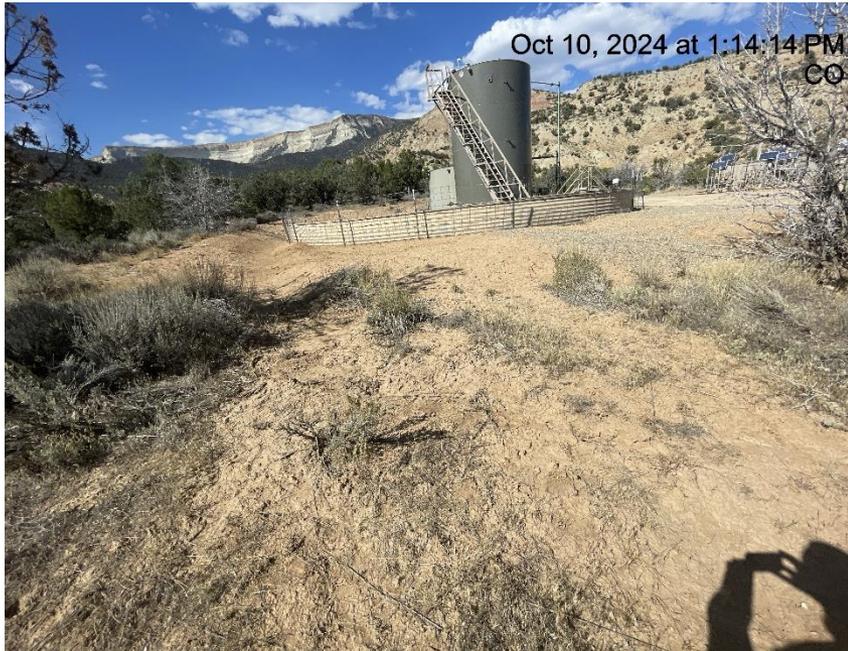
**Photo # 4946 Failure to minimize erosion & transport of sediment off location - sediment laden stormwater is traveling through ditch & migrating off location into a vegetated area - insufficient BMP's/runoff controls.**

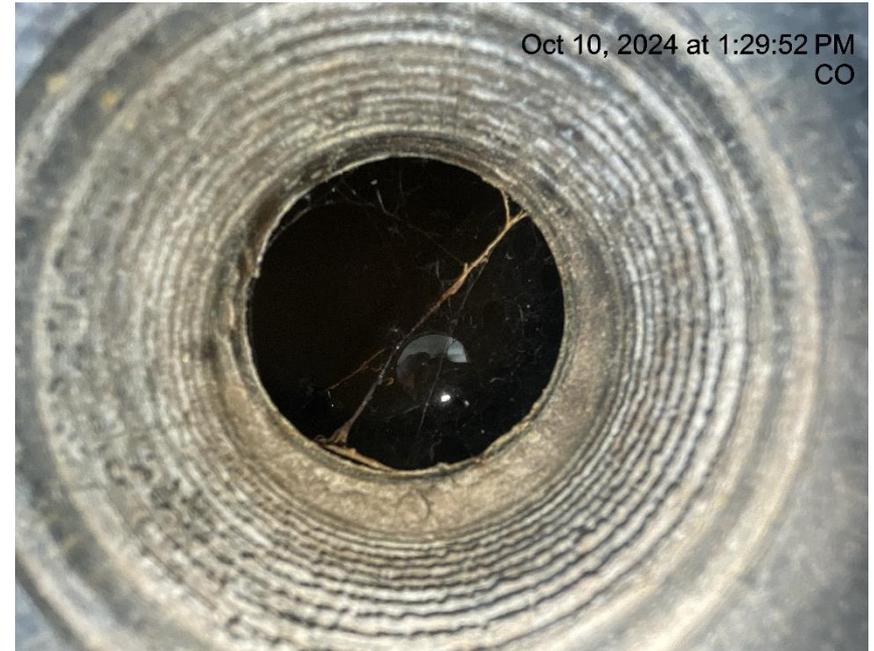
**Photo # 4947 Failure to maintain chemical BMP - Chemical tank containment approximately 3/4th full of fluid/BMP insufficient to contain possible spill**
