# Final Reclamation and Stormwater Inspection

Operator: KERR MCGEE OIL & GAS ONSHORE LP -  
47120

Location ID: 407867

Inspection Document #: 708201686

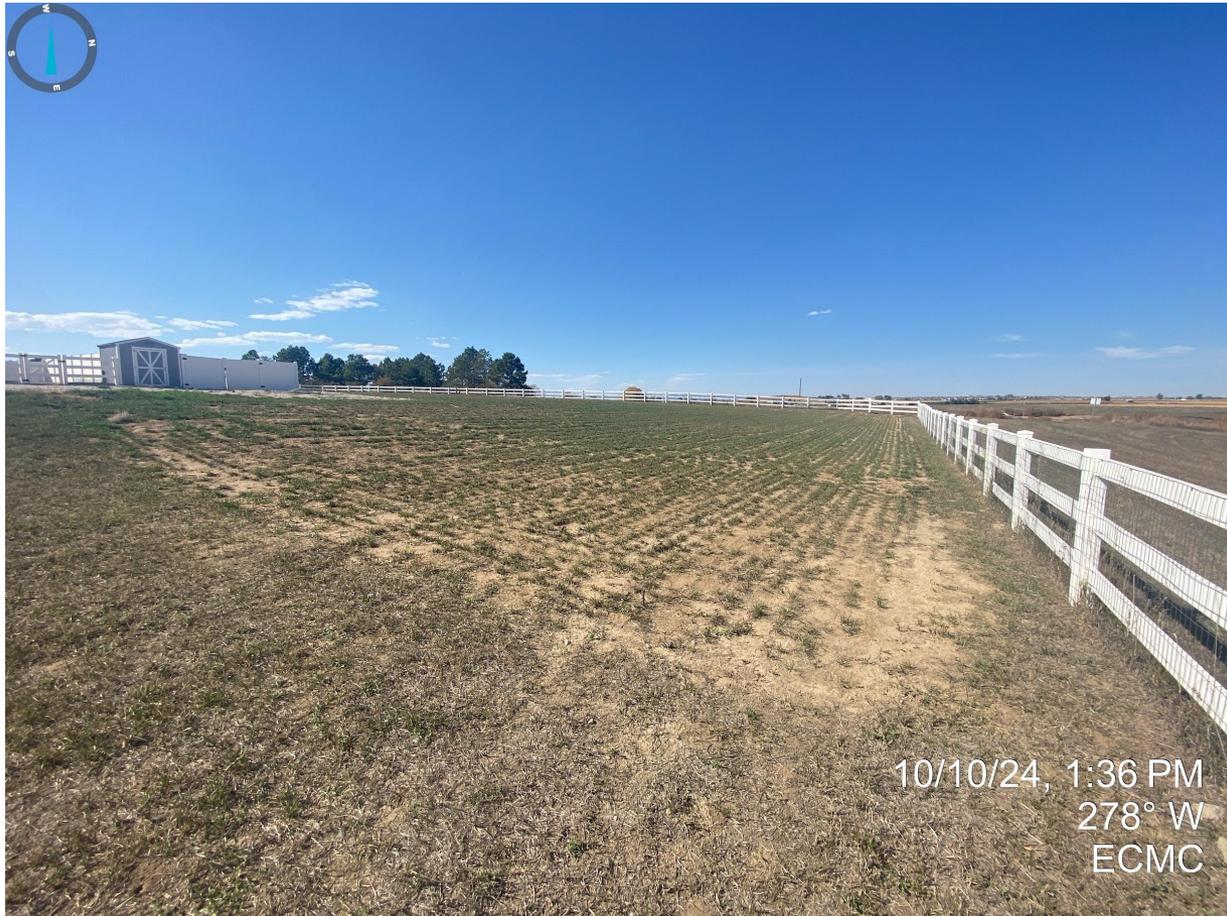
**Photo 1.** Photo taken from the southeastern/eastern portion of the disturbance area. Photo illustrates that the eastern side of the disturbance area appears to be progressing towards reclamation standards with evidence of vegetation establishment.

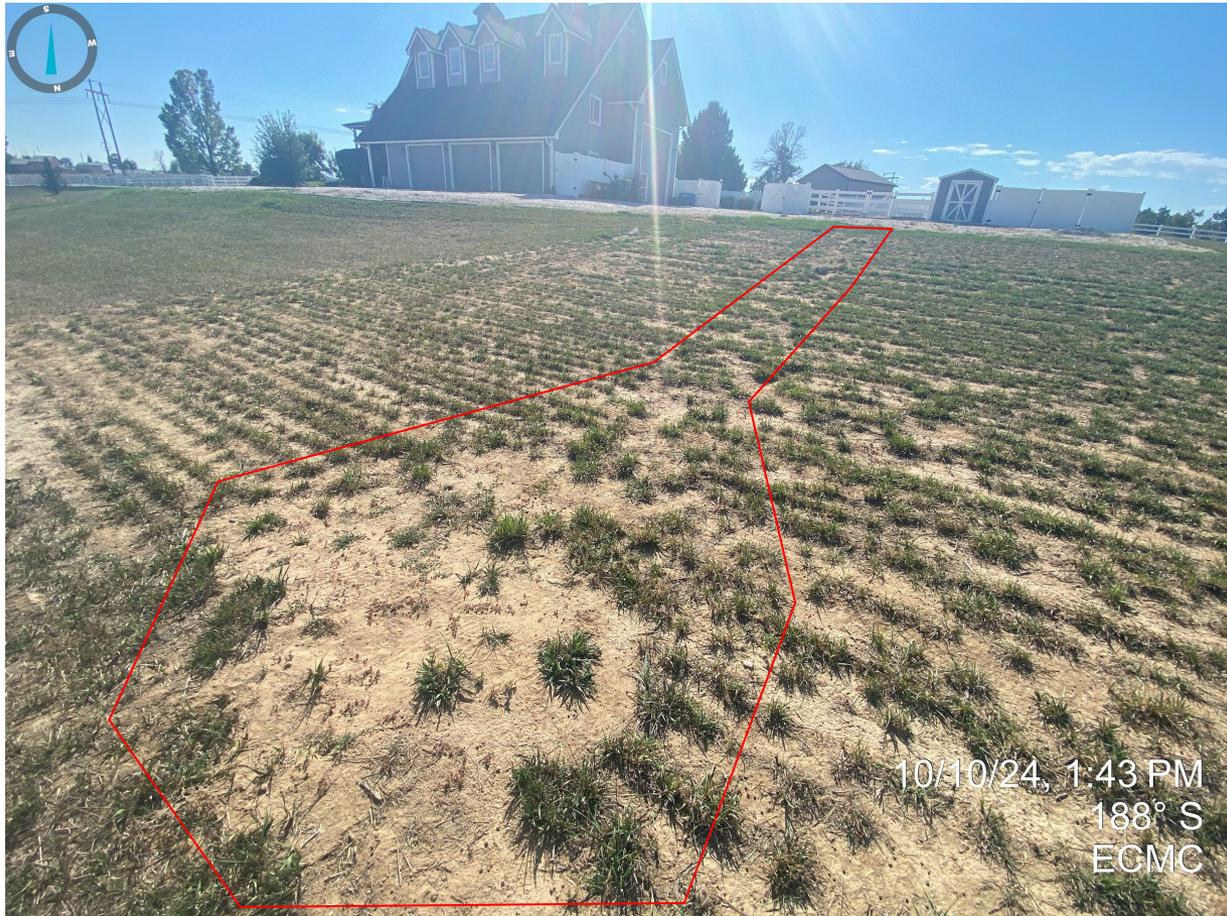
**Photo 2.** Photo taken from the eastern side of the disturbance area. Red polygon illustrates approximate extent of erosion degradation (e.g. riling) and sediment deposition in the reclaimed portions. Additional stormwater control measures and/or maintenance required to stabilize the soil and prevent sediment laden stormwater from exiting off location.

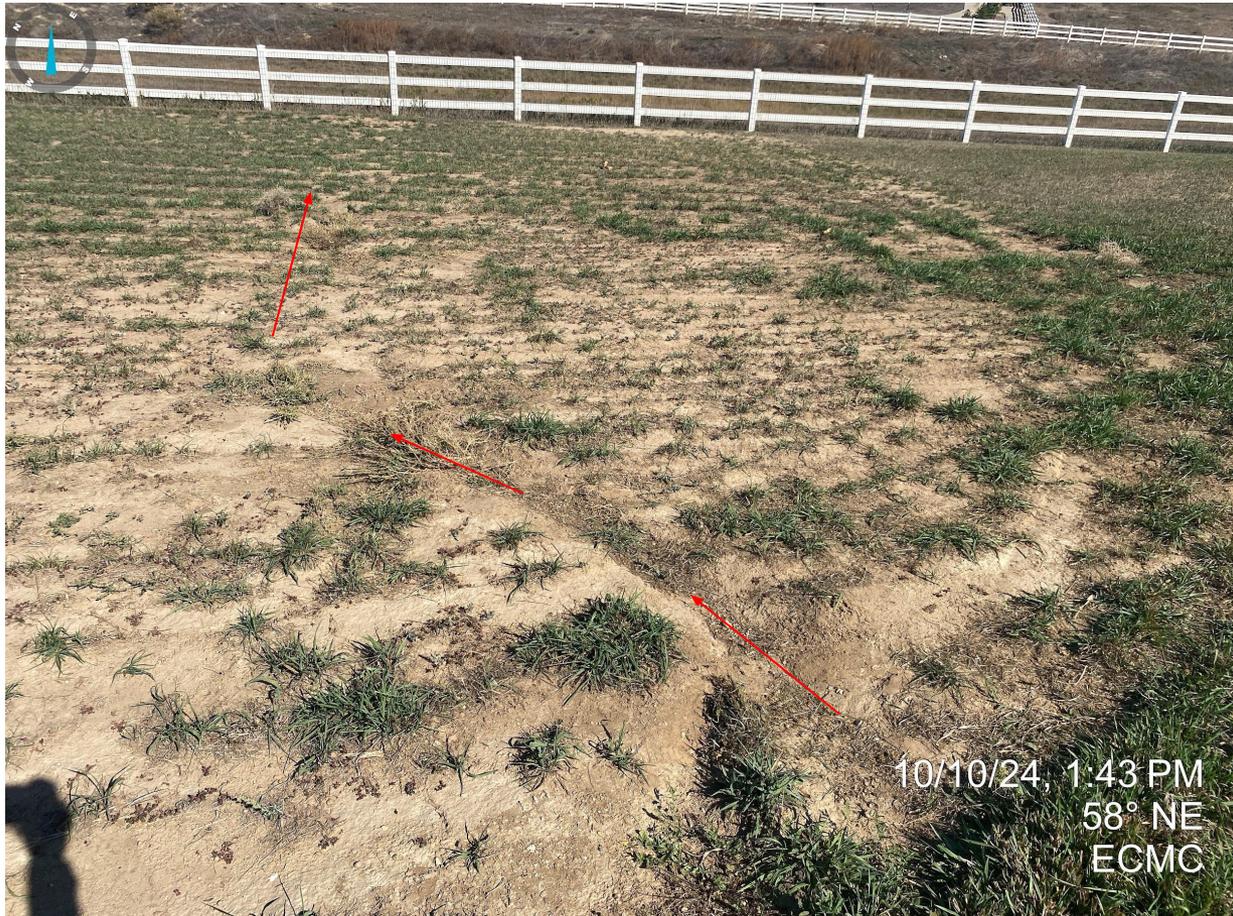
**Photo 3.** Continued from Photo 2; erosion degradation (e.g. riling) observed.

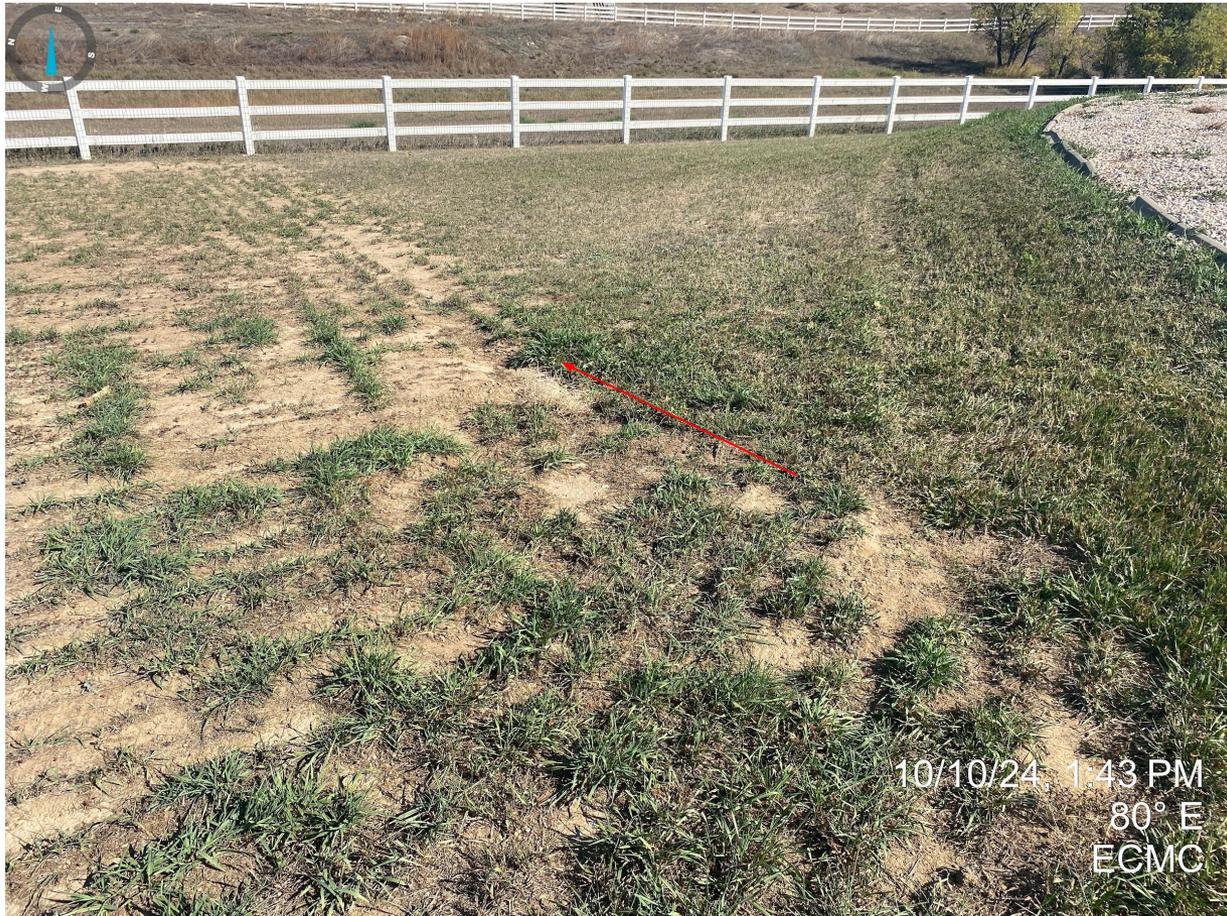
**Photo 4.** Additional stormwater erosion degradation (e.g. riling) observed on the southern portion of the disturbance area.

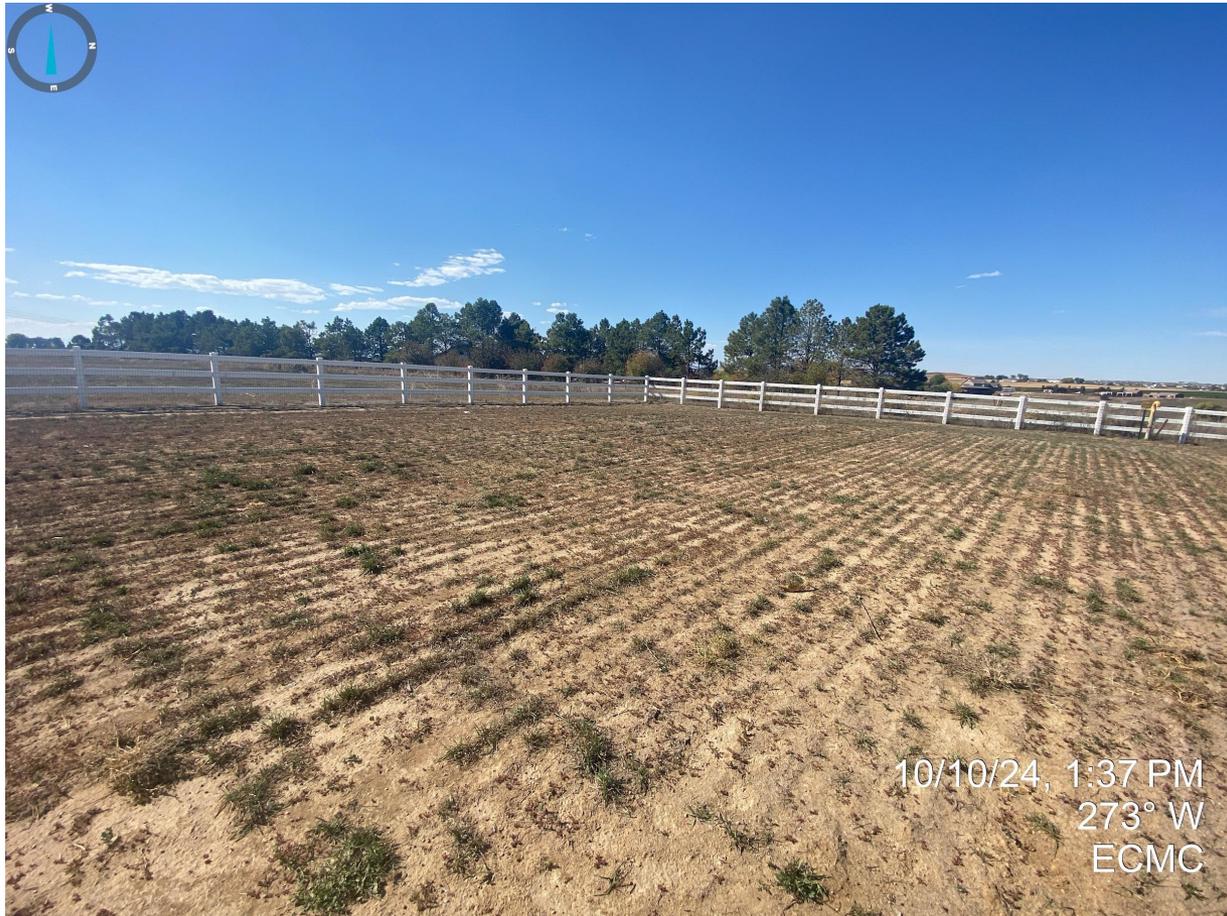
**Photo 5.** Northwestern disturbance area. Reclaimed portions don't appear to be progressing towards Rule 1004 standards and regulations. Additional reclamation activities are required.

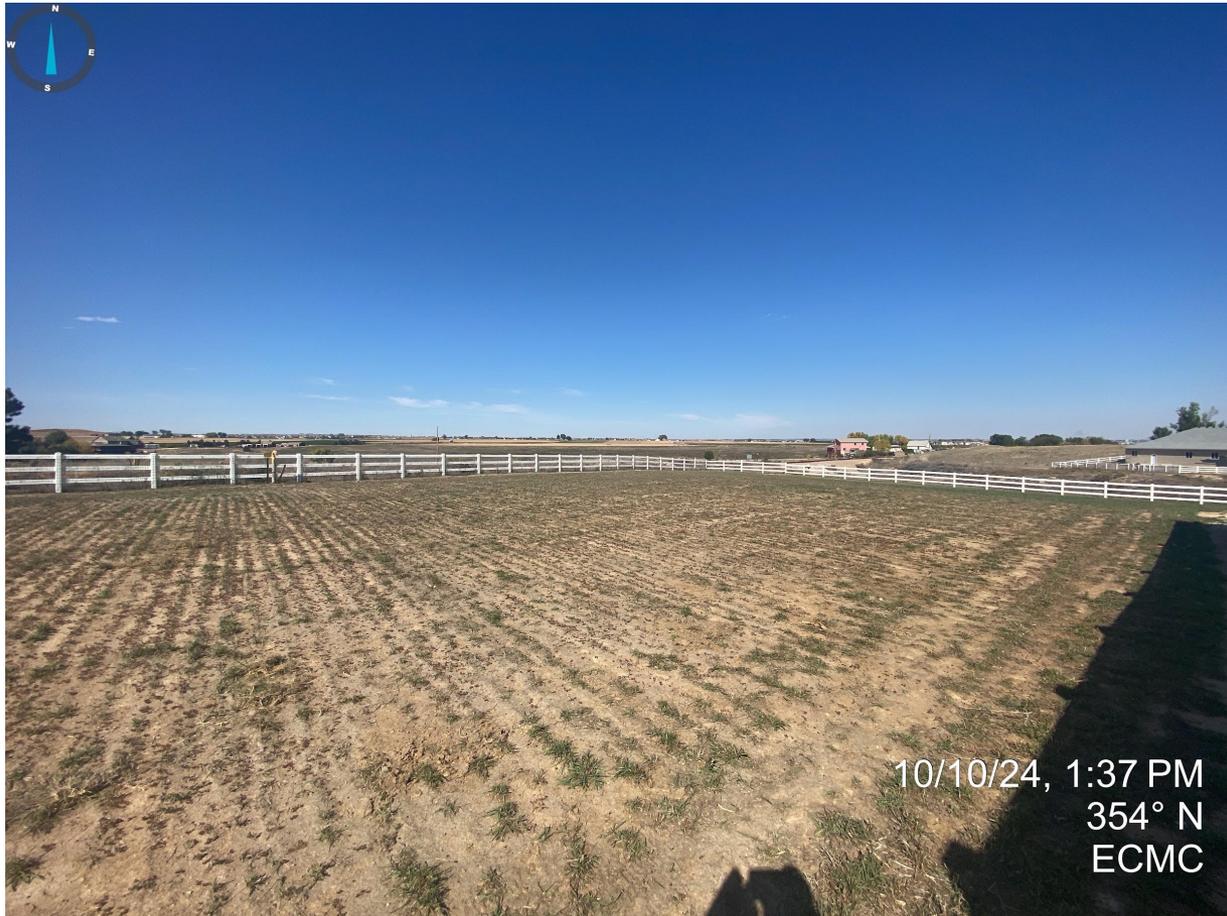
**Photo 6.** Northern disturbance area. Reclaimed portions don't appear to be progressing towards Rule 1004 standards and regulations. Additional reclamation activities are required.

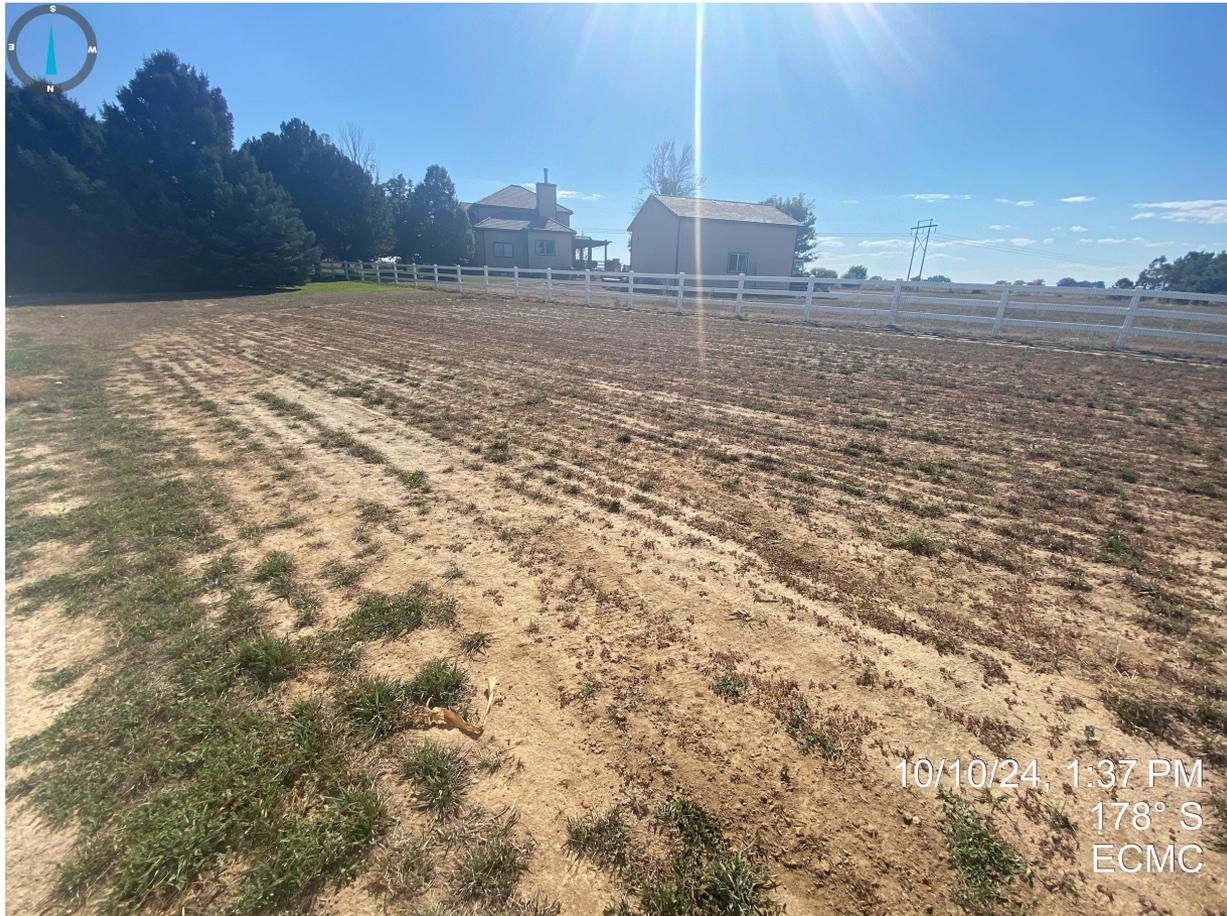
**Photo 7.** Western disturbance area. Reclaimed portions don't appear to be progressing towards Rule 1004 standards and regulations. Additional reclamation activities are required.

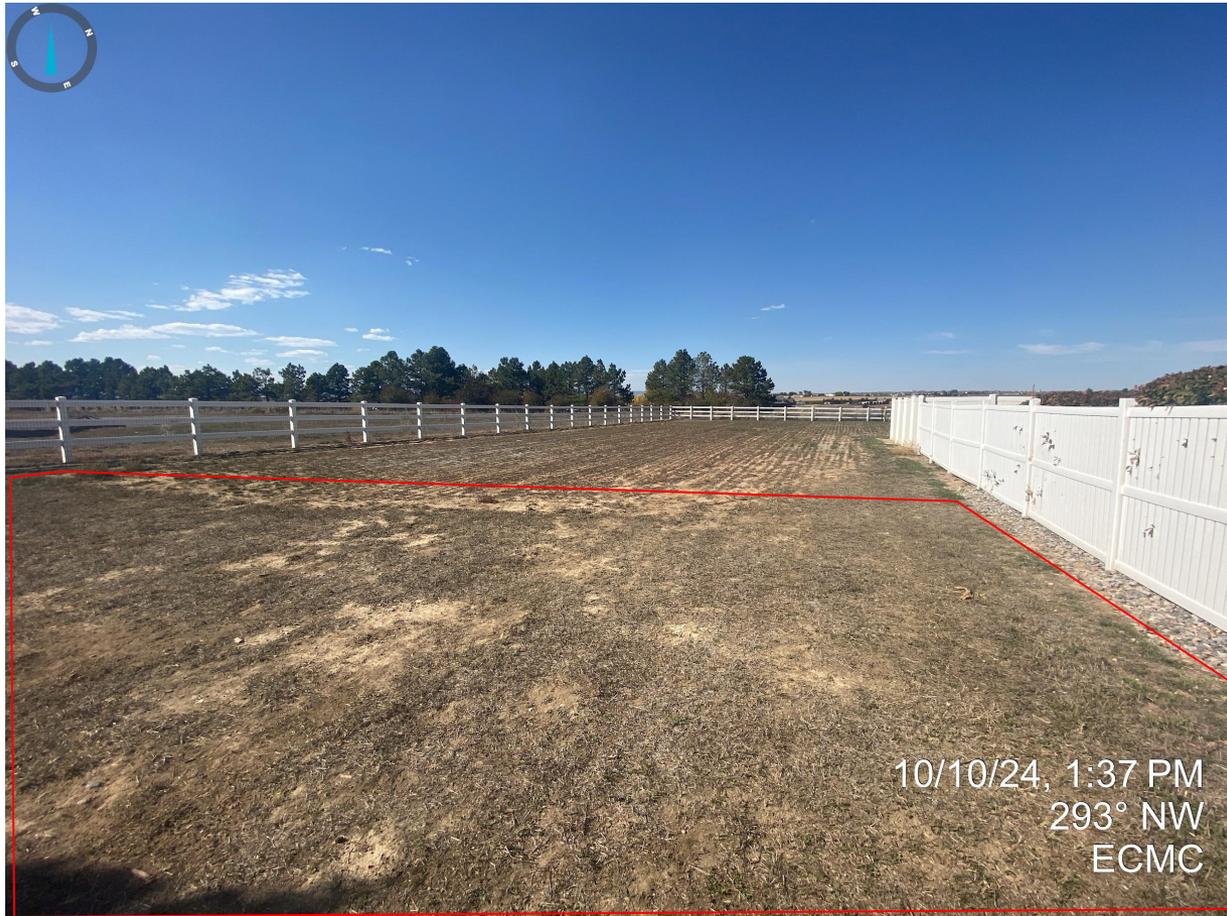
**Photo 8.** Southern/southwestern disturbance area. The outlined red polygon illustrates a portion of the disturbance area that does not appear to have been reclaimed; no evidence of drill rows and/or hydromulch observed.

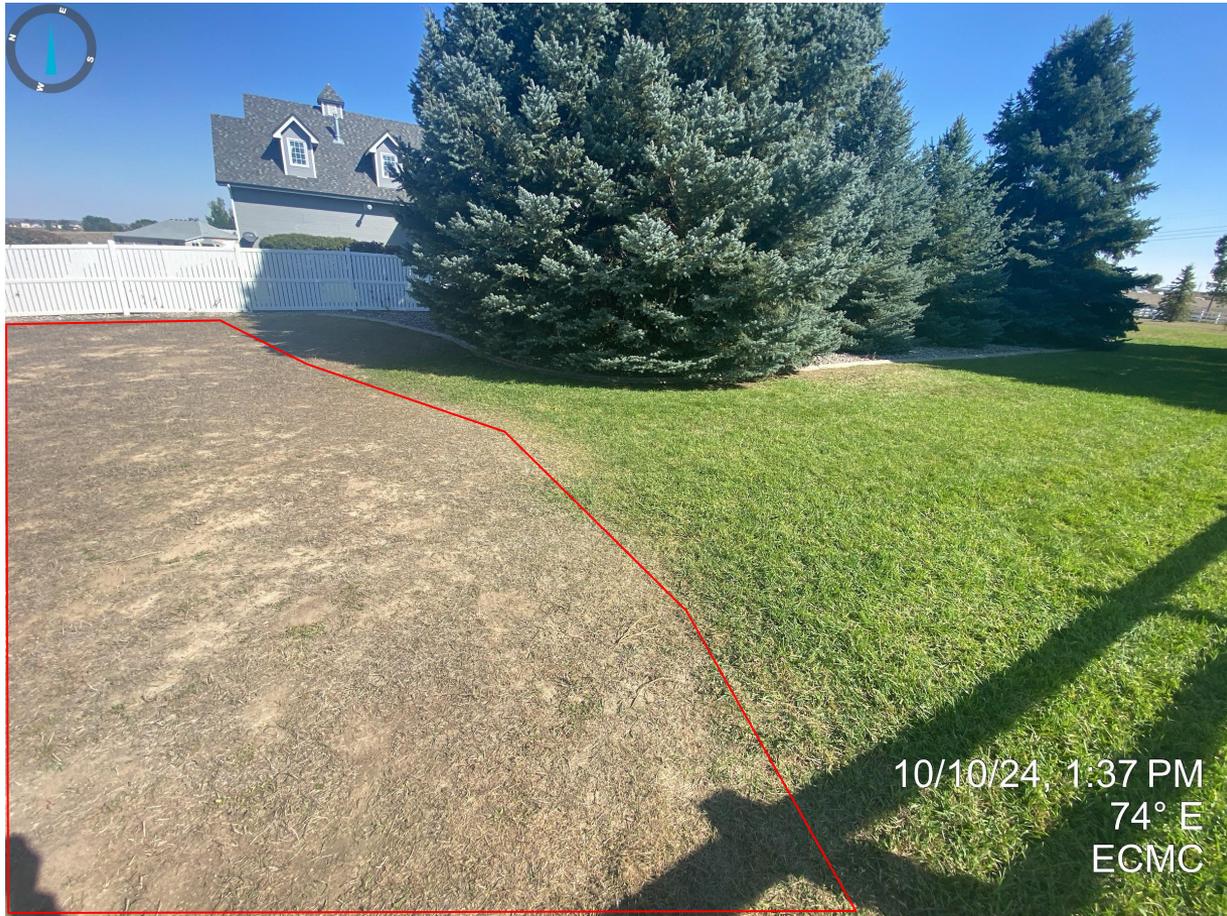
**Photo 9.** Southern/southwestern disturbance area. The outlined red polygon illustrates a portion of the disturbance area that does not appear to have been reclaimed; no evidence of drill rows and/or hydromulch observed.

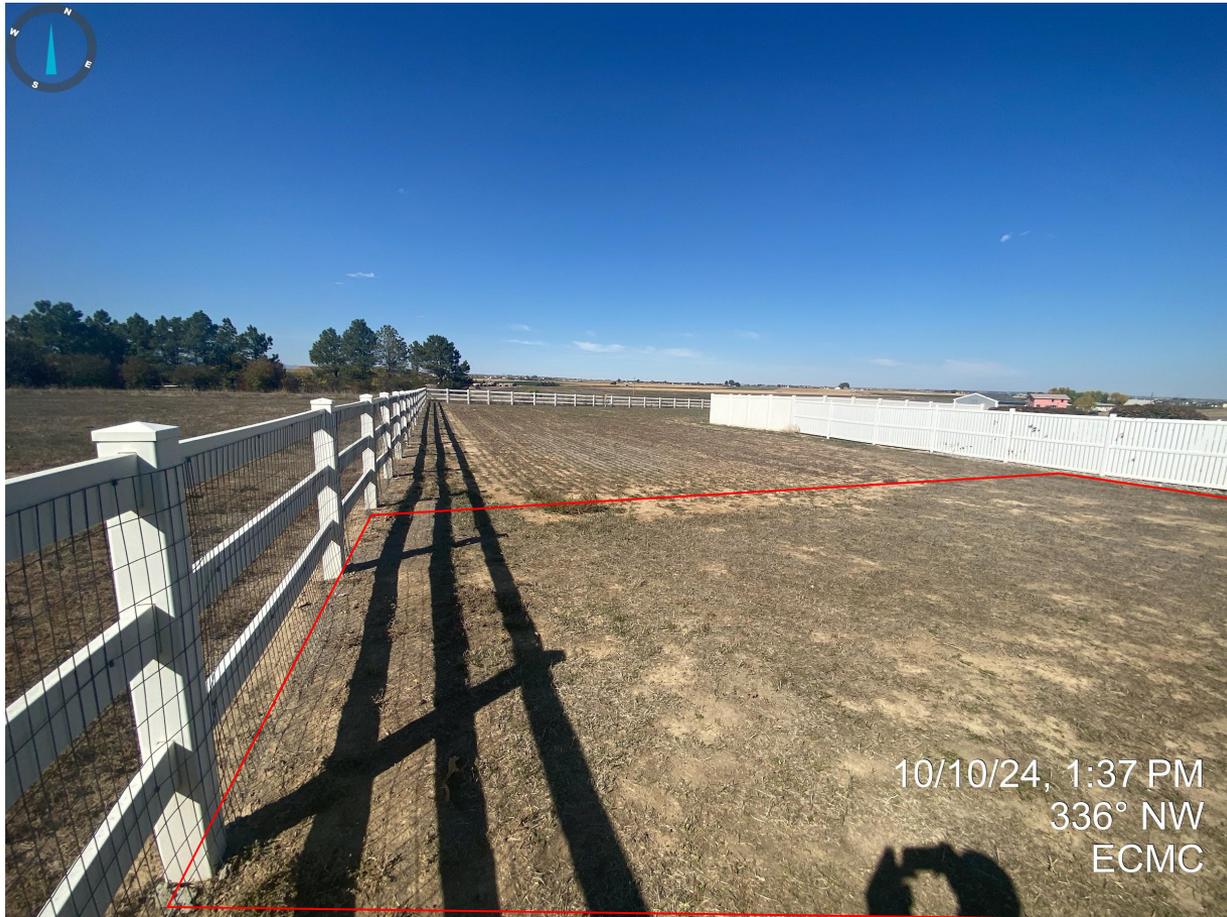
**Photo 10.** Southern/southwestern disturbance area. The outlined red polygon illustrates a portion of the disturbance area that does not appear to have been reclaimed; no evidence of drill rows and/or hydromulch observed.

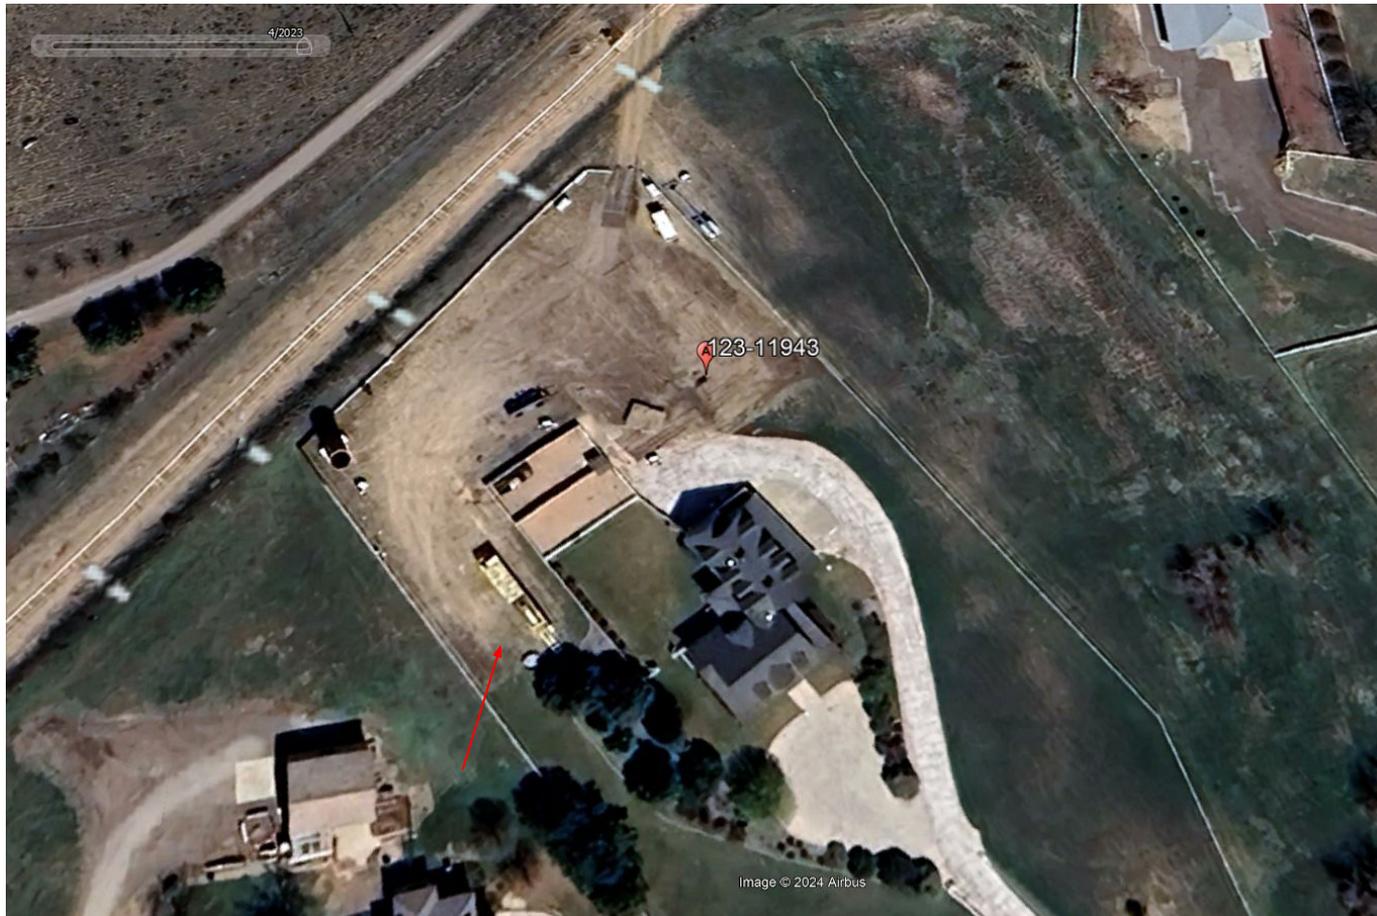
**Photo 11.** Google Earth aerial imagery (circa 04/2023) illustrating that equipment appears to have been staged on the southern/southwestern portion of the disturbance area (in reference to Photos 7-10); these areas could potentially be compacted and/or were not reclaimed.

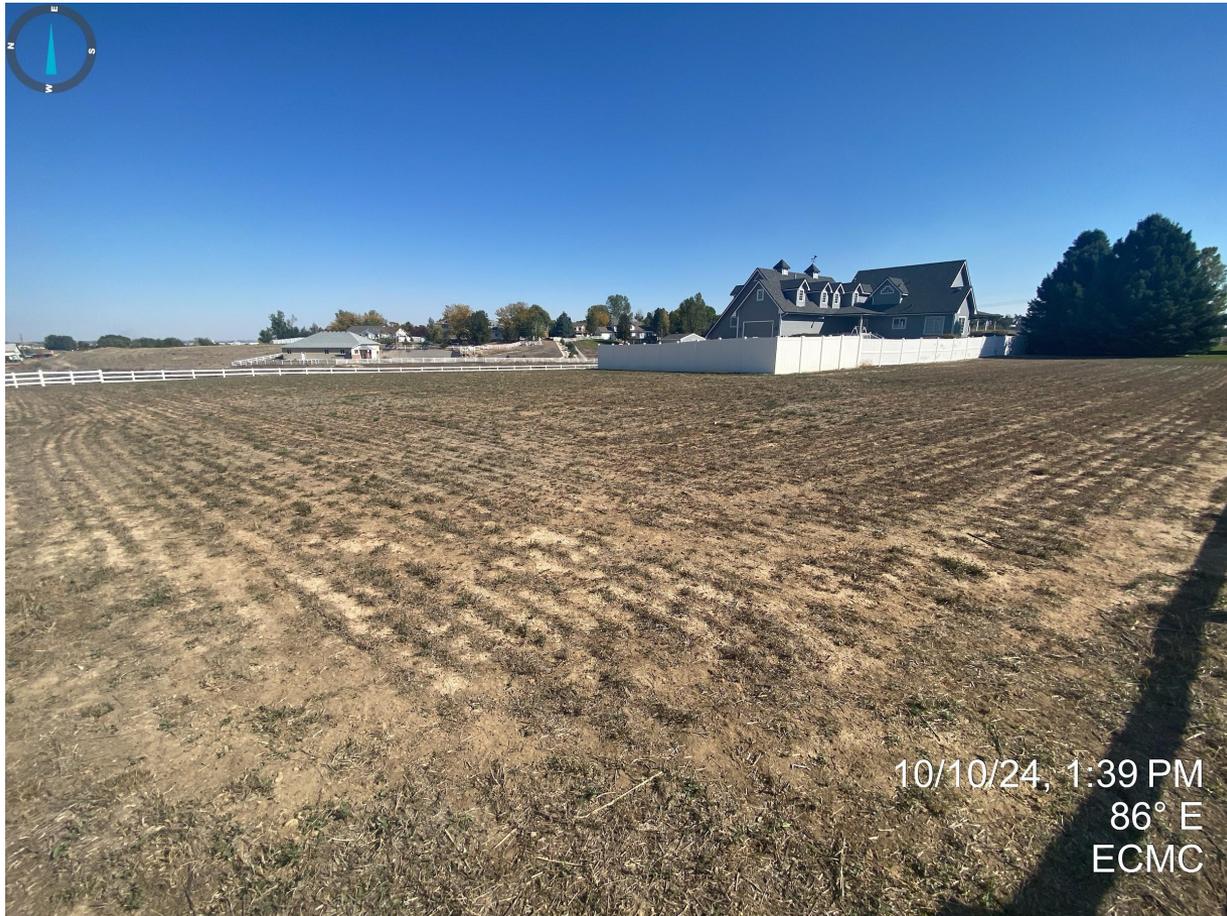
**Photo 12.** Northwestern disturbance areas; facing east. Reclaimed portions don't appear to be progressing towards Rule 1004 standards and regulations. Additional reclamation activities are required.

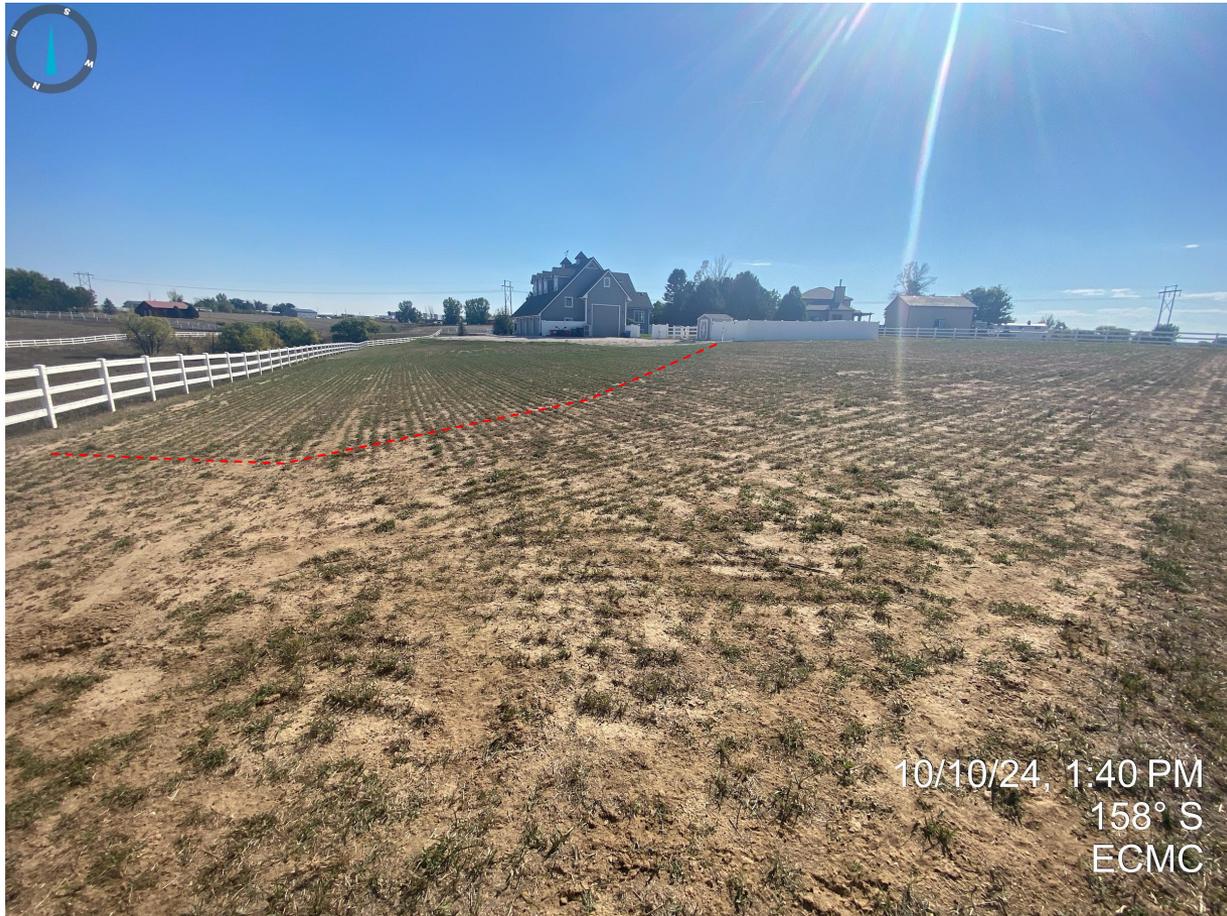
**Photo 13.** Northeastern disturbance areas; facing south. Photo illustrates the difference between the northern (right of dotted line) and eastern (left of dotted line) reclaimed portions. The northern areas do not appear to be progressing towards reclamation standards and regulations. Additional reclamation activities are required.
