## Inspection Photos

Location Name: TEP ROCKY MOUNTAIN LLC, PA-67S95W/6SE1W

Location ID: 334965

Date: 10/14/2024

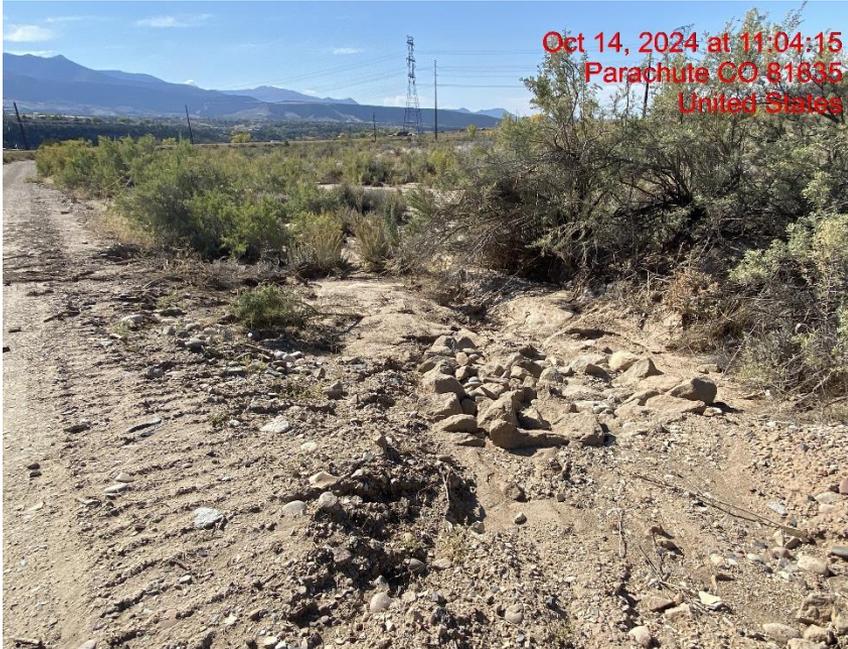
**Insufficient Erosion Control – Photo #04165**

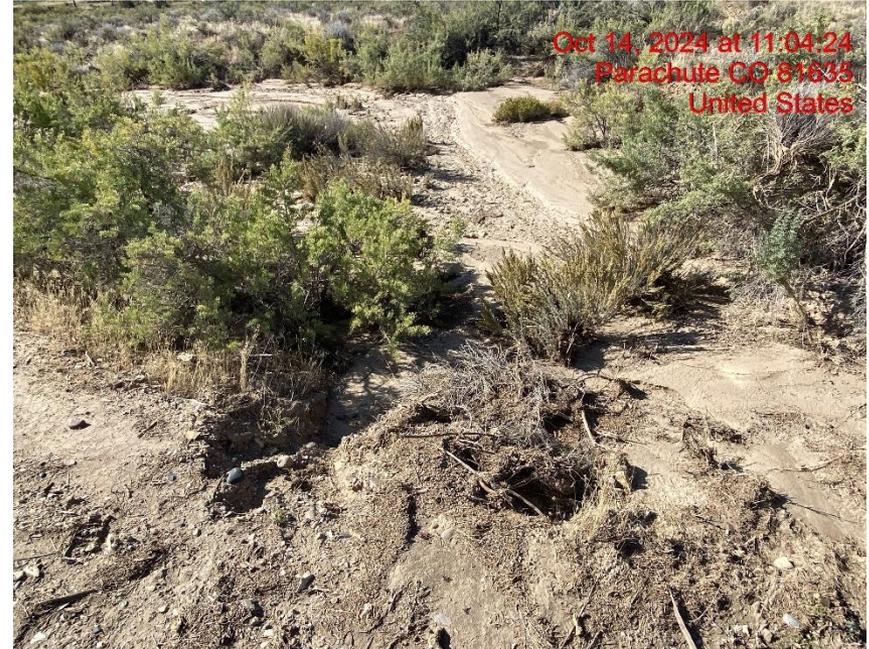
**Insufficient Erosion Control/Transport of Sediment From  
Lease Road – Photo #04166**

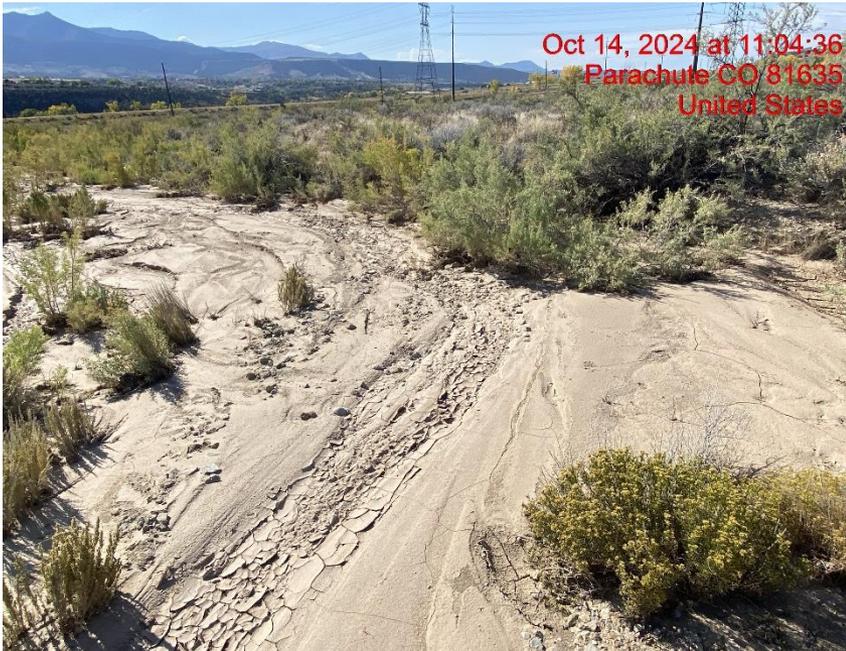
Transport of Sediment From Lease Road – Photo #04167

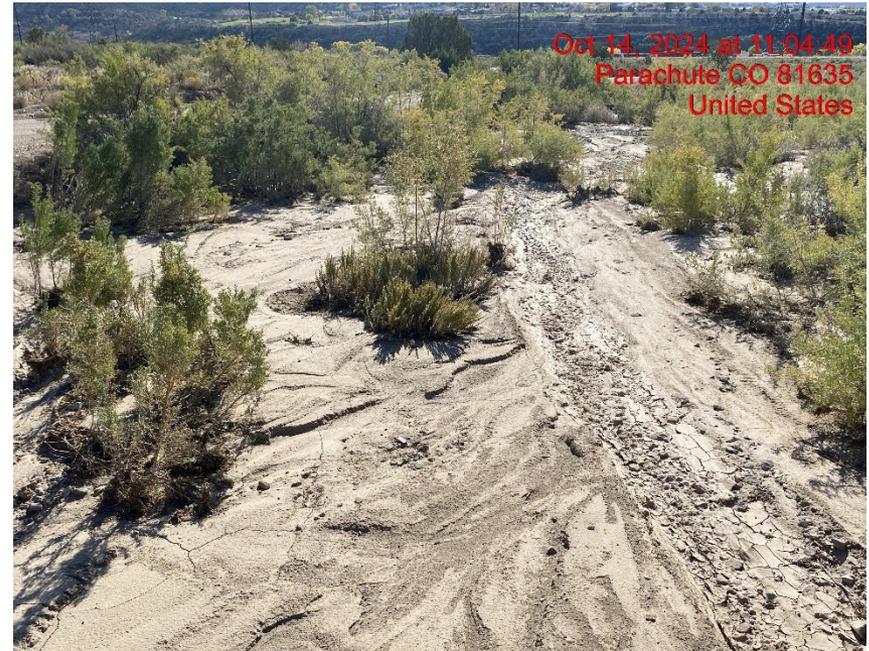
Transport of Sediment From Lease Road – Photo #04168
