Inspection Photos

Operator: CAERUS PICEANCE LLC #10456

Location ID: 479149

Inspection Doc: 696206375

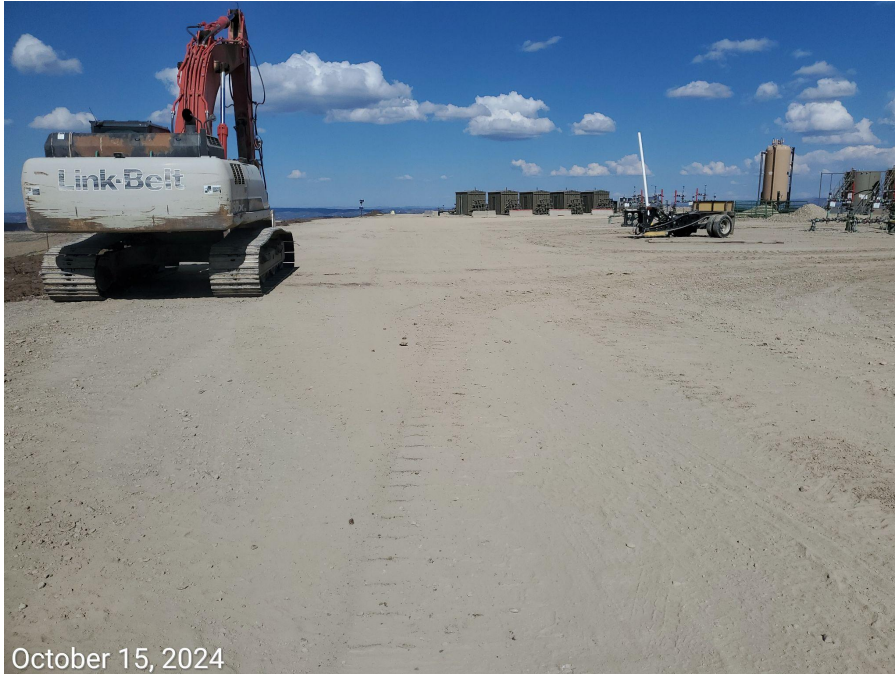
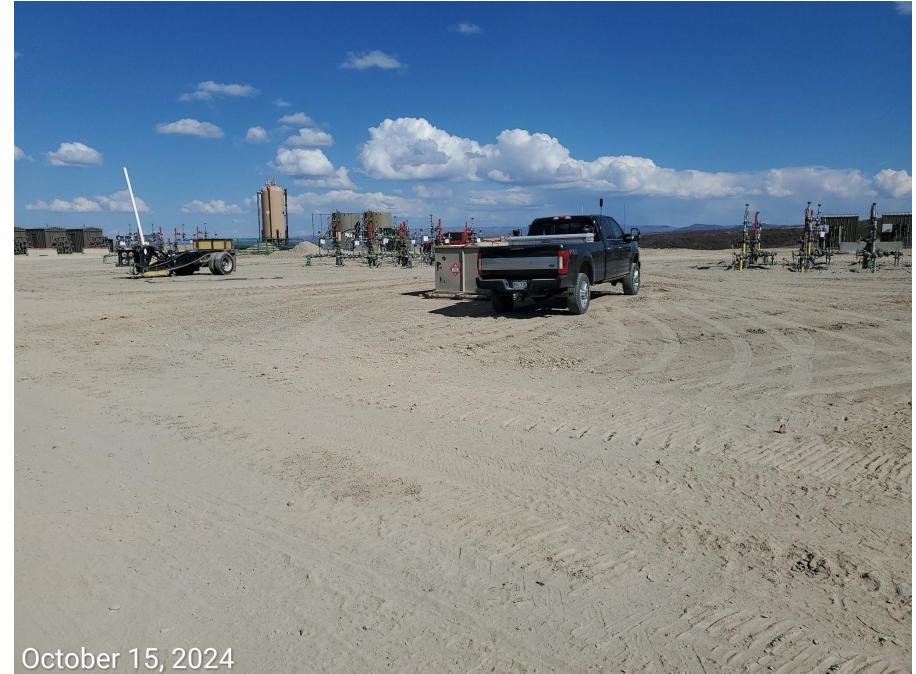
Photo 1: Photos 1-2 taken from the west end of the working pad surface. Photos provide an overview of the pad from north, northeast, southeast to south. Interim reclamation operators “in process” at time of inspection.

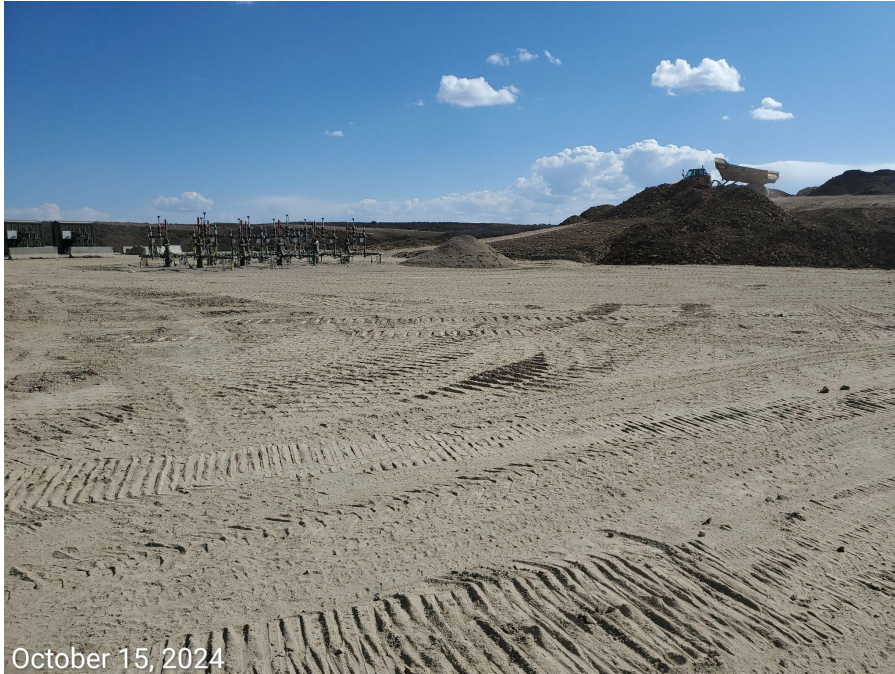
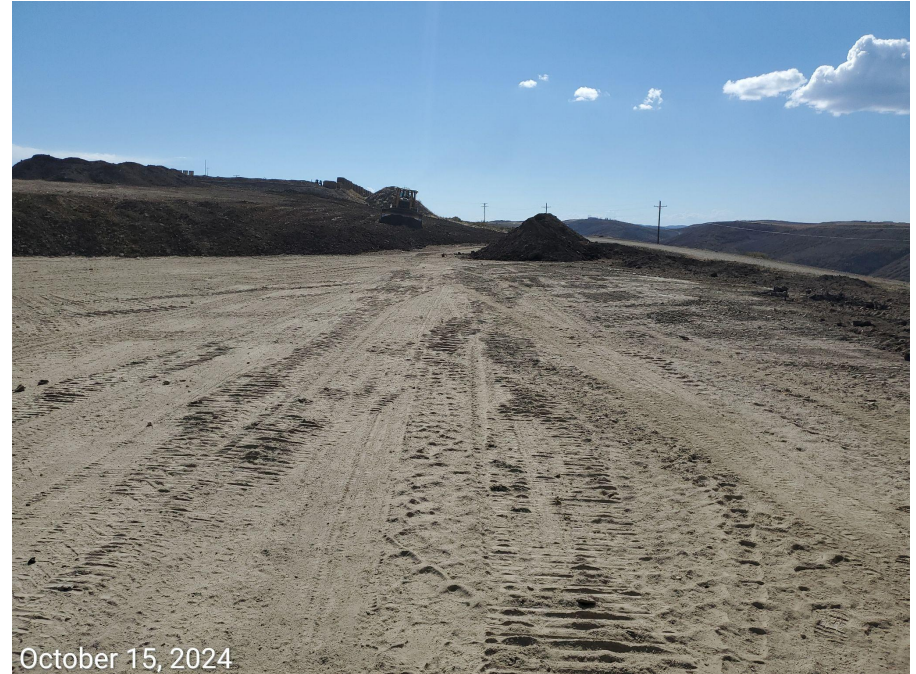
Photo 2: See comments under photo 1.

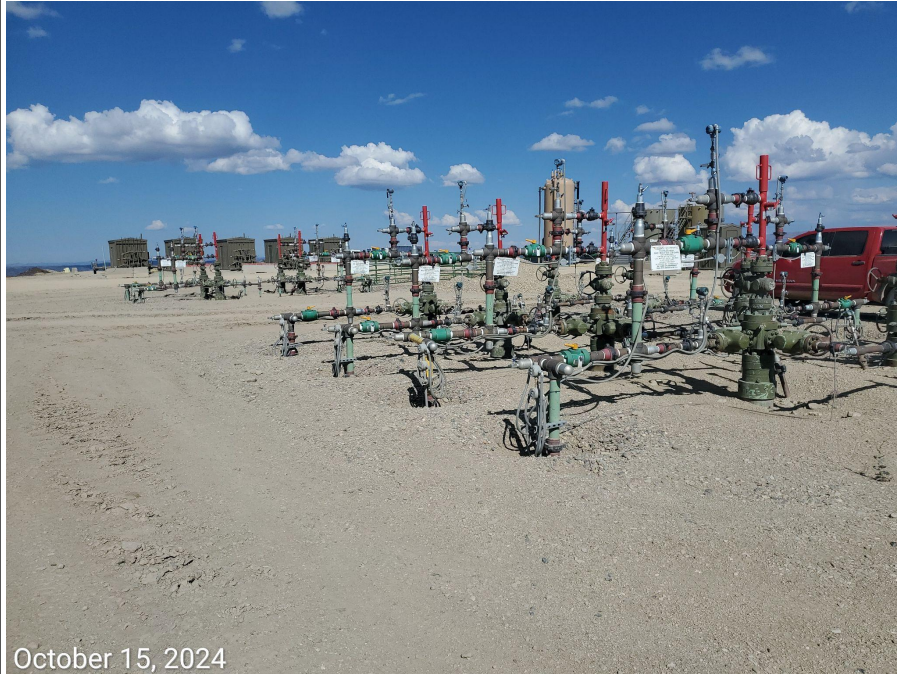
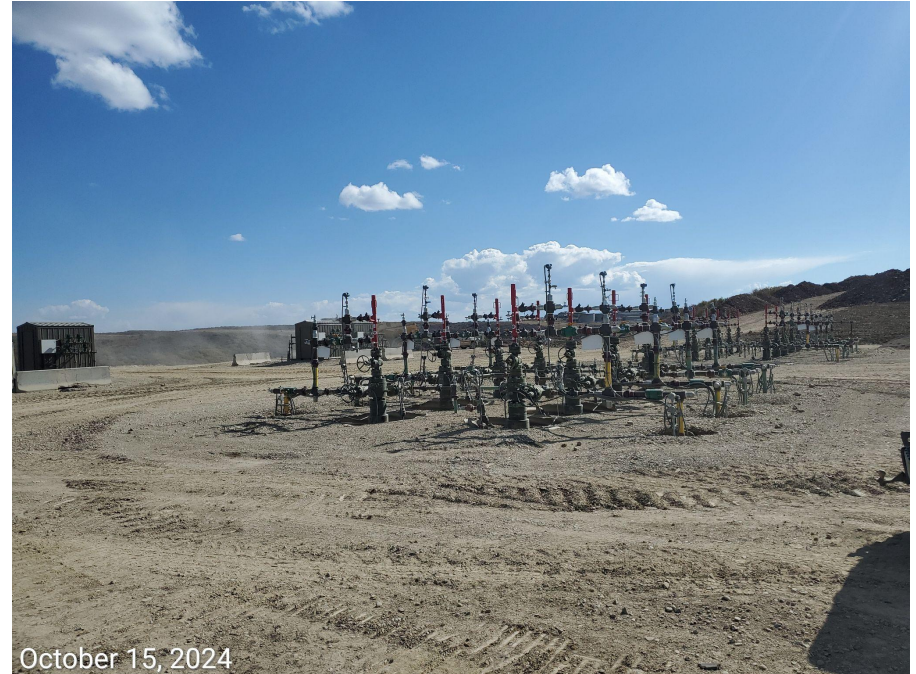
Photo 3: Photos show wells on Location.

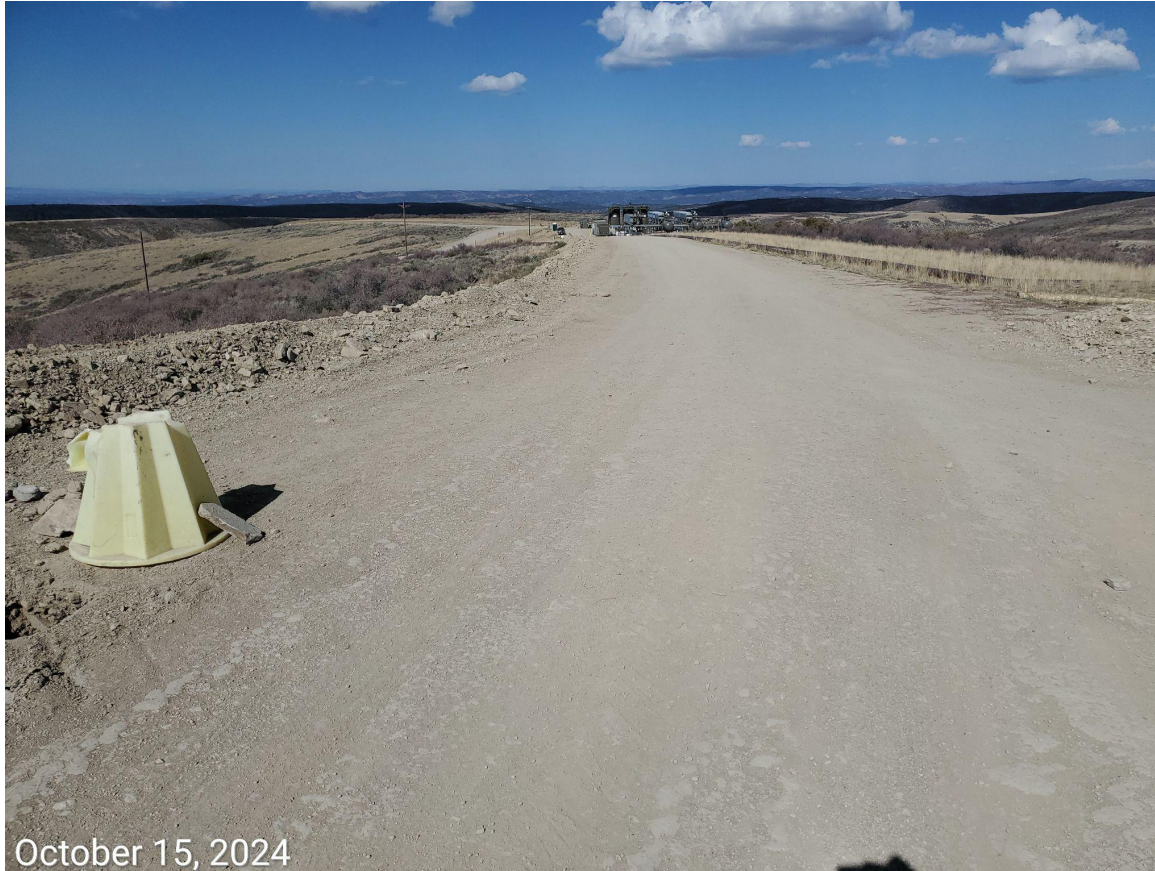
Photo 4: Photo taken from the north end of the Location, facing north. Pursuant to Operator's Reclamation plan (#403909113), road will be reclaimed; pursuant to Form 4 #403940442, road will be retained until well completion operations are finished BJU M23A 496 due to a shared completions pad and temporary frac lines are in place

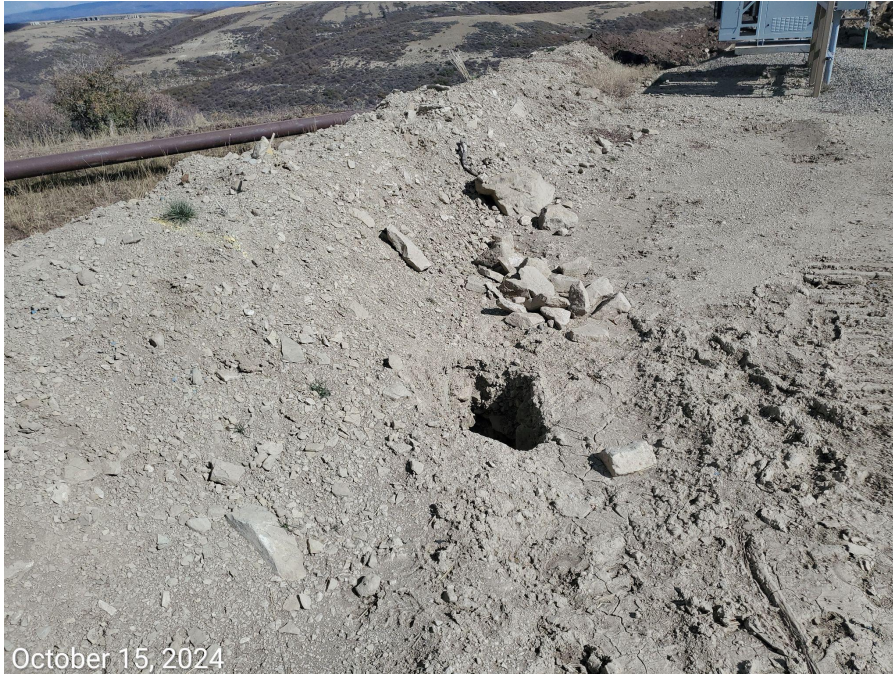
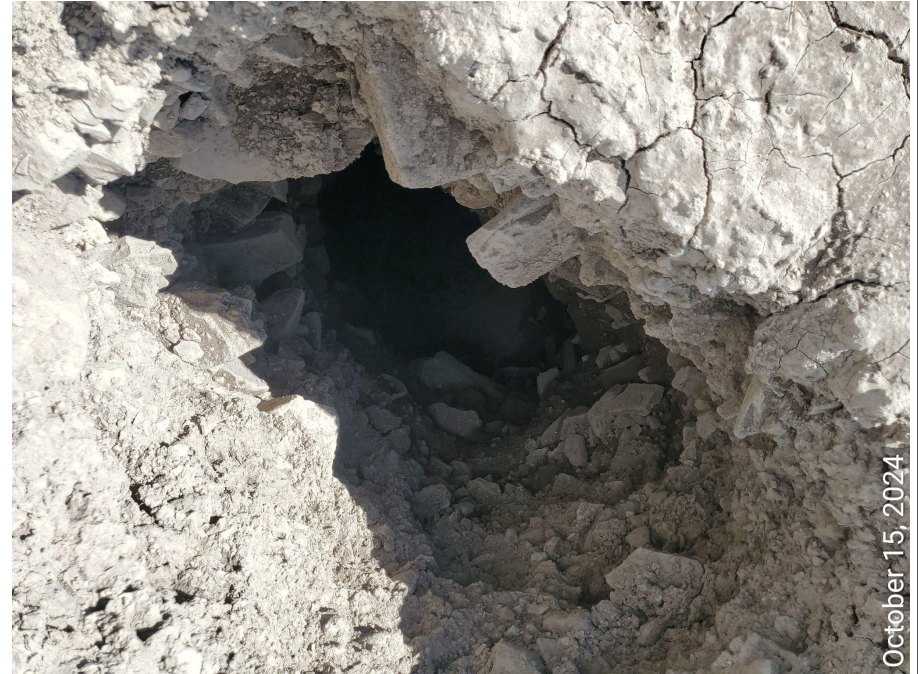
Photo 5: Photos taken from the northeast corner of the working pad surface. Photo shows a hole on the location; hole is approximately 2-3' x 1', depth is unknown. Hole requires safety fence/BMPs to prevent access by people of wildlife.

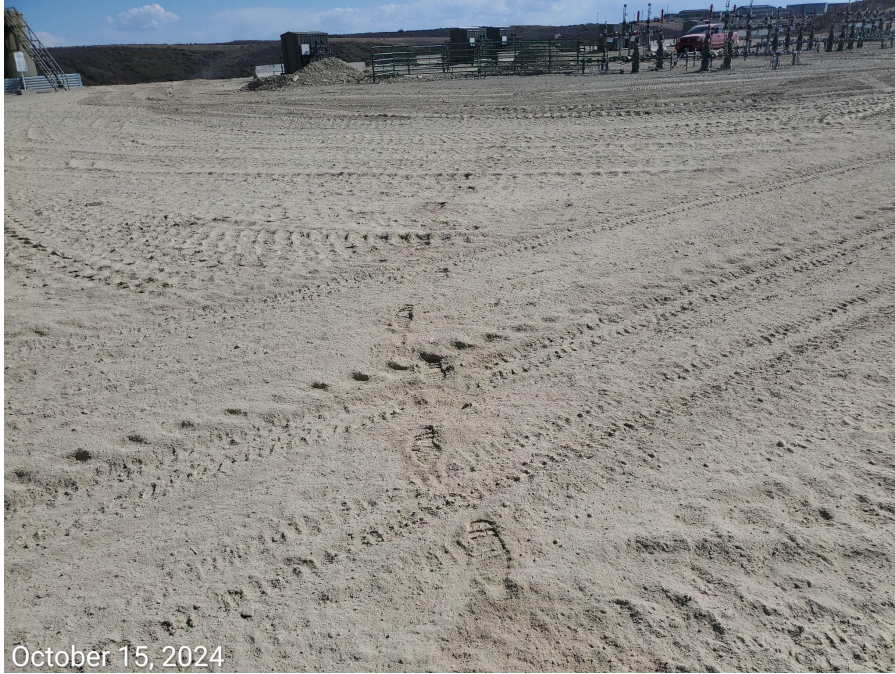
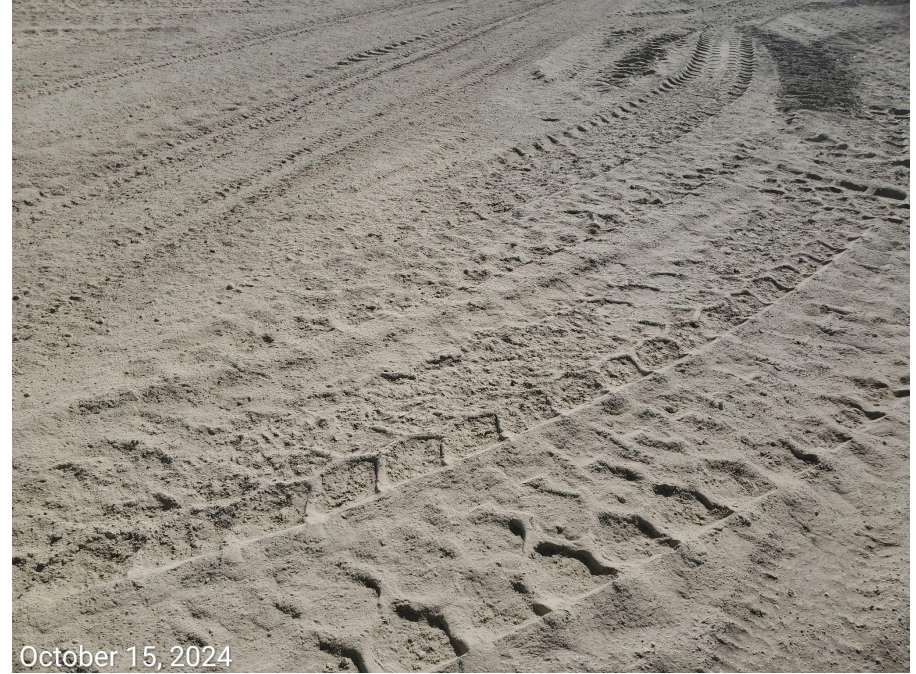
Photo 6: Photo example showing soils on the working pad surface are loose/powdery and at risk of becoming fugitive dust.

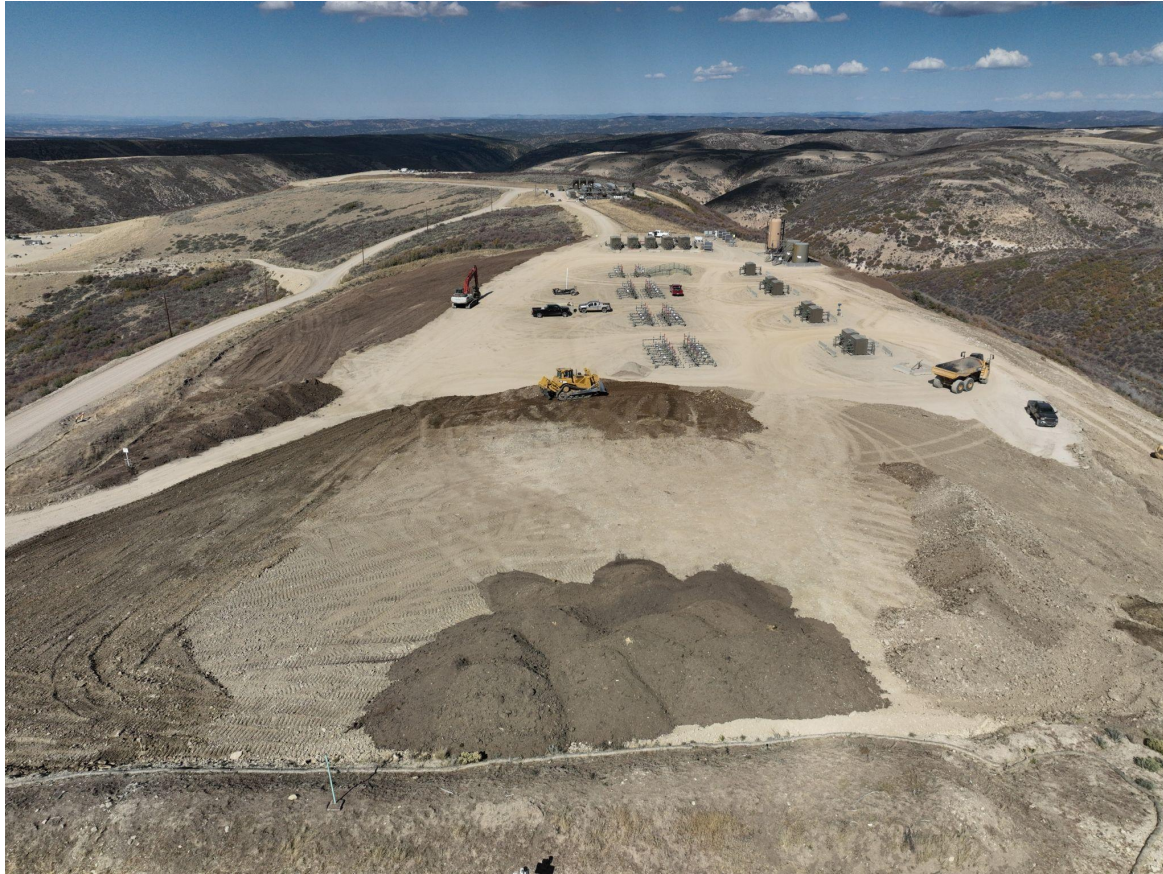
Photo 7: Photo taken with use of a sUAS during inspection. Photo taken south of the Location, facing north. Photo provides an overview of the Location, and shows interim reclamation activities “in process”.

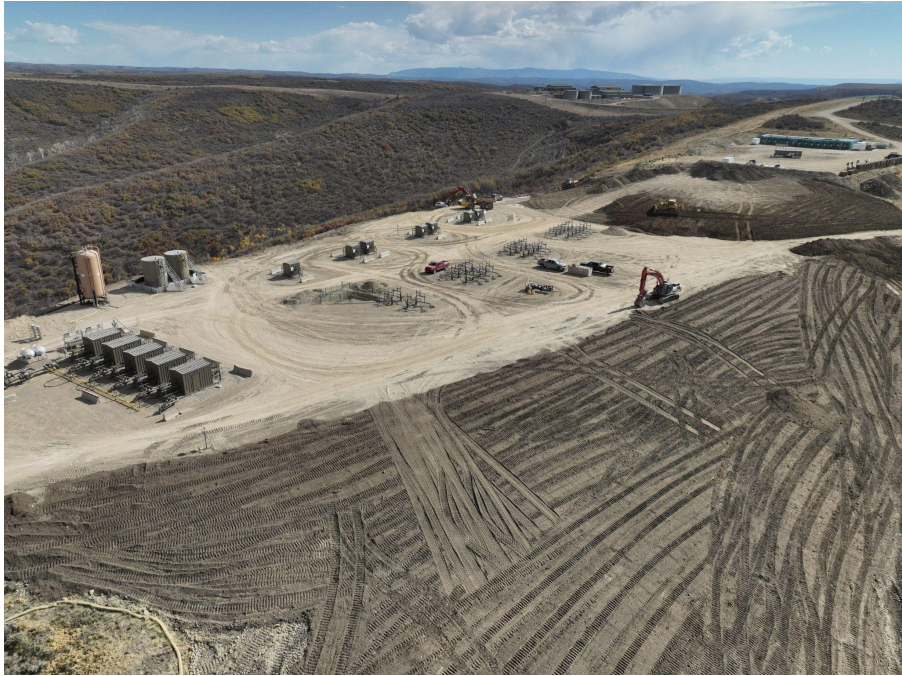
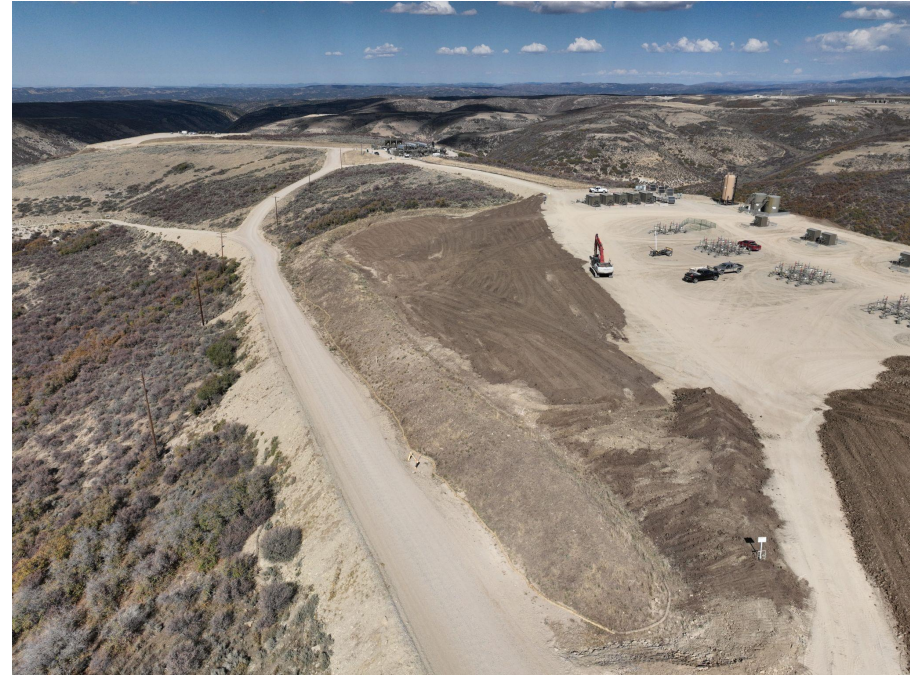
Photo 8: Photos taken with use of a sUAS during inspection. Photos provides an overview of the Location, and shows interim reclamation activities “in process”.

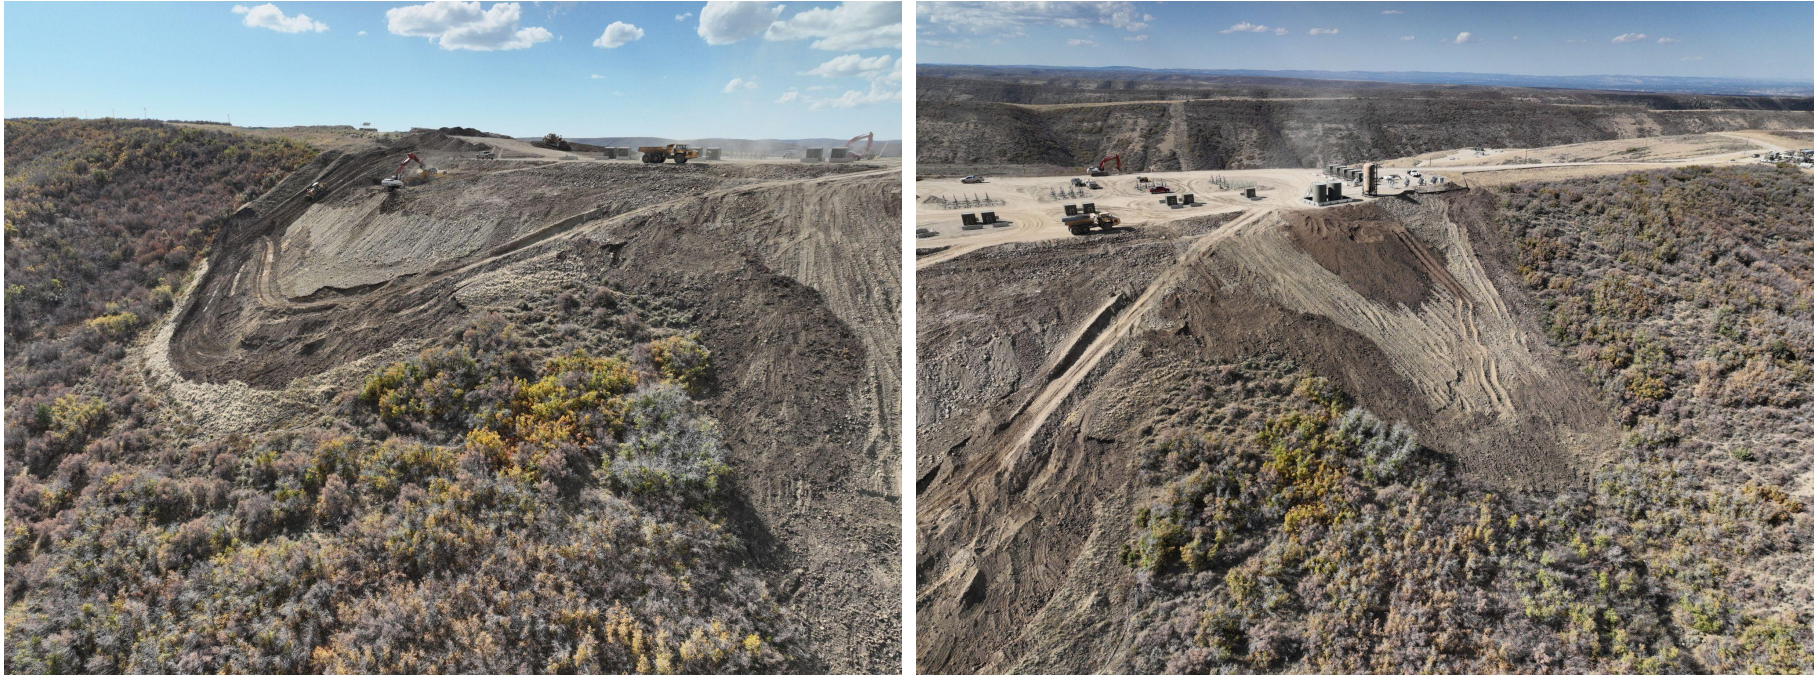
Photo 9: Photos taken with use of a sUAS during inspection. Photos taken from the east of the of the location, facing southwest/northwest. Photos provides an overview of the Location, and shows interim reclamation activities “in process”.

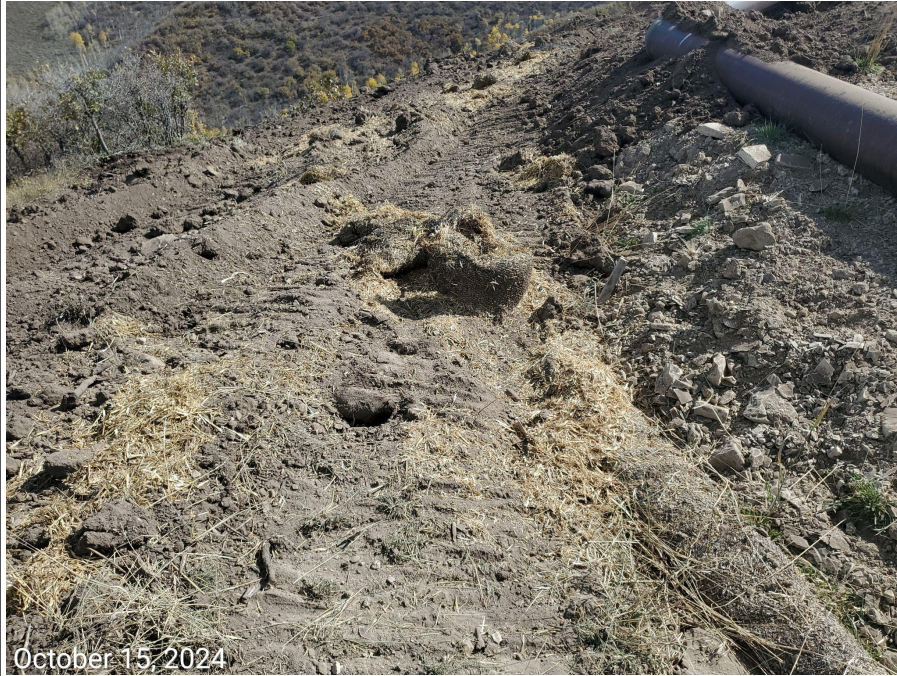
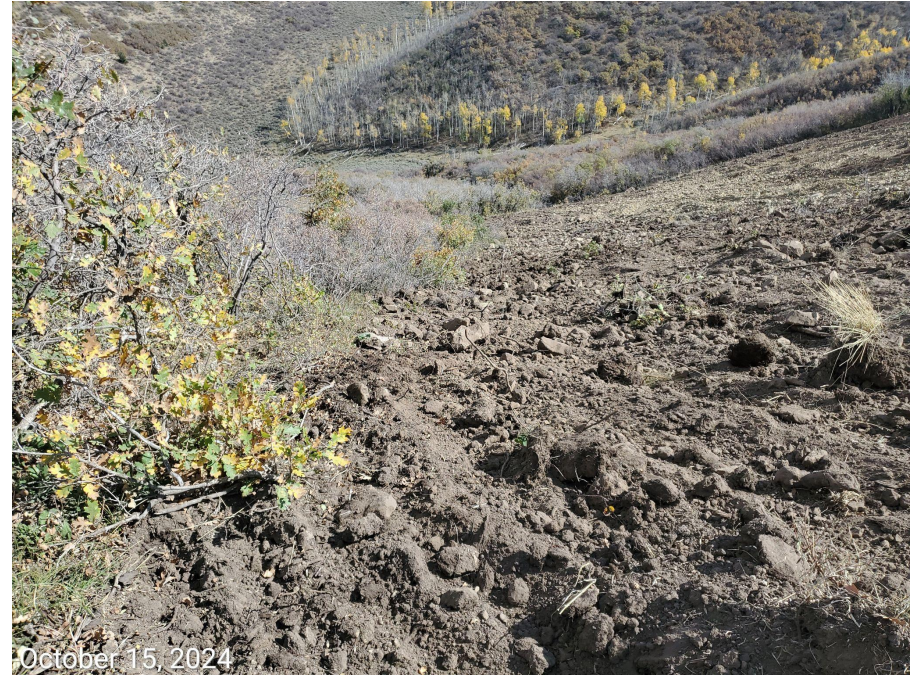
Photo 10: Photos taken from the interim areas on the northeast end of the Location. Photos show perimeter stormwater and erosion control BMPs are missing or insufficient. BMPs previously implemented, including erosion logs, appear to have have either been removed, not maintained, or covered during current construction/interim reclamation operations.

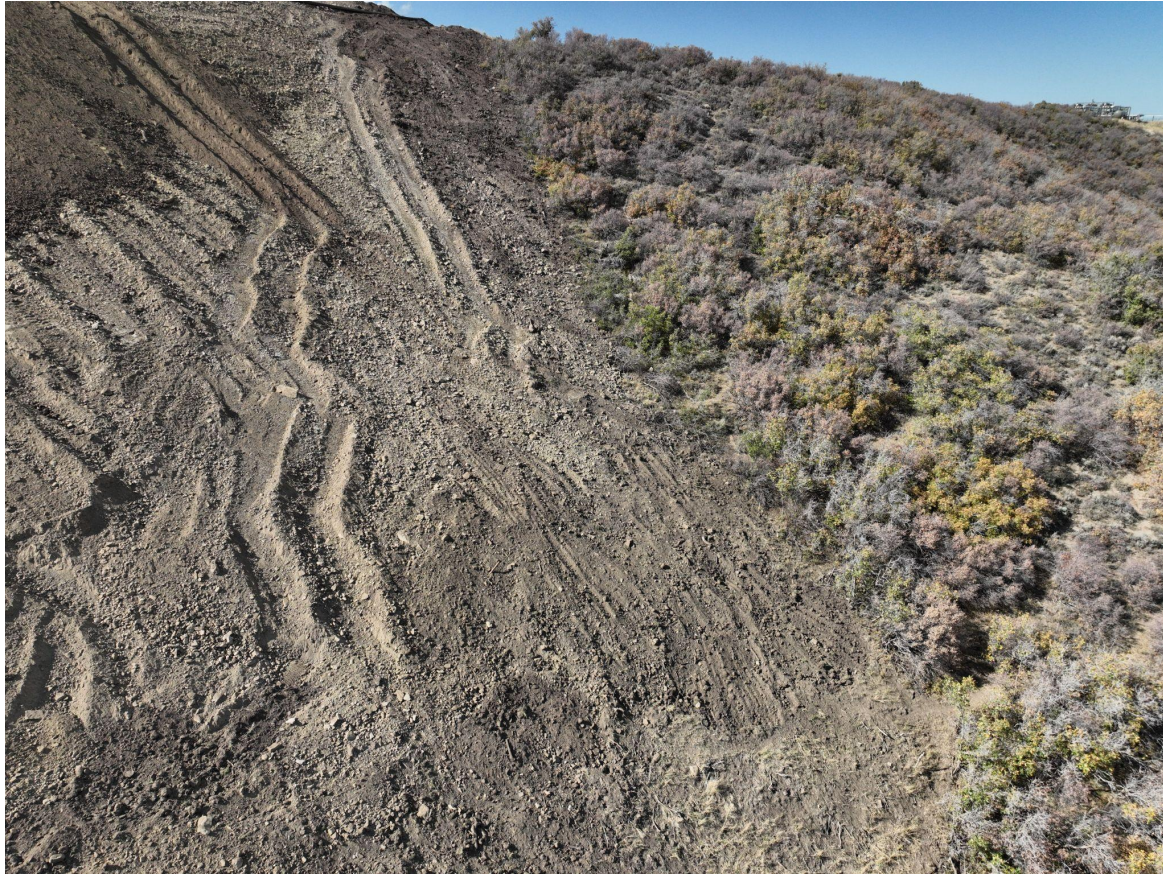
Photo 11: Photo taken with use of a sUAS during inspection. Photos taken from the northeast end of the of the location, facing northwest. Photos show perimeter stormwater and erosion control BMPs are missing or insufficient. BMPs previously implemented, including erosion logs, appear to have have either been removed, not maintained, or covered during current construction/interim reclamation operations.

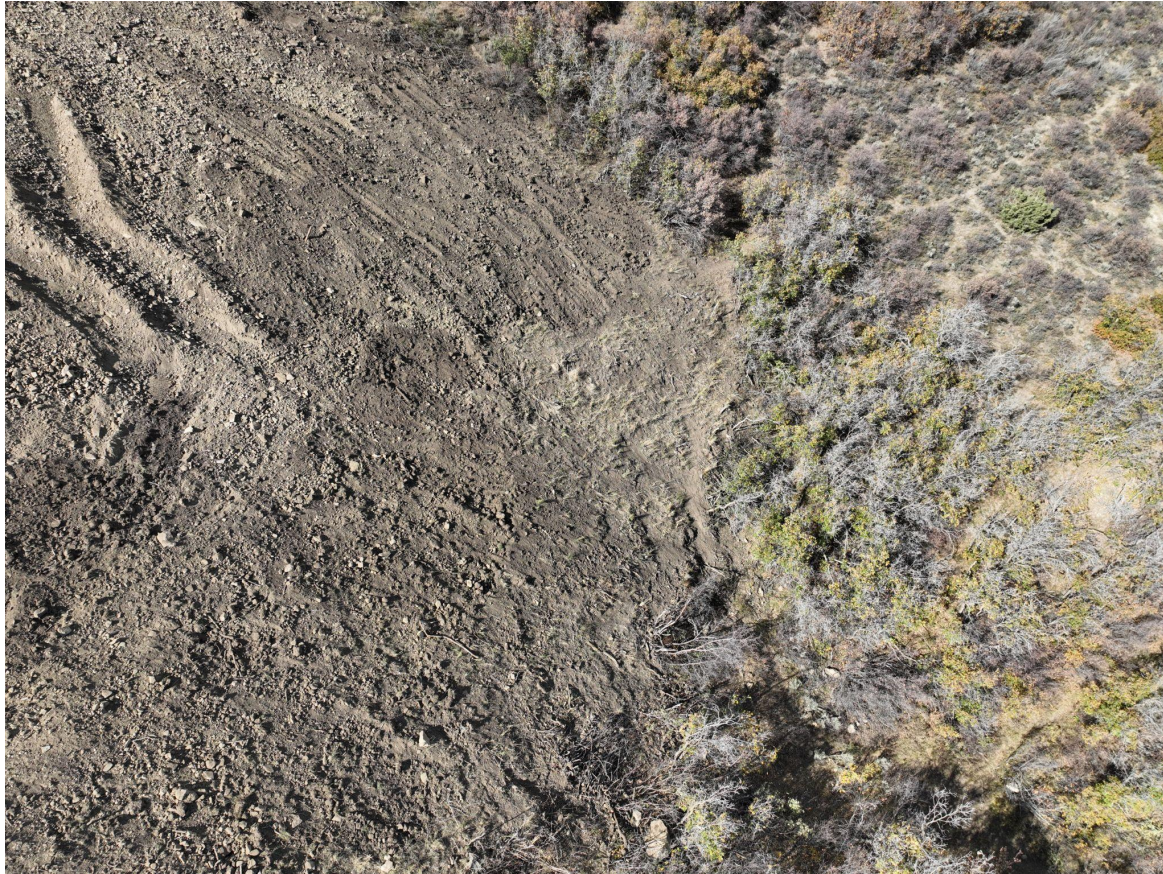
Photo 12: See comments under photo 11.

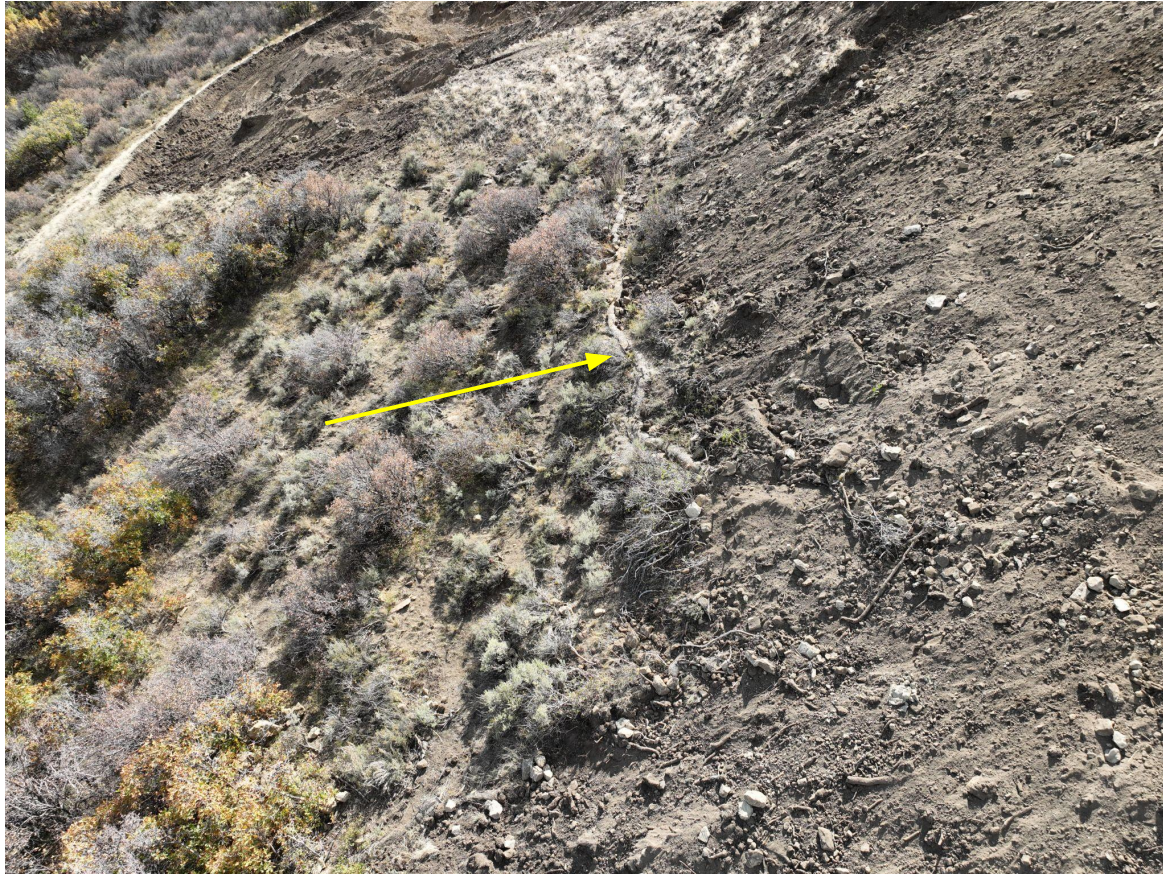
Photo 13: Photo taken with use of a sUAS during inspection. Photos taken from the east end of the of the location, facing south. Photos show perimeter stormwater and erosion control BMPs are missing or insufficient. BMPs previously implemented, including erosion logs (arrow), appear to have have either been removed, not maintained, or covered during current construction/interim reclamation operations.

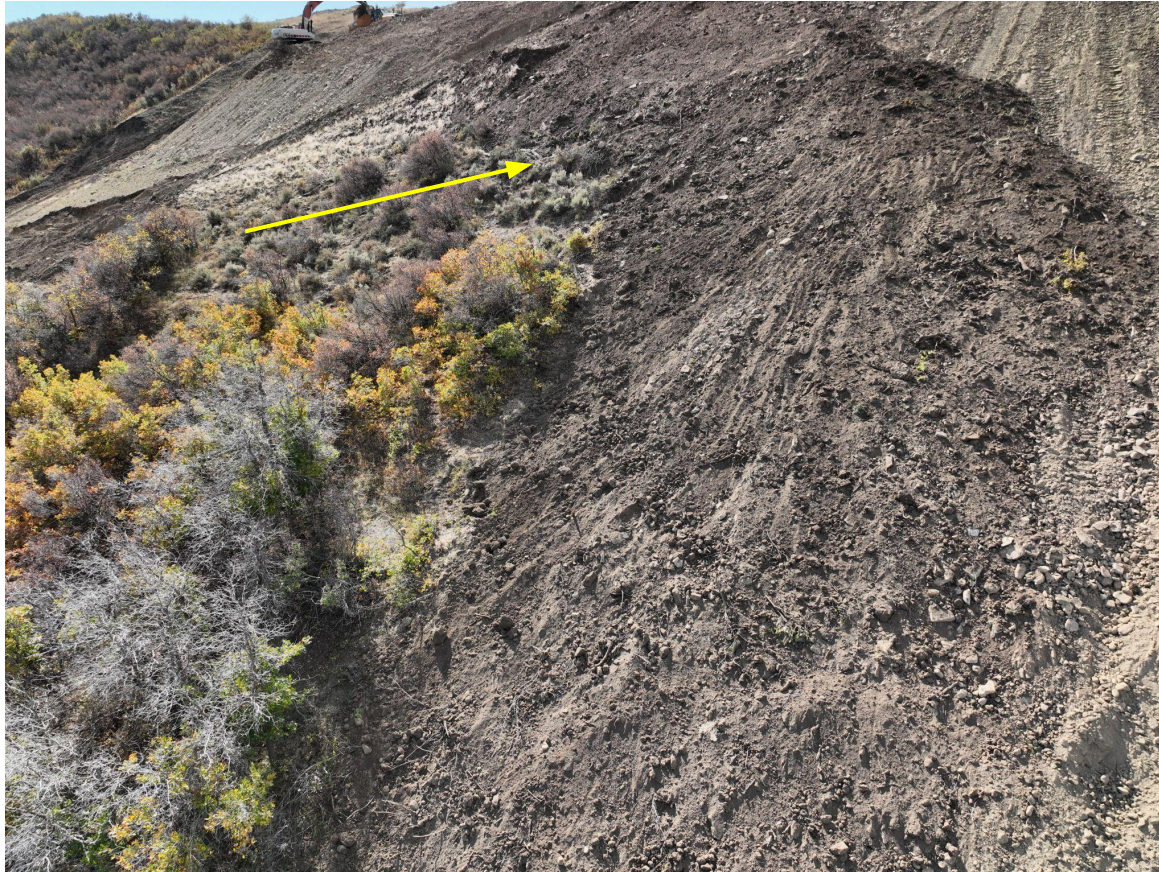
Photo 14: Continued from photo 13; see comments under photo 13.

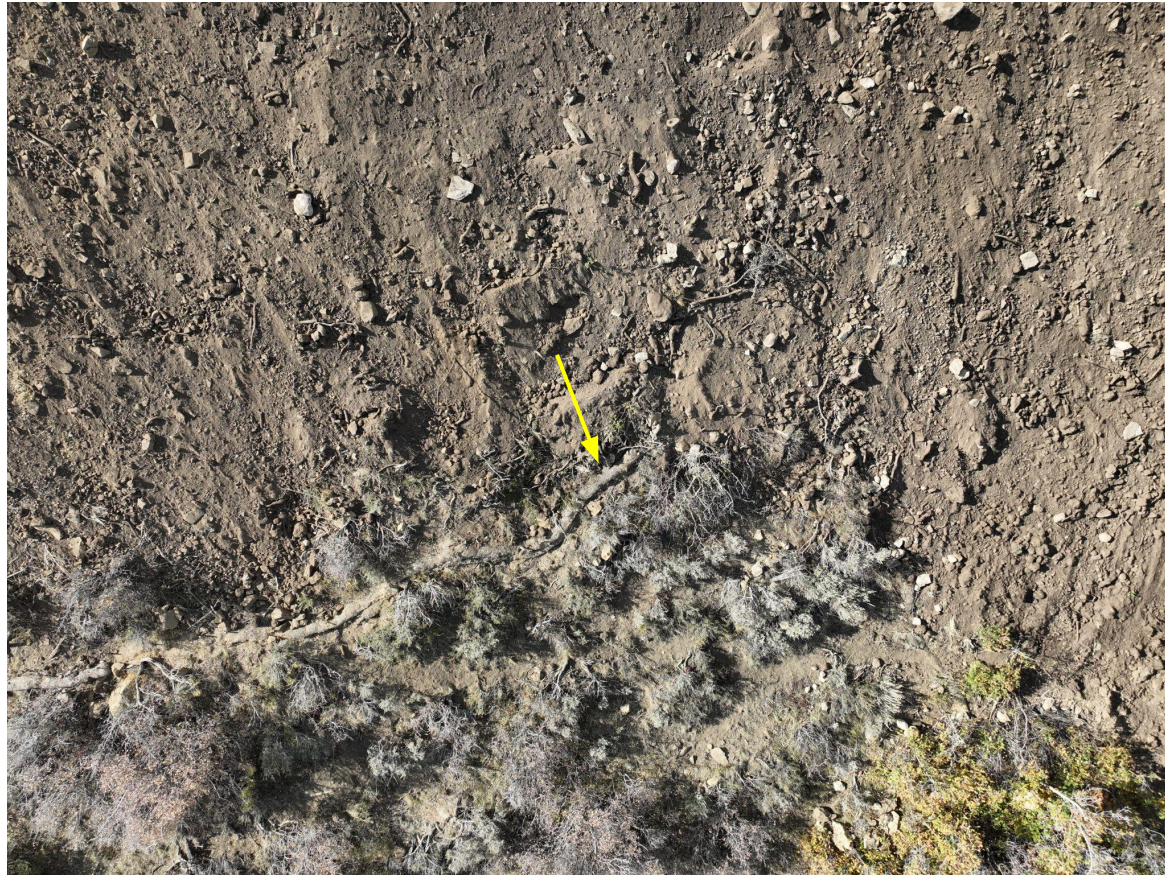
Photo 15: Continued from photo 13; see comments under photo 13.
