Inspection Photos

Location Name: TEP ROCKY MOUNTAIN LLC Duggan RWF 11-32

Location ID: 324118

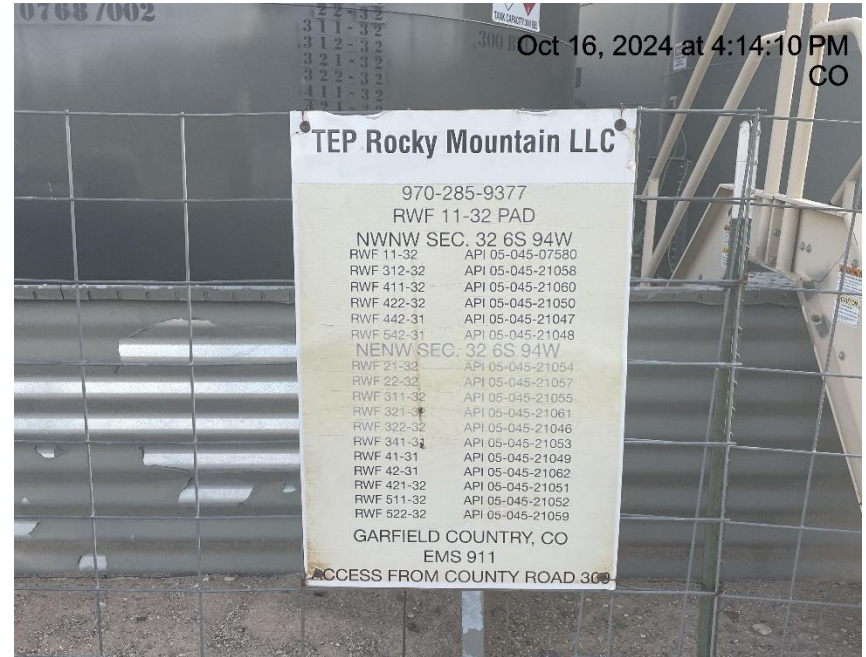
Photo # 6499 Battery sign weathered & some info starting to fade

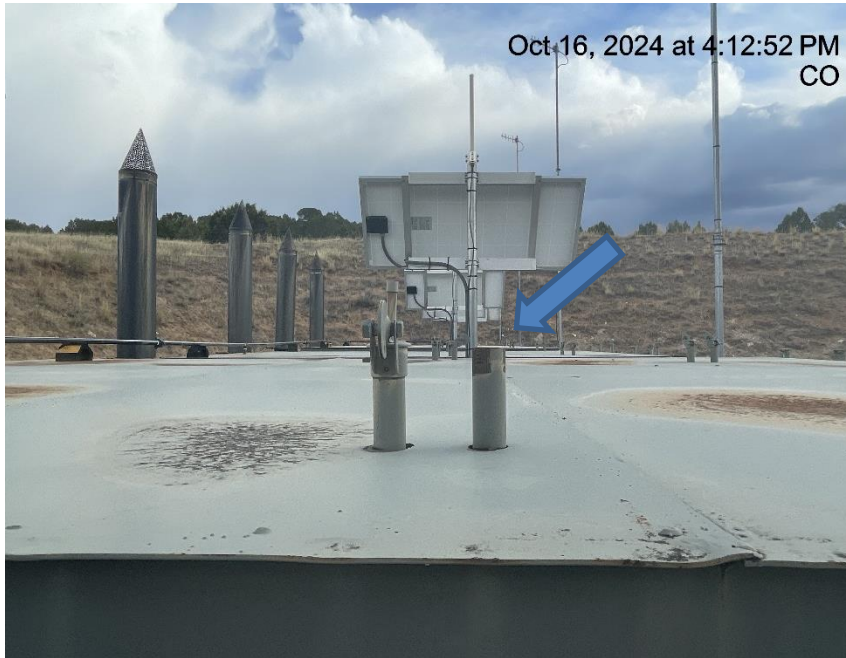
Photo # 6500 Rupture disc vent line does not comply with CECMC pressure safety device rules

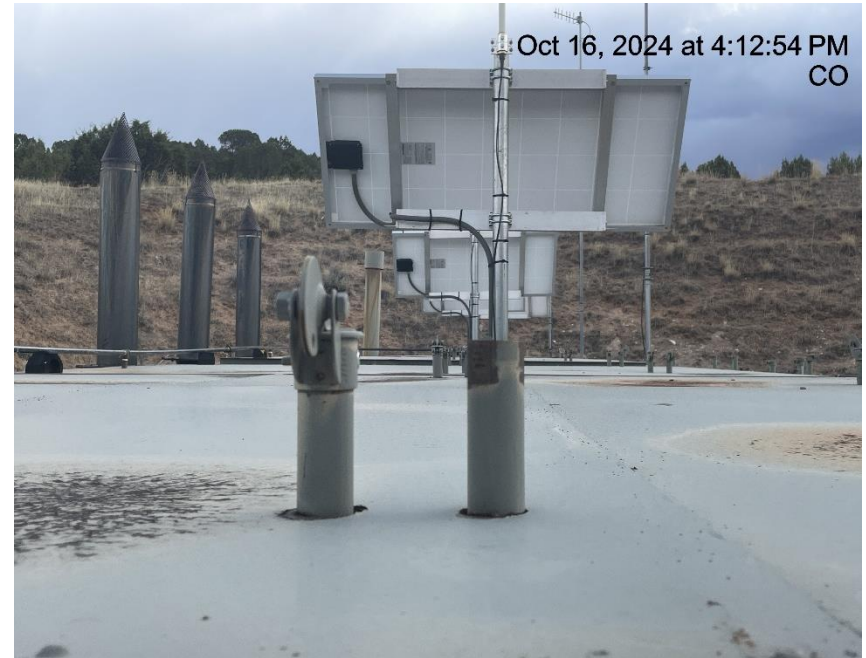
Photo # 6501 Rupture disc vent line does not comply with CECMC pressure safety device rules

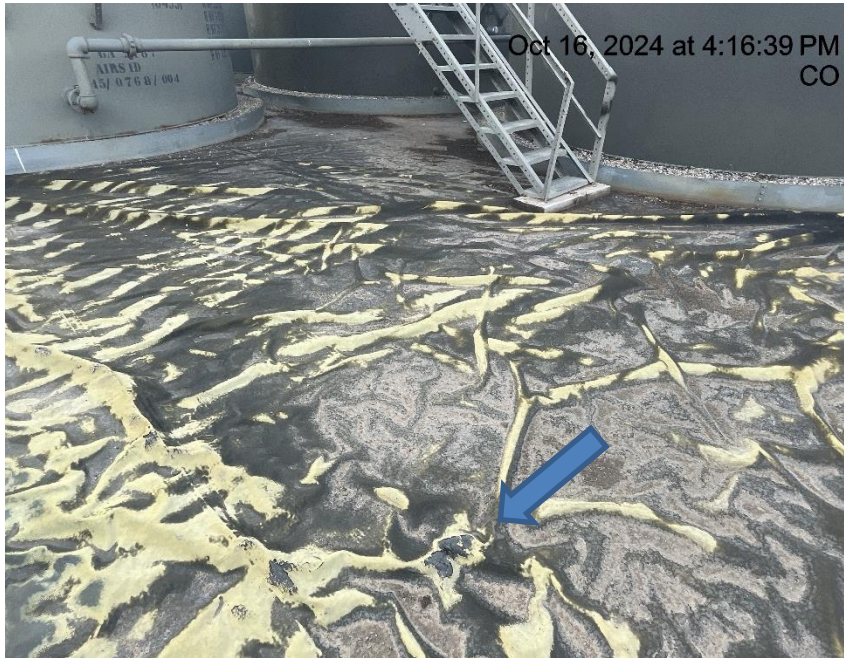
Photo # 6502 Hole in liner/liner needs maintenance

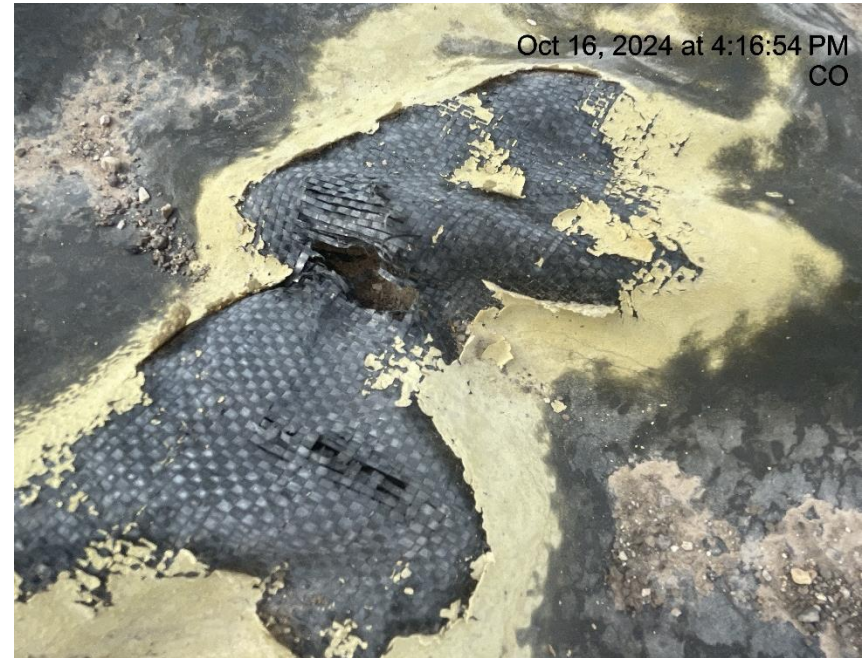
Photo # 6503 Hole in liner/liner needs maintenance

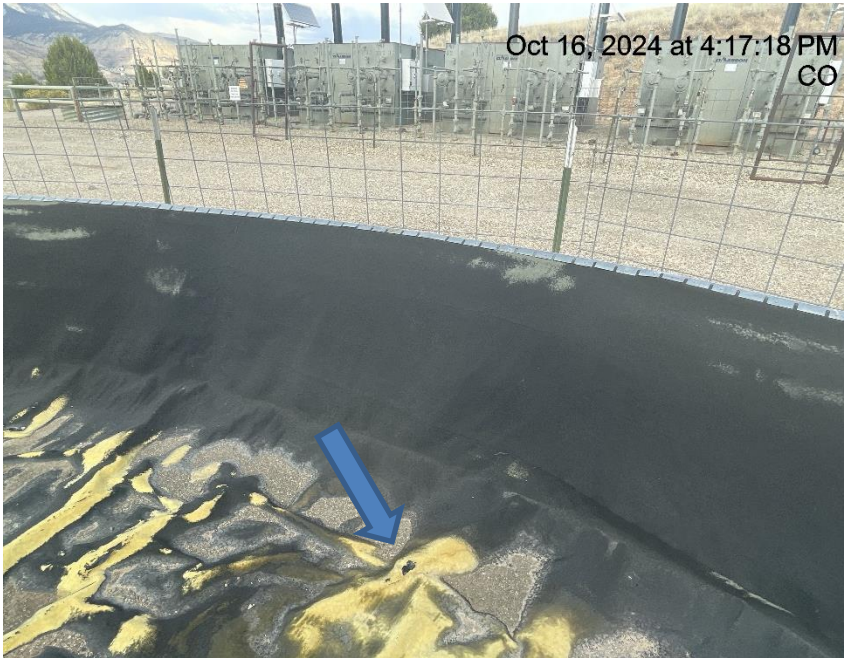
Photo # 6504 Hole in liner/liner needs maintenance

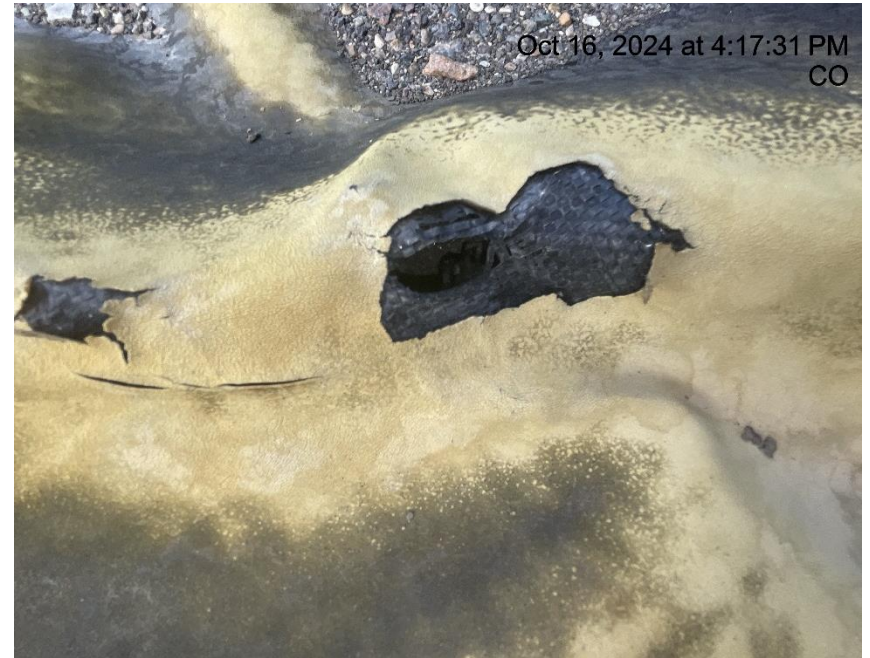
Photo # 6505 Hole in liner/liner needs maintenance

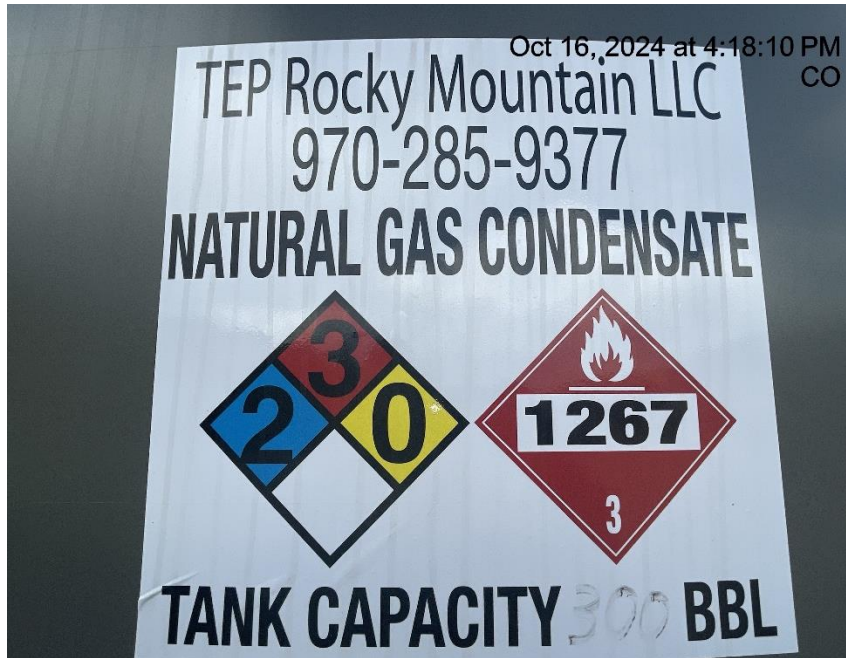
Photo # 6506 Capacity on tank label fading & becoming illegible
