# Inspection Photos

ID#479908

Operator: **DOVER ATWOOD CORPORATION**

Inspection Date: 10/14/2024

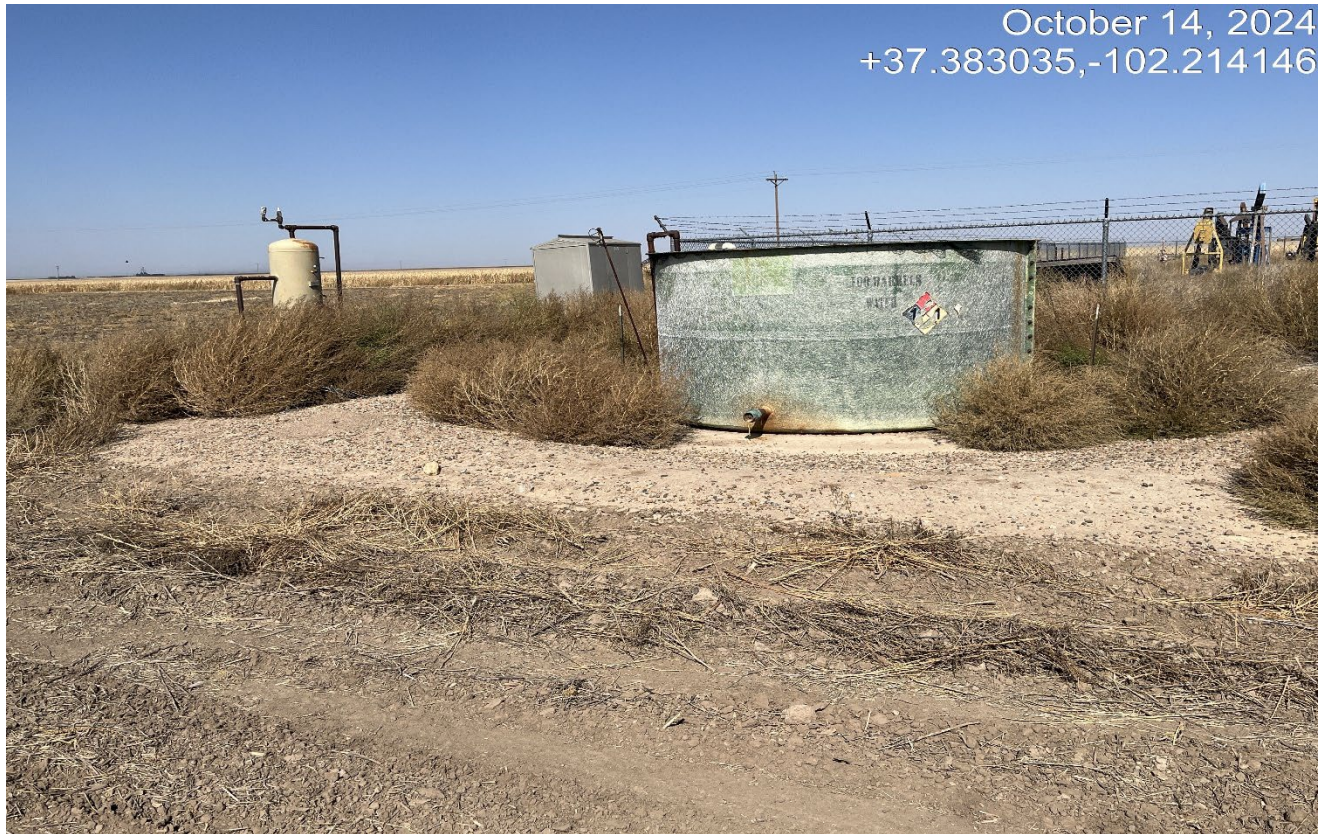
**Photo 1.** Facing northwest at the facility. The tank does not have secondary containment and the labeling is faded. There are weeds all around the equipment which is a fire hazard.

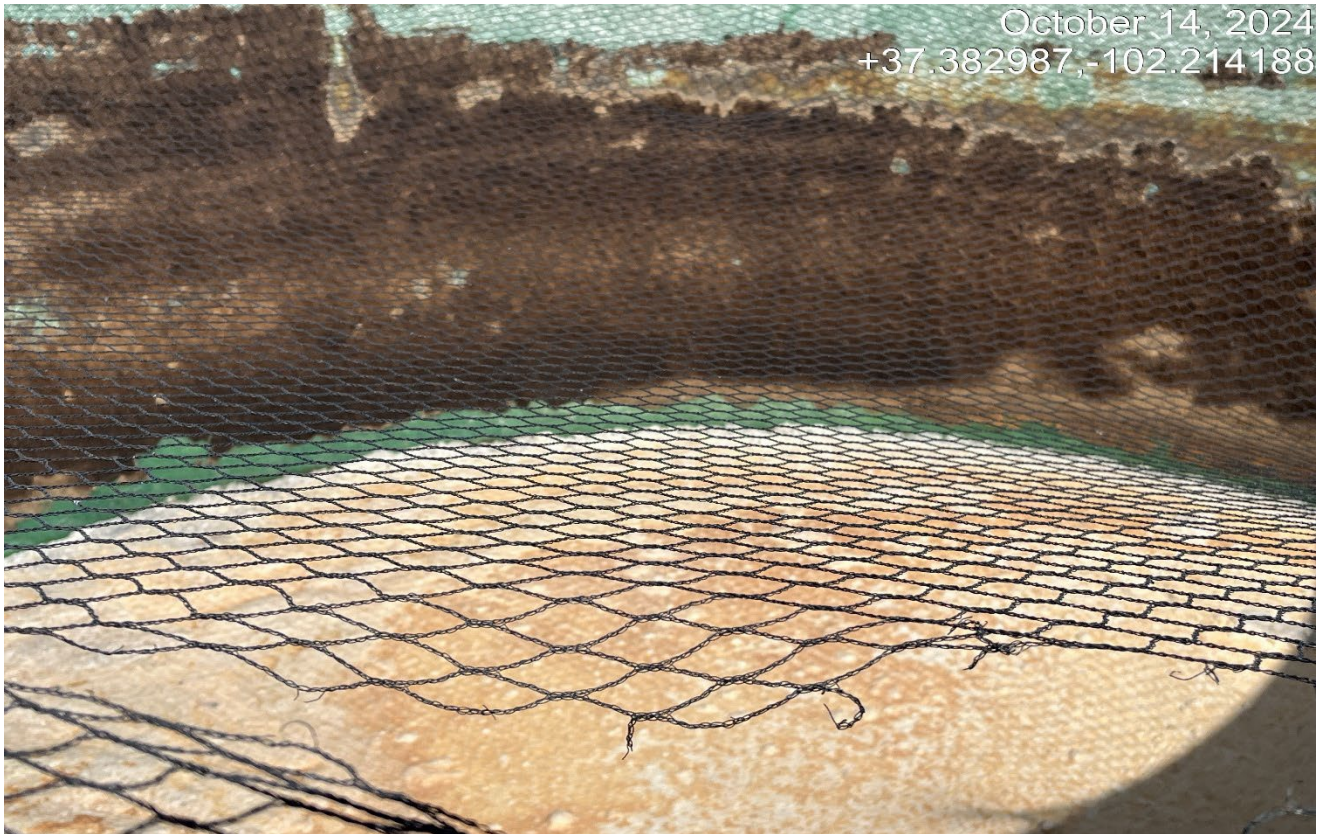
**Photo 2.** There is netting on the open top tank. Some of the edges are torn and need maintenance.

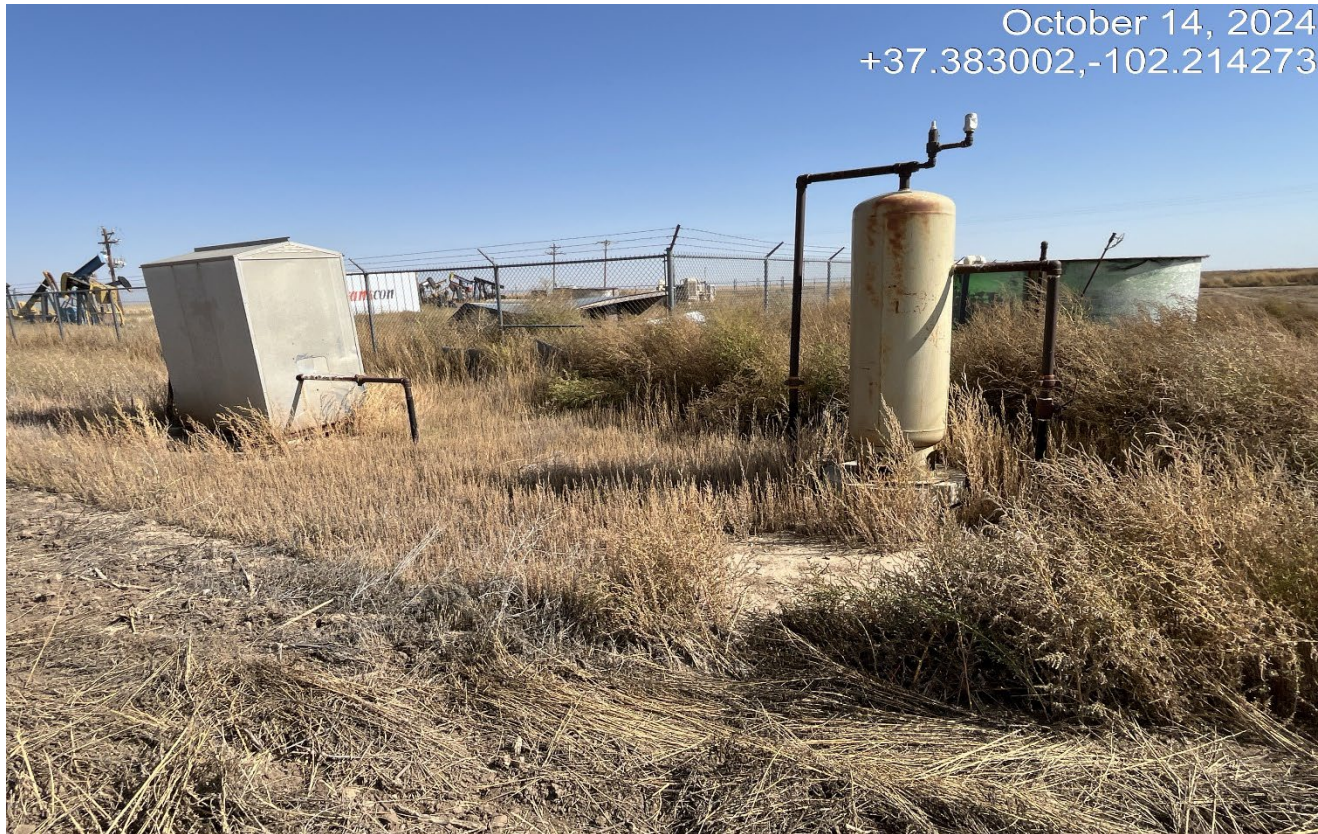
**Photo 3.** Northeast at the facility. There is a fenced in storage yard adjacent to this facility. Oil and gas equipment is being stored inside the fenced area.
