# Inspection Photos

API# 009-06598

Operator: **DOVER ATWOOD CORPORATION**

Inspection Date: 10/14/2024

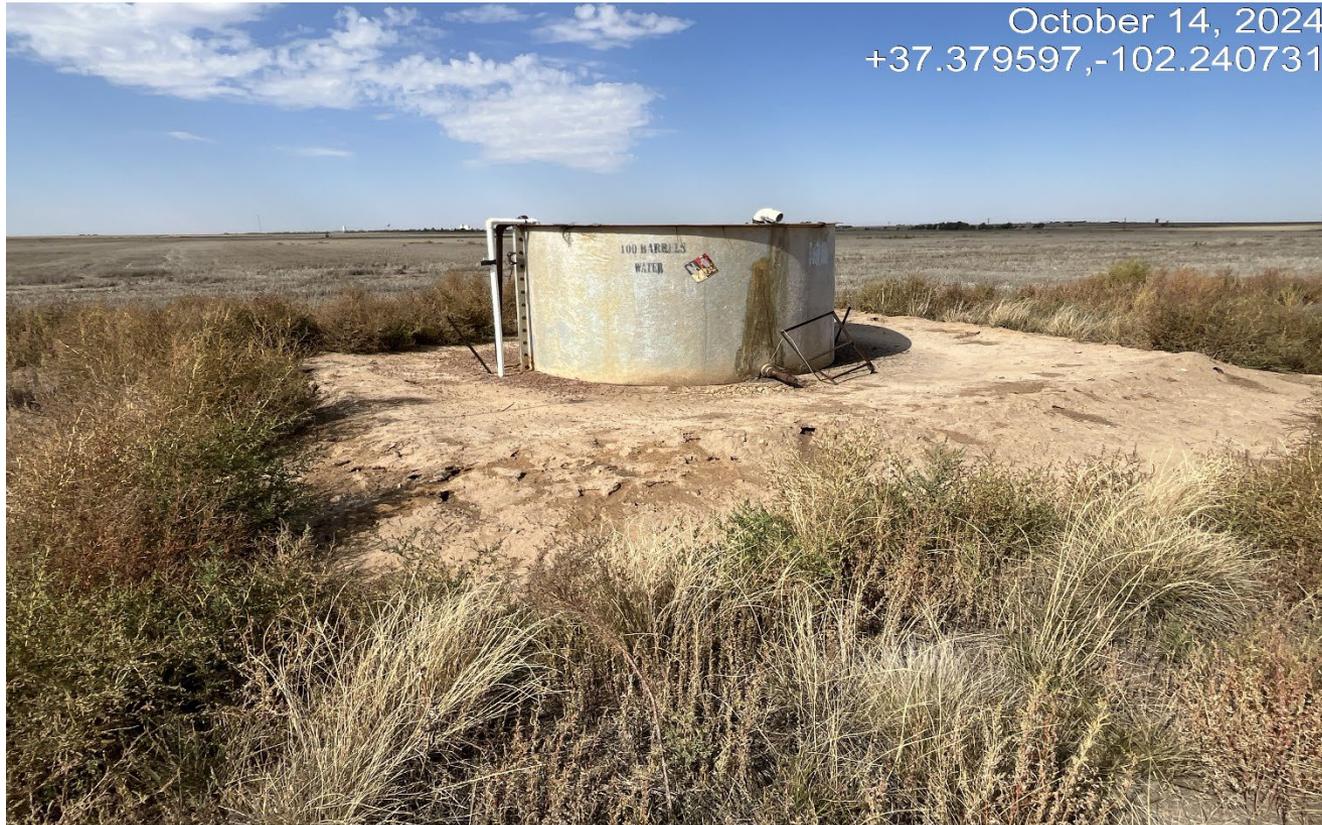
**Photo 1.** Facing toward the tank battery approx. 1200' east of the wellsite. There is insufficient secondary containment of the tank.

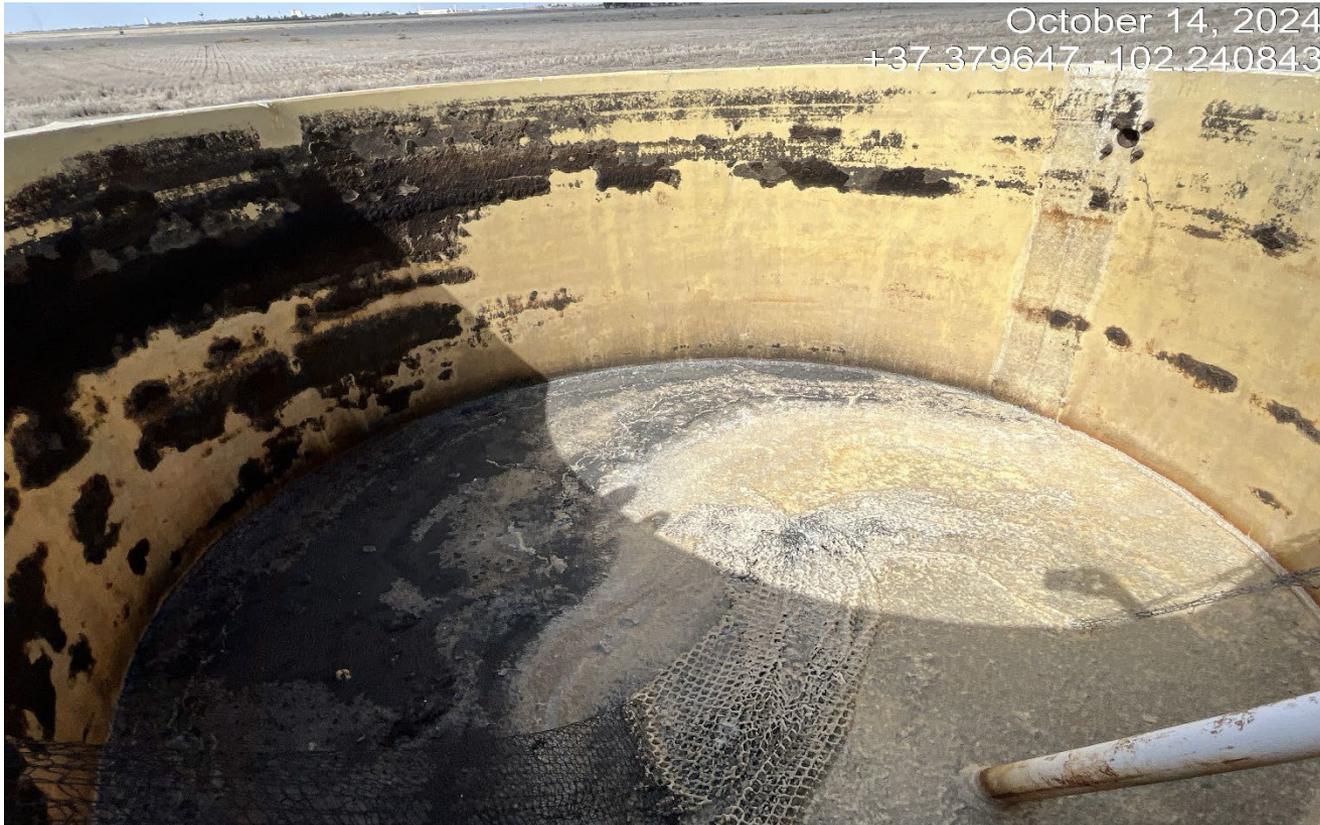
**Photo 2.** There is no netting on the open top tank contains a hardened E&P substance.

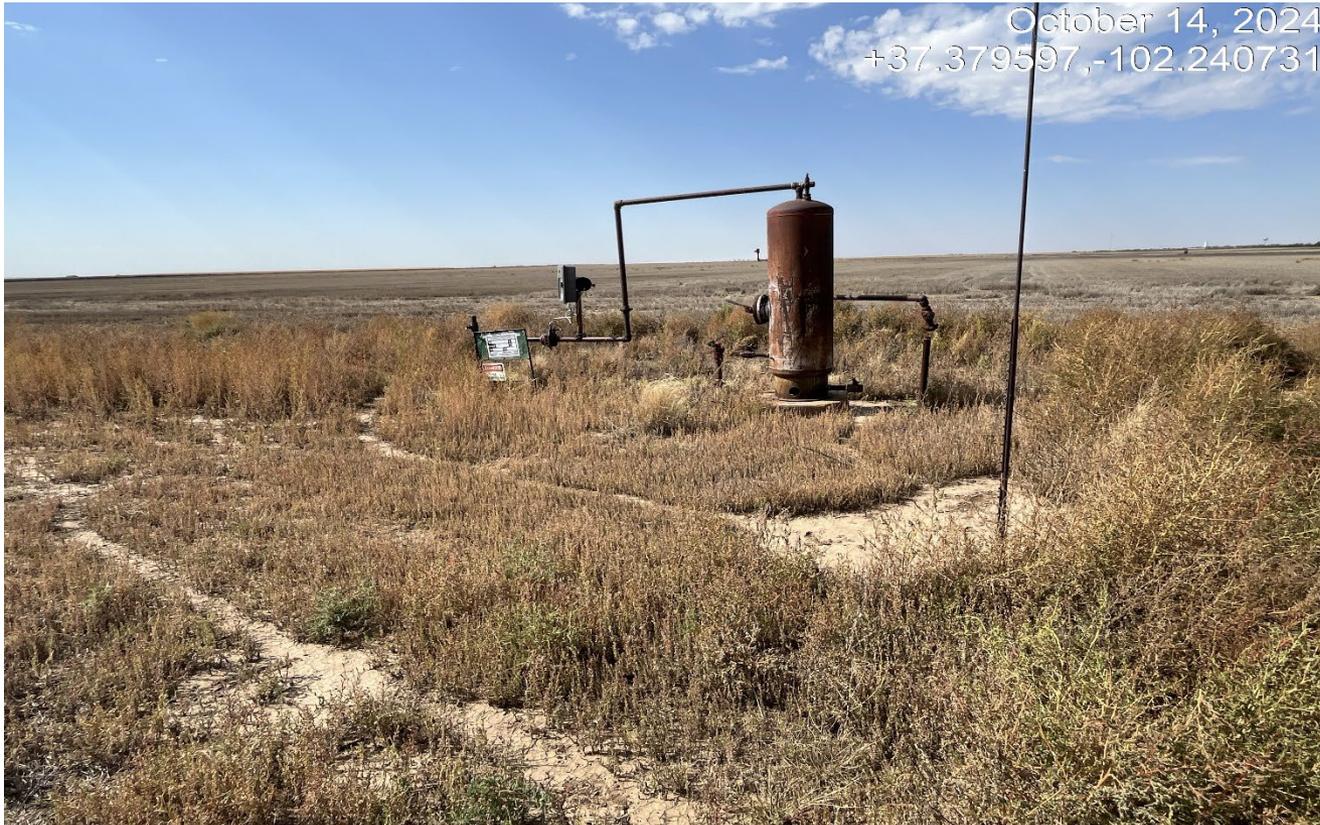
**Photo 3.** Facing toward the equipment. There are weeds around the equipment which is a fire hazard.

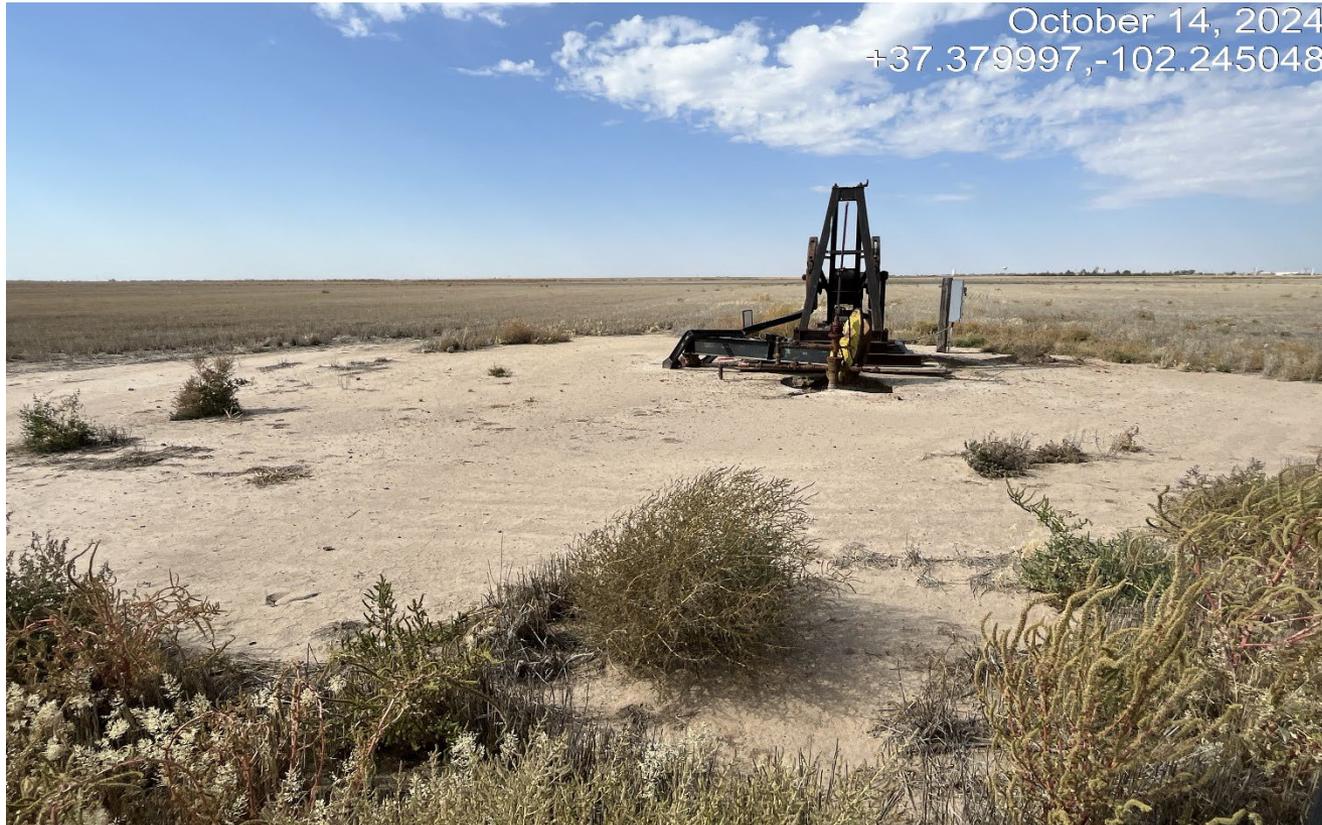
**Photo 4.** Facing west at the wellsite.

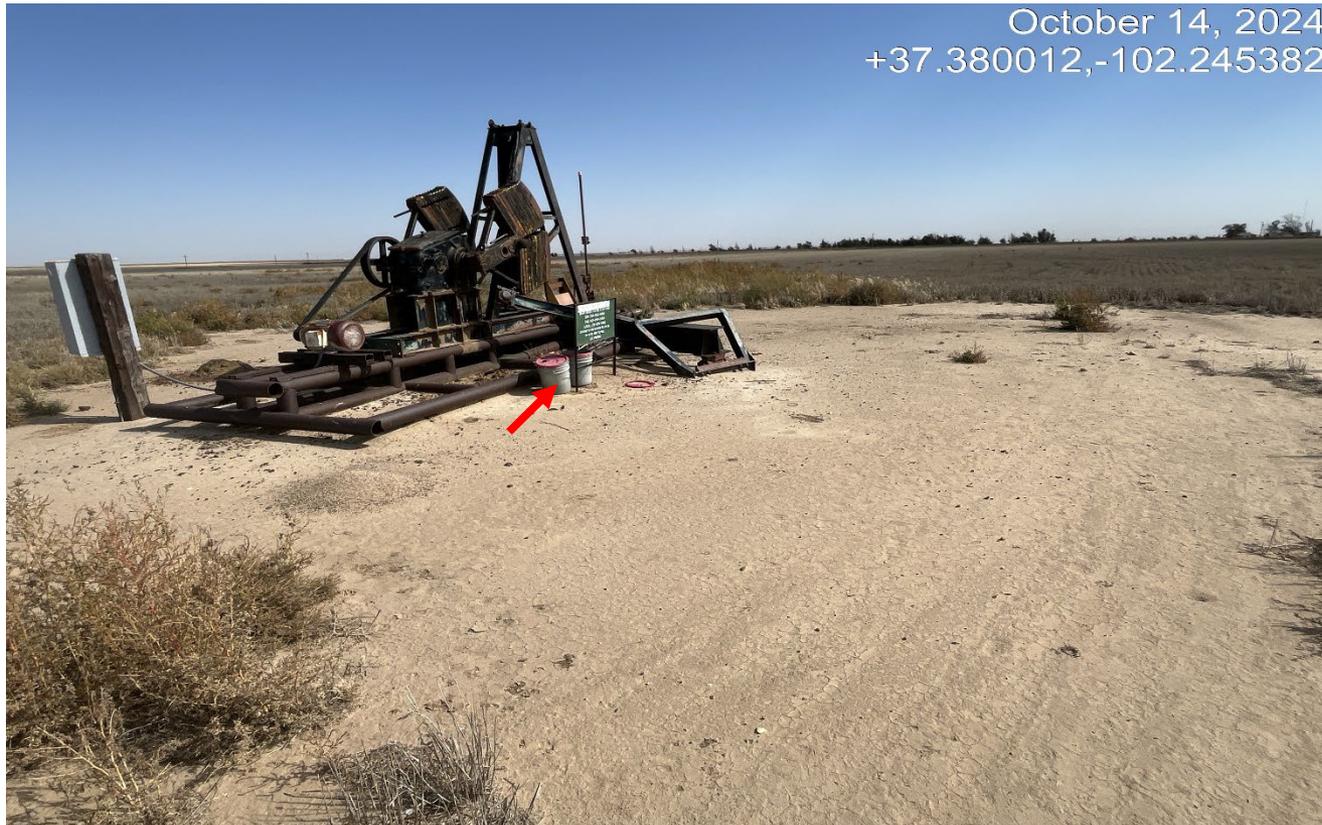
**Photo 5.** There is buckets of chemical at red arrow that need to be removed.
