Inspection Photos

October 15th, 2024

Operator: Simcoe LLC - 10749

Location ID: 306796

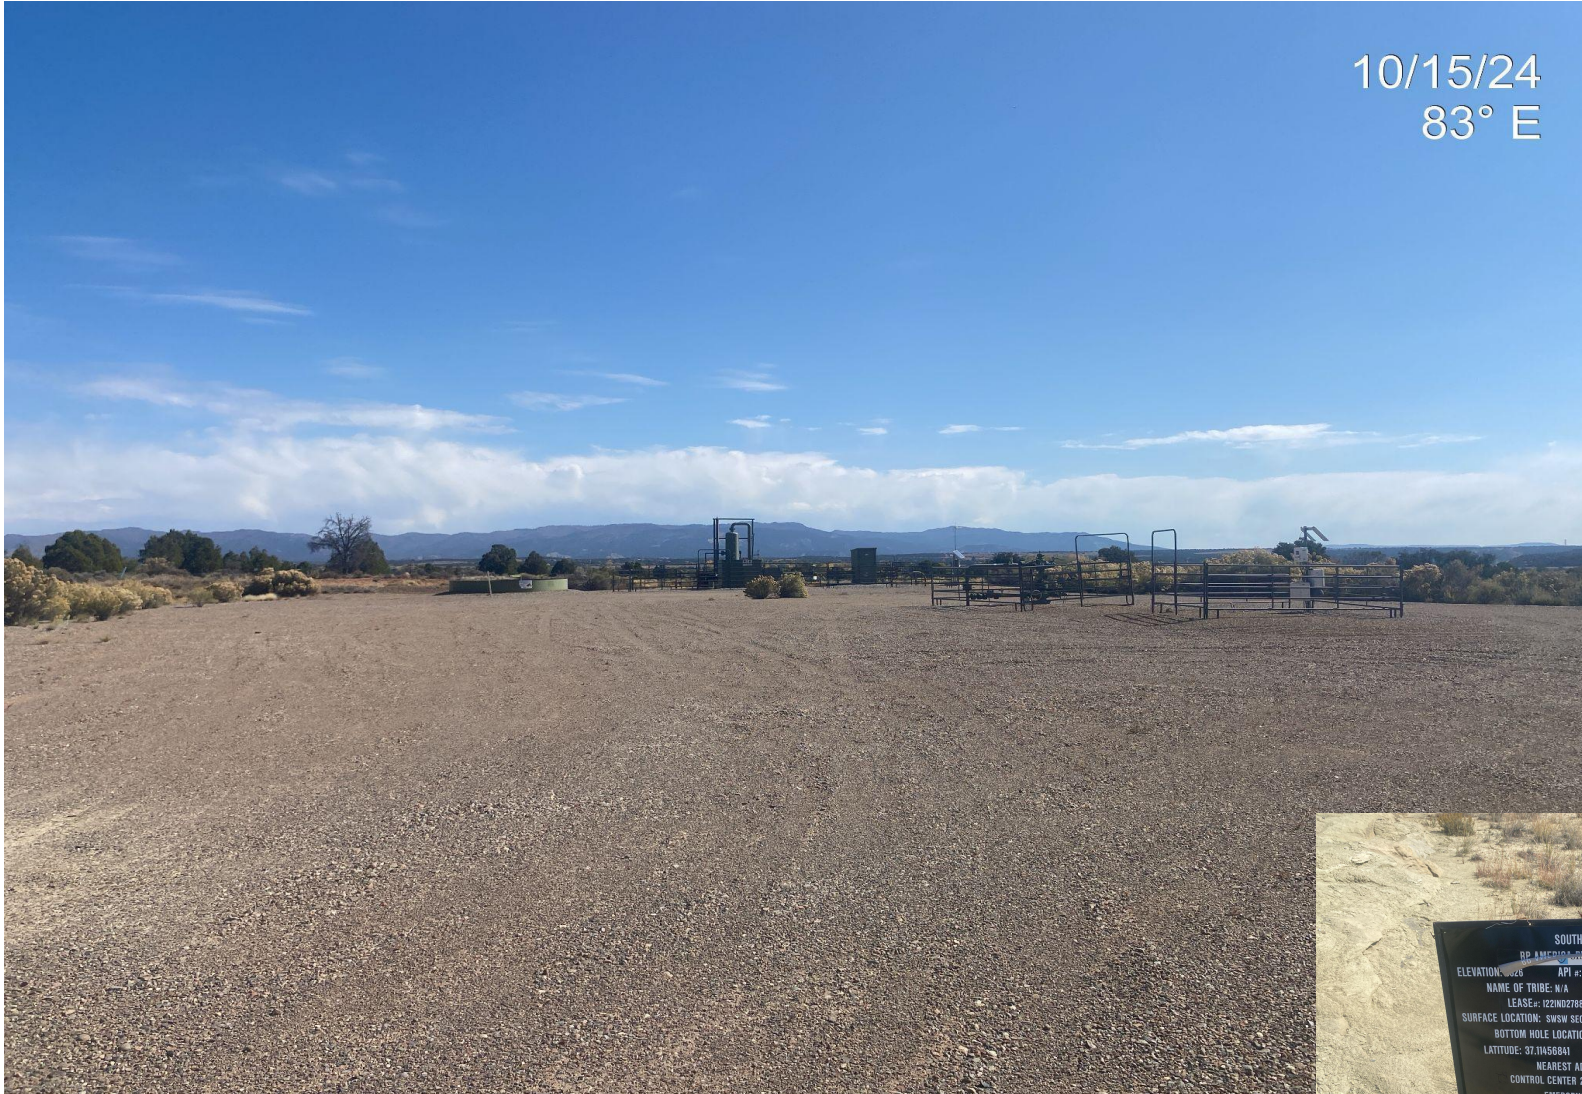
Photo 1. View of the well pad taken from the access point facing center.

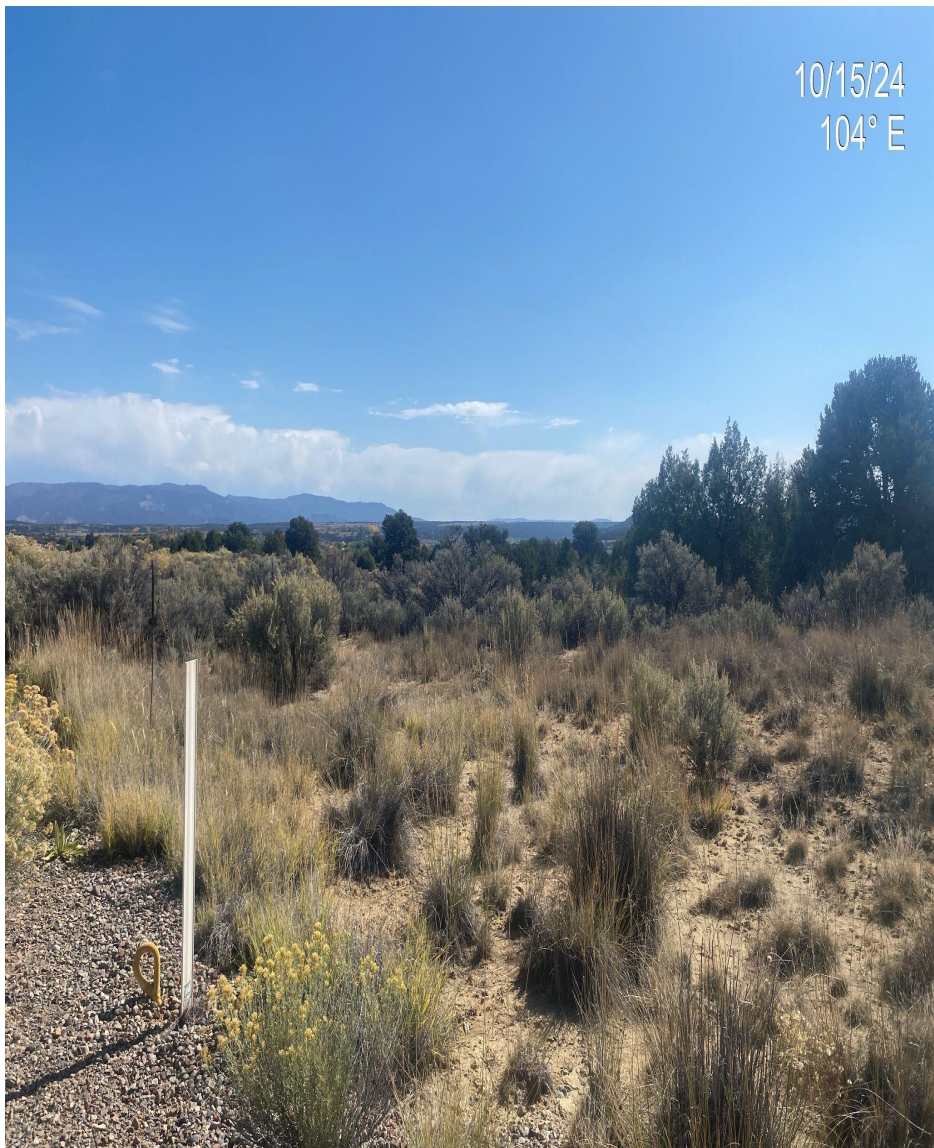
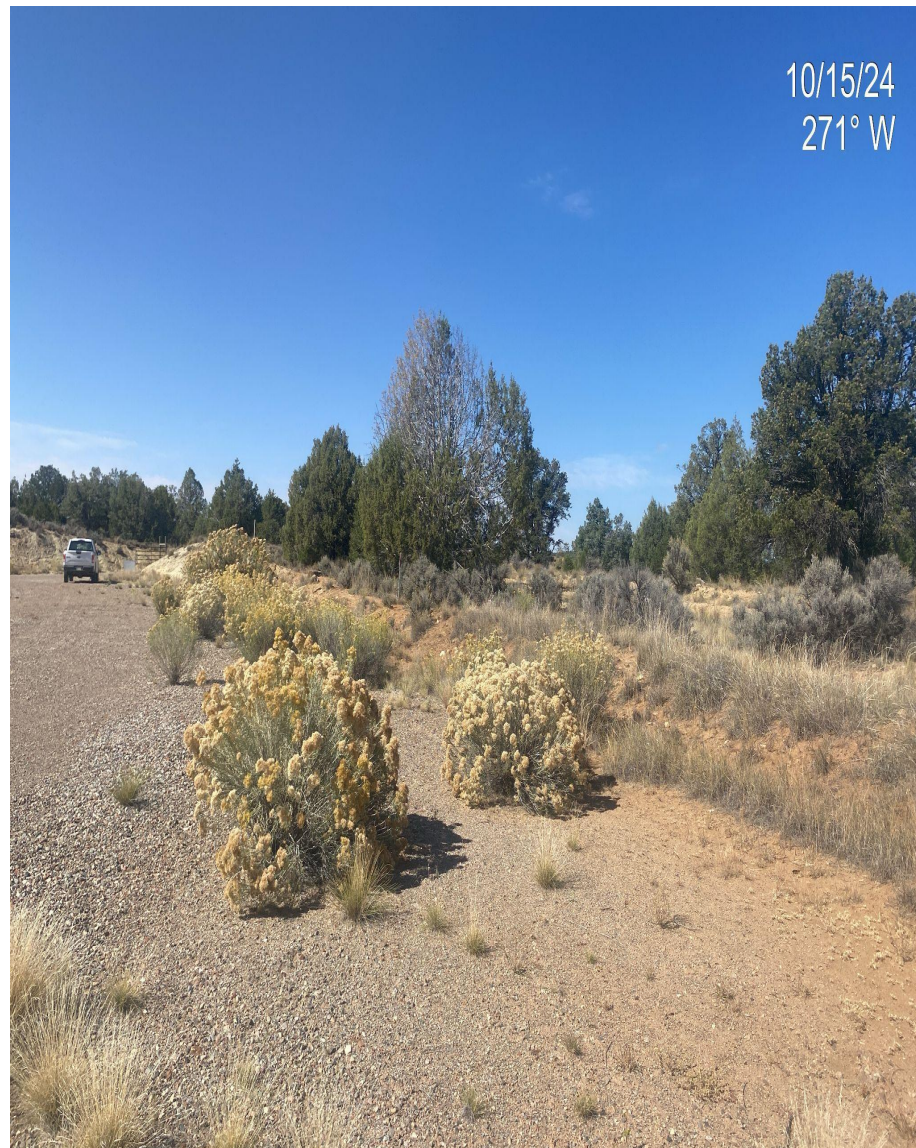
Photo 2. View of eastern and western interim reclamation areas composed of but not limited to Purple Threeawn, Rubber Rabbitbrush and Intermediate Wheatgrass.

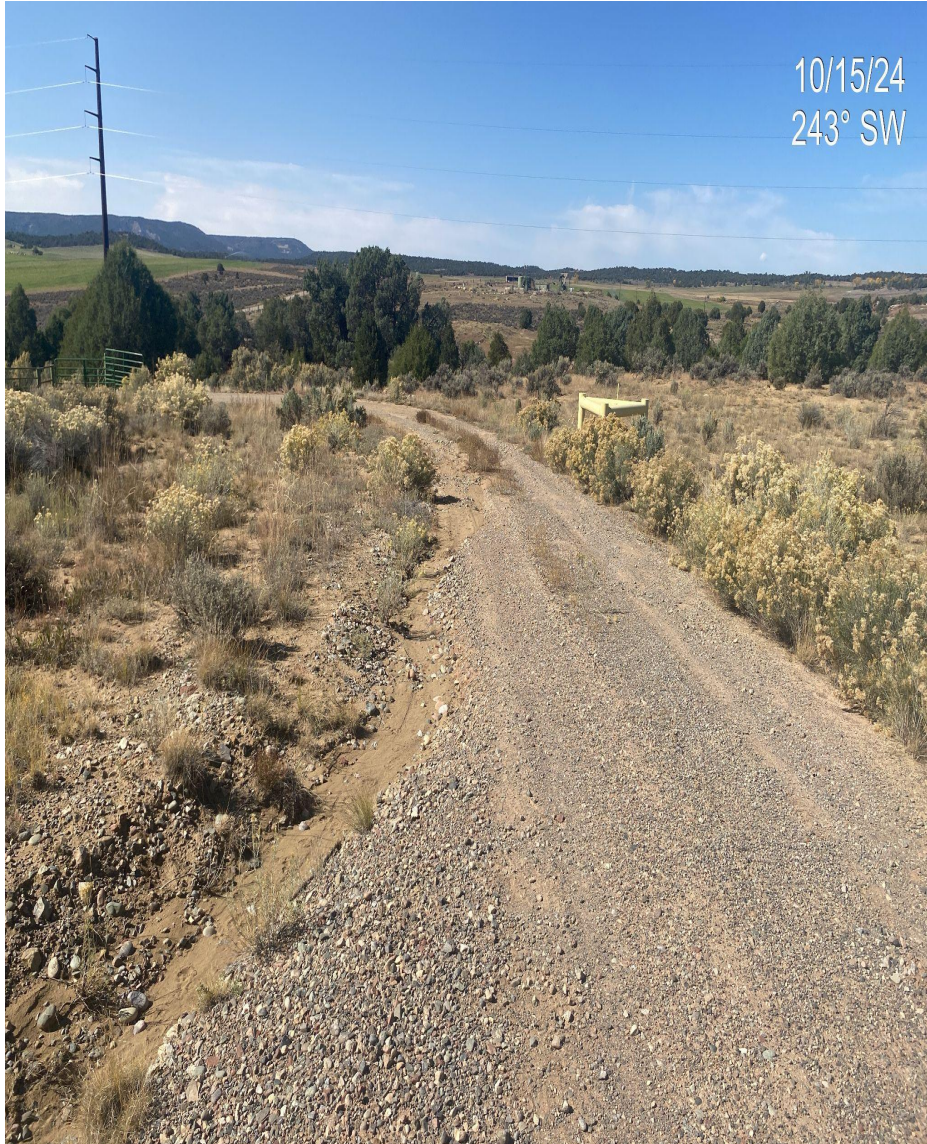
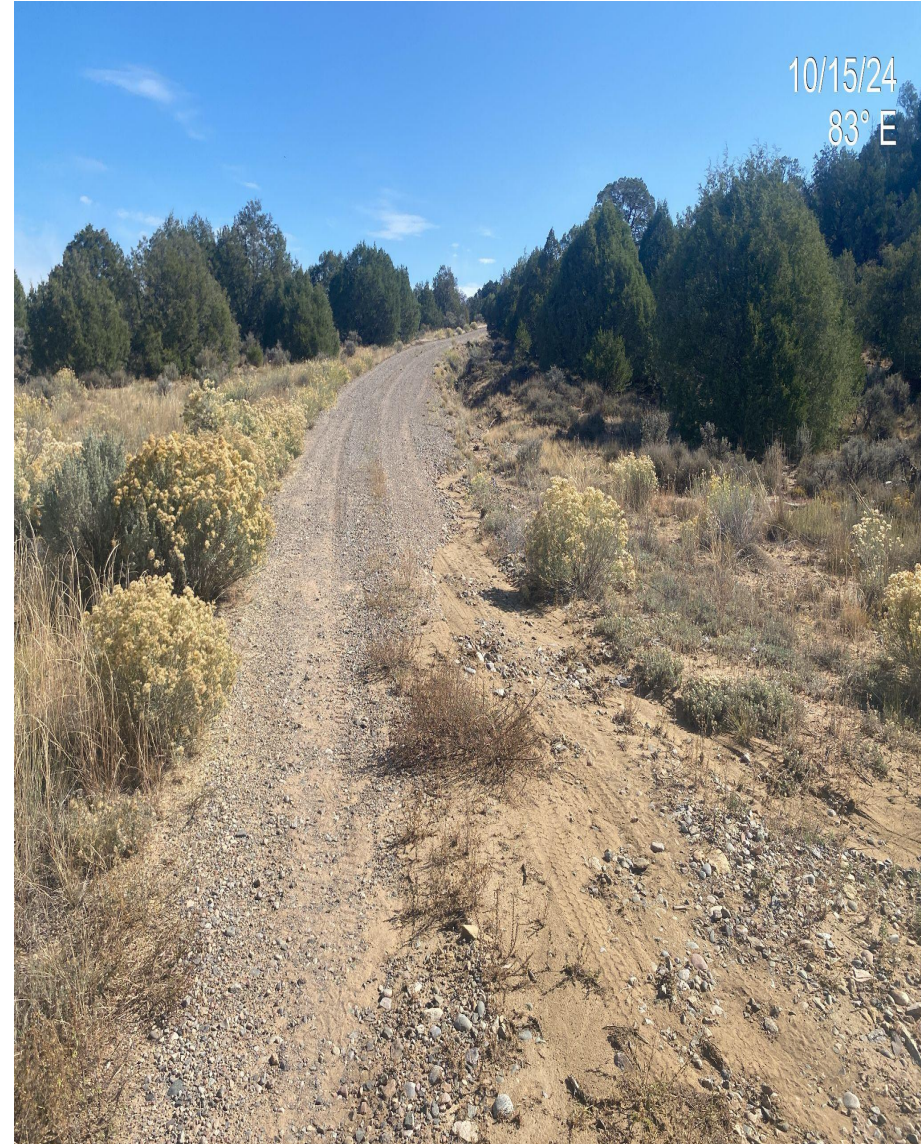
Photo 3. Stormwater issues observed along the access road. Evidence of sediment transport and deposition. Additional stormwater BMPs along the access road are needed.

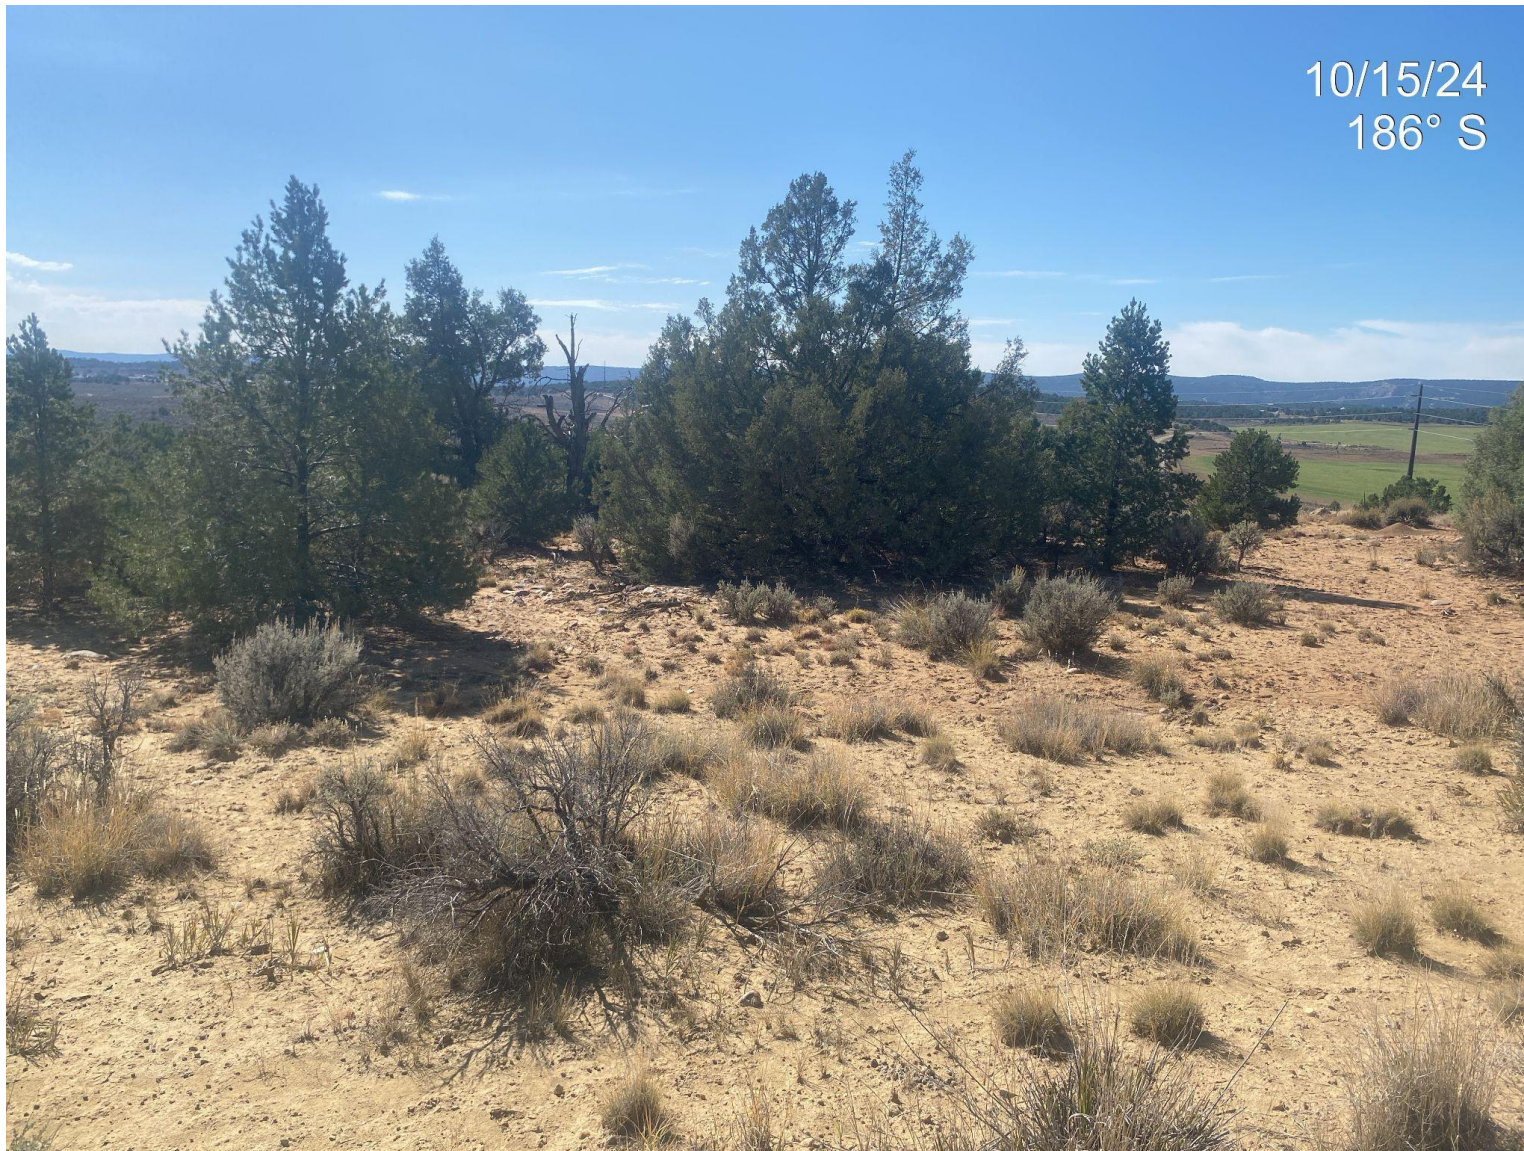
Photo 4. Reference area composed of Intermediate Wheatgrass, Sagebrush and Juniper.
