Inspection Photos

Operator: Simcoe LLC - 10749

Location ID: 306800

Inspection Photos
Location Name: Southern Ute N2
Location ID: 306800

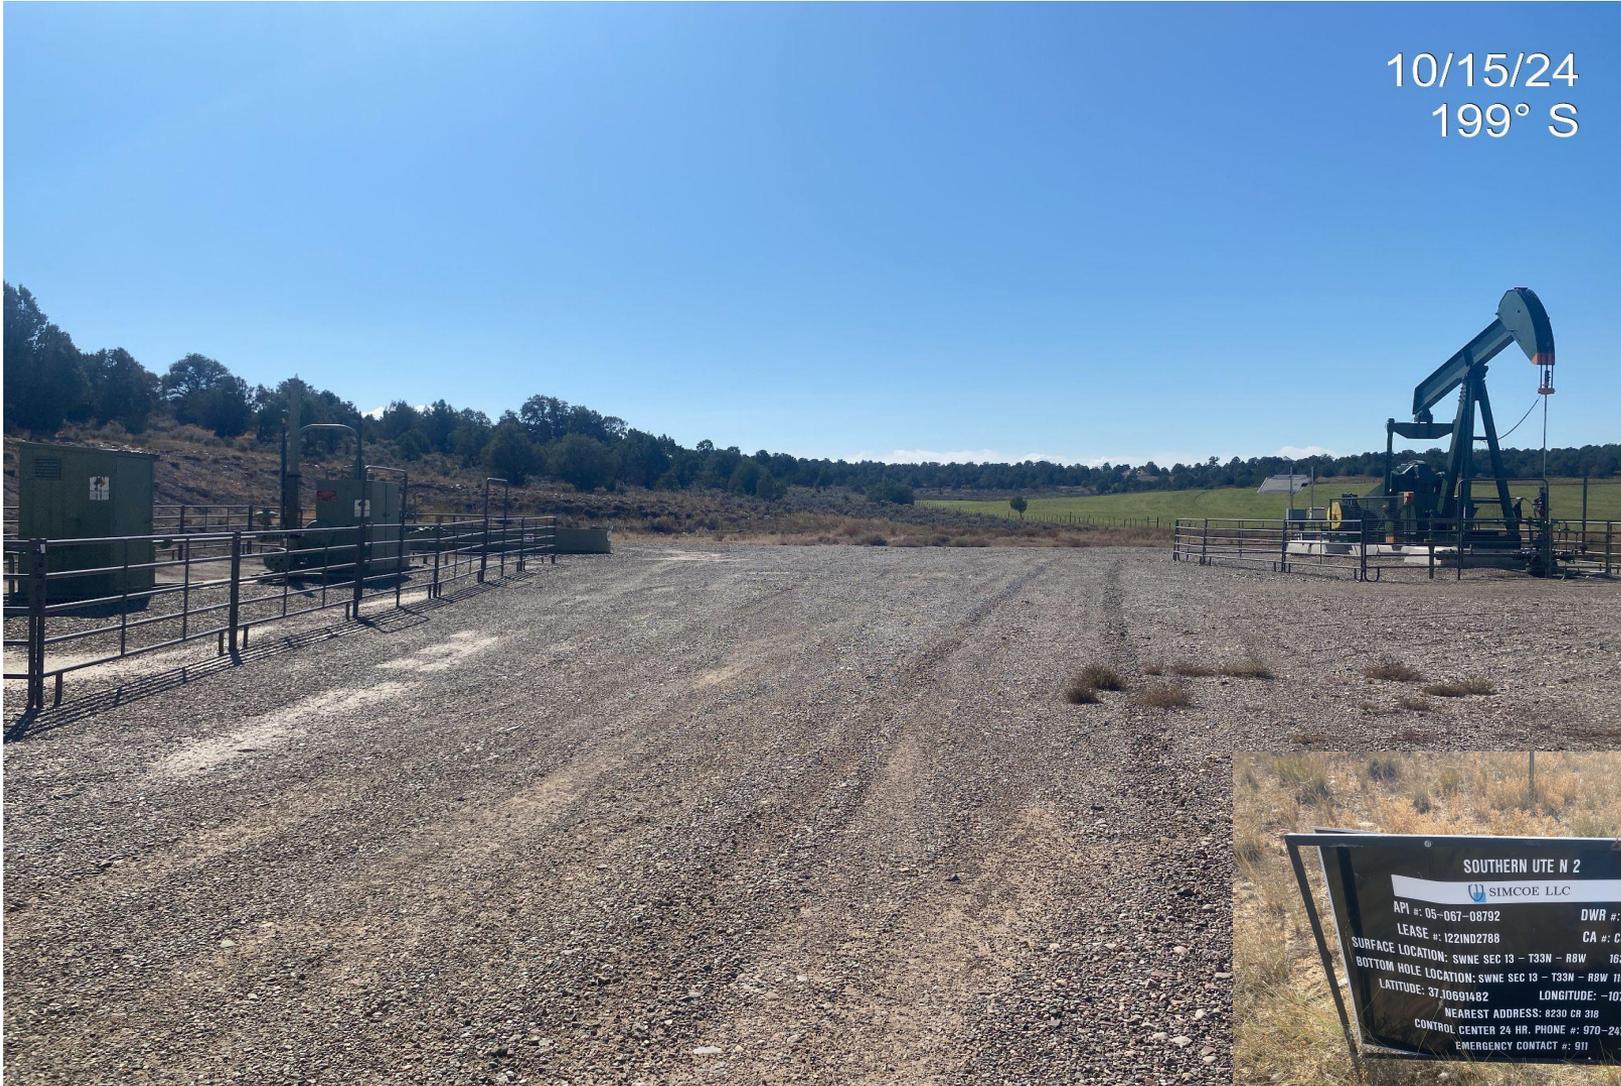
Photo 1. View of the well pad taken from the access point facing center.

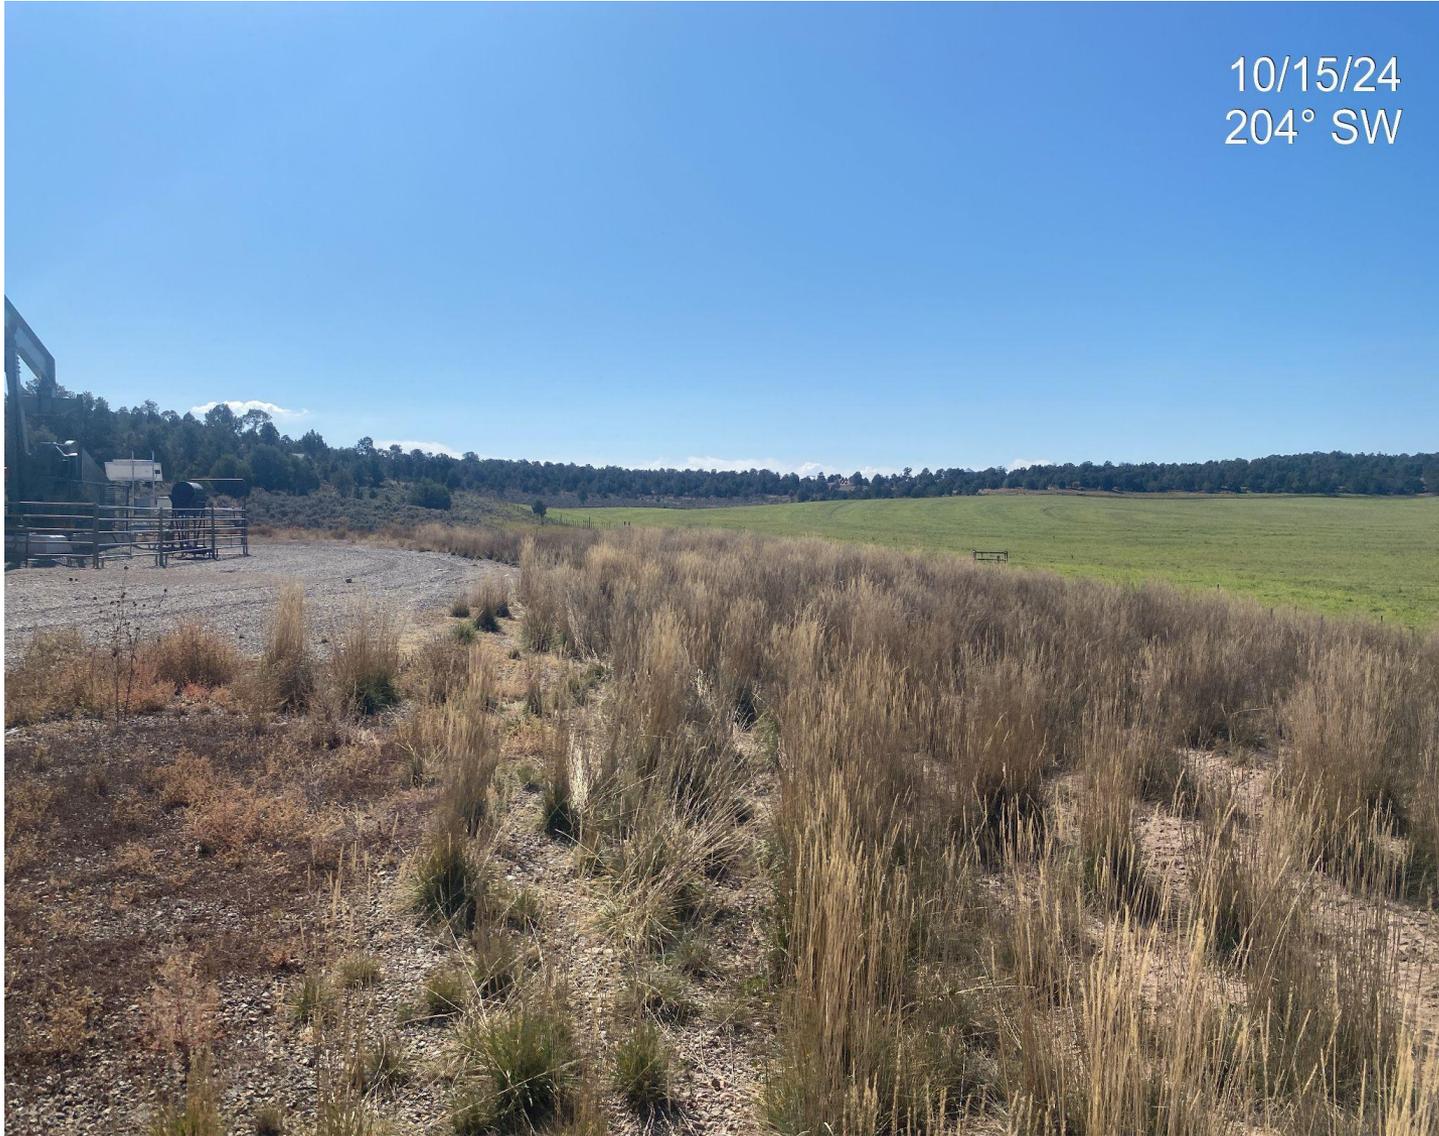
Photo 2. View of the western interim reclamation composed predominantly of Intermediate Wheatgrass.

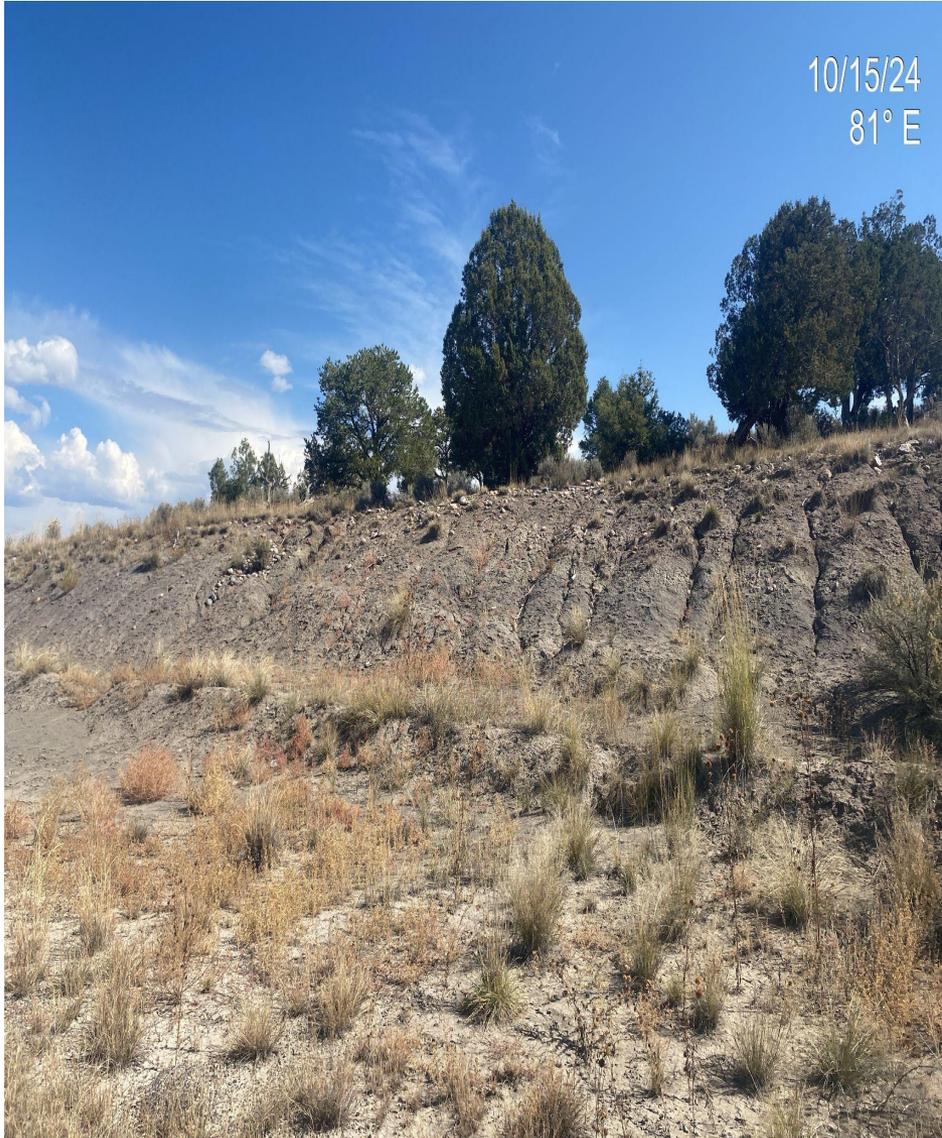
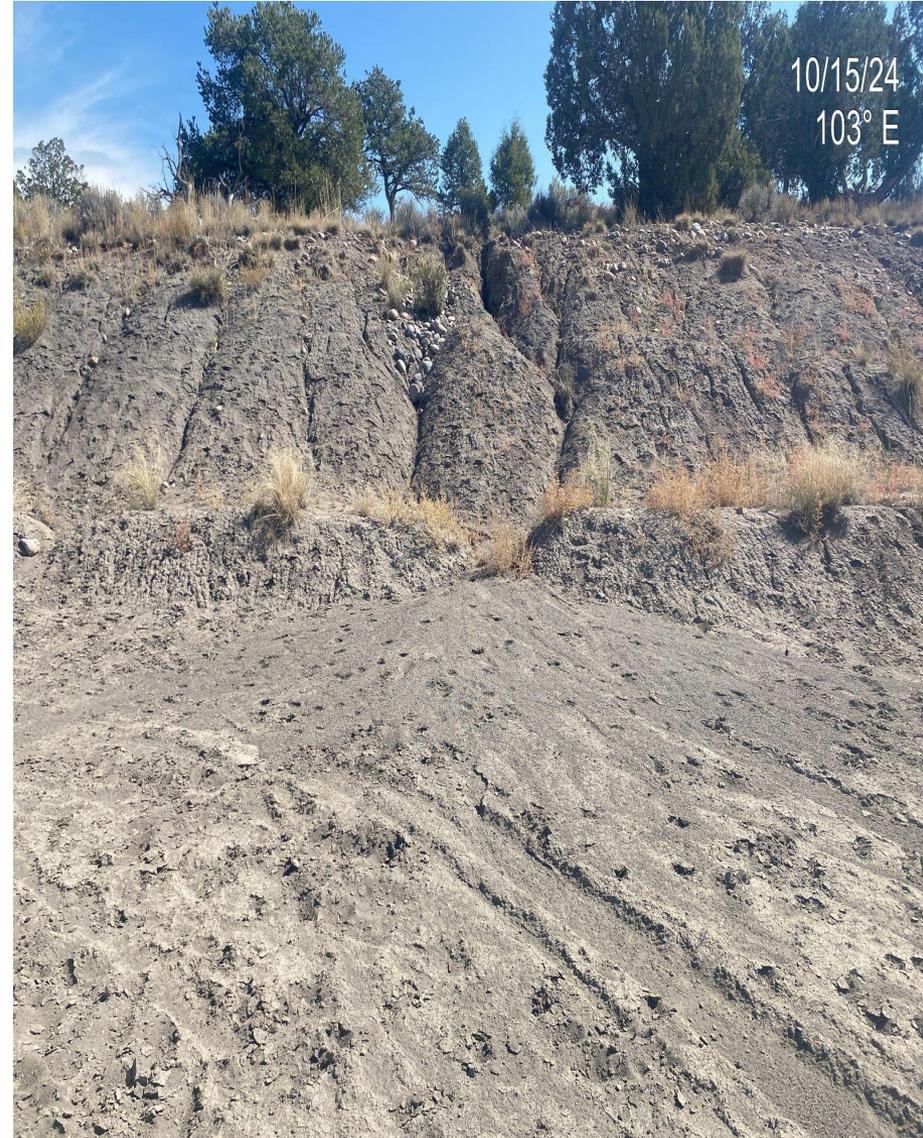
Photo 3. View of the eastern interim reclamation/cut slope. Area is lacking vegetation with evidence of gully erosion and sediment transport/deposition on the active pad.

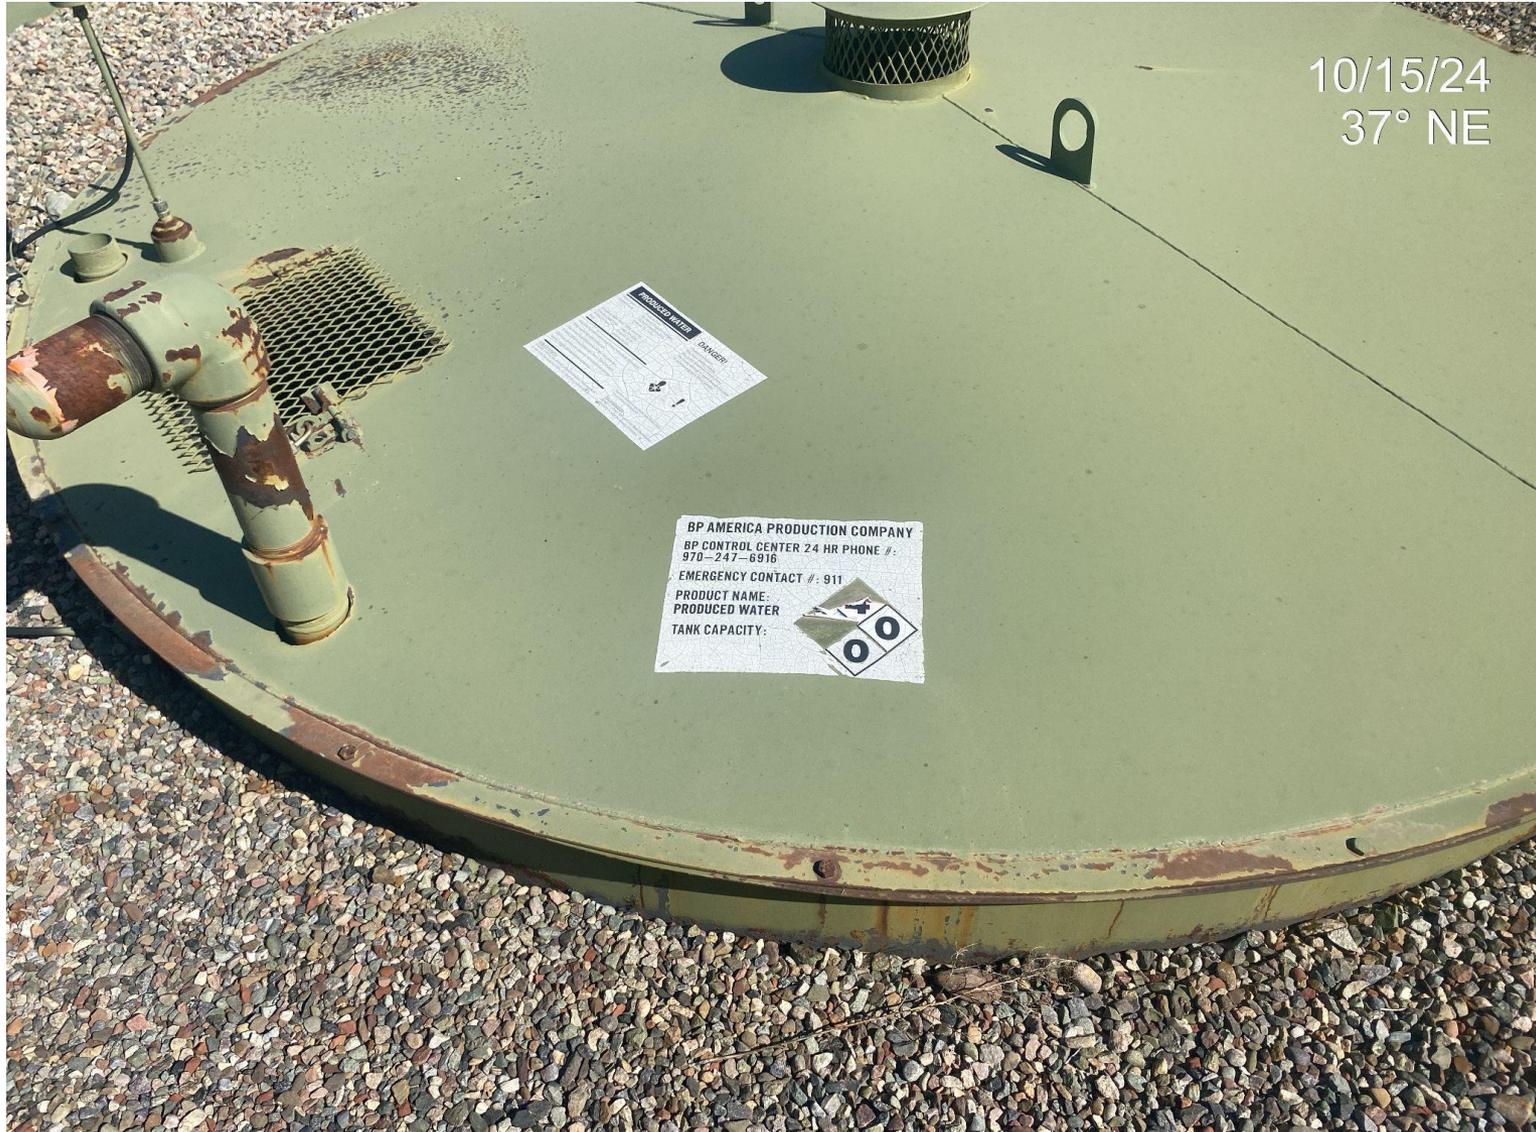
Photo 4. View of produced water tank label that is deteriorating and no longer displaying tank capacity.

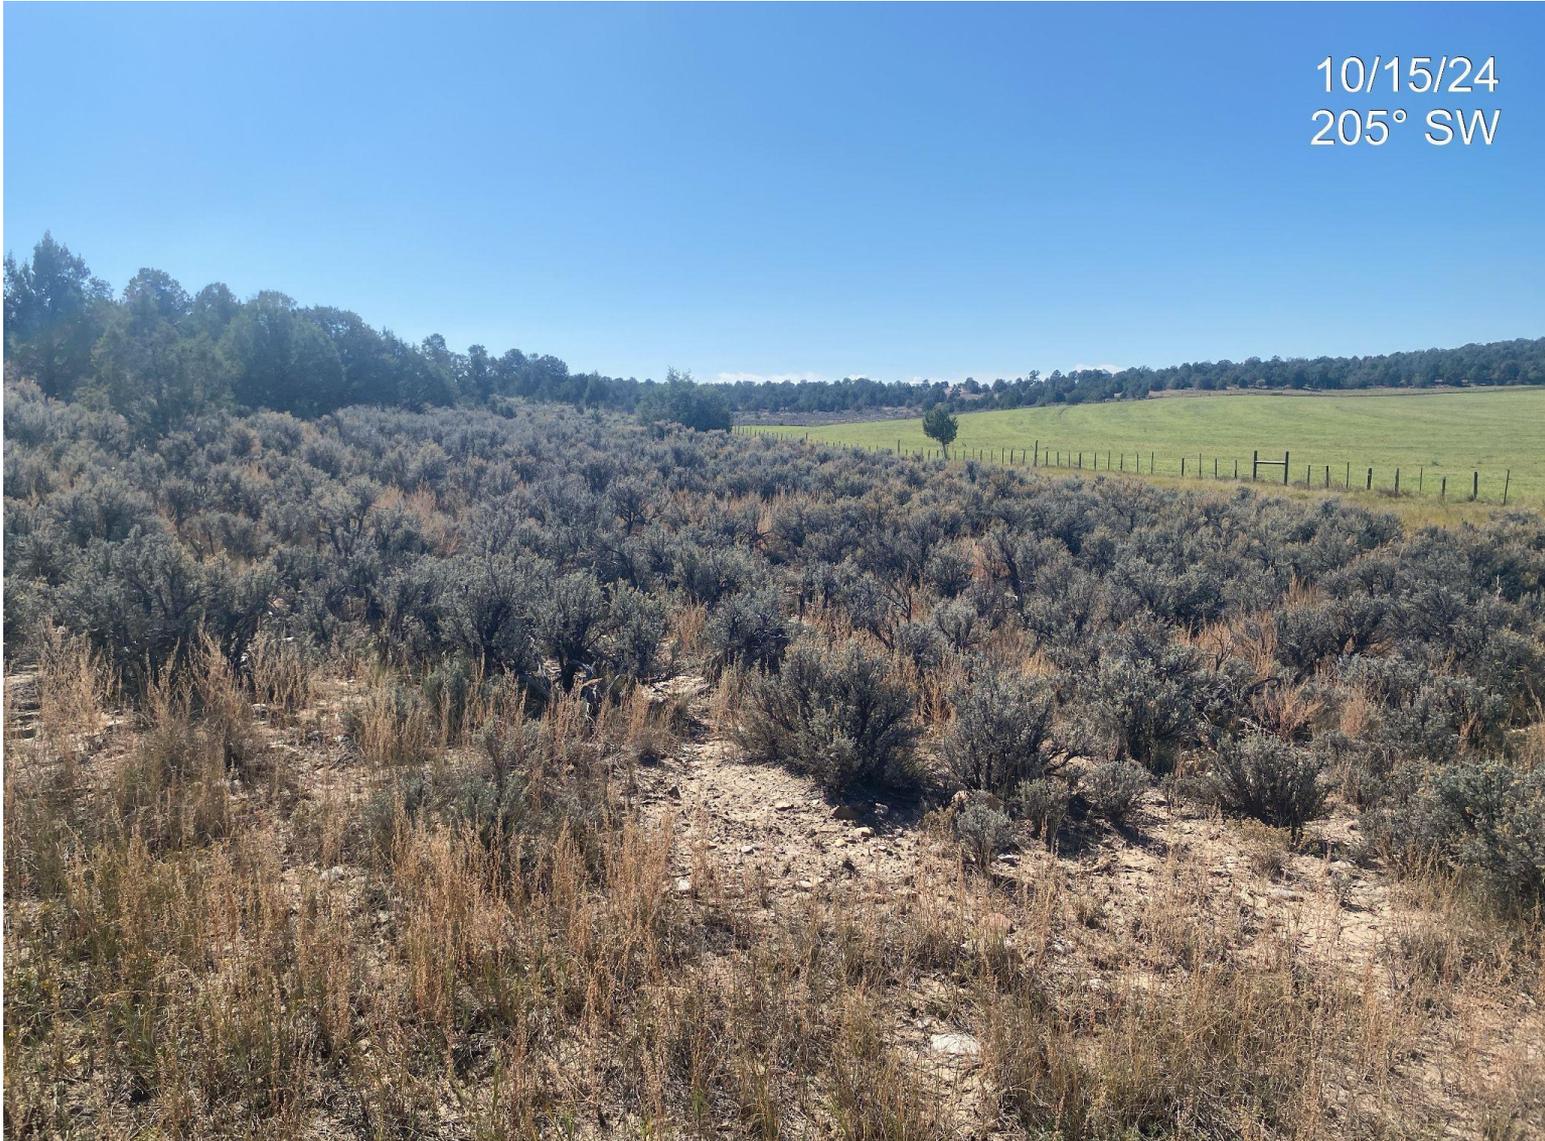
Photo 4. Reference area composed of Sagebrush and Smooth Brome.
