Construction and Stormwater Inspection

Operator: EXTRACTION OIL & GAS INC - 10459

Location ID: 449925

Inspection Document #: 708201708

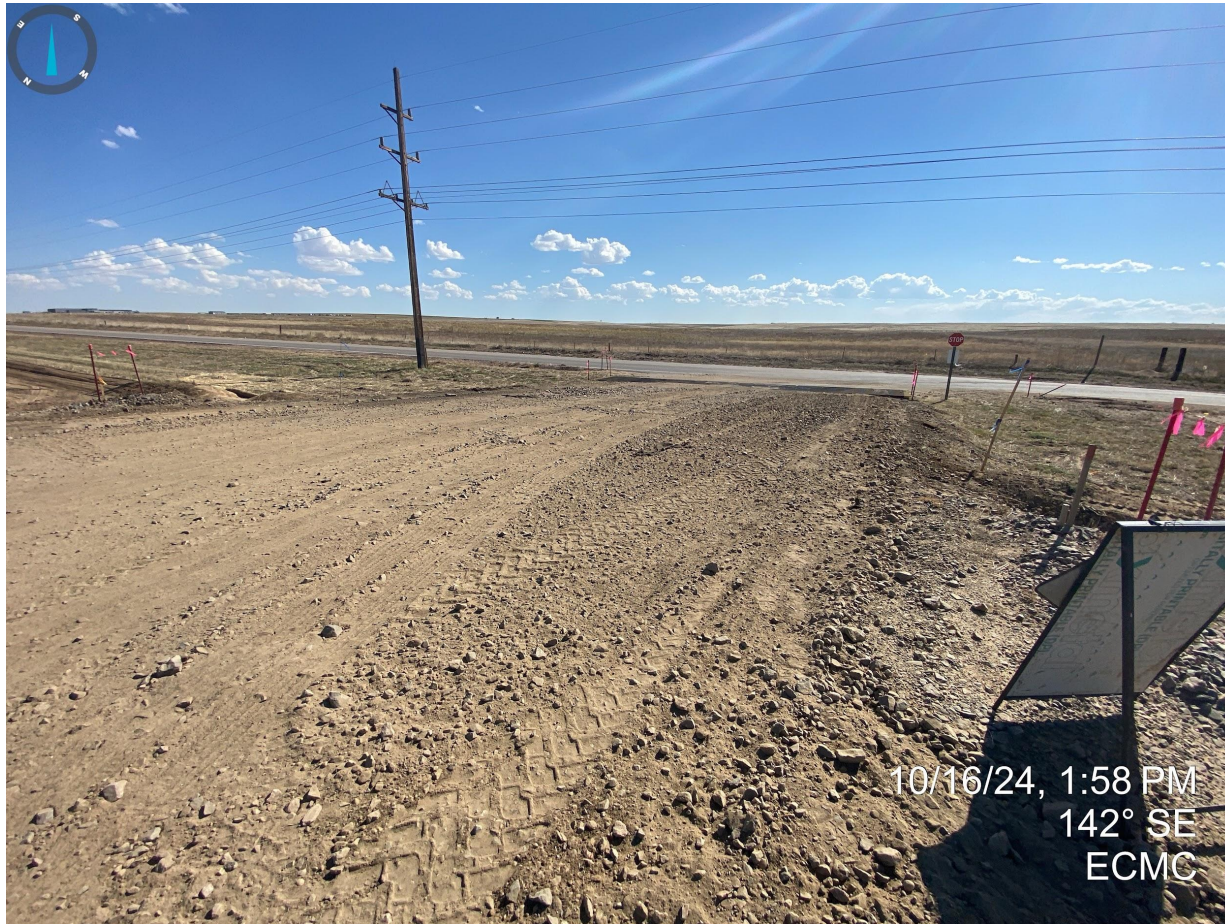
Photo 2. Vehicle track out pad at the location entrance requires maintenance.

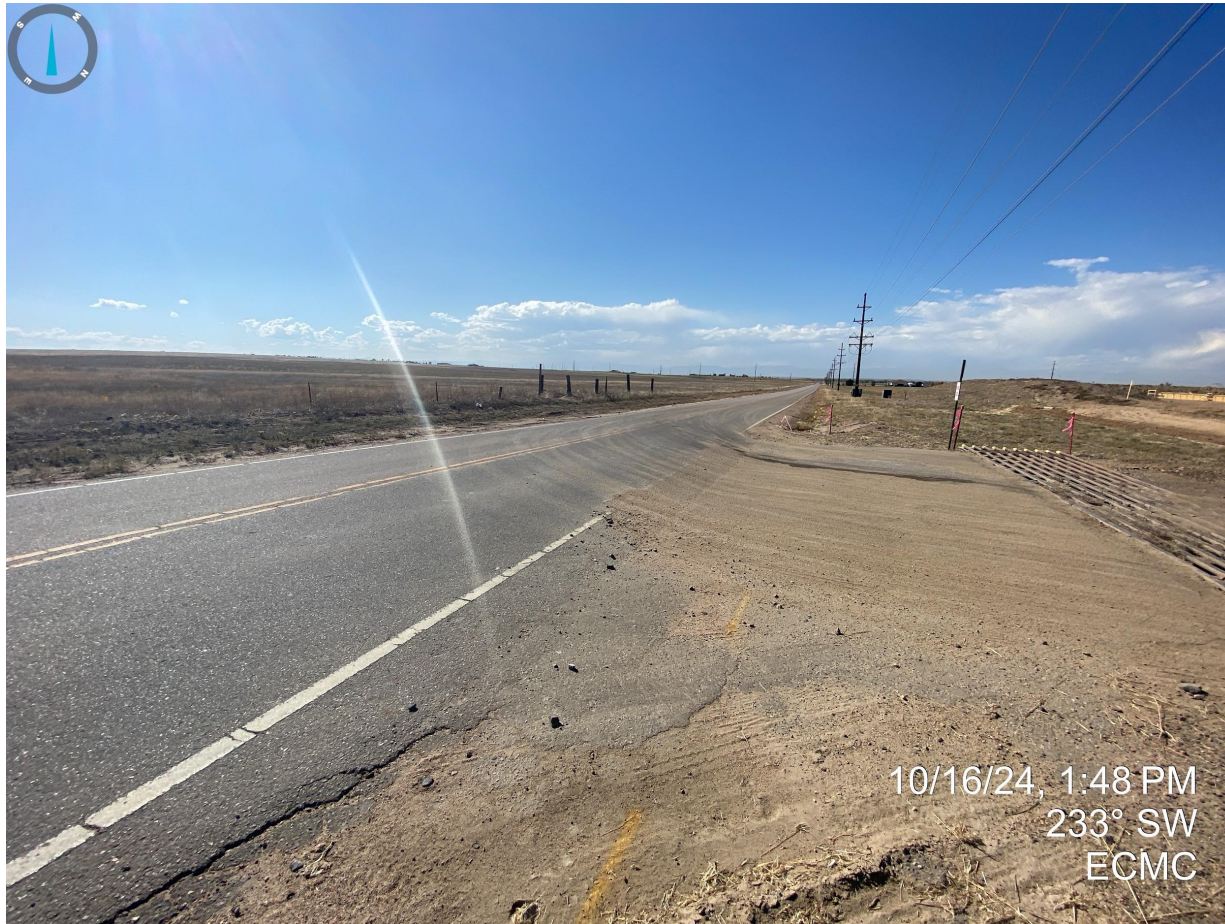
Photo 3. Sediment is beginning to collect at the location entrance and transferring onto the adjacent roadway. Additional BMPs/maintenance is required.

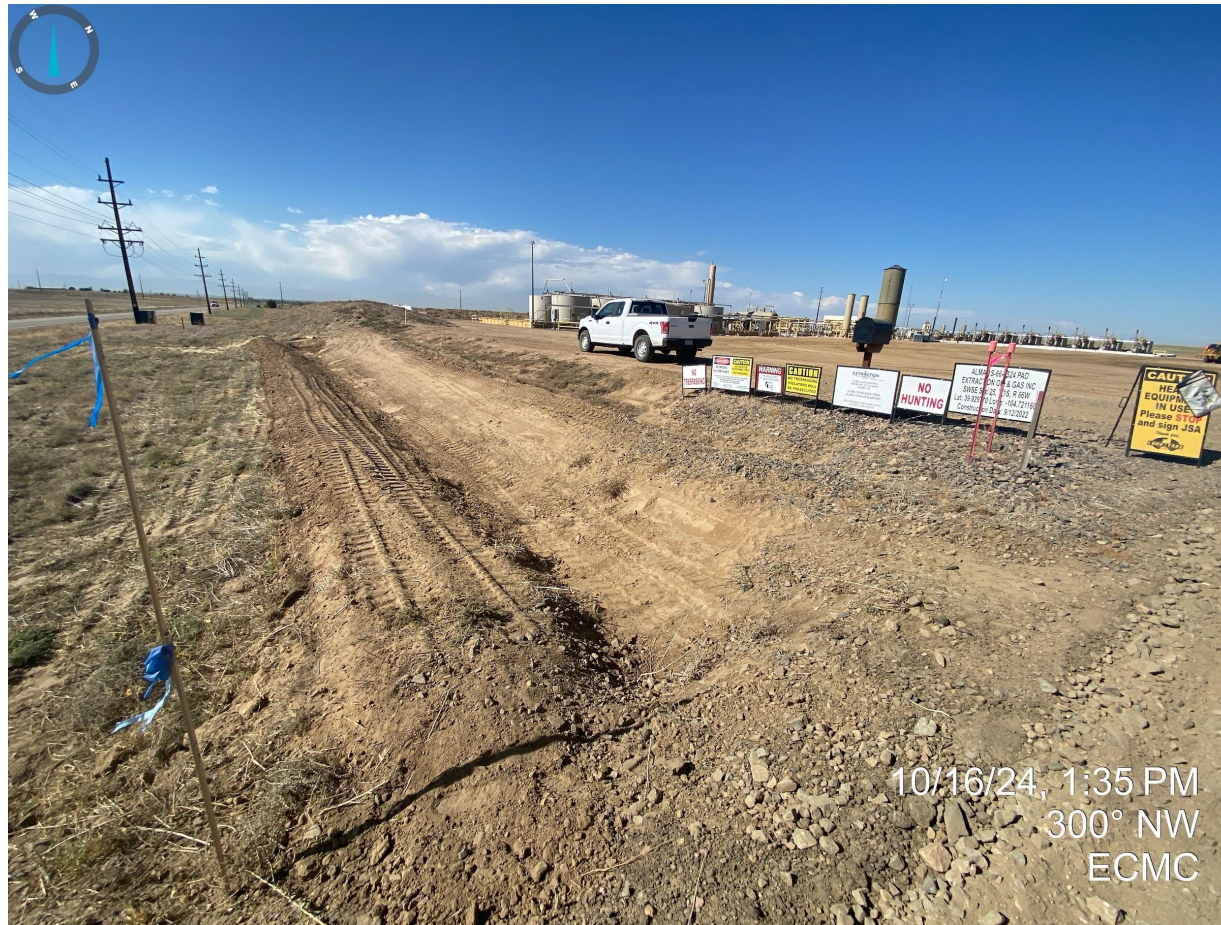
Photo 4. Sediment trap located near the southern portion of the drilling pad, west of entrance.

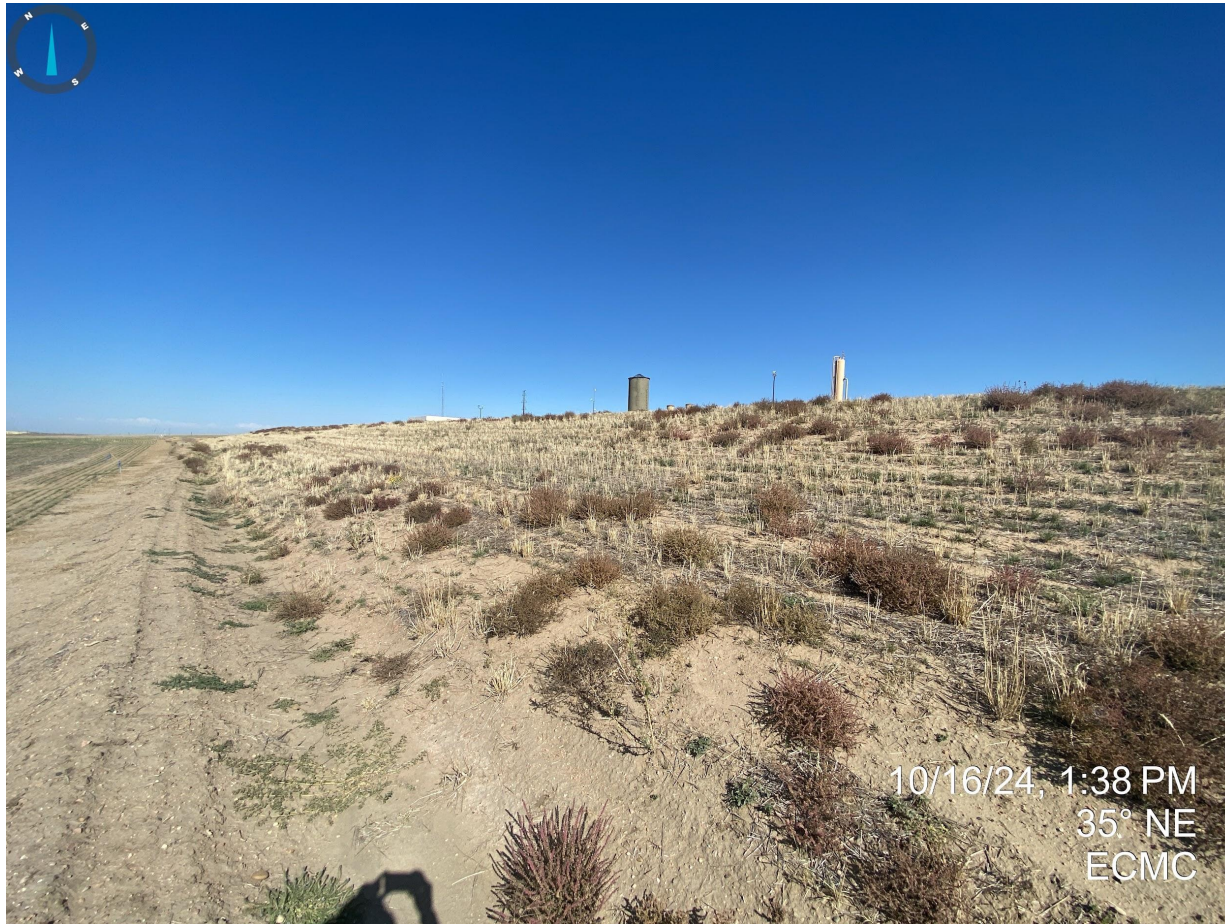
Photo 5. Undesirable vegetation was observed on the western (existing) topsoil stockpile.

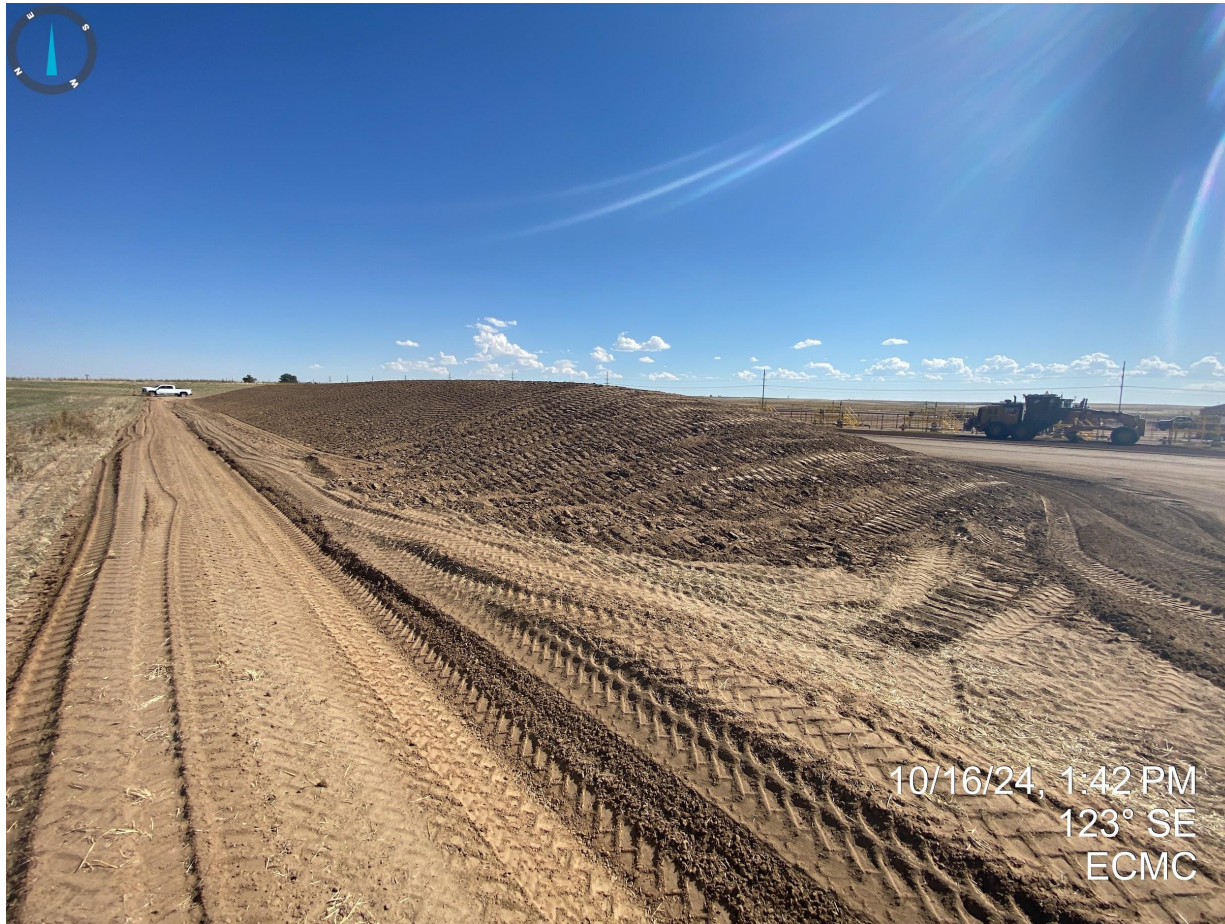
Photo 6. Ditch and berm has been constructed around the perimeter of the location.

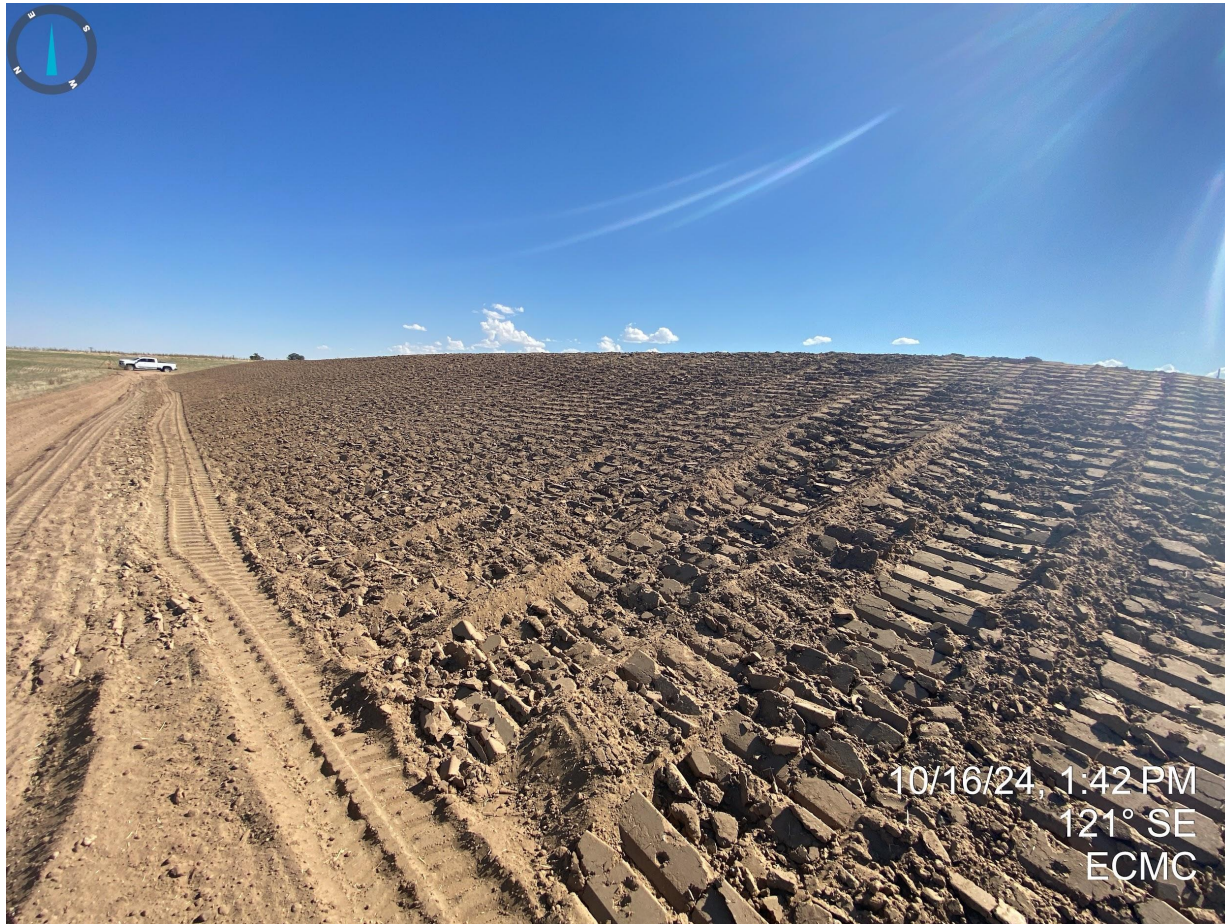
Photo 7. Appears that topsoil has been salvaged from the eastern interim areas as part of a drilling pad expansion. The topsoil stockpile appears to have been equipment tracked for short term stabilization.

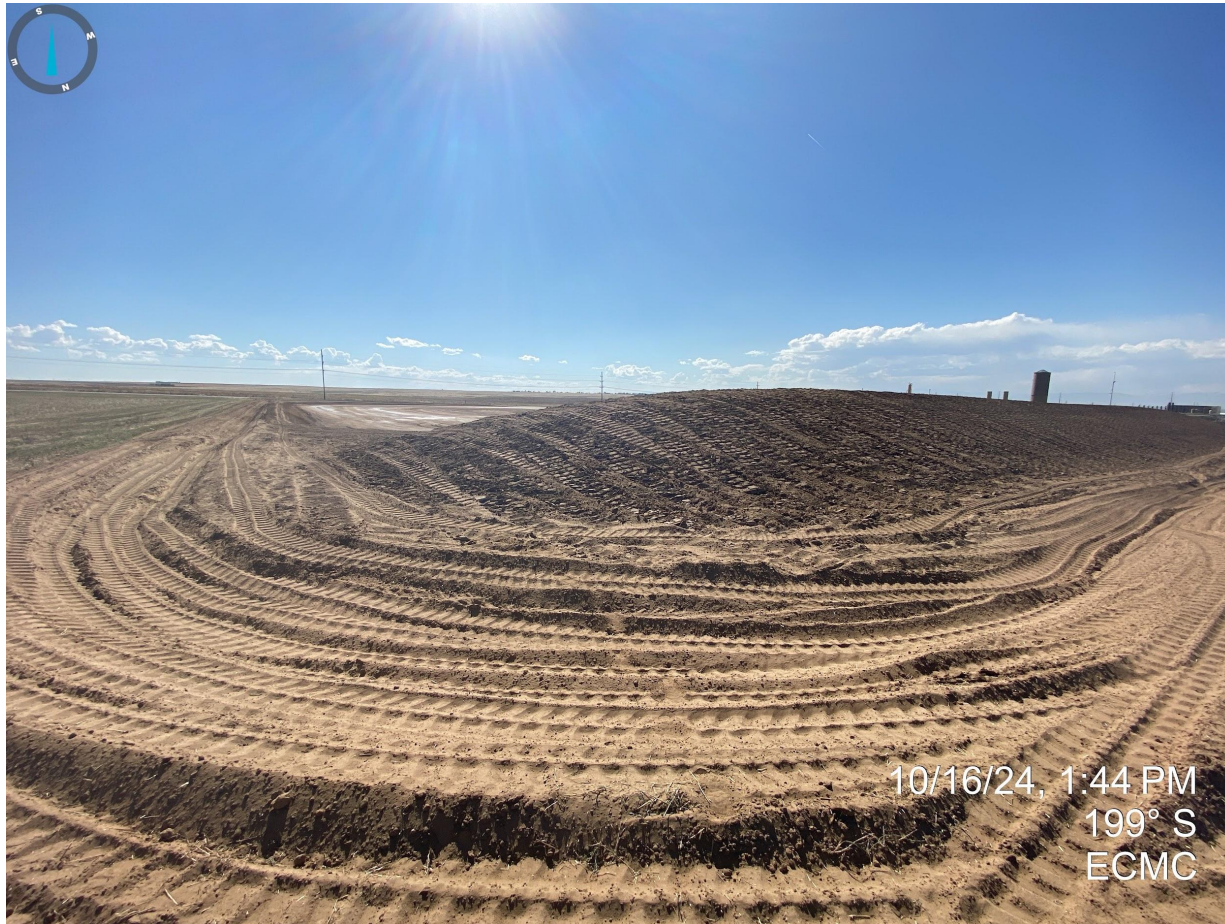
Photo 8. Continued from Photo 7; perimeter stormwater BMPs and topsoil stockpile pictured.

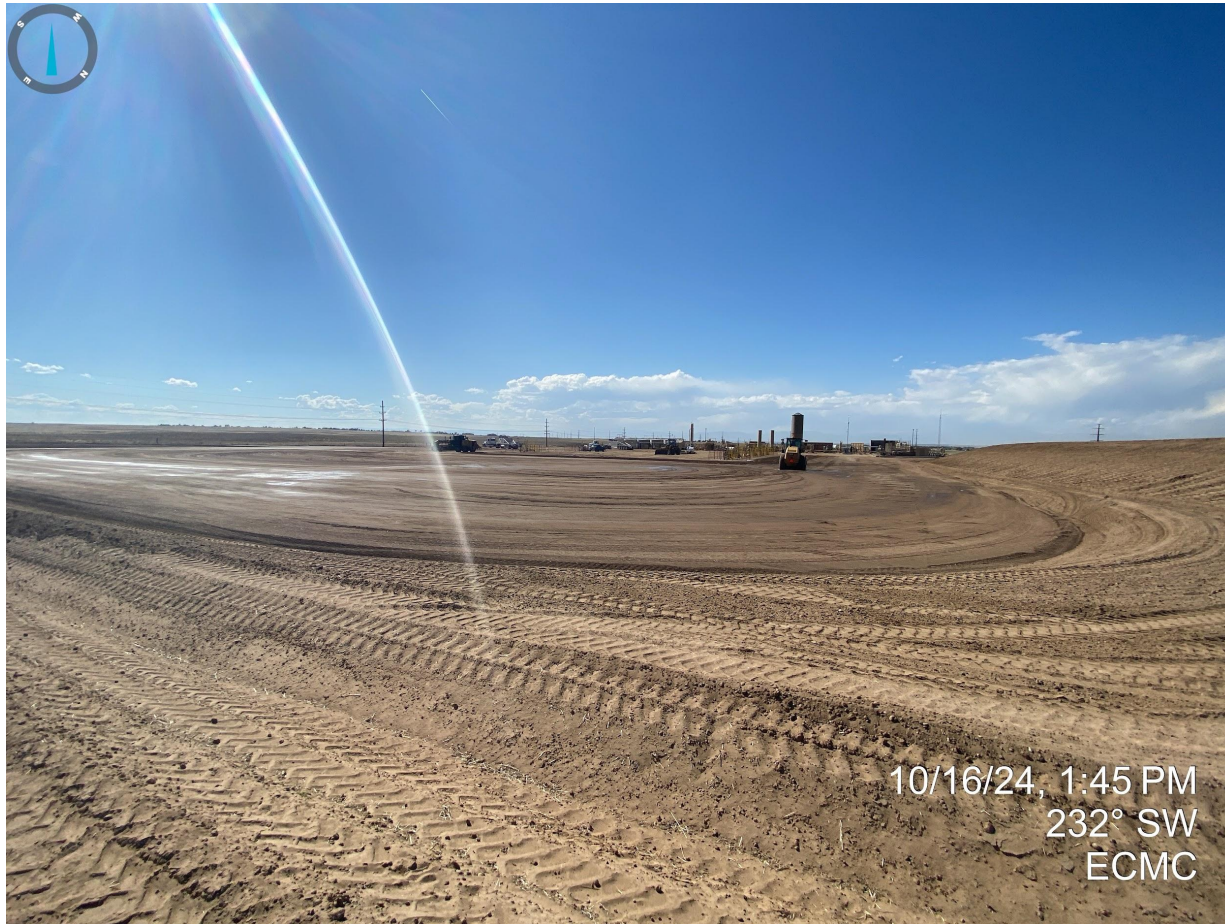
Photo 9. Overview of drilling pad expansion on the eastern portion of the location.

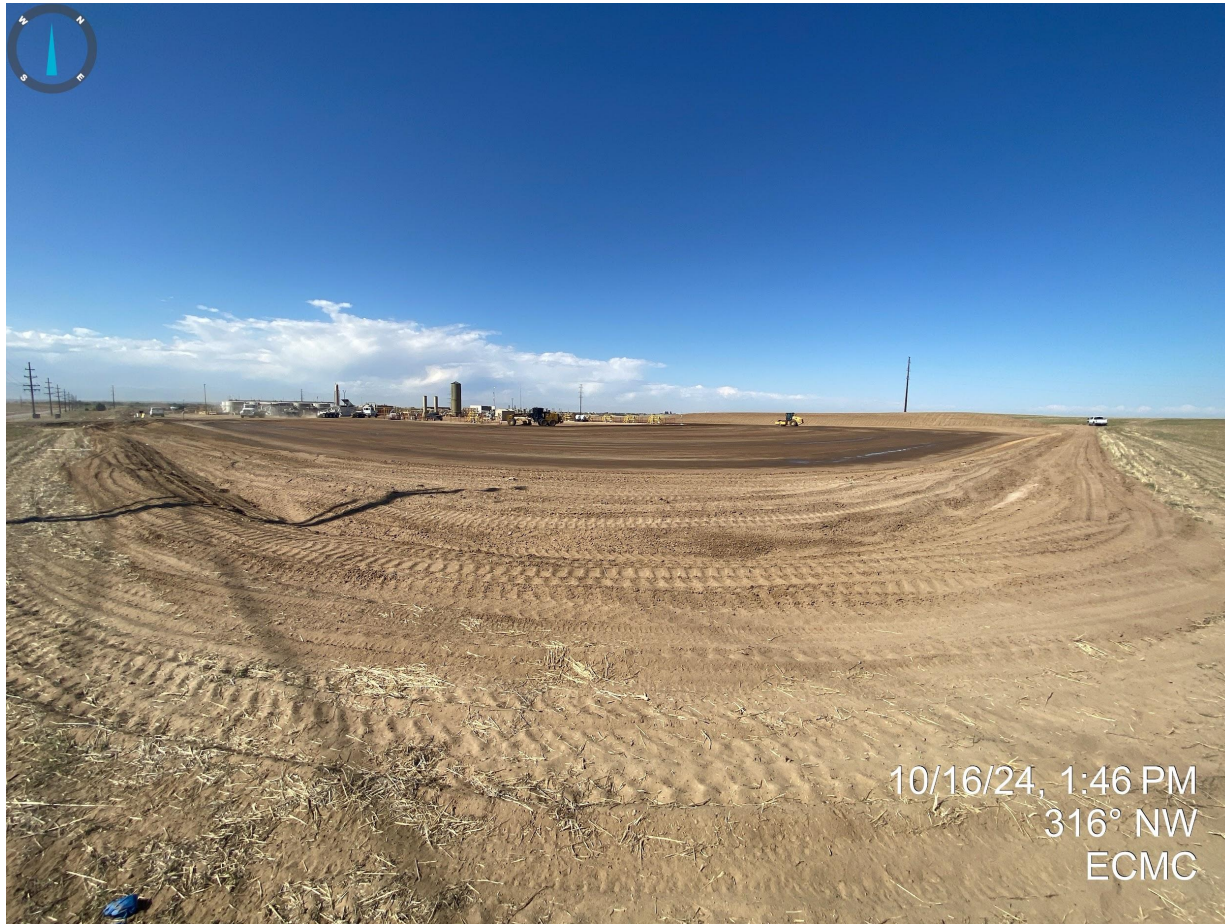
Photo 10. Taken from the southeast corner of the location. Photo illustrates perimeter ditch and berm constructed.

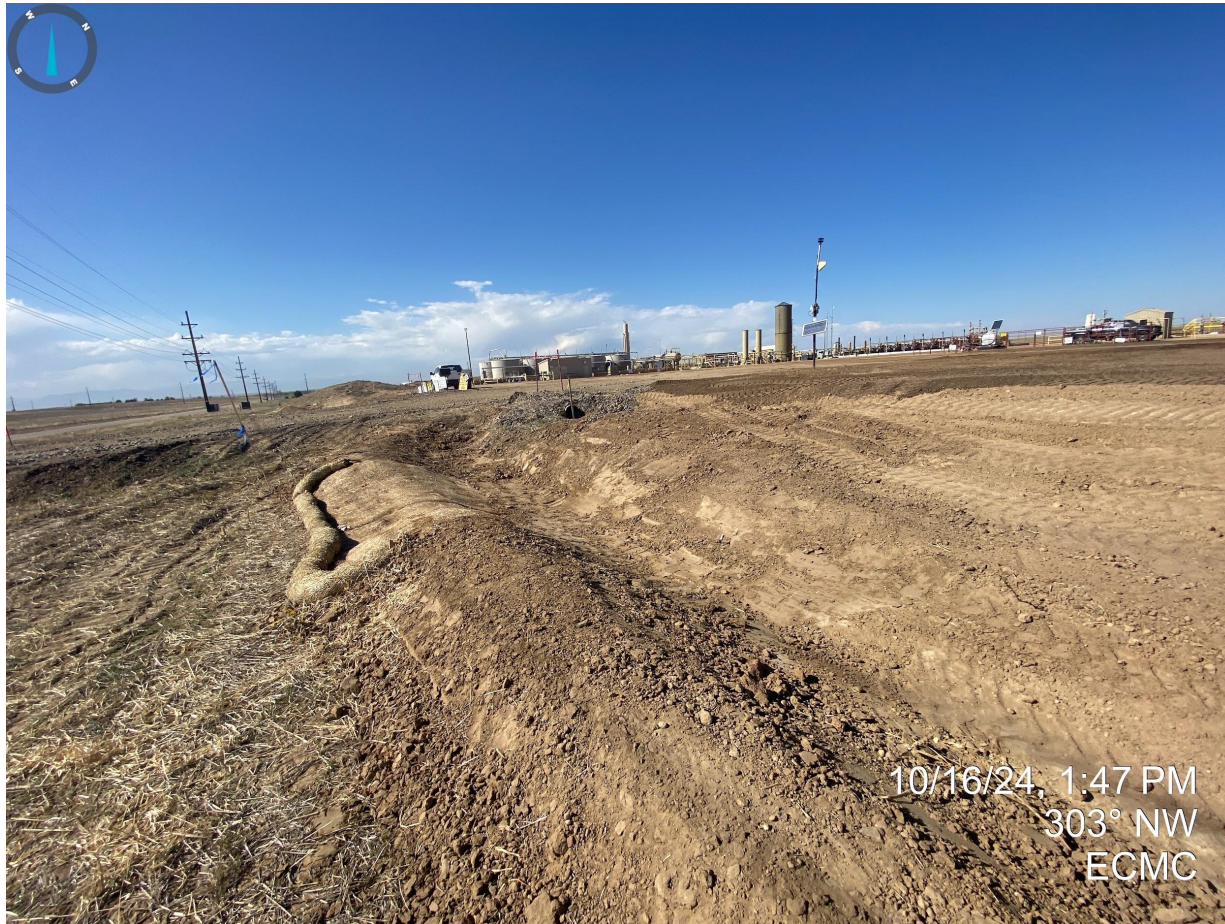
Photo 11. Sediment trap located near the southern portion of the drilling pad, east of entrance.
