## Inspection Photos

Location Name: TEP ROCKY MOUNTAIN LLC, KNIGHT-67S95W/3NWNW

Location ID: 334598

Date: 10/15/2024

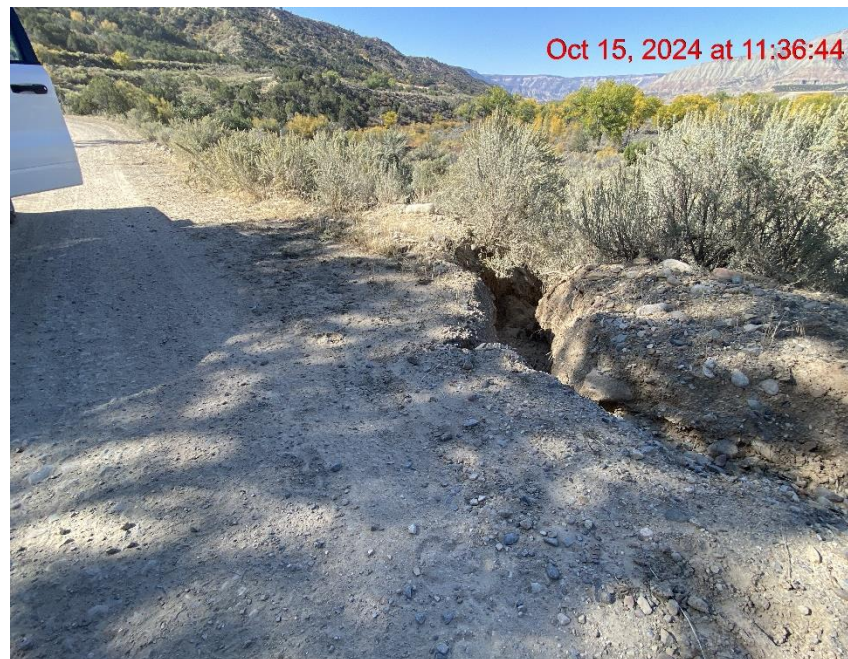
**Insufficient Erosion Control – Photo #04234**

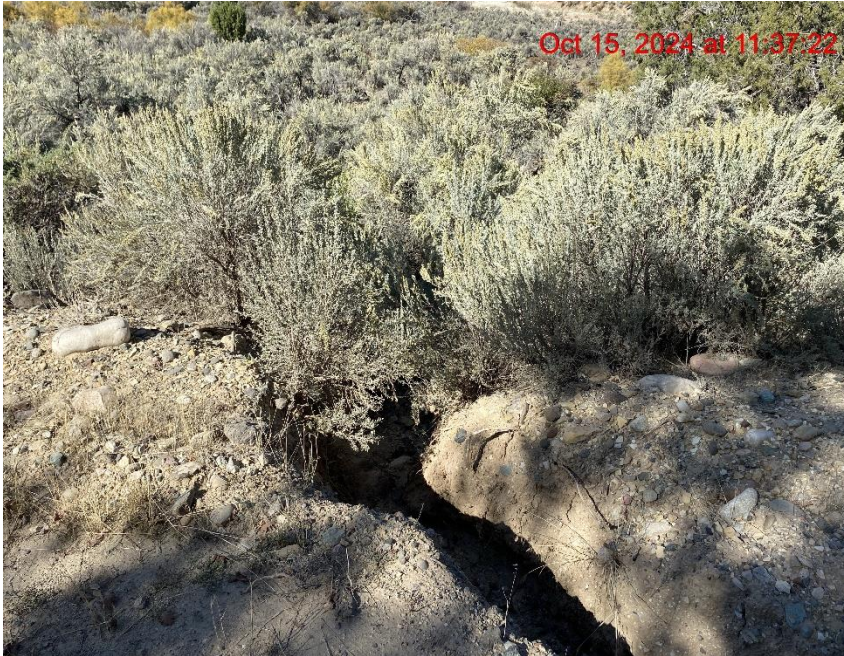
**Insufficient Erosion Control/Sediment Transport from Lease Road – Photo #04236**

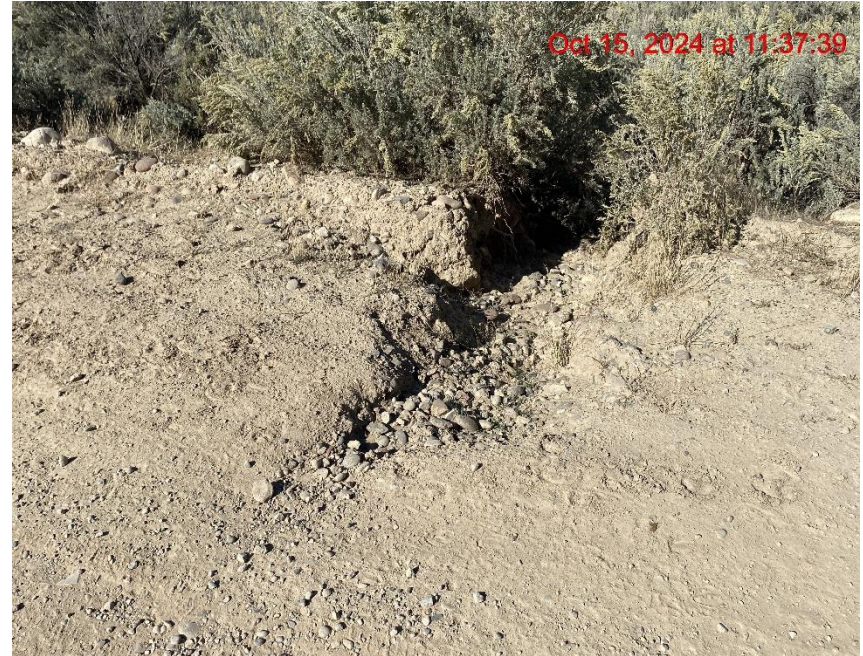
**Insufficient Erosion Control/Sediment Transport from Lease Road – Photo #04237**

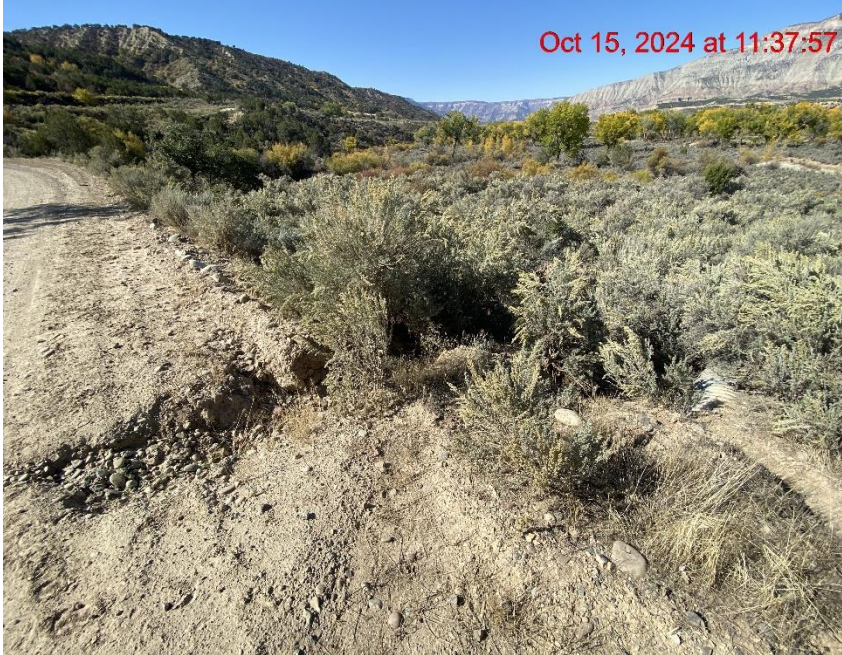
**Insufficient Erosion Control/Sediment Transport from Lease  
Road – Photo #04238**
