Inspection Photos

Location Name: TEP Rocky Mountain LLC Duggan RWF 14-29 Pad

Location ID: 429828

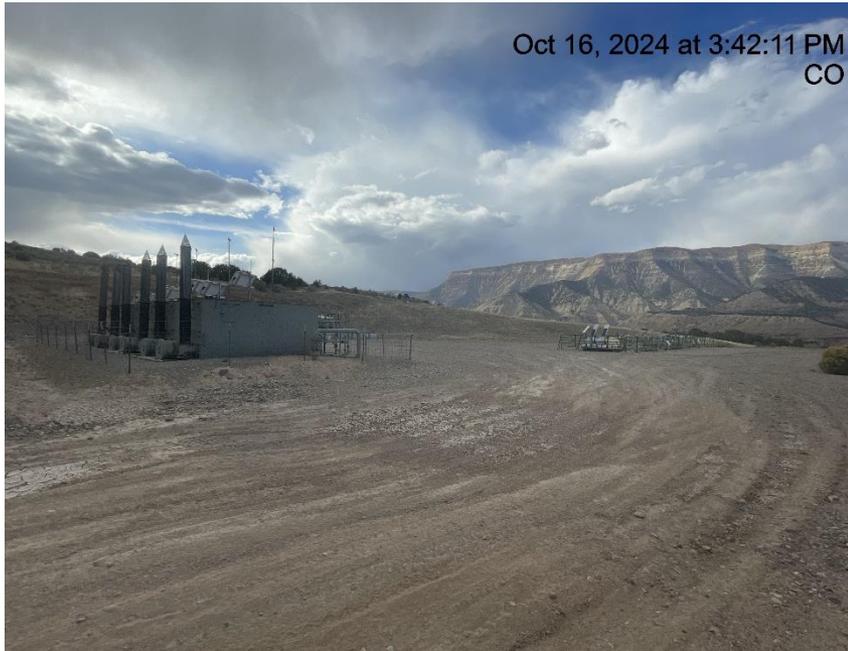
Photo # 6398 From entrance to location

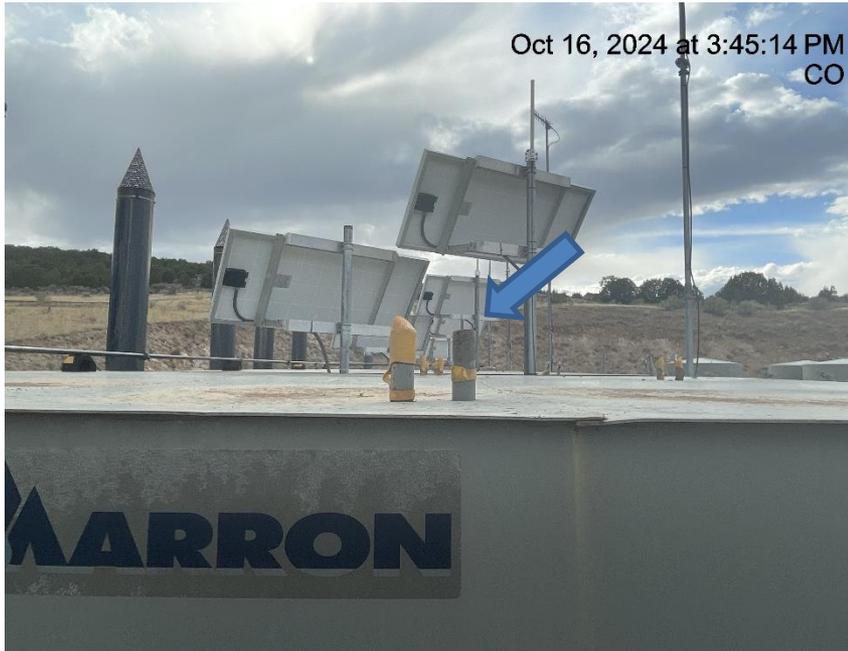
Photo # 6406 Rupture disc vent line does not comply with CECMC pressure safety device rules

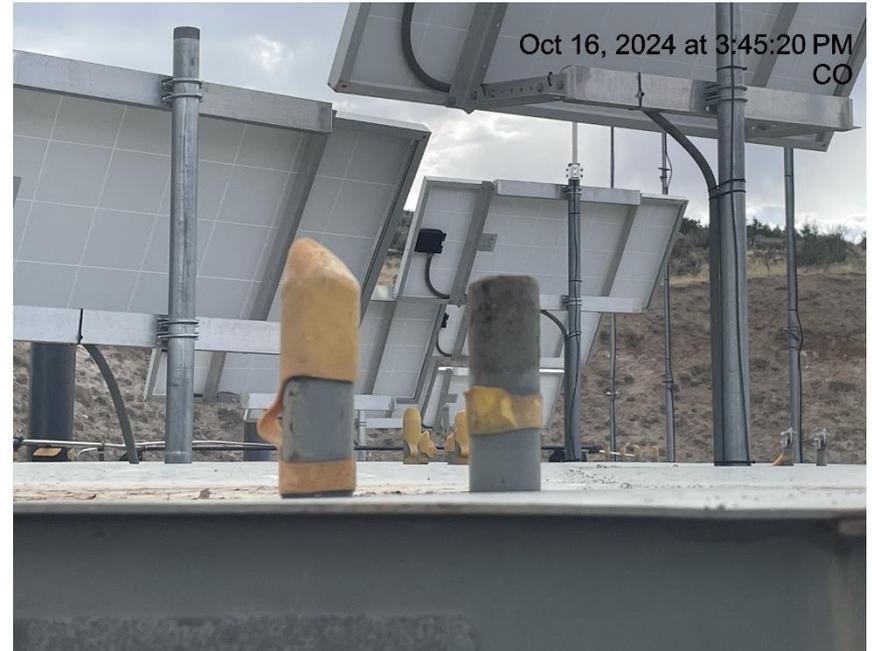
Photo # 6407 Rupture disc vent line does not comply with CECMC pressure safety device rules

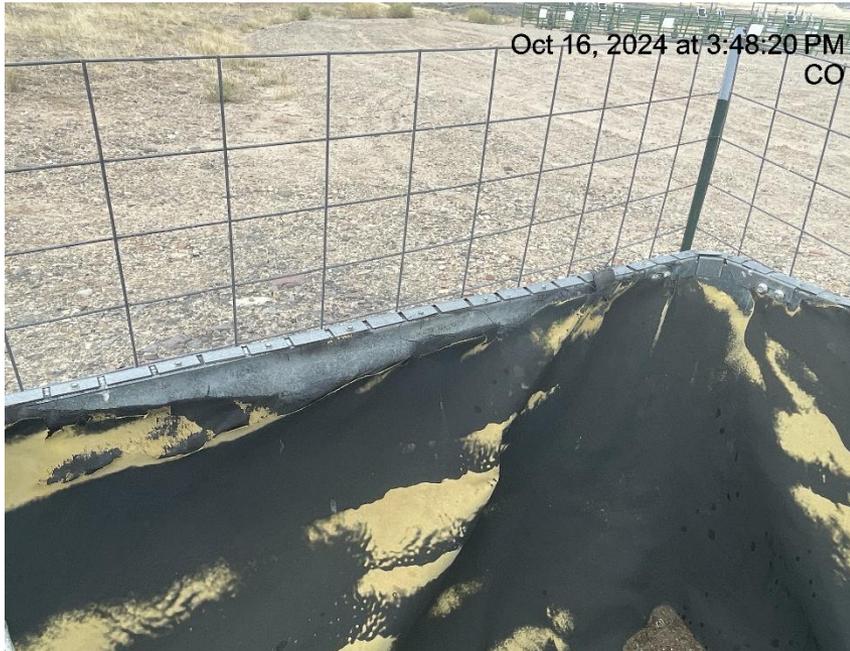
Photo # 6408 Secondary containment liner showing some signs of disrepair

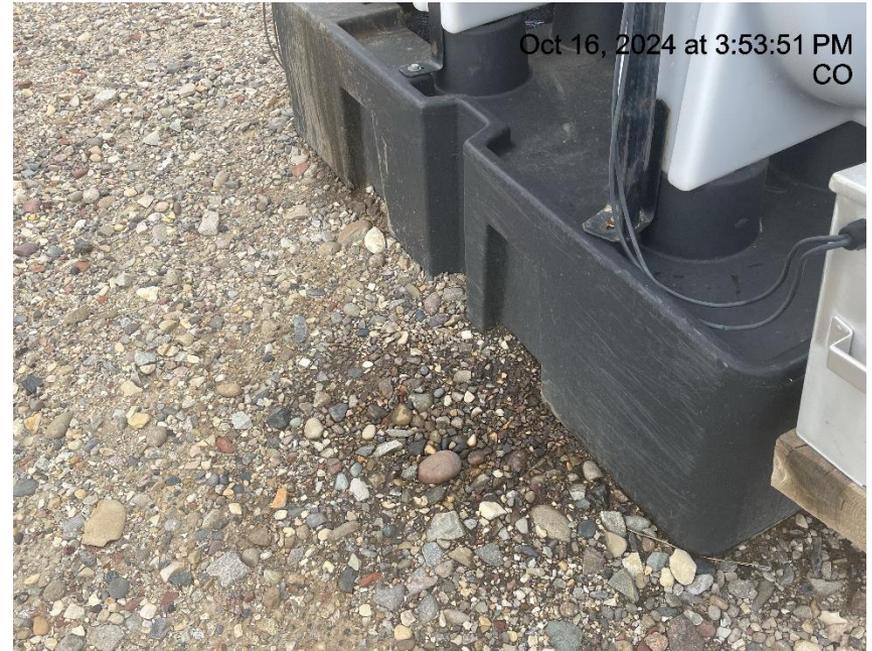
Photo # 6409 Small amount of staining near chemical tank containment
