Final Reclamation and Stormwater Inspection

Date: 10/16/24

Operator: Axis Exploration LLc - 10646

Inspection Photos
Location Name: Qualls 5-13
Location ID: 320193

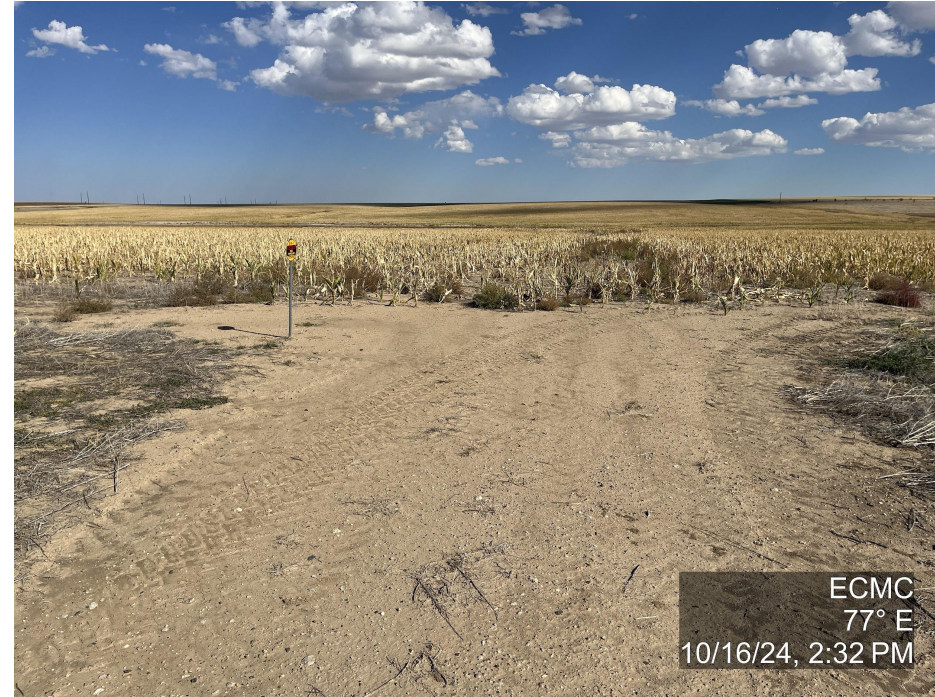
Photo 4. The photo was taken at the tank battery location facing East. The photo illustrates weeds and poor crop growth along the well access road.

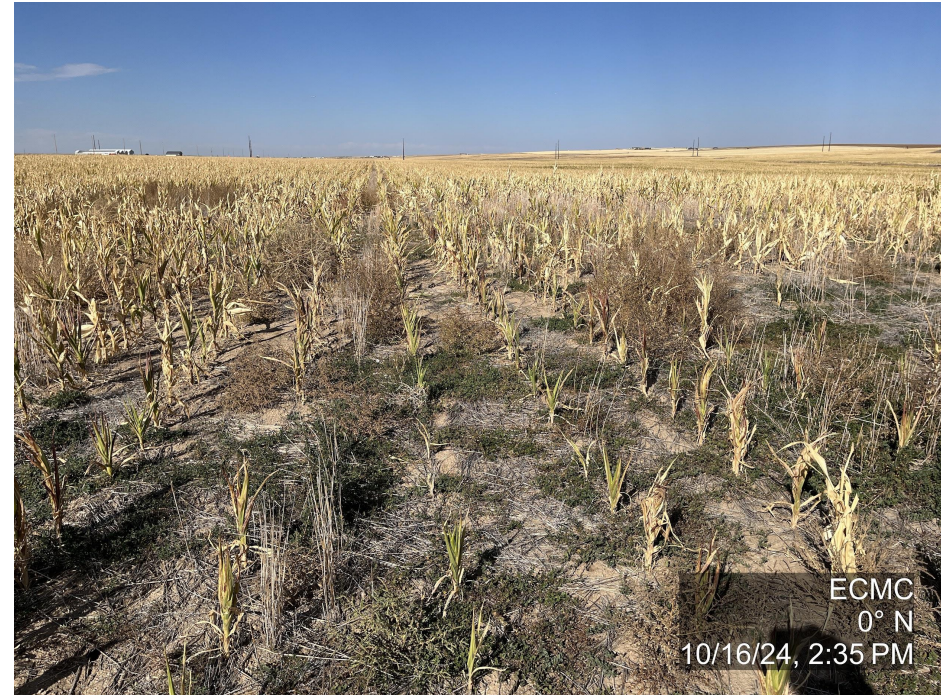
Photo 6. The photo was taken at the well location facing North. The photo illustrates crop vegetation at the well location is not representative of reference crop and is dominated by kochia, cereal rye, field bindweed and bare soil.

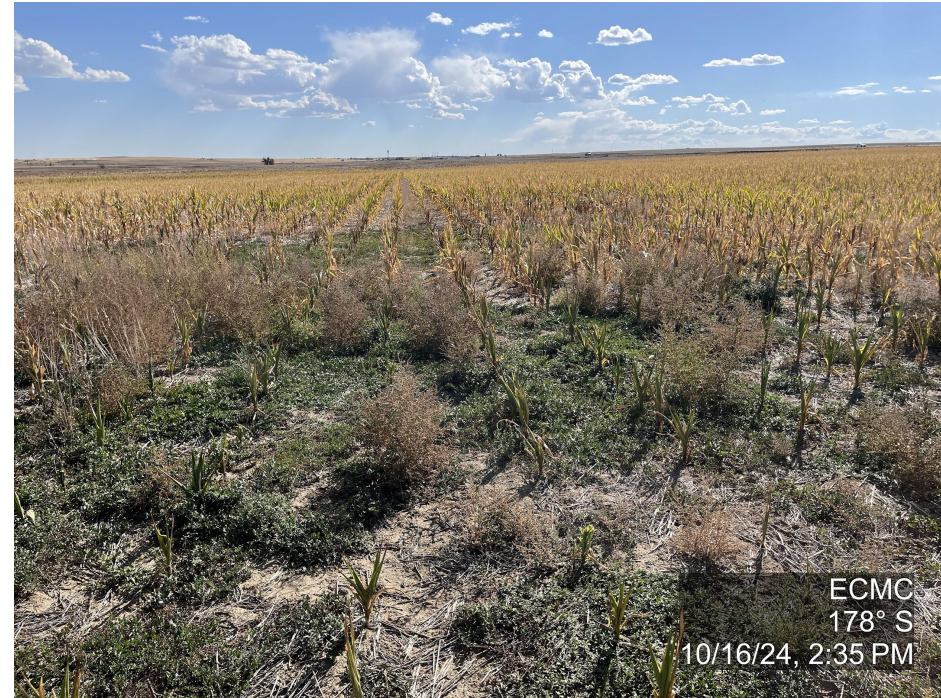
Photo 8. The photo was taken at the well location facing South. Refer to the comment for photo 6.

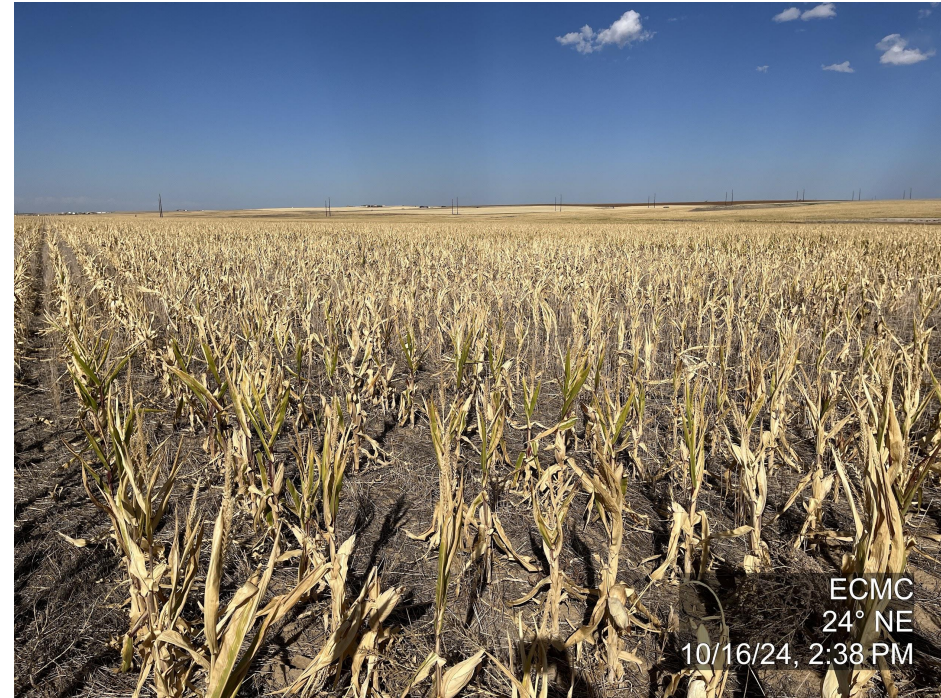
Photo 10. The reference photo was taken near the well location facing Northeast. The photo illustrates the well location is not representative of reference crop.
