Inspection Photos

Location Name: TEP ROCKY MOUNTAIN LLC, GIBSON GULCH UNIT-66S91W/31SEW

Location ID: 334881

Date: 10/17/2024

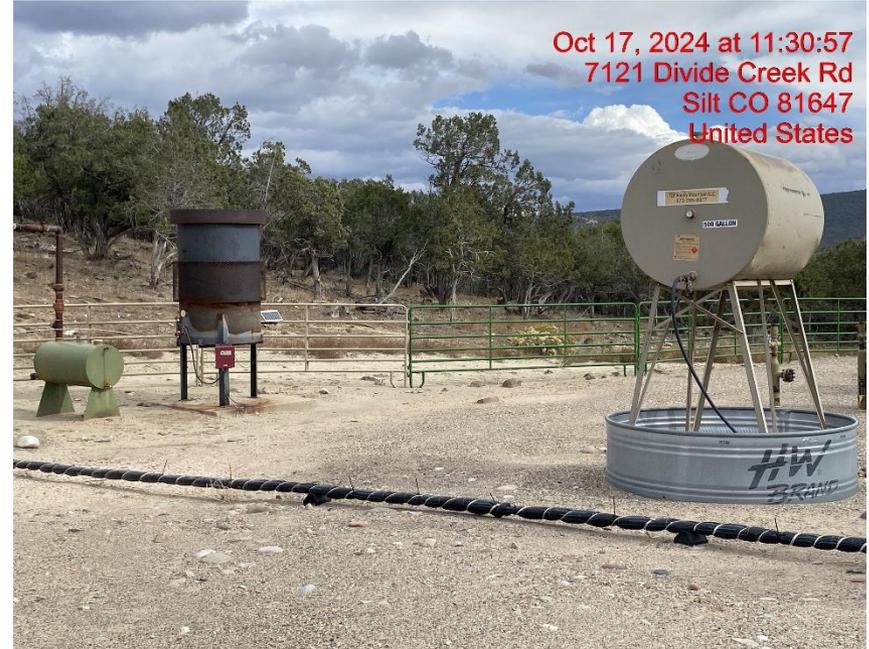
ECD (Not in Use)/Methanol Tank – Photo #04283

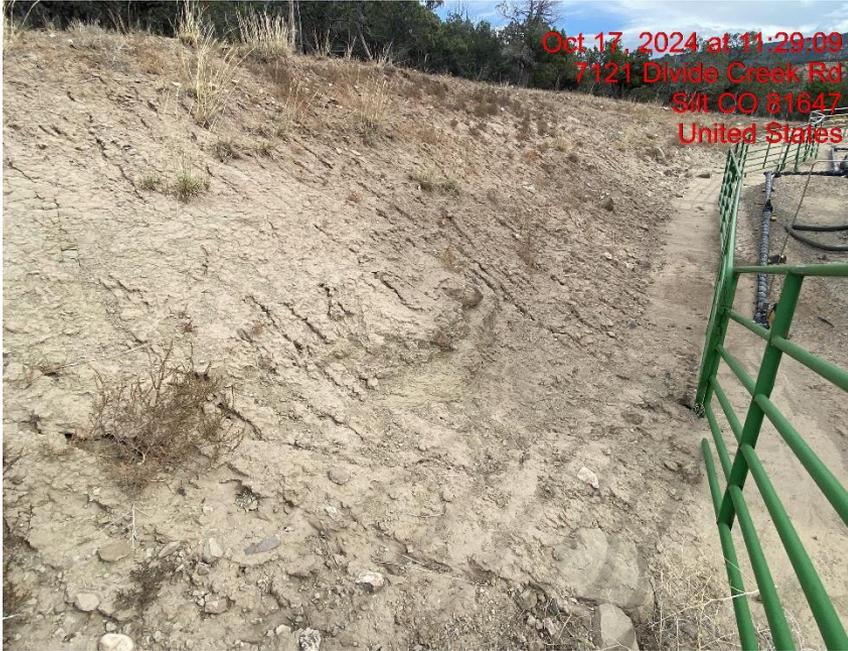
Insufficient Erosion Control – Photo #04276

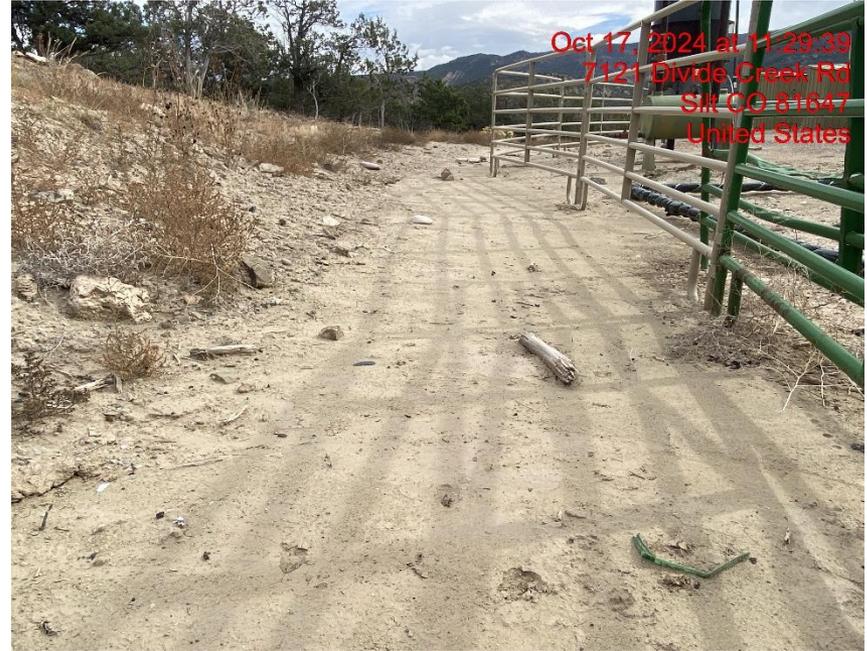
Insufficient Erosion Control – Photo #04278

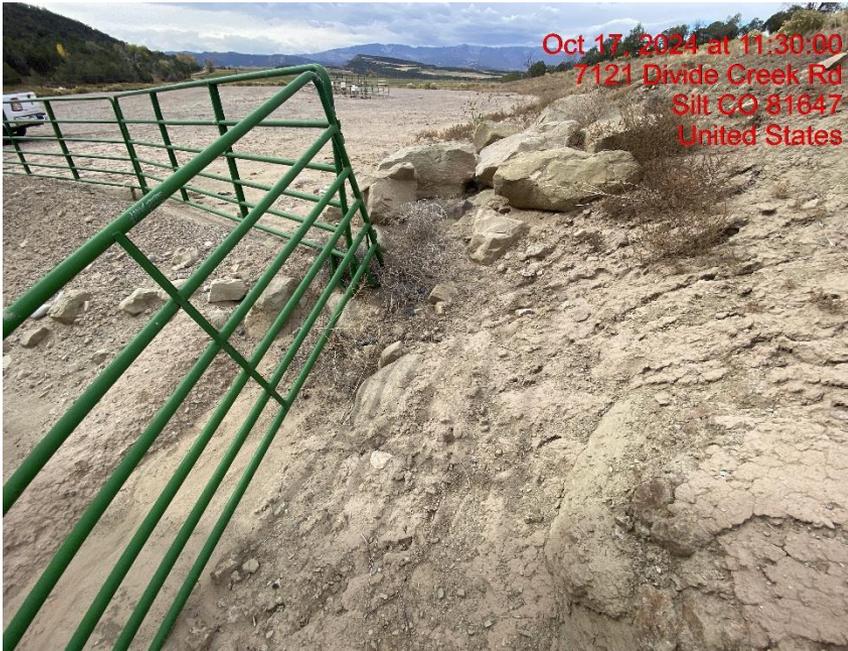
Insufficient Erosion Control/Degradation – Photo #04279

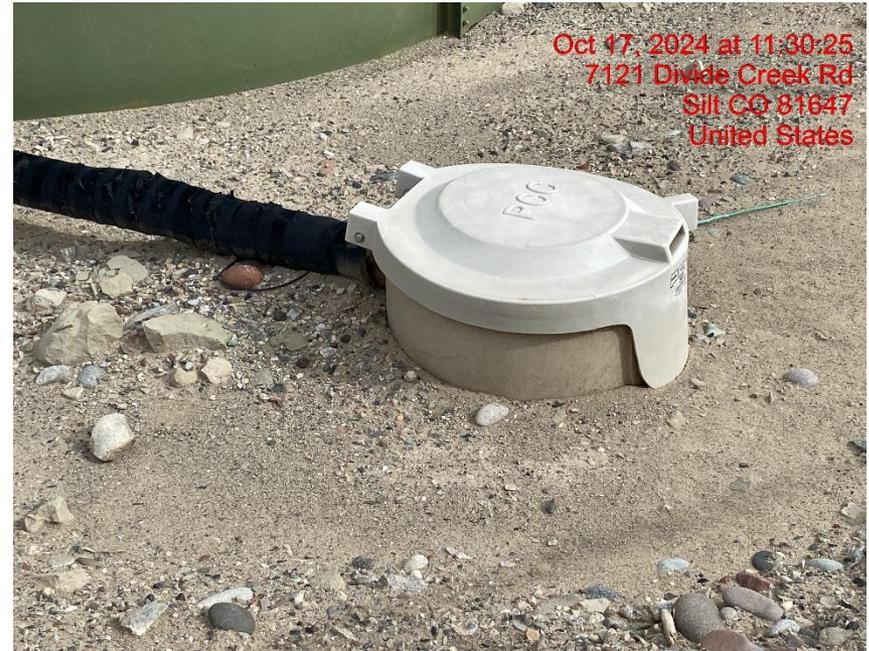
Sediment Encroaching Into Production Equipment/Degradation – Photo #04280
