# Inspection Photos

Location Name: TEP ROCKY MOUNTAIN LLC DOE 1-M-18 Pad

Location ID: 335744

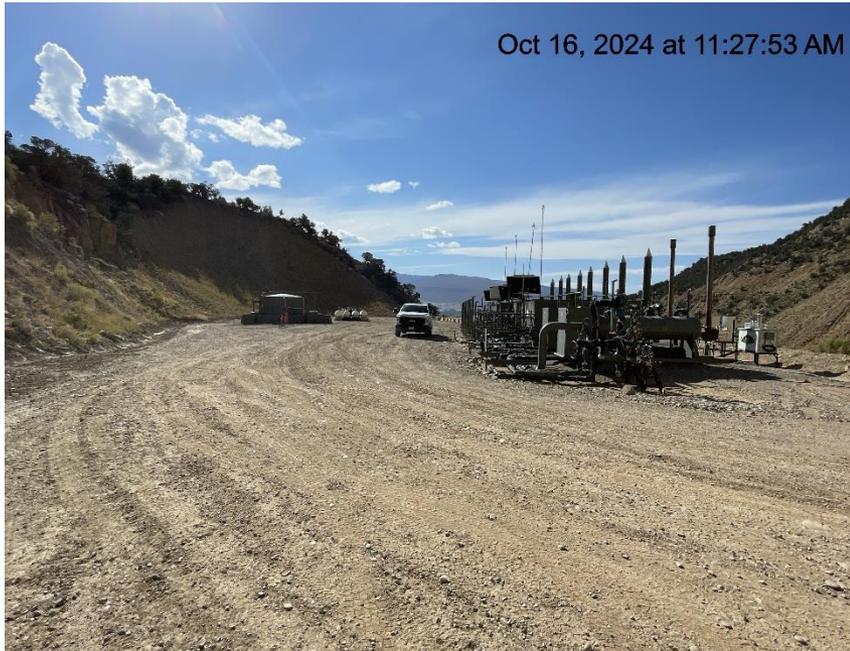
Photo # 5897 From entrance to location

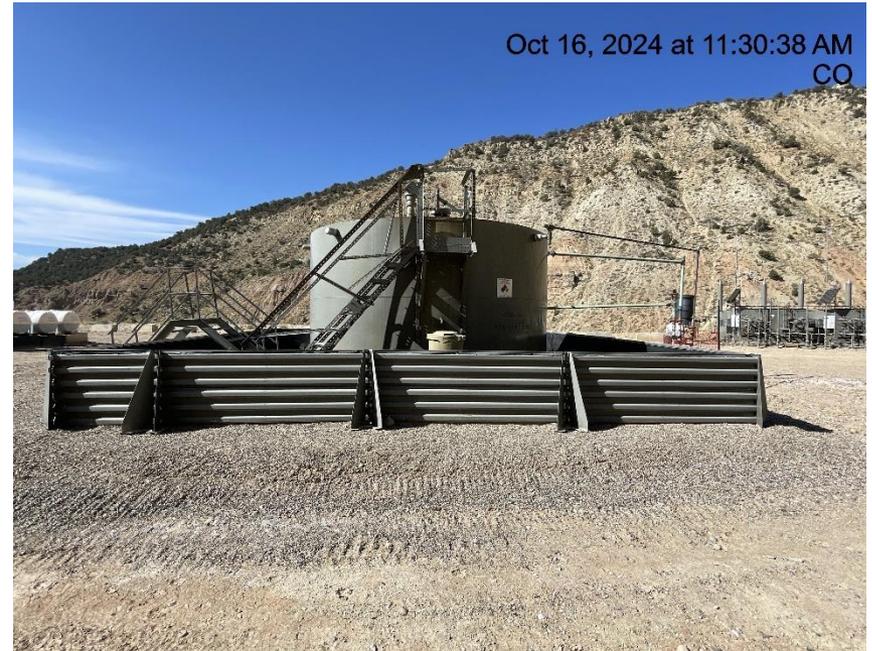
Photo # 5908 Battery lacks required signage

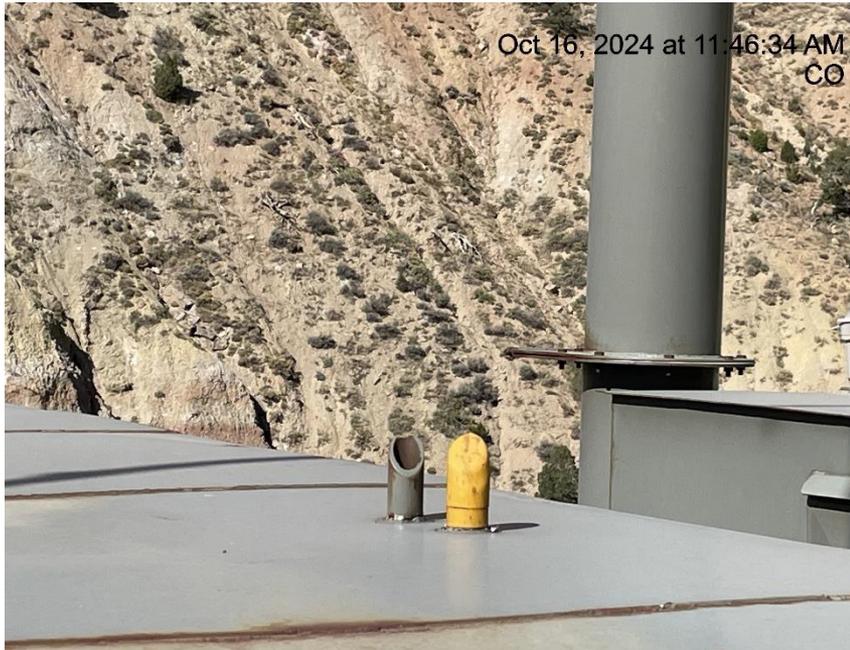
**Photo # 5911 PRV vent line does not comply with CECMC pressure safety device rules**

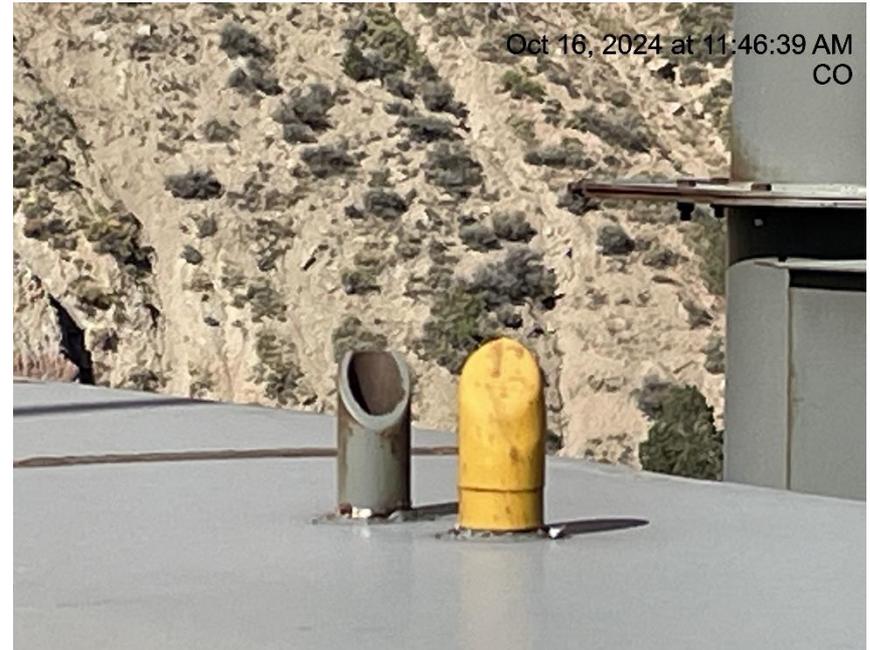
**Photo # 5912 PRV vent line does not comply with CECMC pressure safety device rules**

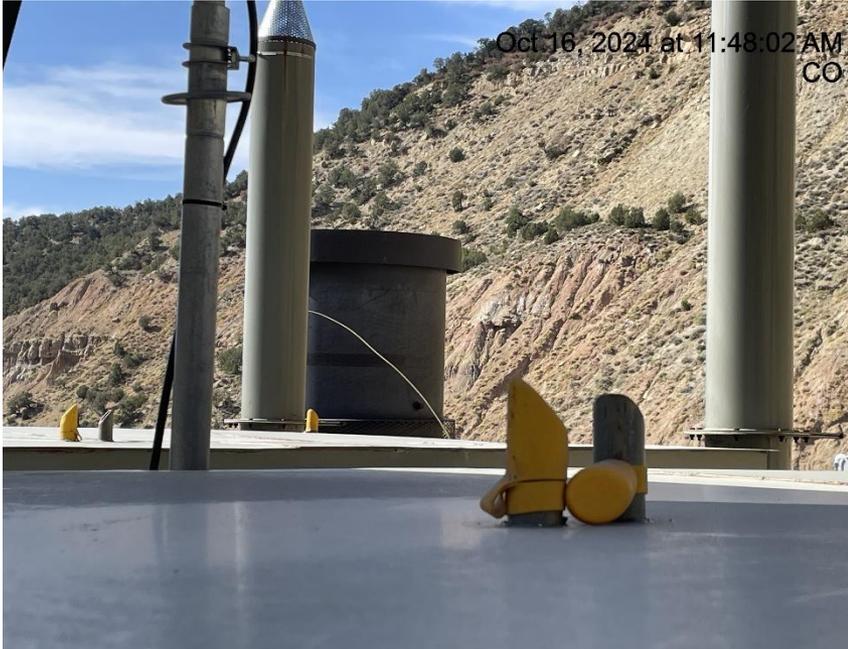
**Photo # 5913 PRV vent line does not comply with CECMC pressure safety device rules**

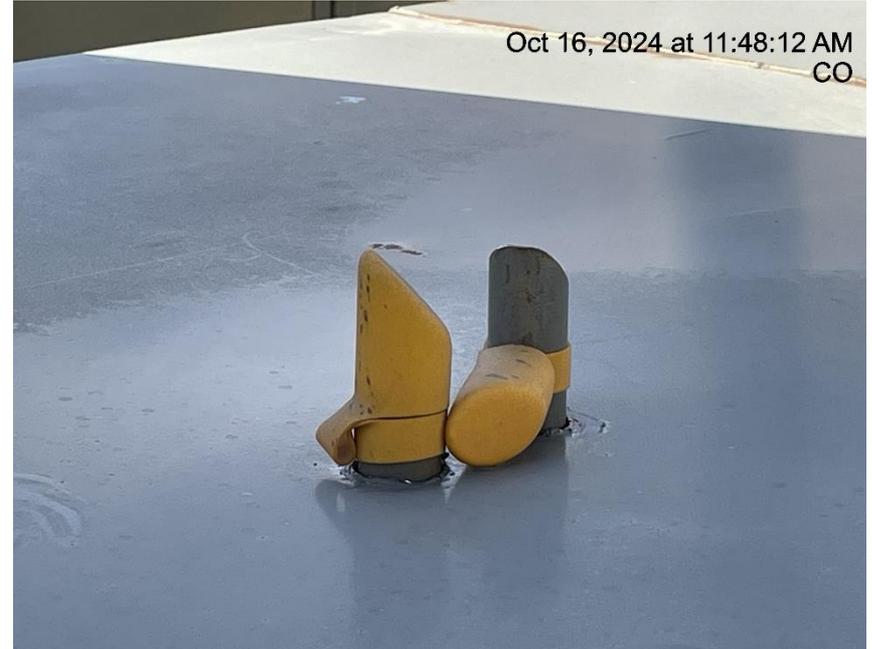
**Photo # 5914 PRV vent line does not comply with CECMC pressure safety device rules**

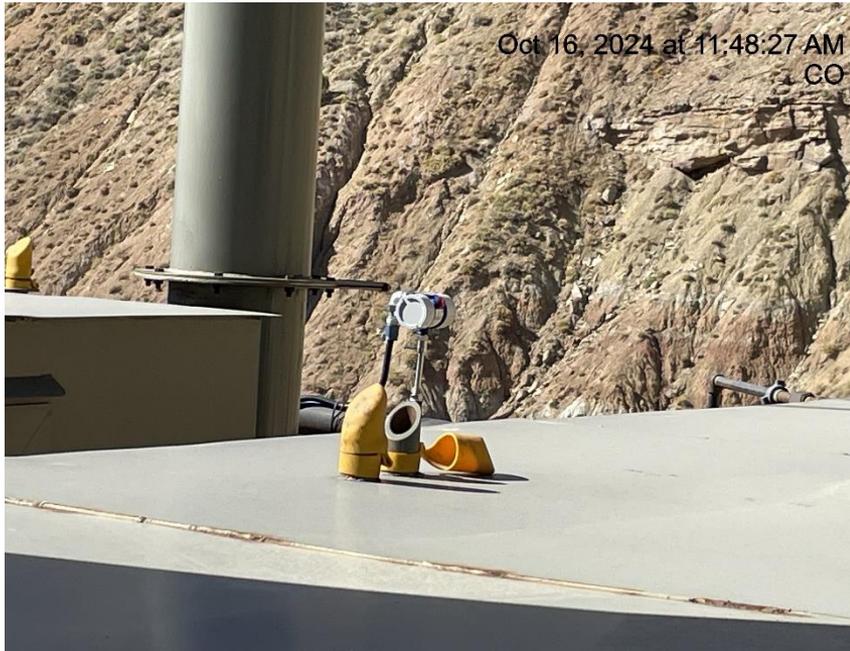
**Photo # 5915 PRV vent line does not comply with CECMC pressure safety device rules**

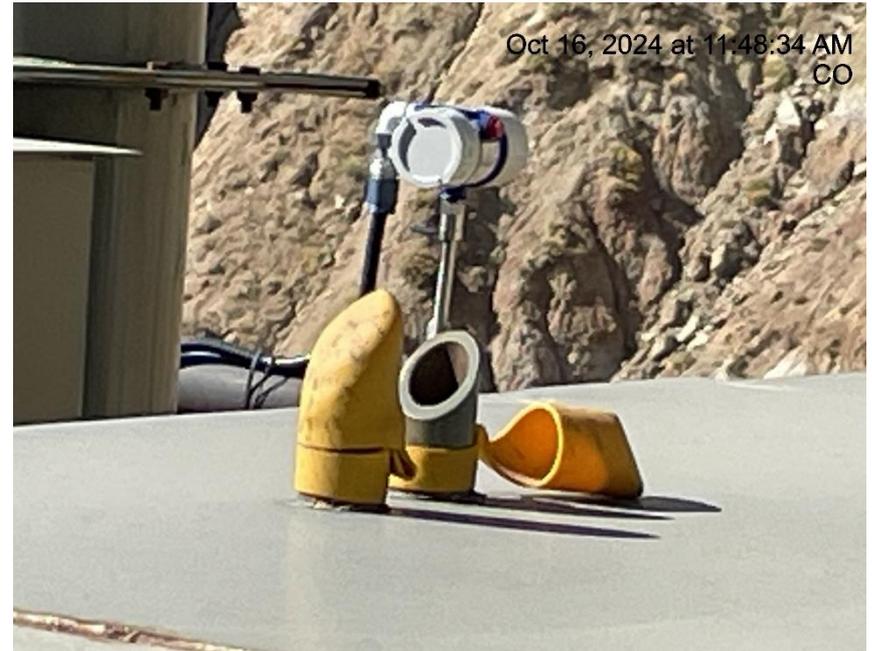
**Photo # 5916 PRV vent line does not comply with CECMC pressure safety device rules**

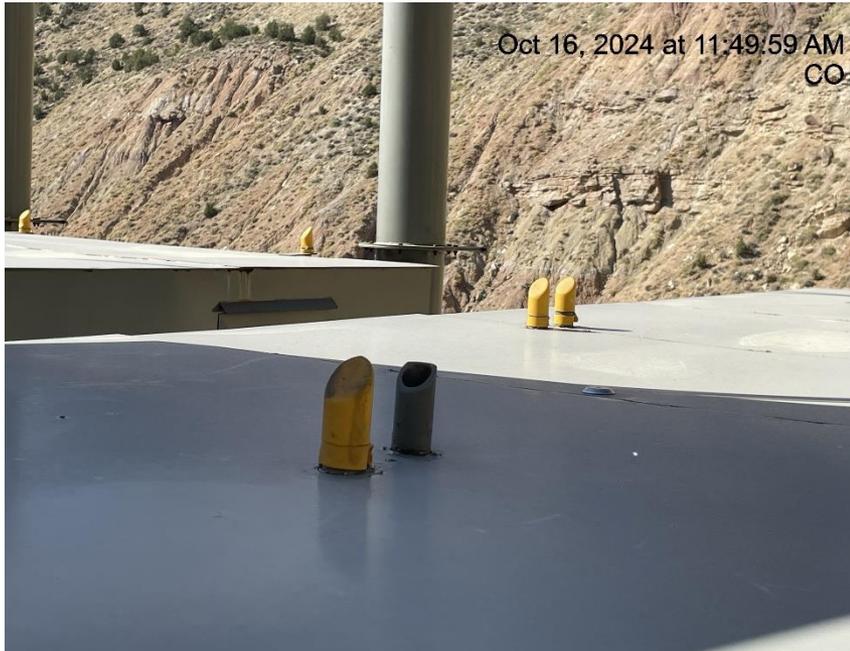
**Photo # 5917 PRV vent line does not comply with CECMC pressure safety device rules**

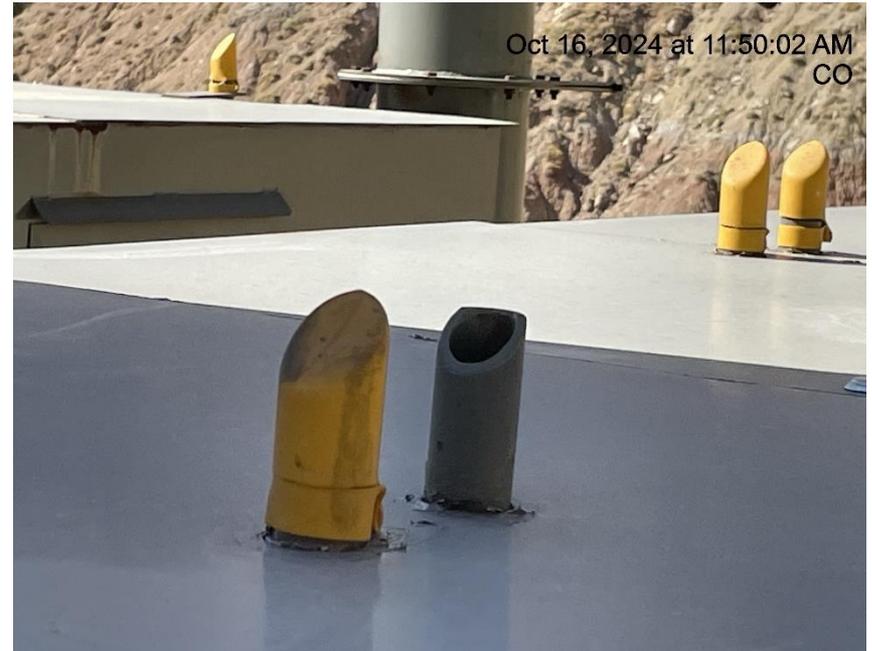
**Photo # 5918 PRV vent line does not comply with CECMC pressure safety device rules**
