Inspection Photos

October 22nd, 2024

Operator: Simcoe LLC - 10749

Inspection Photos
Location Name: Bondad Ute 1-36 2
Location ID: 307021

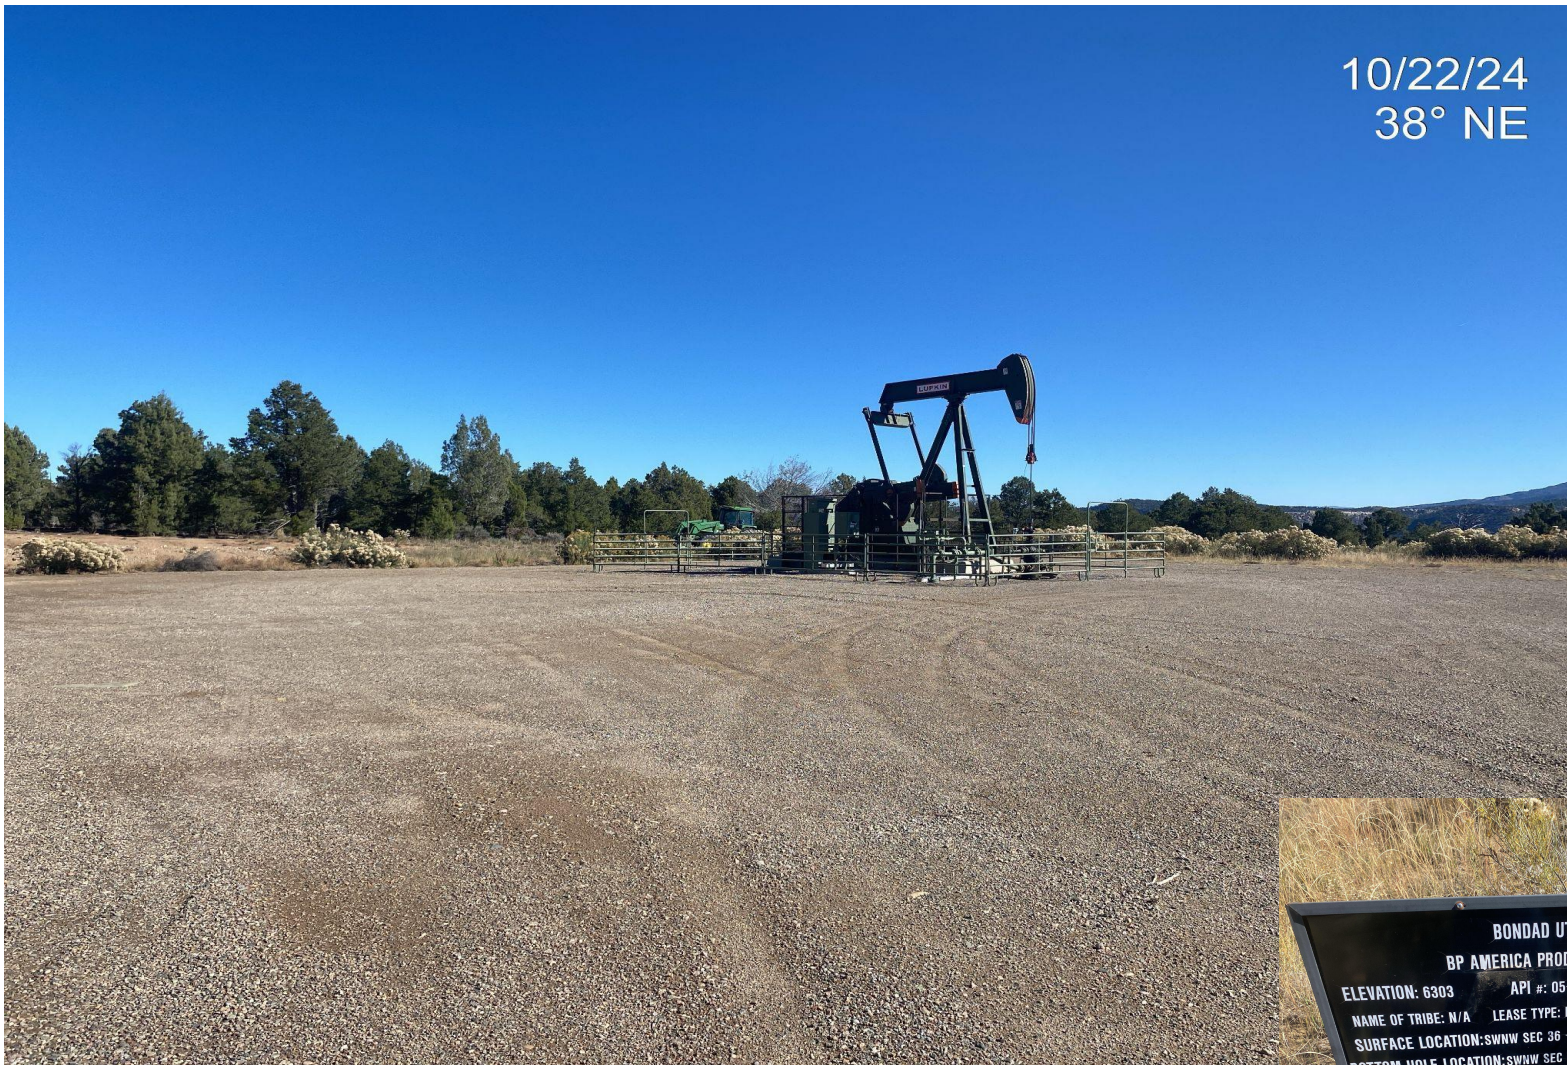
Photo 1. View of the well pad taken from the access point facing center. Note: well sign is not reflecting current operator.

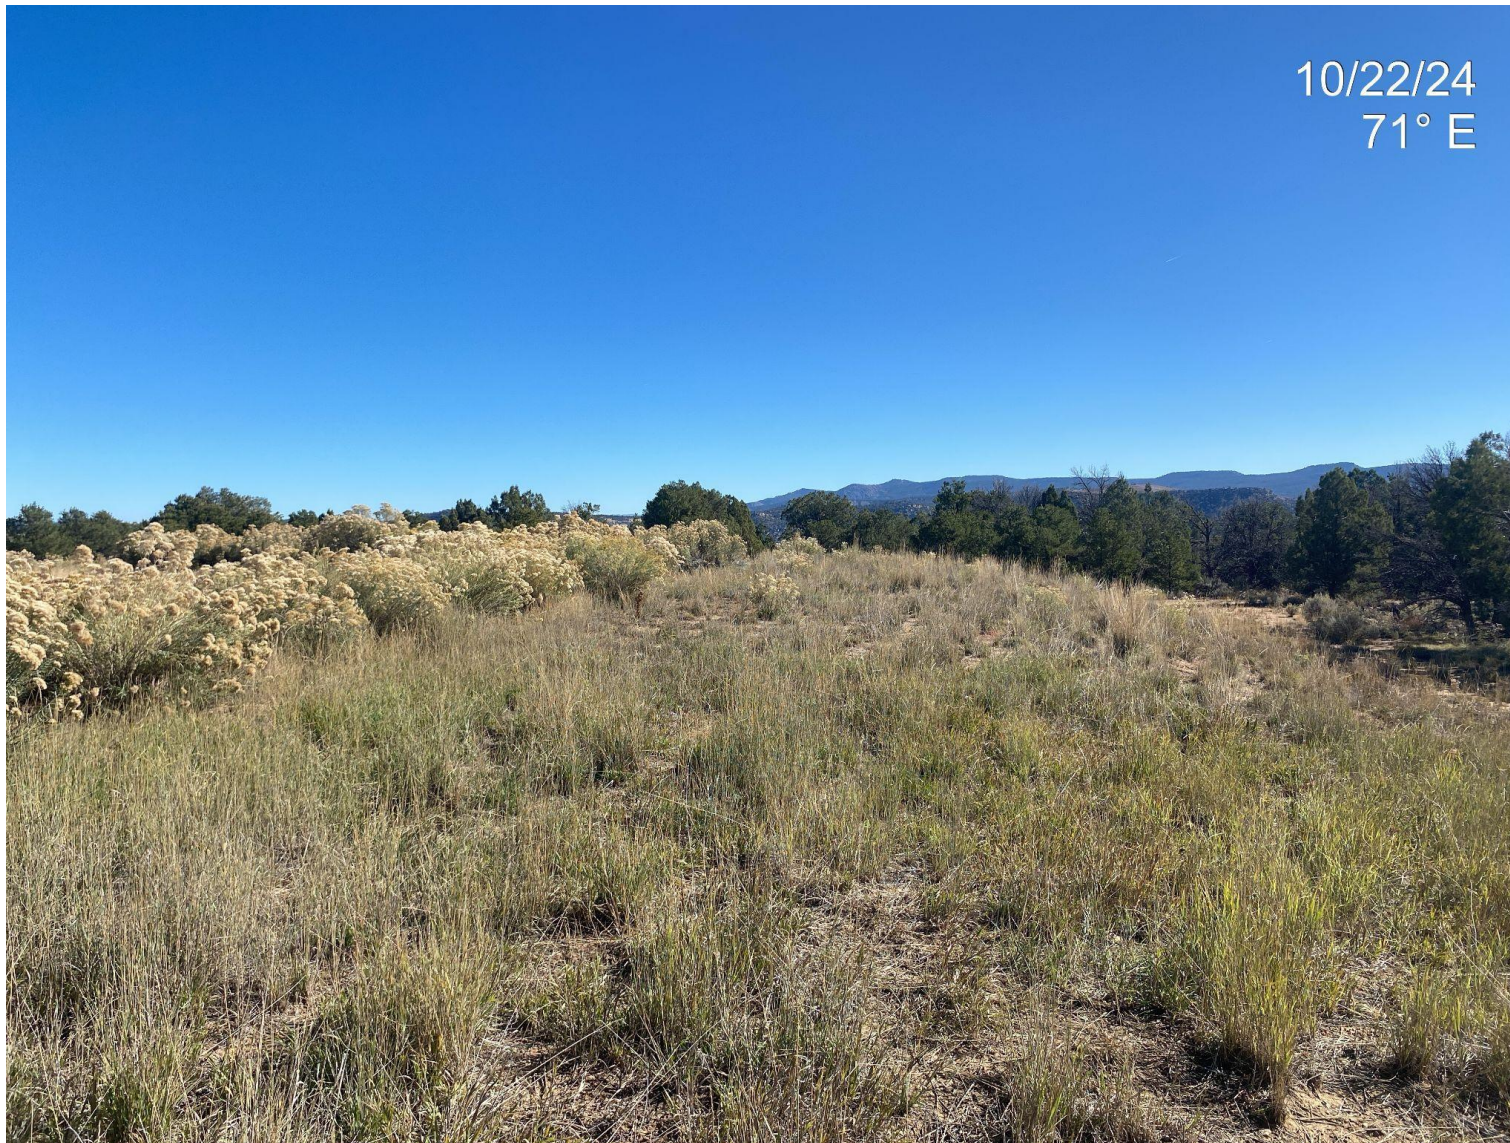
Photo 2. View of the southern interim reclamation area facing west. Vegetation consists of Intermediate Wheatgrass, Smooth Brome and Sand Dropseed.

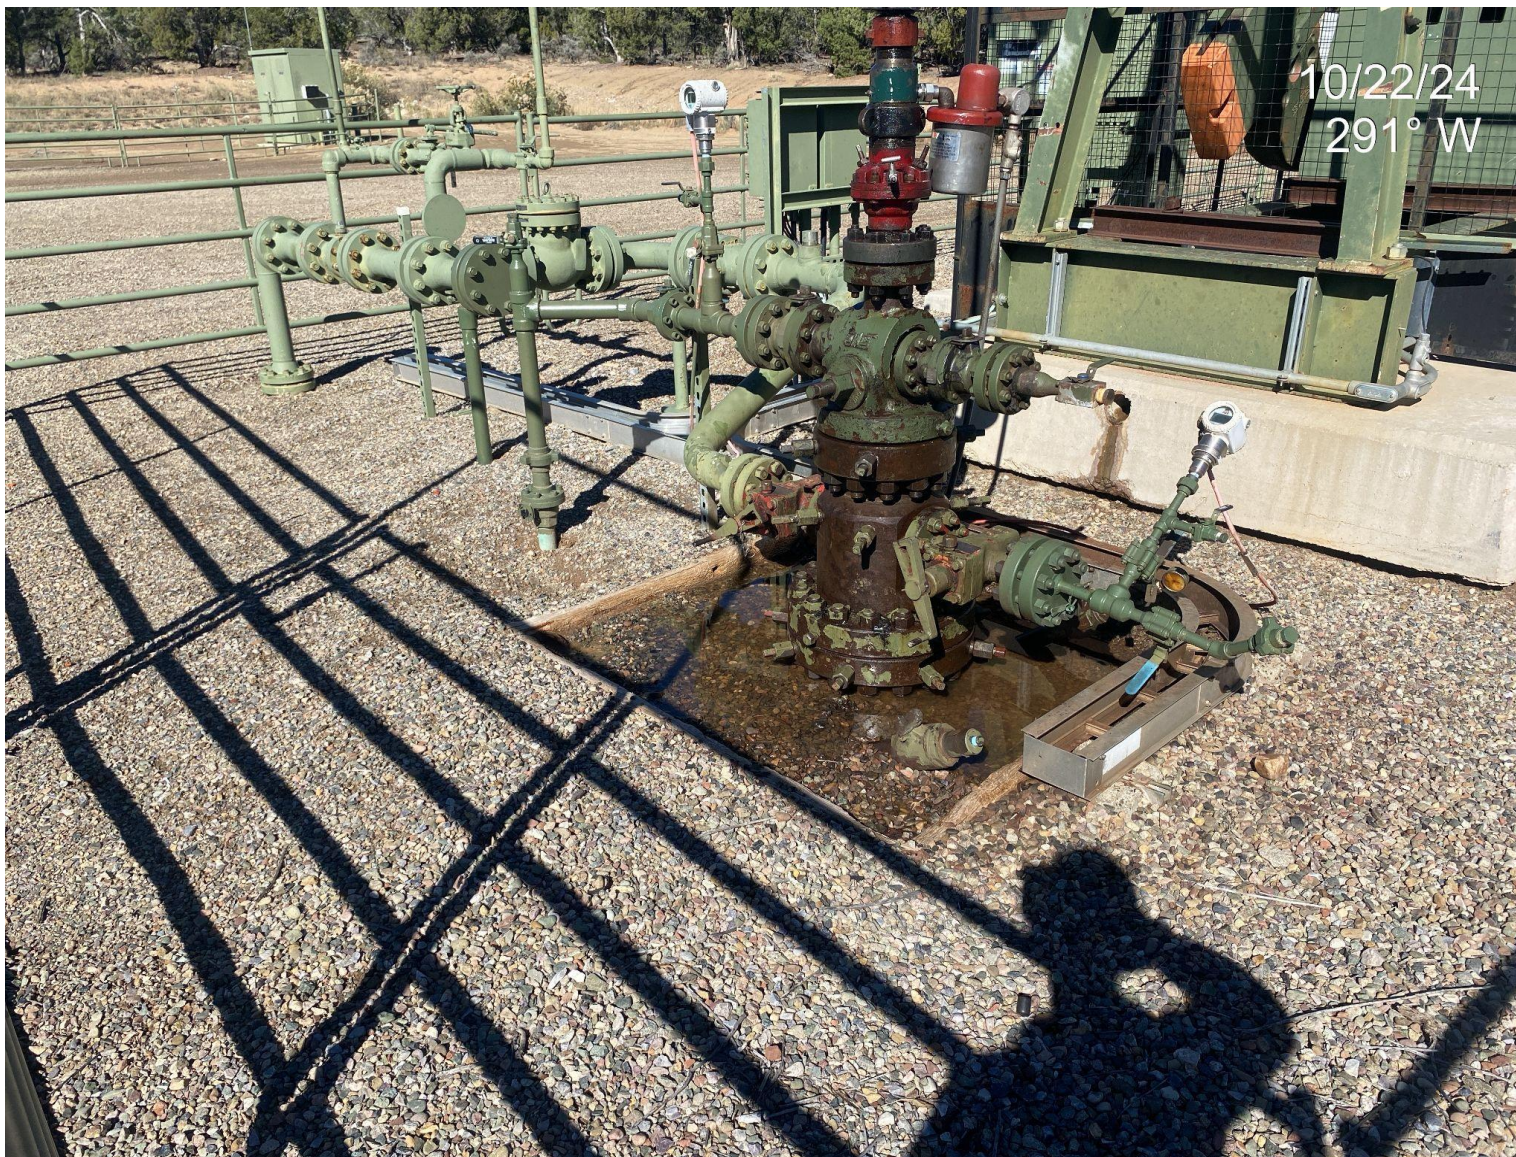
Photo 3. No leaks/impacted surface material observed at well head.

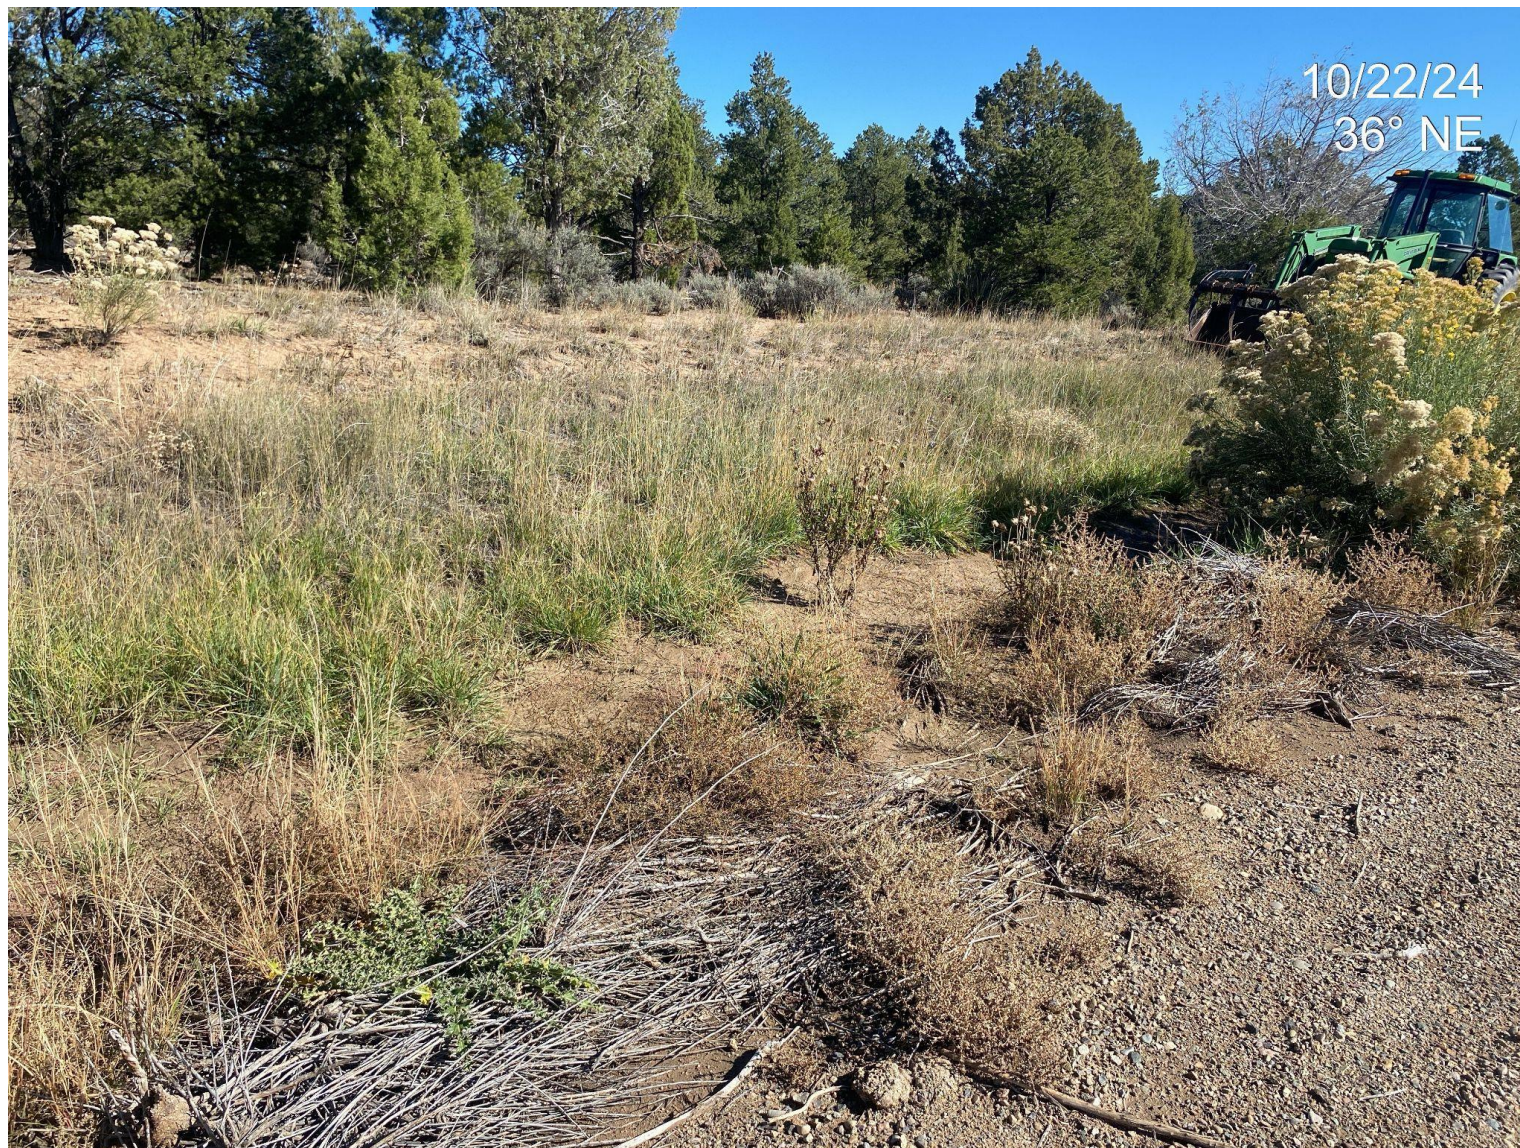
Photo 4. Small patch of flowering Musk Thistle observed along the northern edge of the active pad.

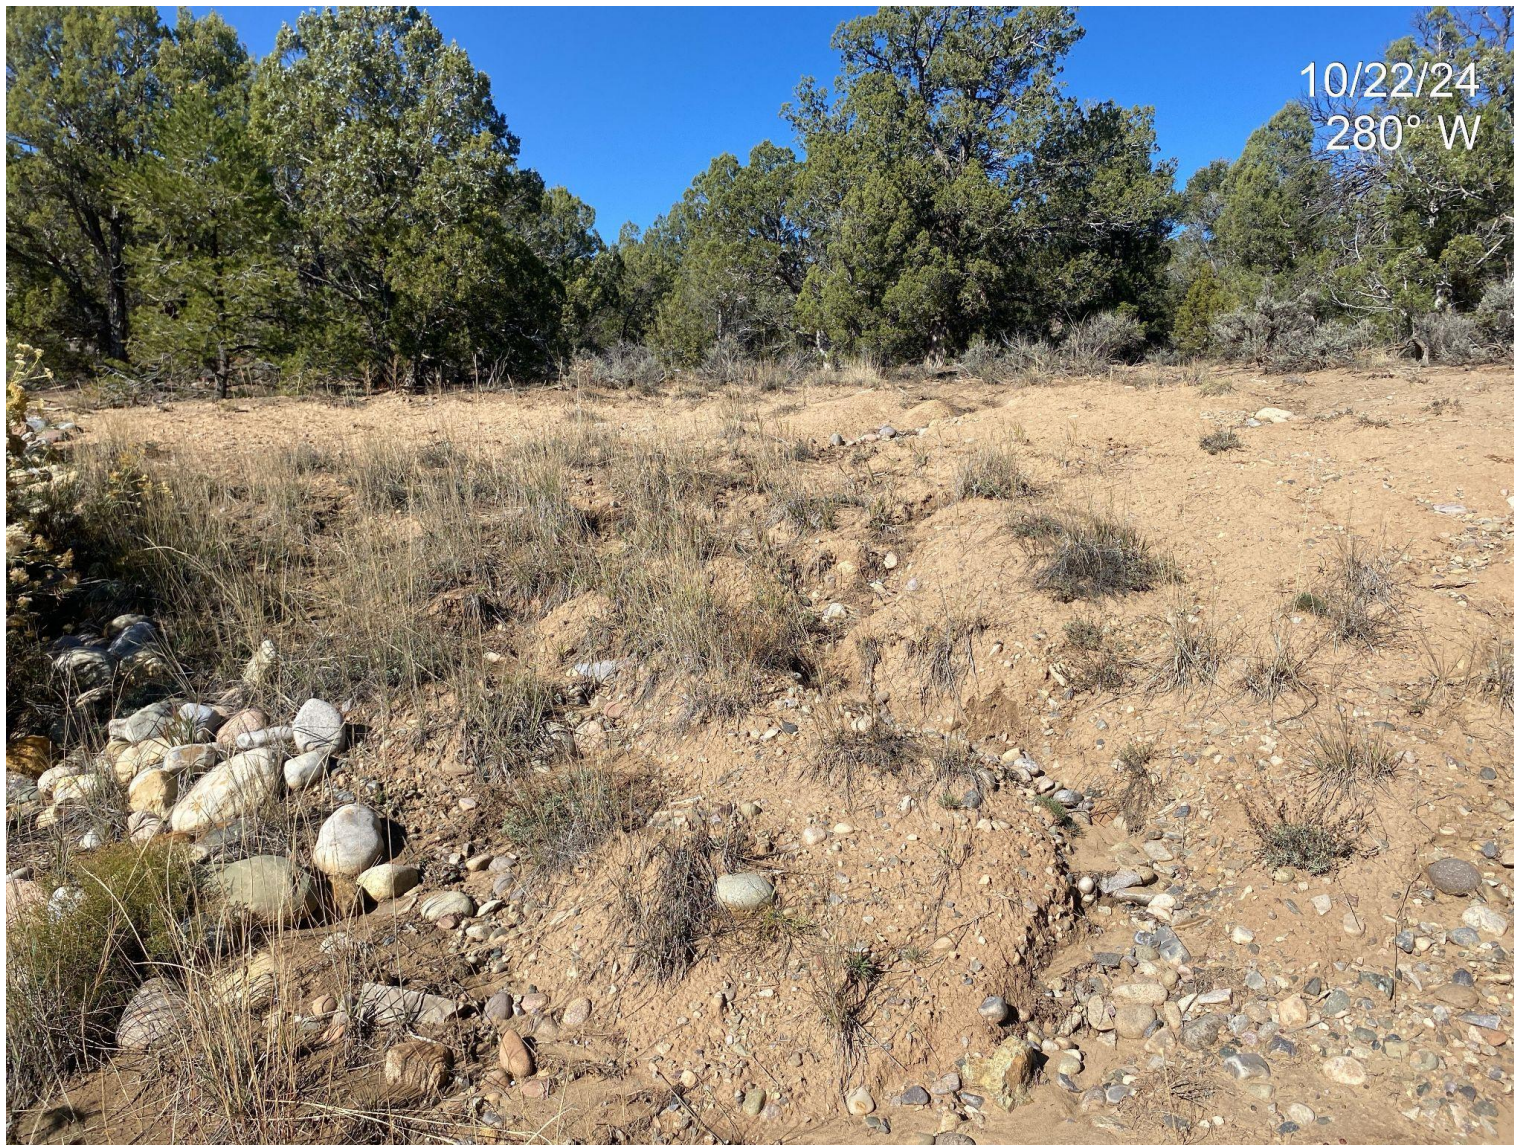
Photo 5. View of erosion forming along existing stormwater BMPs in the northwest corner of the disturbance. Additional stabilization/BMPs are needed in this area.

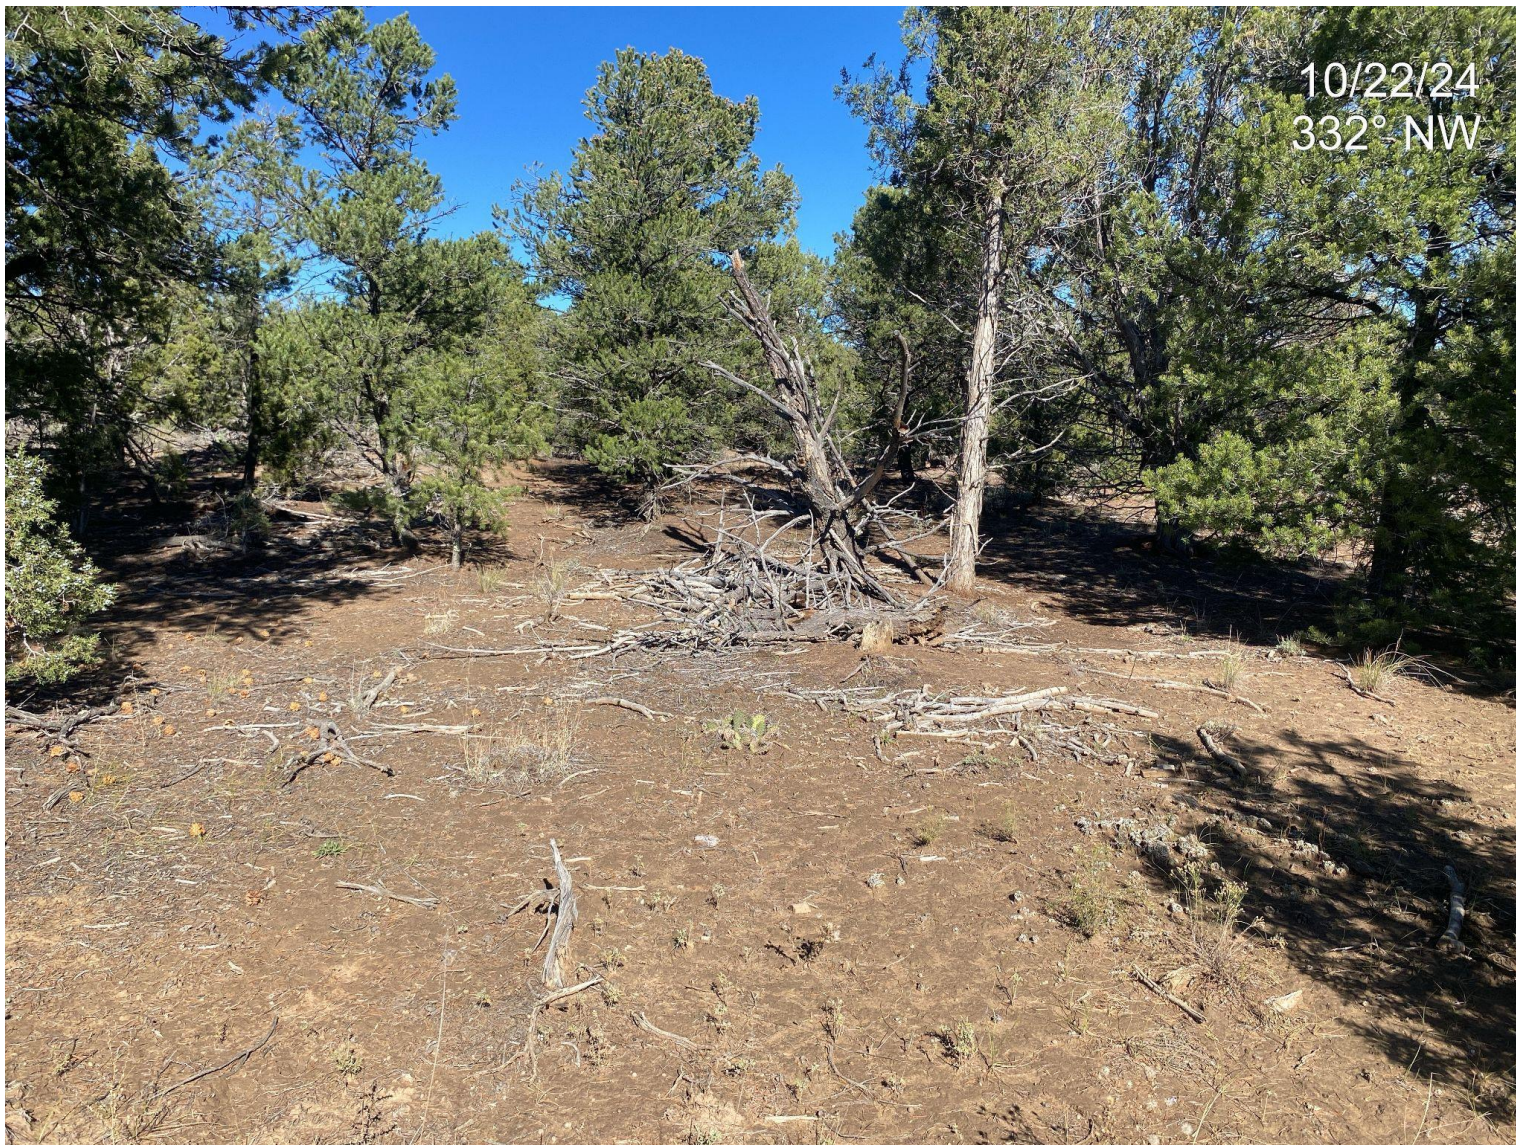
Photo 6. Reference area composed of Prickly Pear, Blue Grama and Juniper.
