Inspection Photos

October 22nd, 2024

Operator: Simcoe LLC - 10749

Inspection Photos
Location Name: McCarville B1
Location ID: 333541

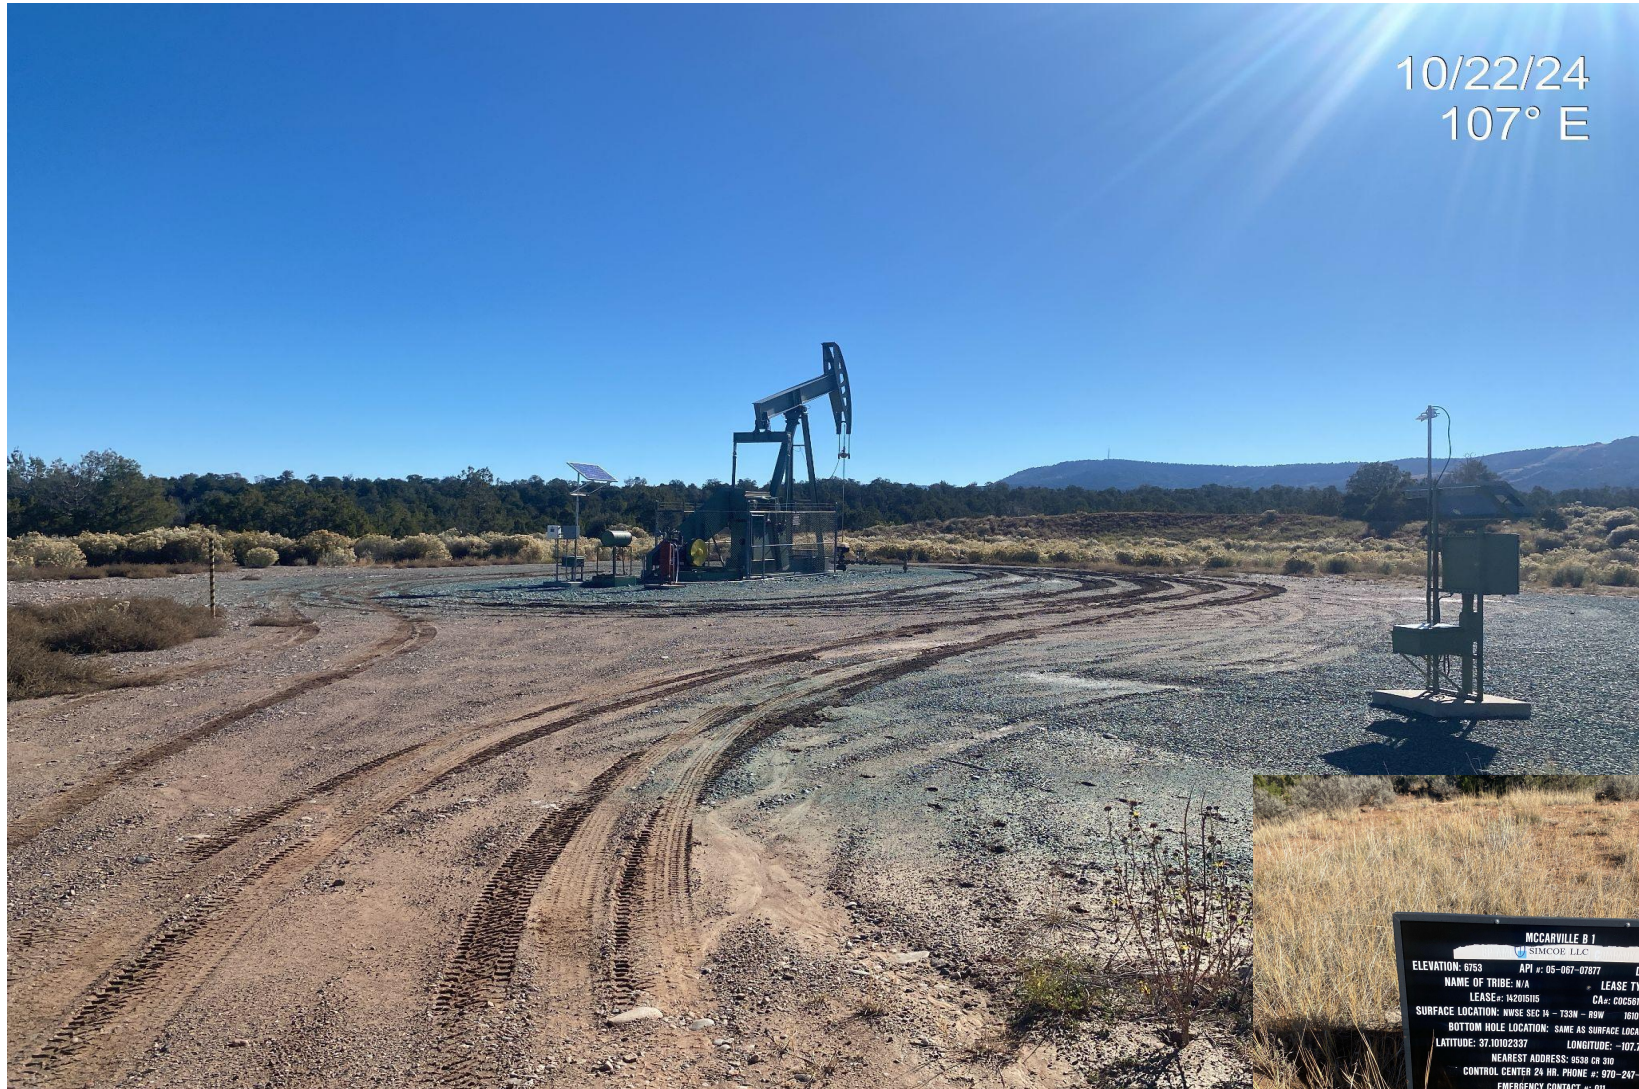
Photo 1. View of the well pad taken from the access point facing center.

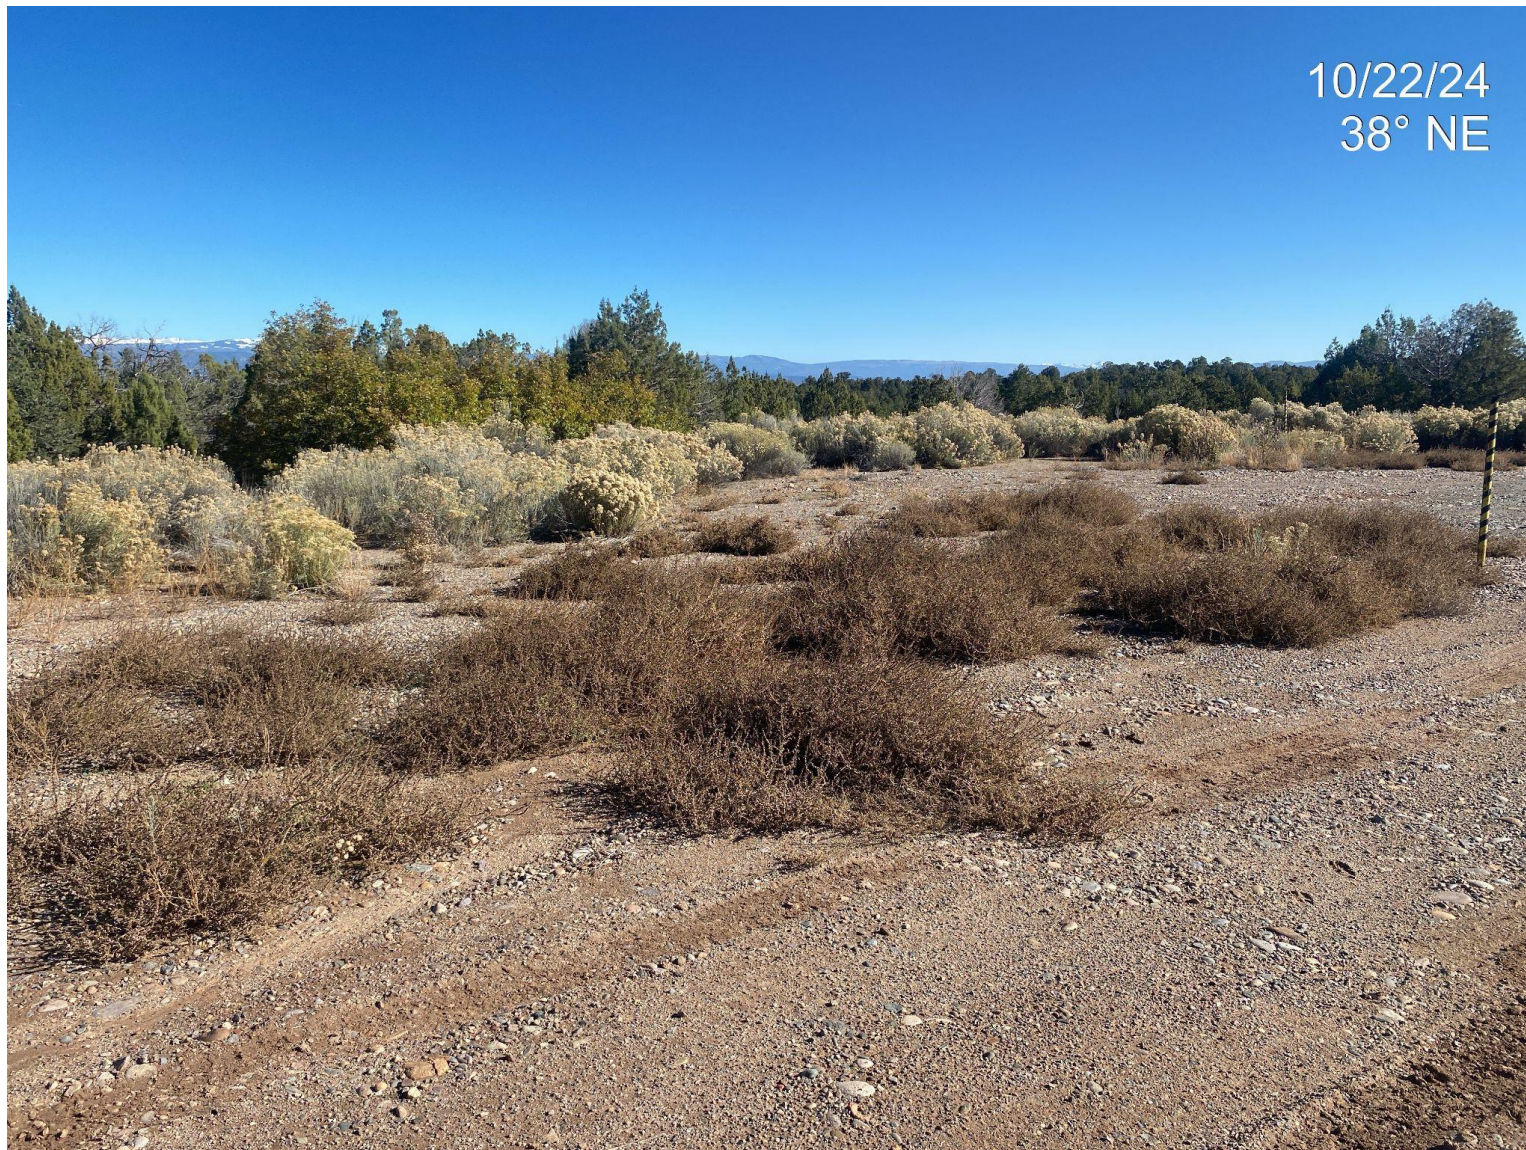
Photo 2. Weedy debris on active well pad.

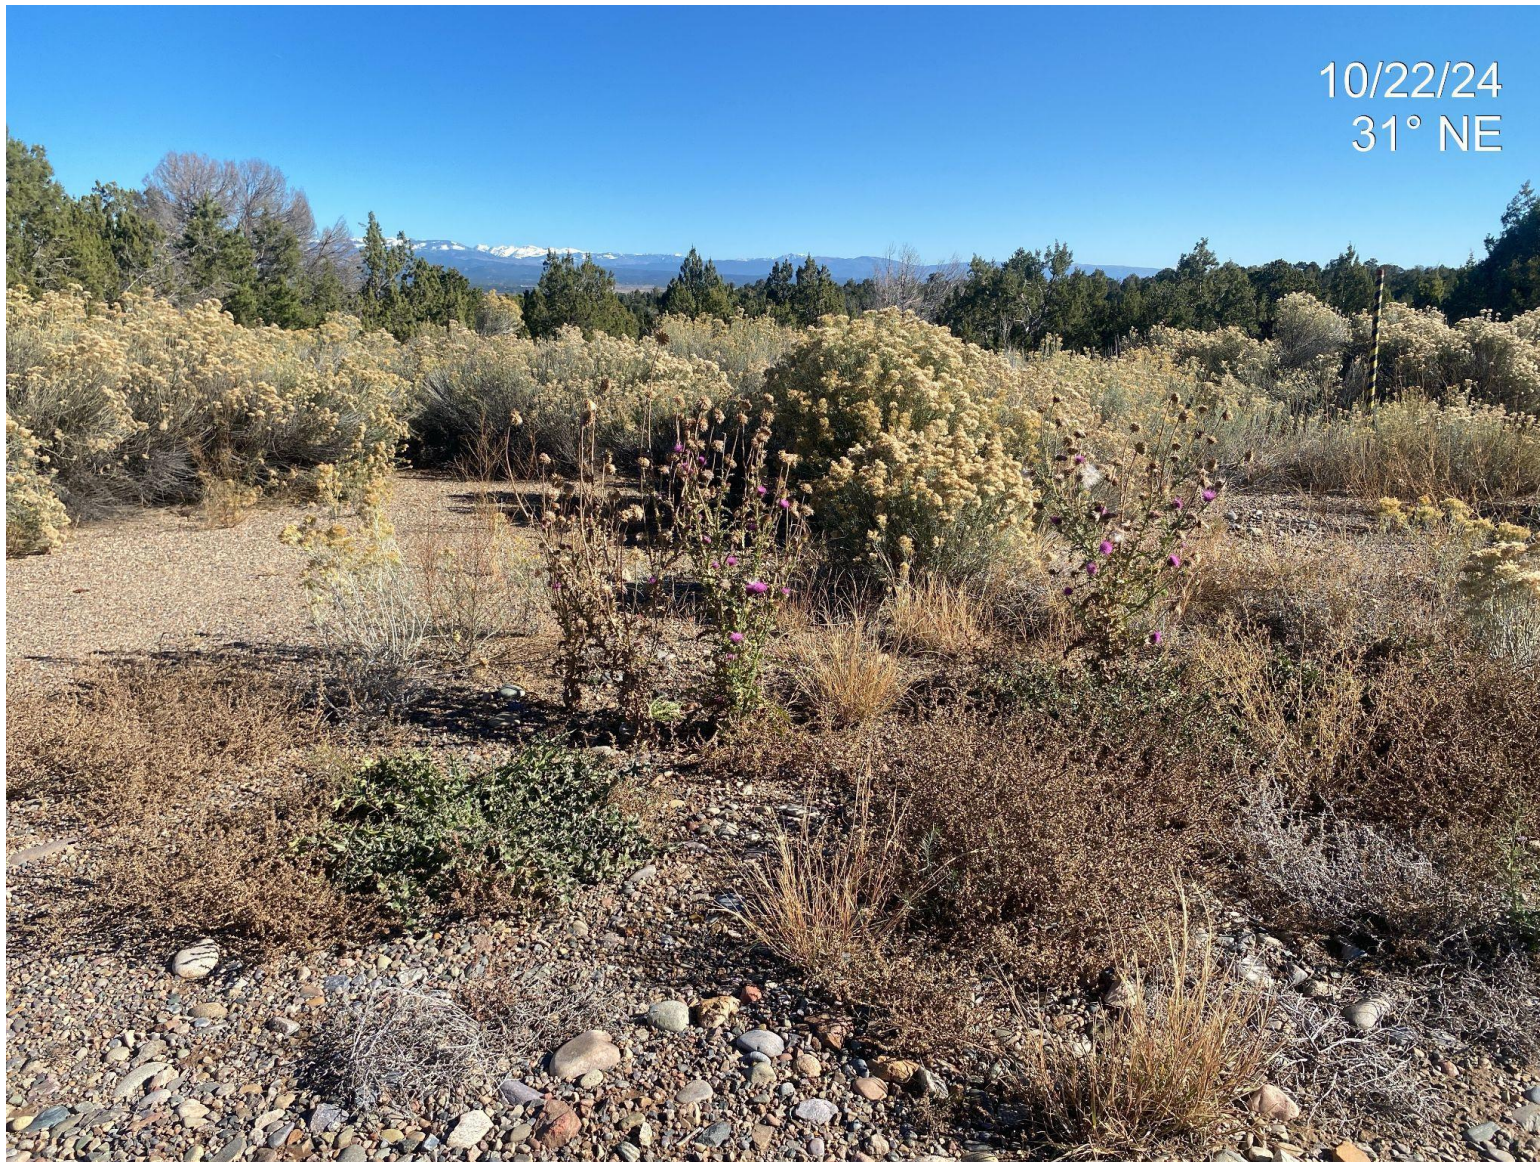
Photo 3. Patch of flowering musk thistle observed along the eastern edge of the disturbance.

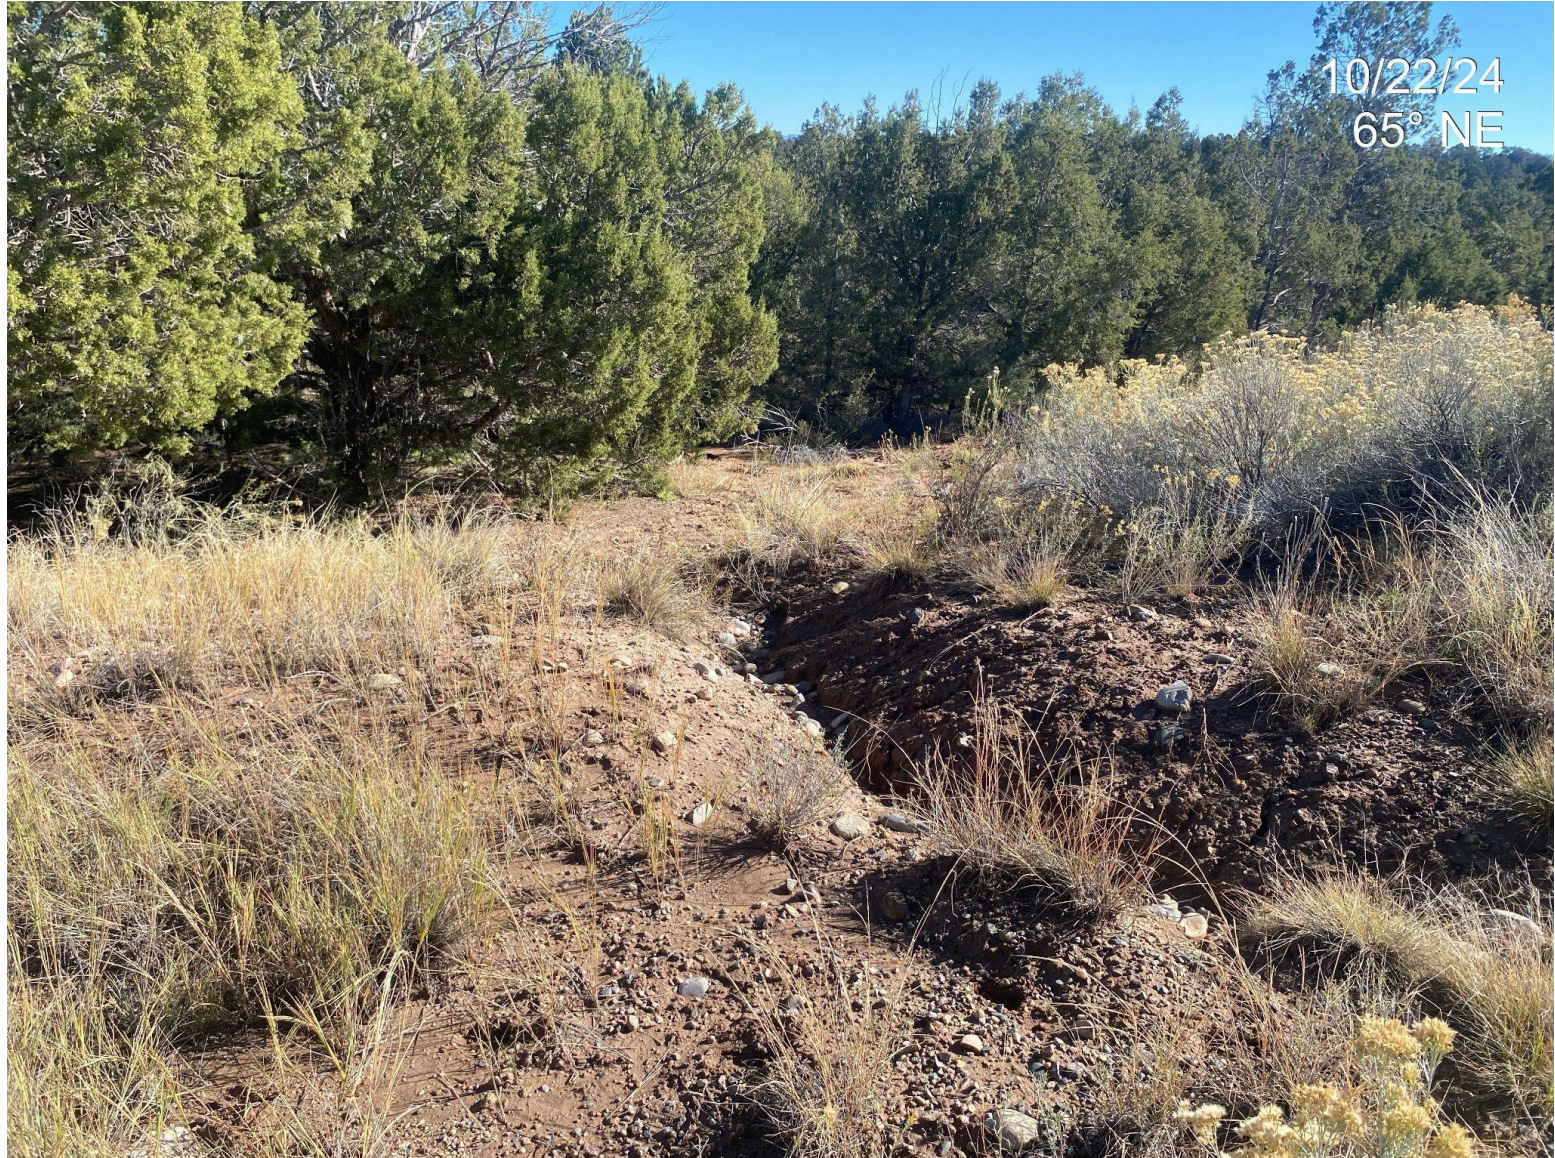
Photo 4. View of gully erosion observed forming in the eastern interim reclamation area.

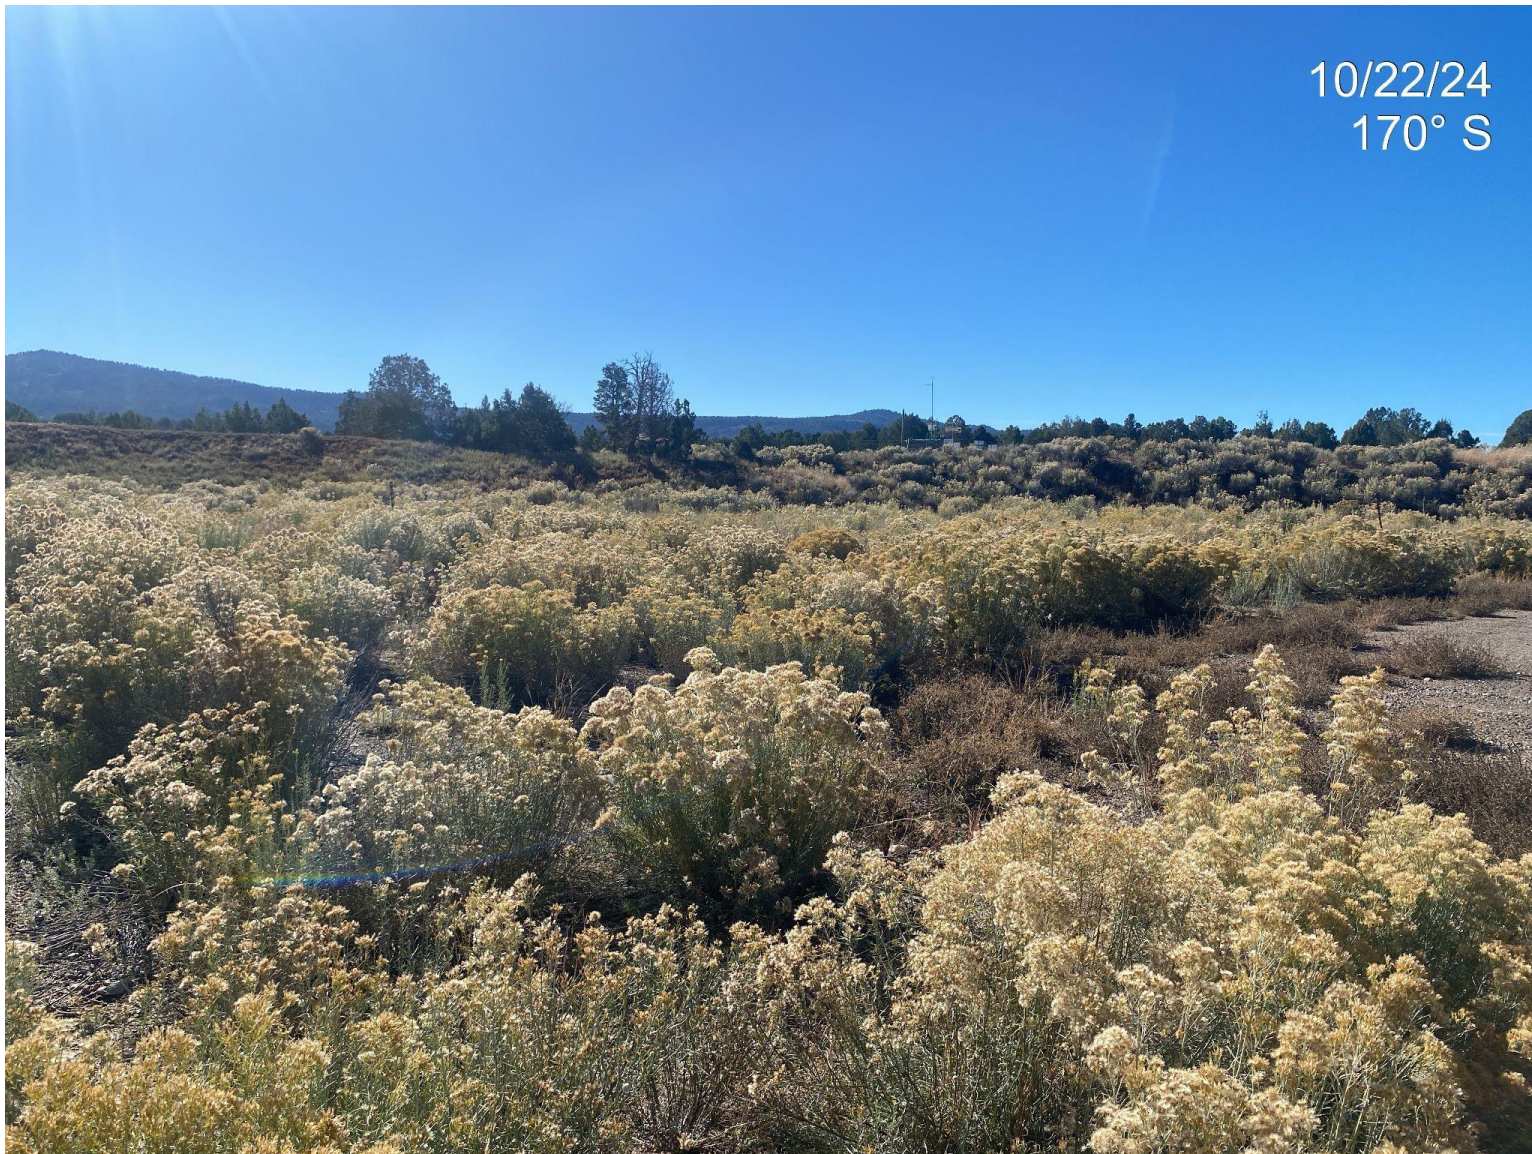
Photo 5. Southern interim reclamation area composed of Rubber Rabbitbrush and Sand Dropseed.

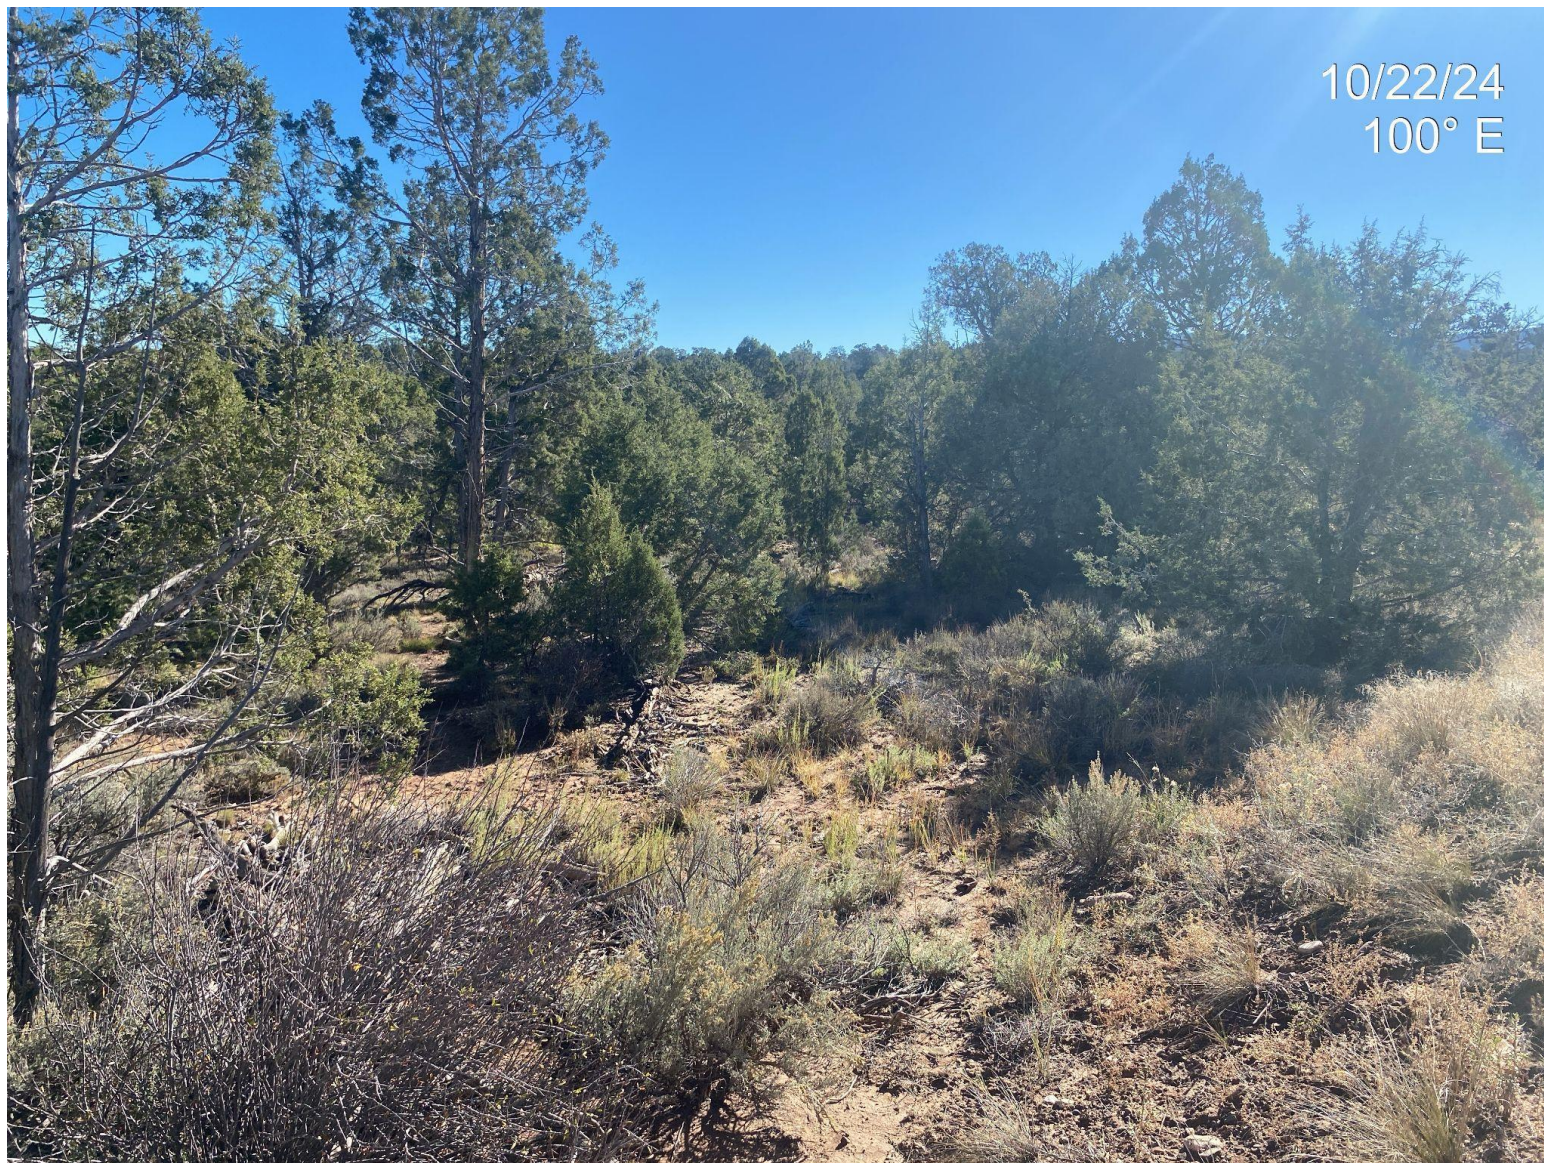
Photo 6. Reference area composed of Sagebrush, Purple Threeawn and Juniper.
