Inspection Photos

Location Name: TEP ROCKY MOUNTAIN LLC, GM-66S96W/27SWNE

Location ID: 335459

Date: 10/22/2024

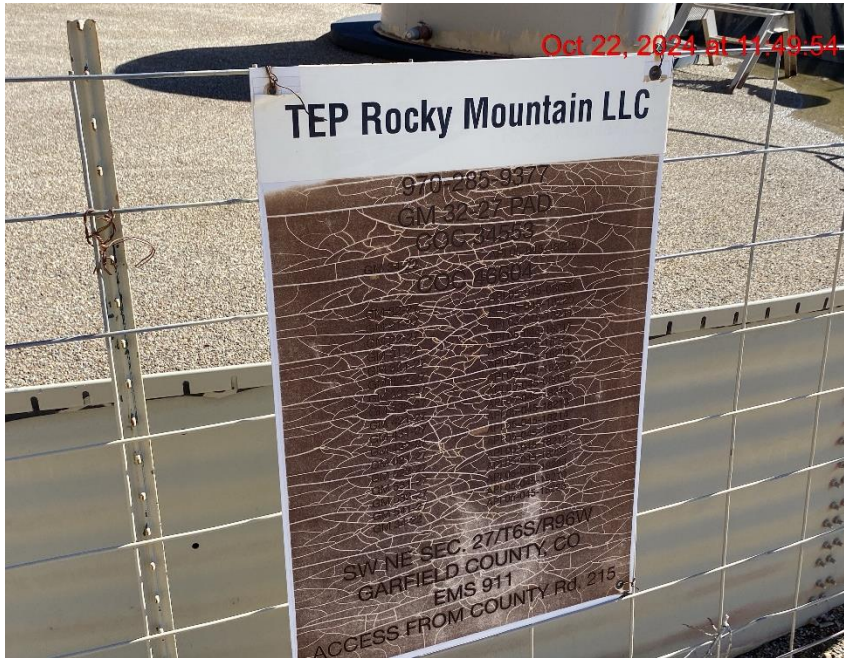
Weathered and Illegible Battery Sign – Photo #04392

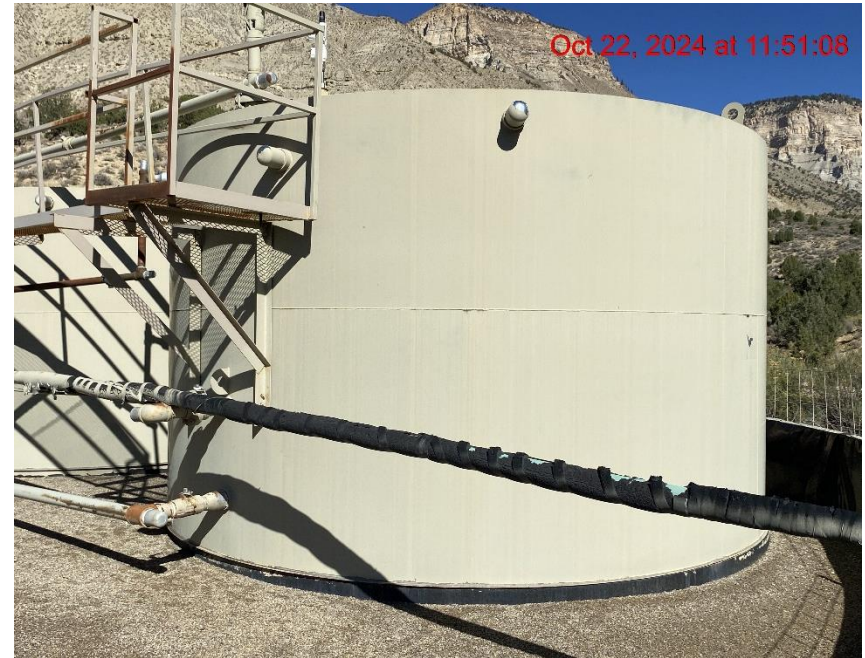
No Labeling on Storage Tank – Photo #04397

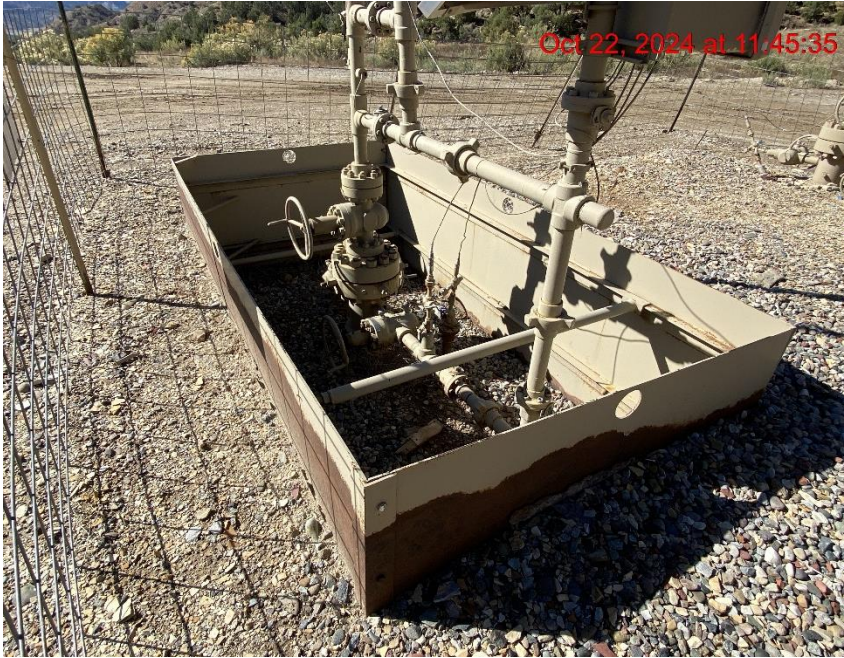
Open Wellhead Cellar/No Wildlife Egress – Photo #04381

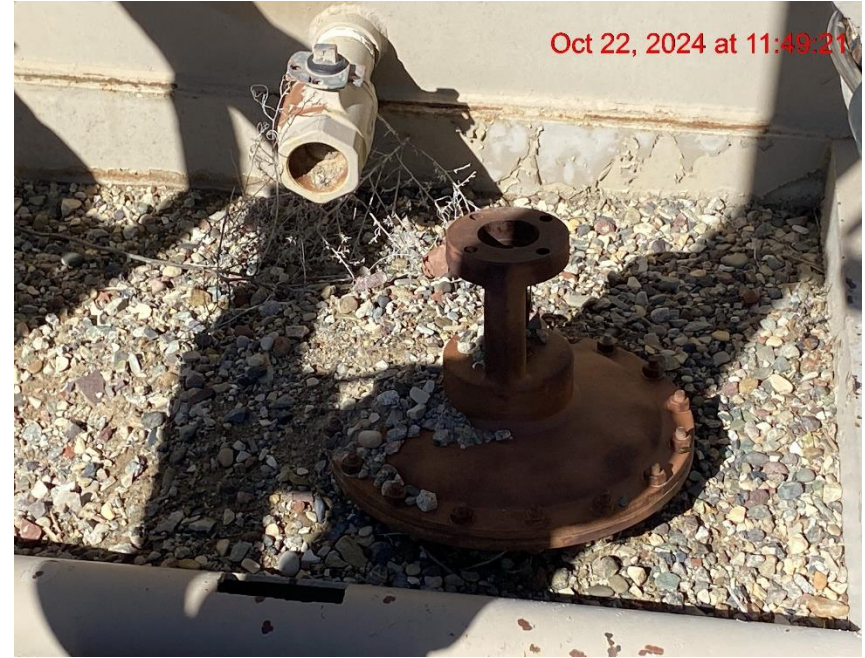
Stored Supplies – Photo #04390

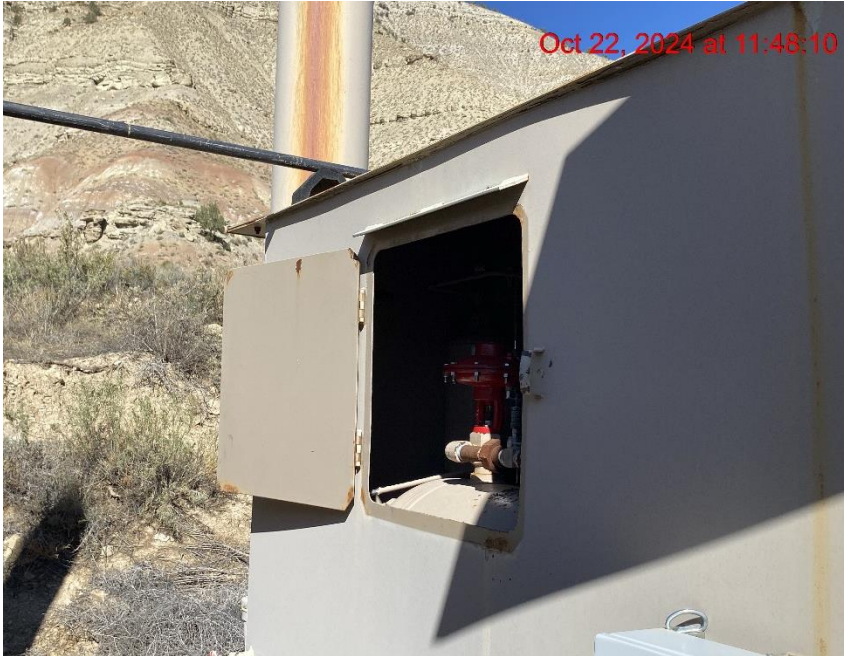
Unsecured Separator/Wildlife Entry Hazard – Photo #04386

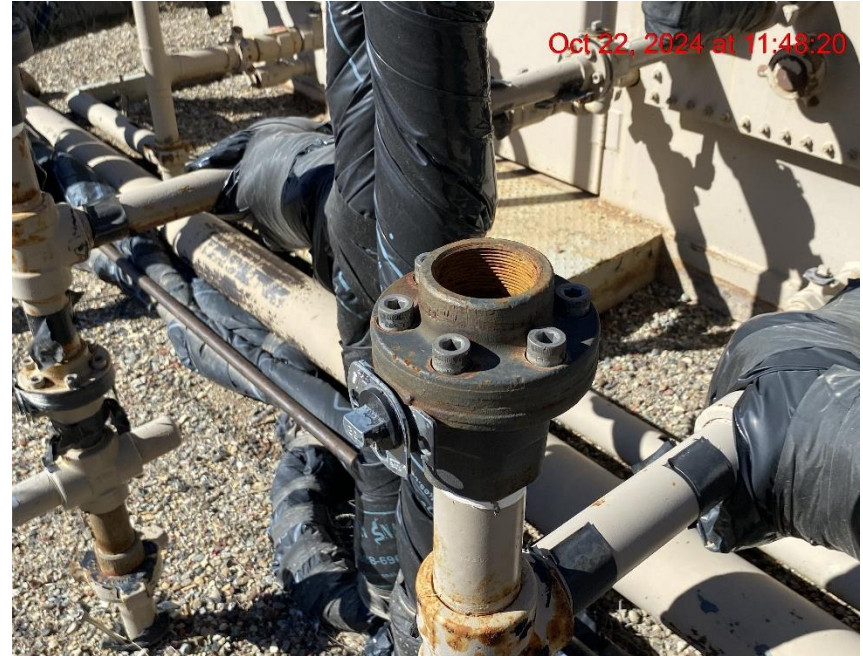
Open-Ended Line on Separator – Photo #04387

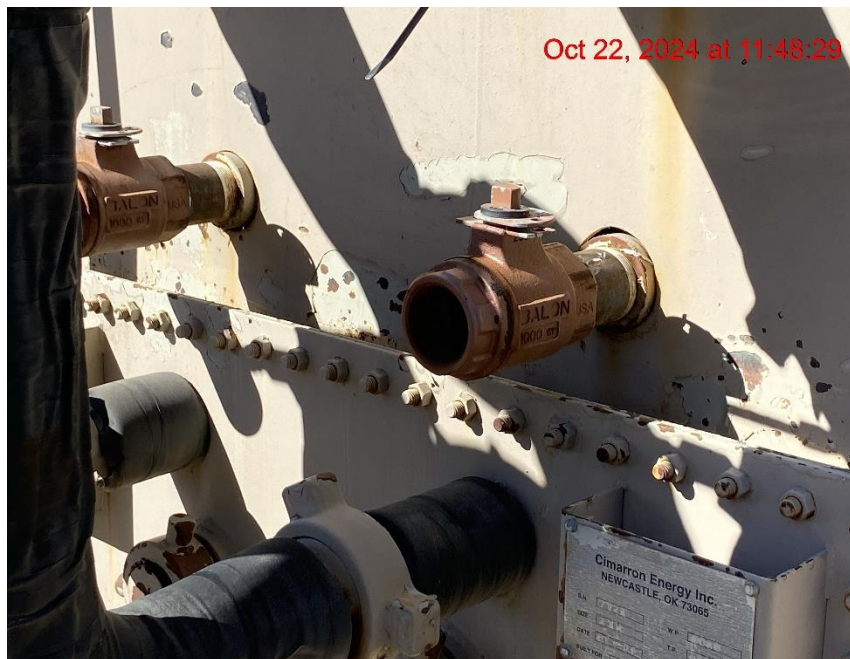
Open-Ended Line on Separator – Photo #04388

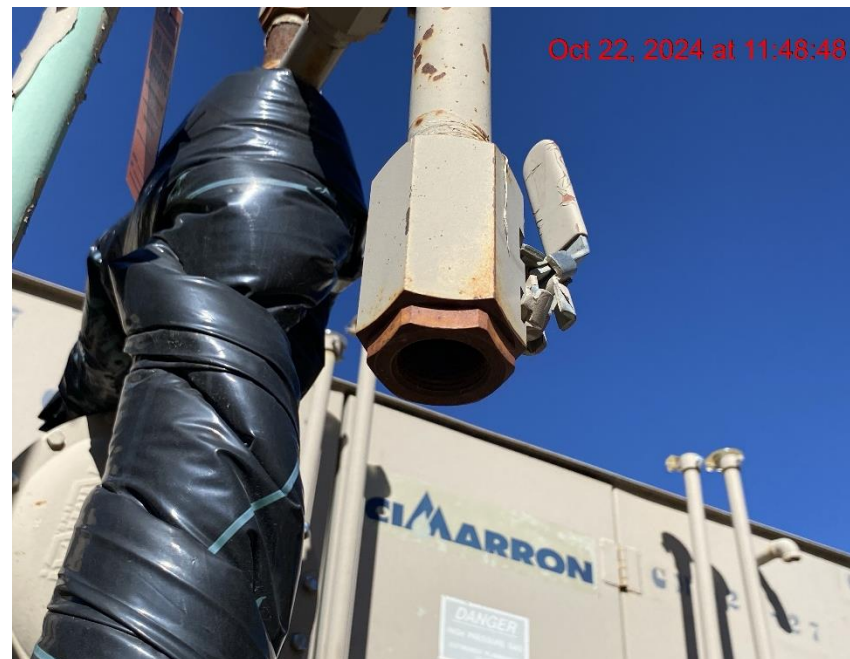
Open-Ended Line on Separator – Photo #04389

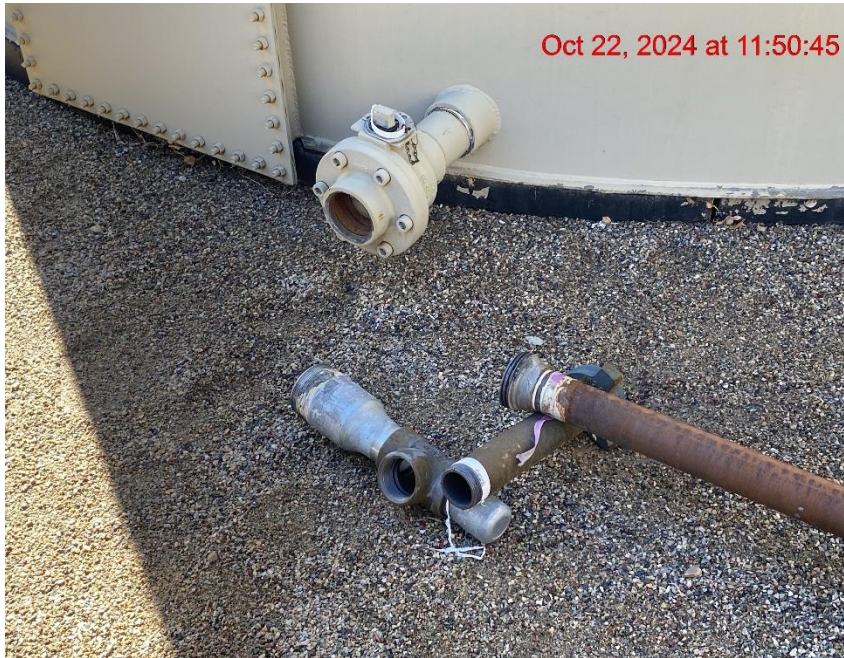
Open-Ended Manifold Line/Stored Supplies – Photo #04396

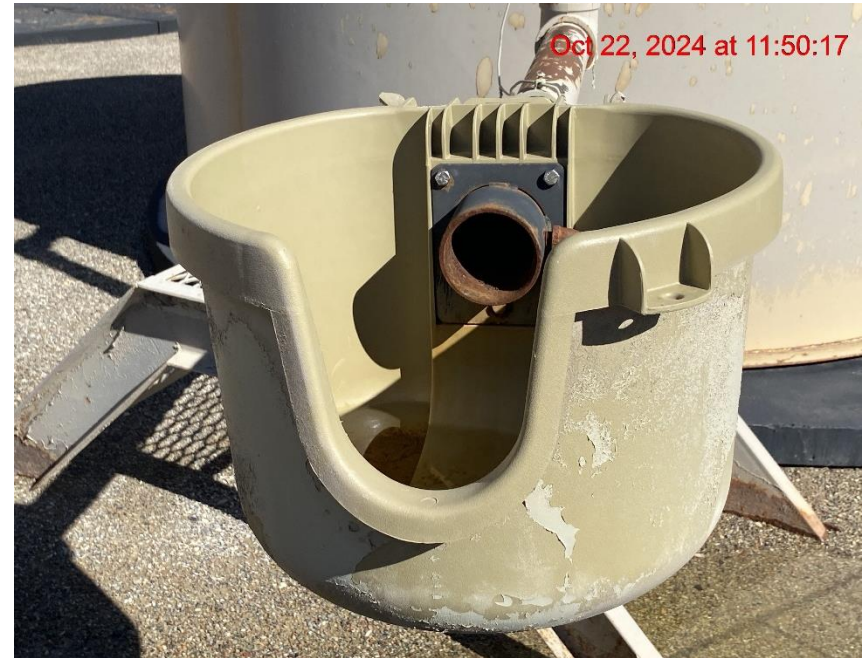
Open-Ended Load Line – Photo #04394

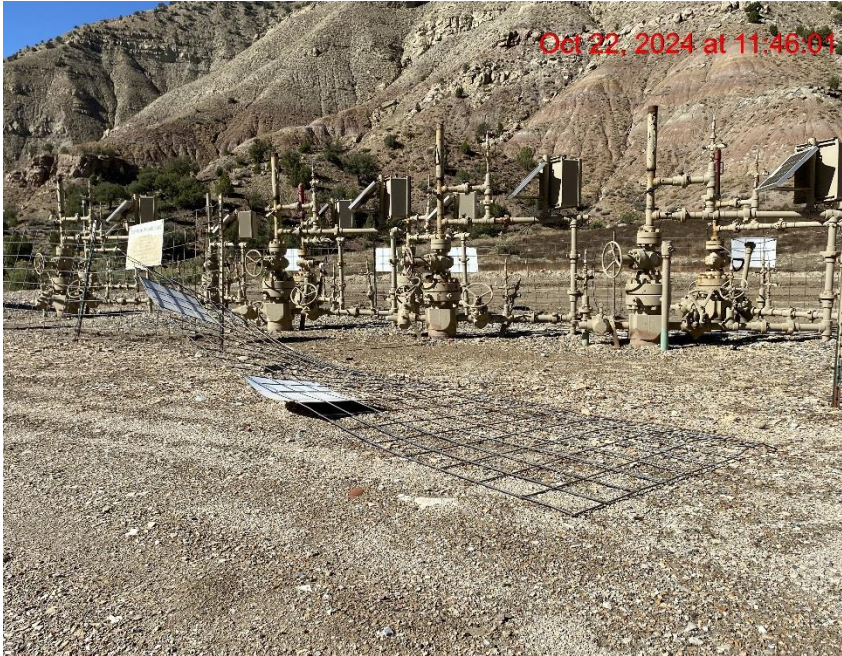
Damaged Wellhead Fencing – Photo #04382
