Inspection Photos

Location Name: QB ENERGY PERRYMAN 10-13 (M10SE) Pad

Location #: 334361

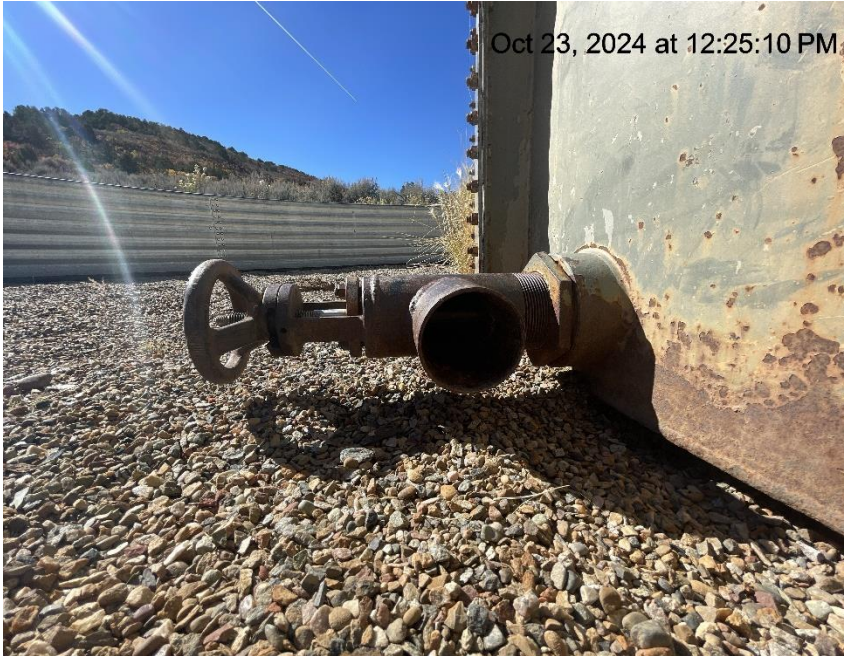
Photo # 6816 Open ended load line

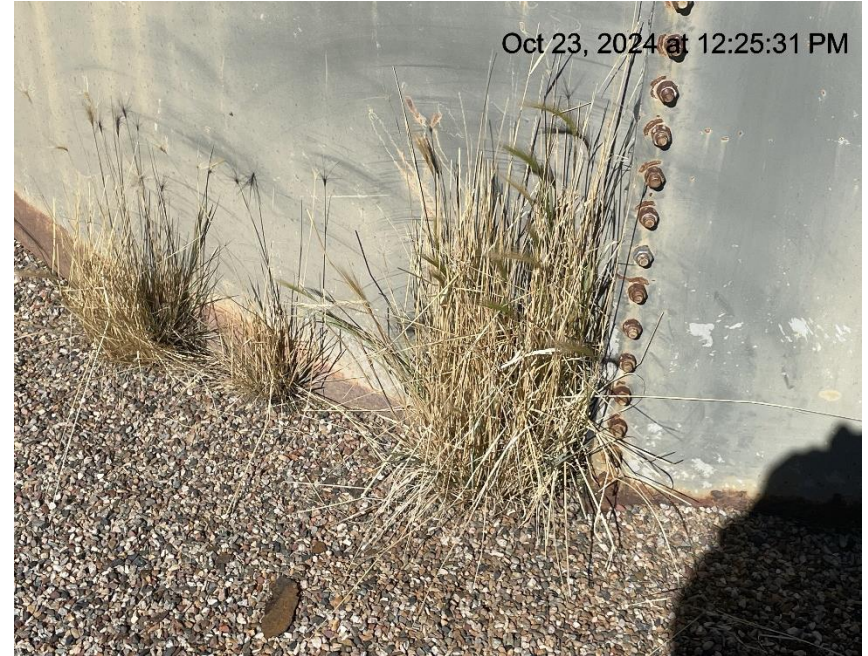
Photo # 6817 Weeds in secondary containment

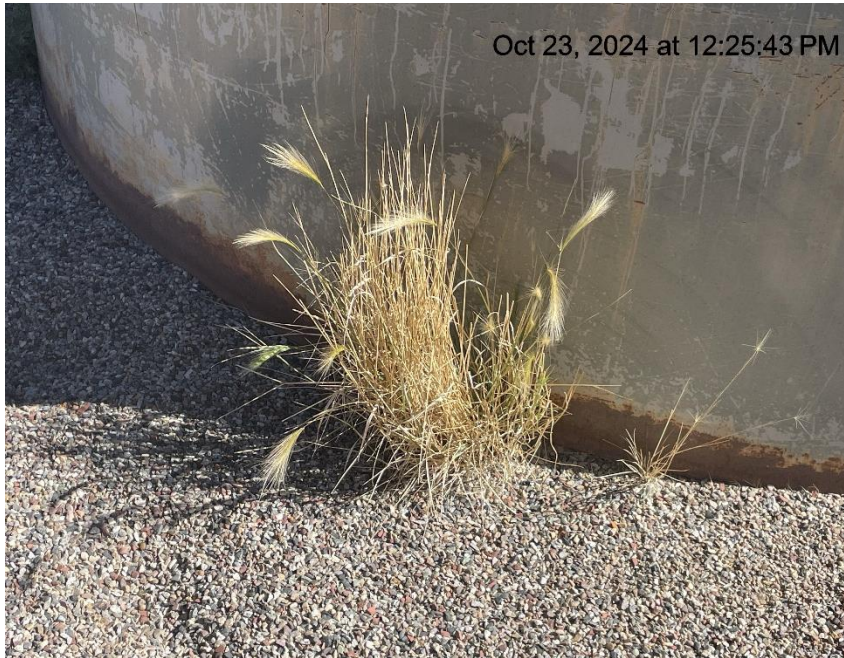
Photo # 6818 Weeds in secondary containment

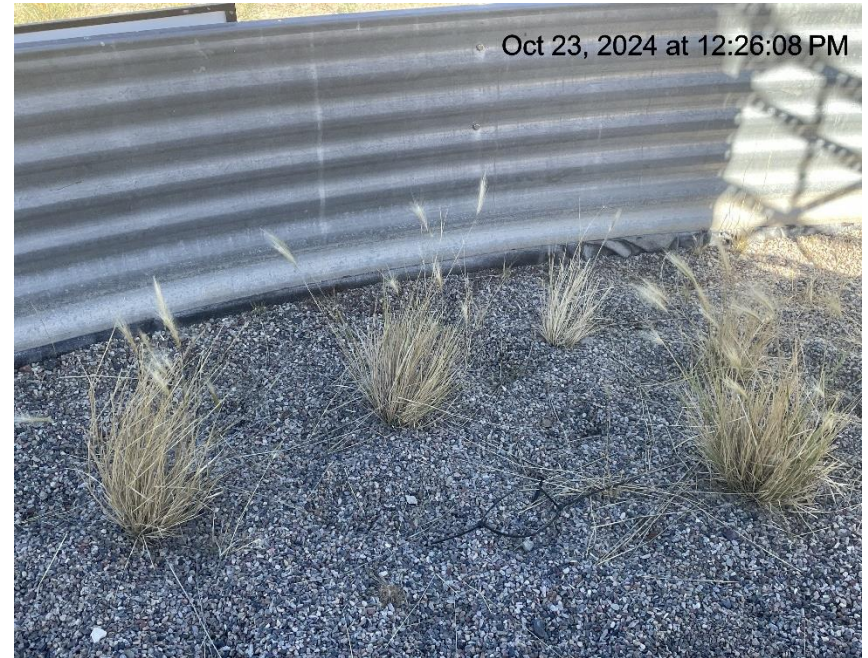
Photo # 6819 Weeds in secondary containment

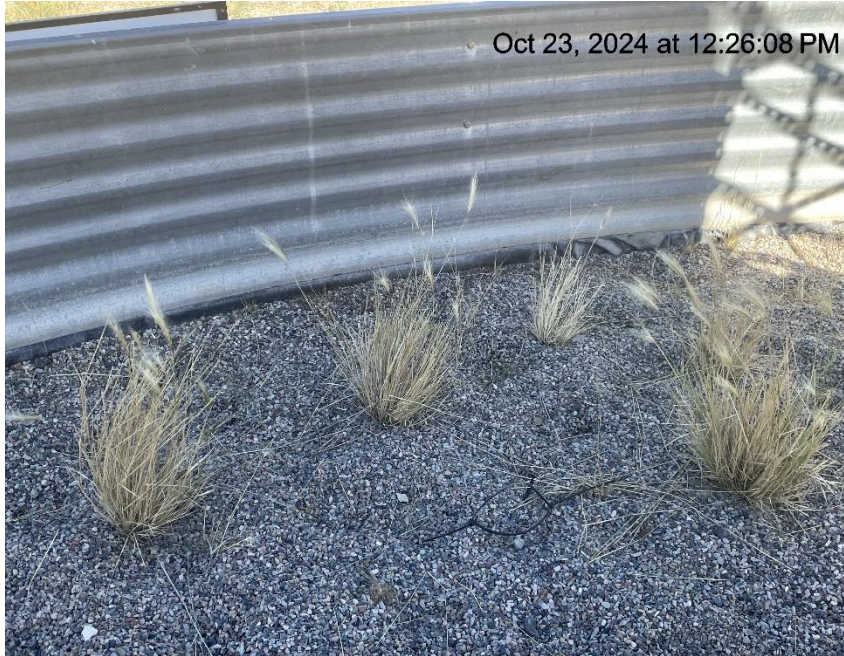
Photo # 6820 Weeds in secondary containment

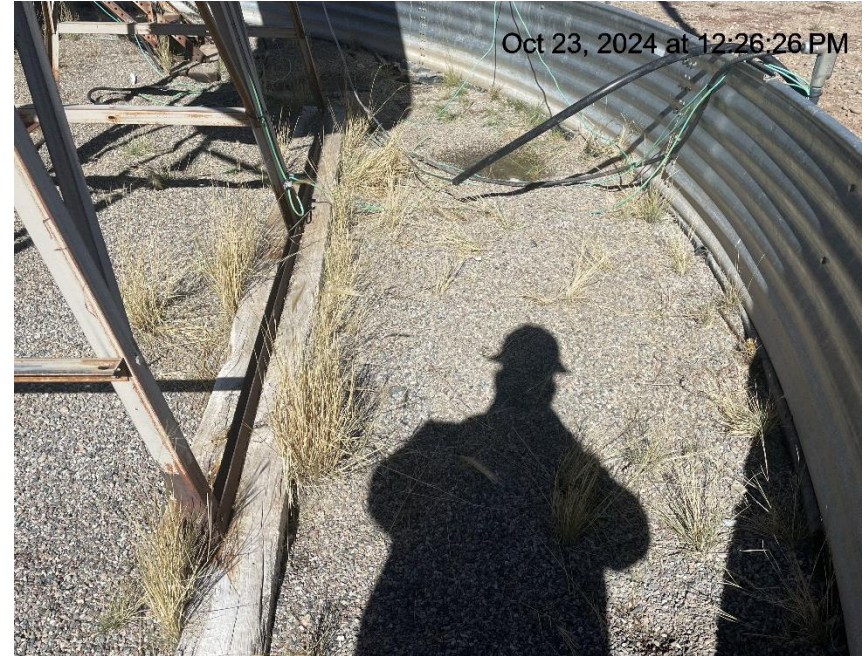
Photo # 6821 Weeds in secondary containment
