Construction and Stormwater Inspection

Operator: PROVIDENCE OPERATING LLC DBA POCO -
10694

Location ID: 460271

Inspection Document #: 708201701

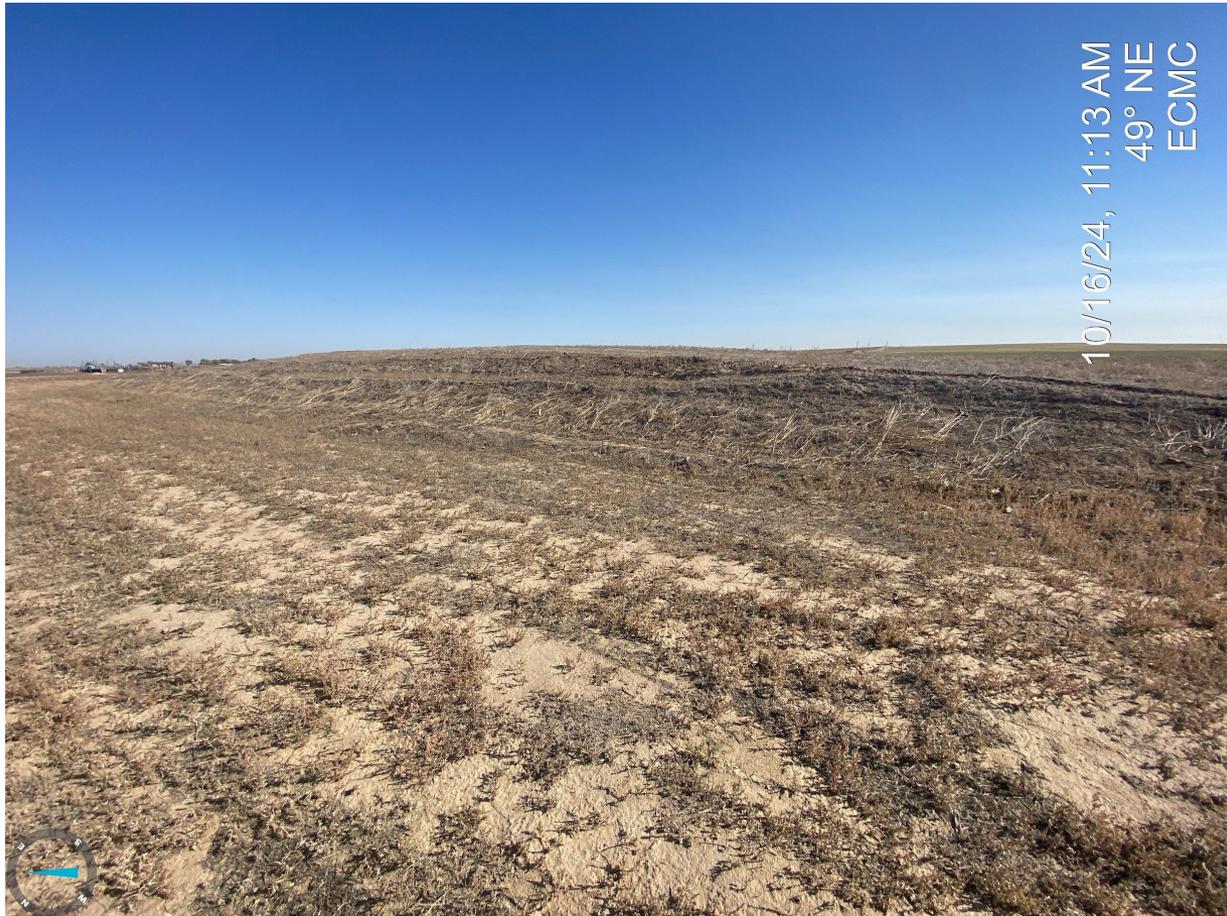
Photo 1. Facing northeast towards the topsoil stockpile. The topsoil stockpile has evidence of significant weed growth (e.g. russian thistle and kochia). Additionally, it does not appear that all topsoil has been salvaged as the stockpile volume on location does not appear to be reflective of the amount of topsoil throughout the salvageable area.

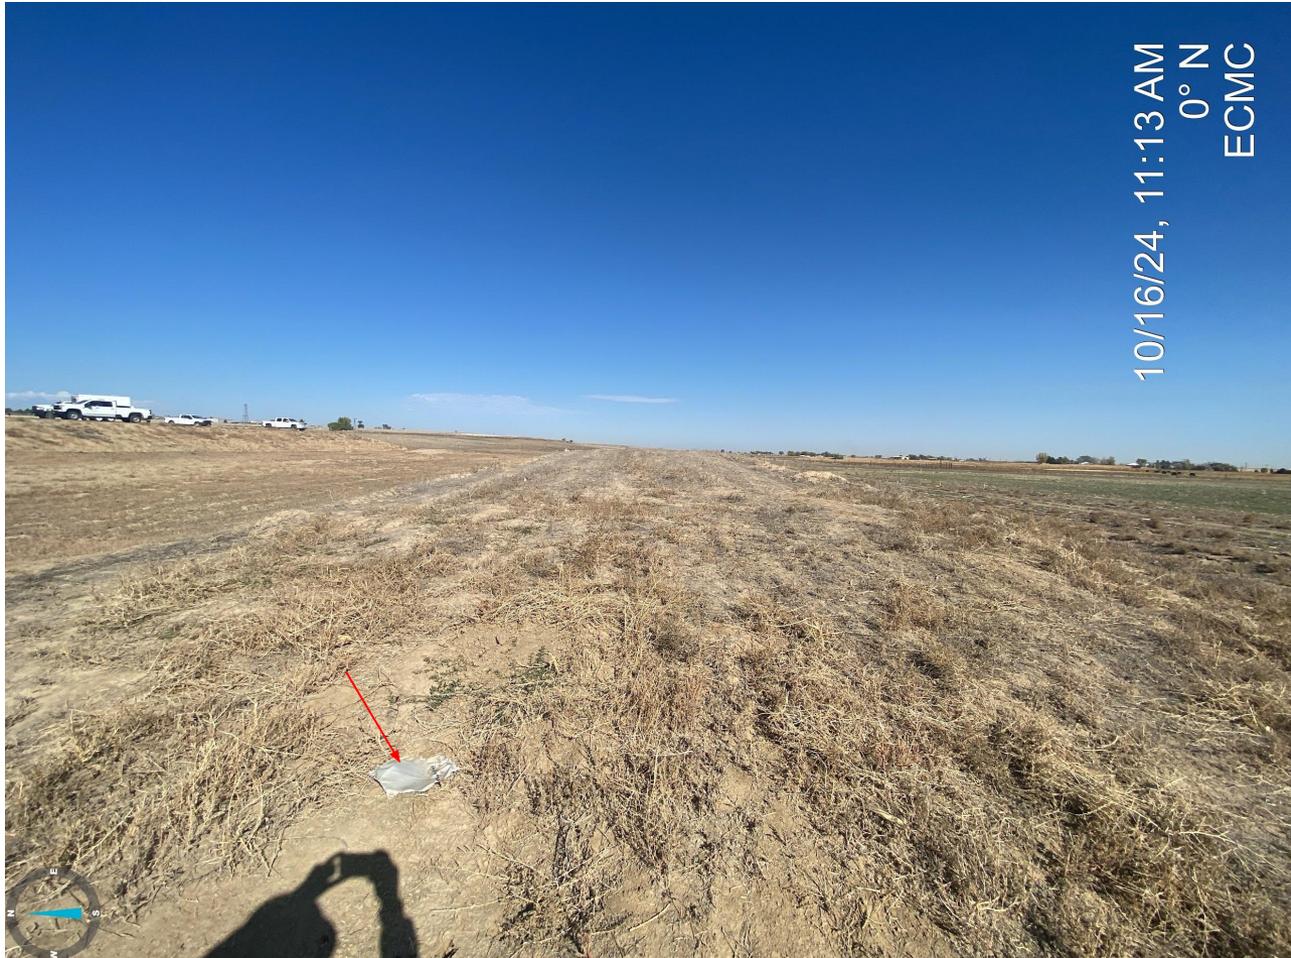
Photo 2. Facing north from the southern portion of the stockpile; see comments in Photo 1. Also pictured, example of trash/debris on location (red arrow).

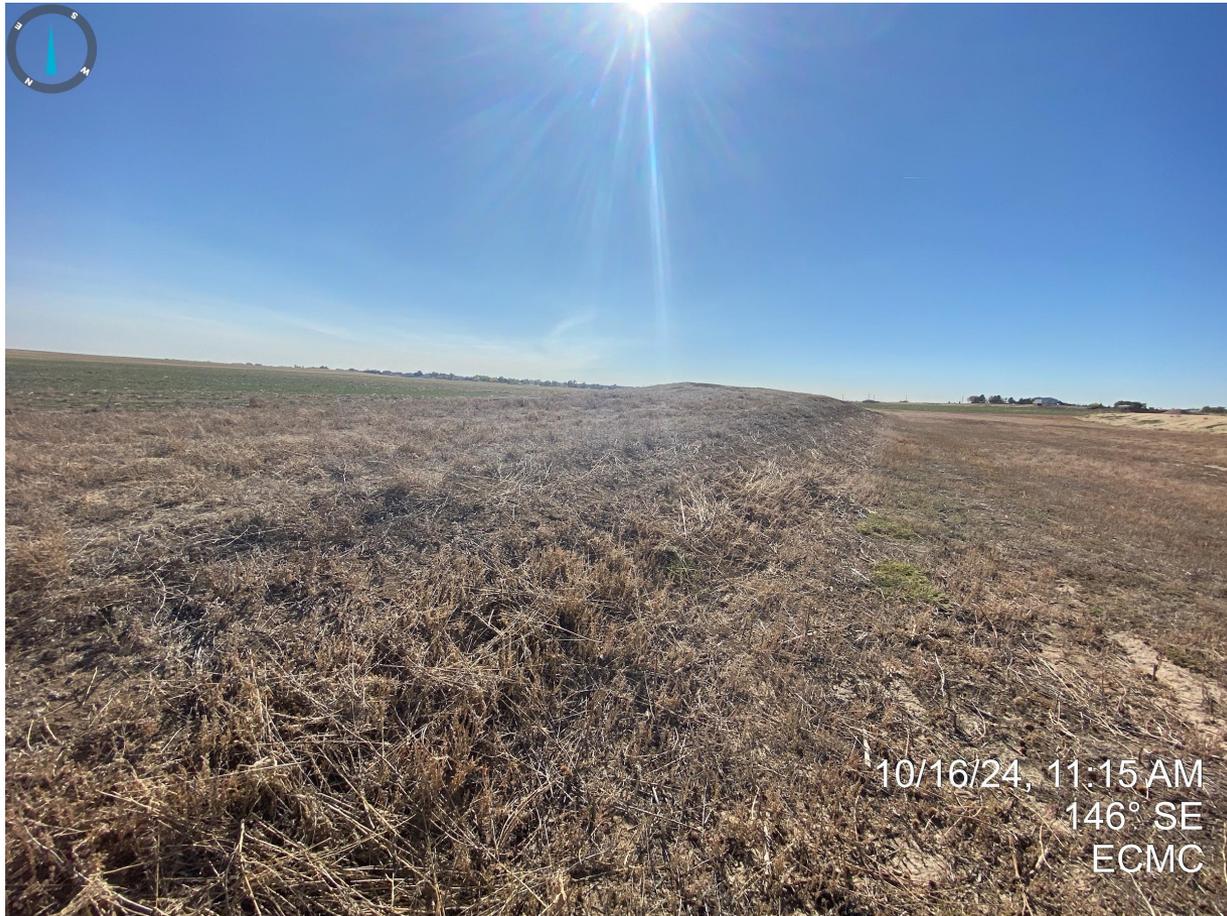
Photo 3. Facing southeast from the northern portion of the stockpile; see comments in Photo 1.

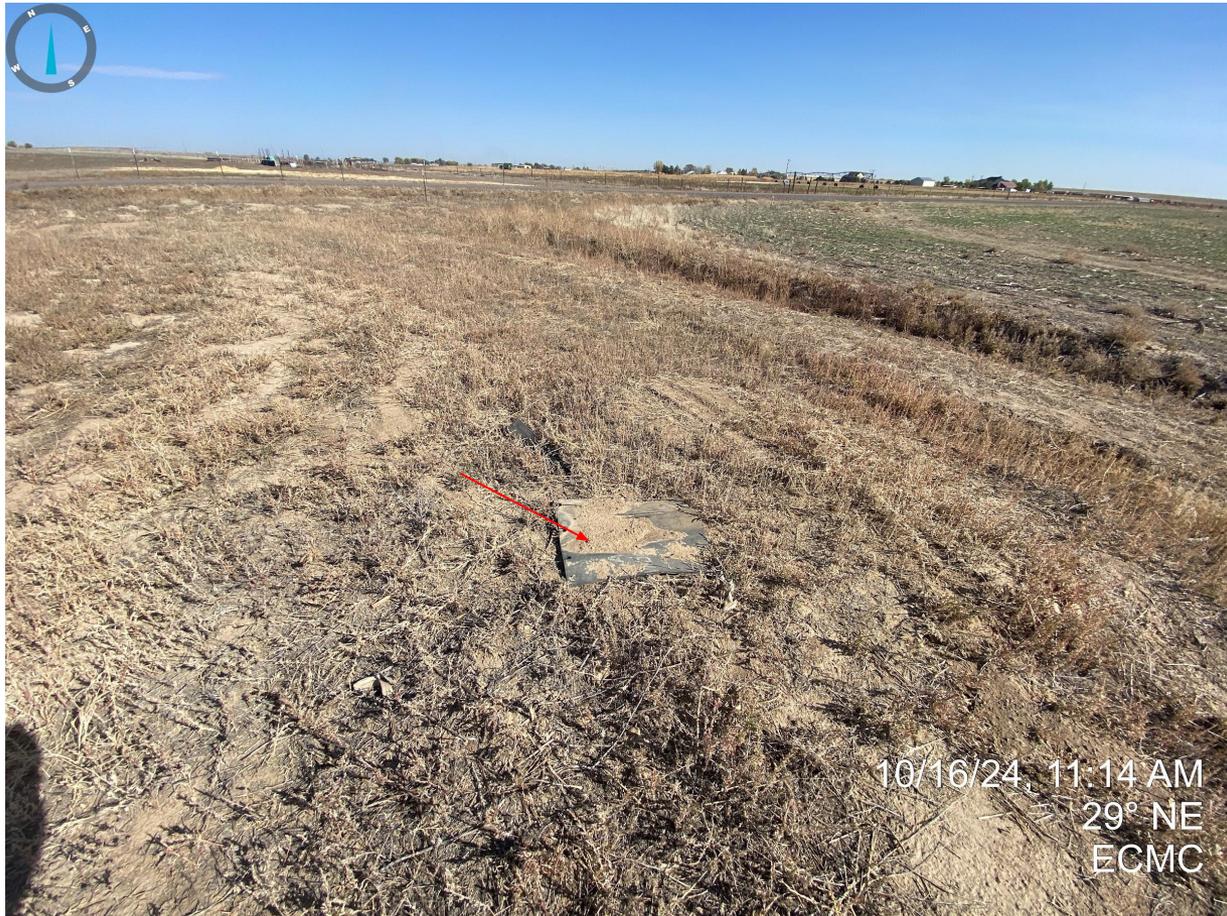
Photo 4. Example of trash/debris on location.

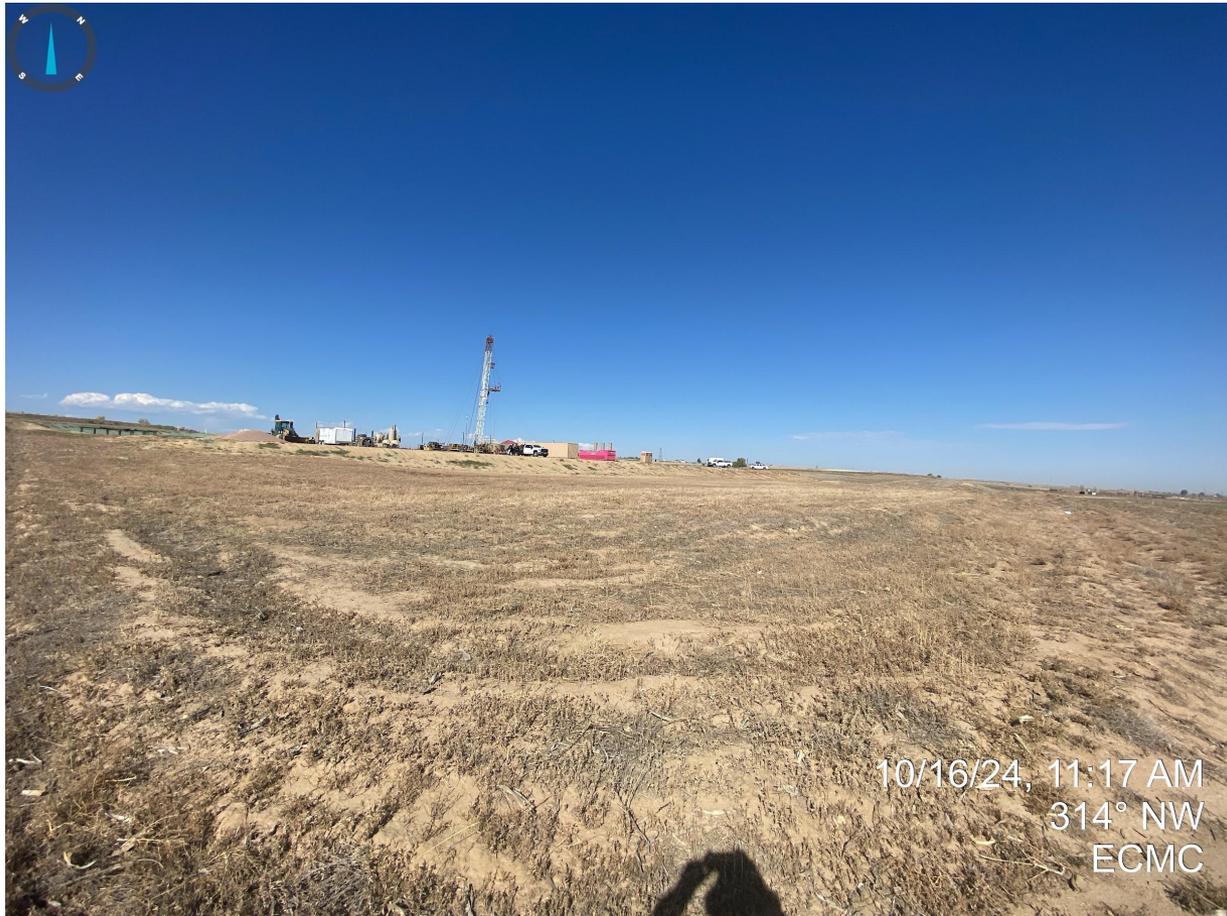
Photo 5. Taken from the southeastern portion of the disturbance area, facing northwest. Disturbance area has evidence of undesirable vegetation (kochia and russian thistle) throughout.

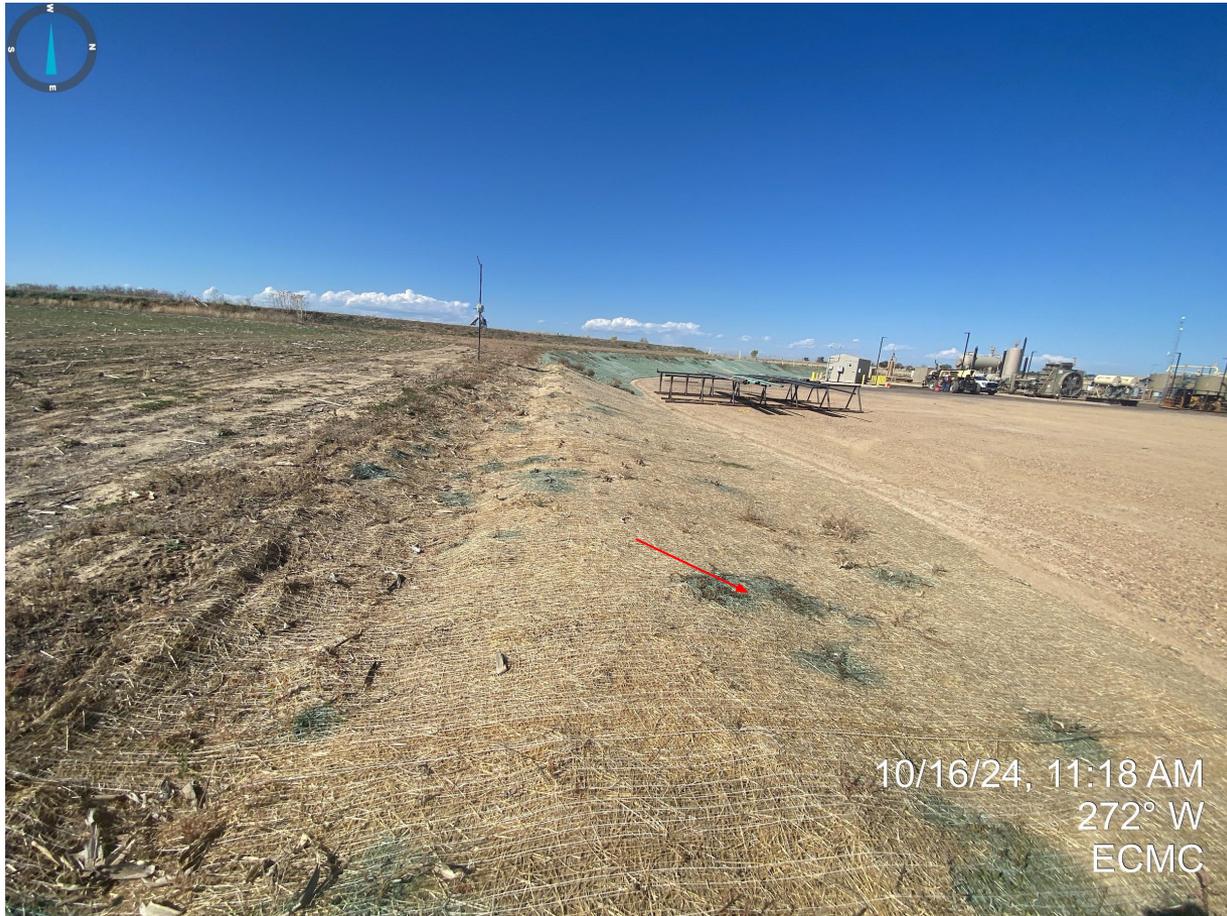
Photo 6. Southern portion of the location. It appears that some undesirable vegetation has been managed for with evidence of spray indicator (possibly blue dye mixed with herbicide).

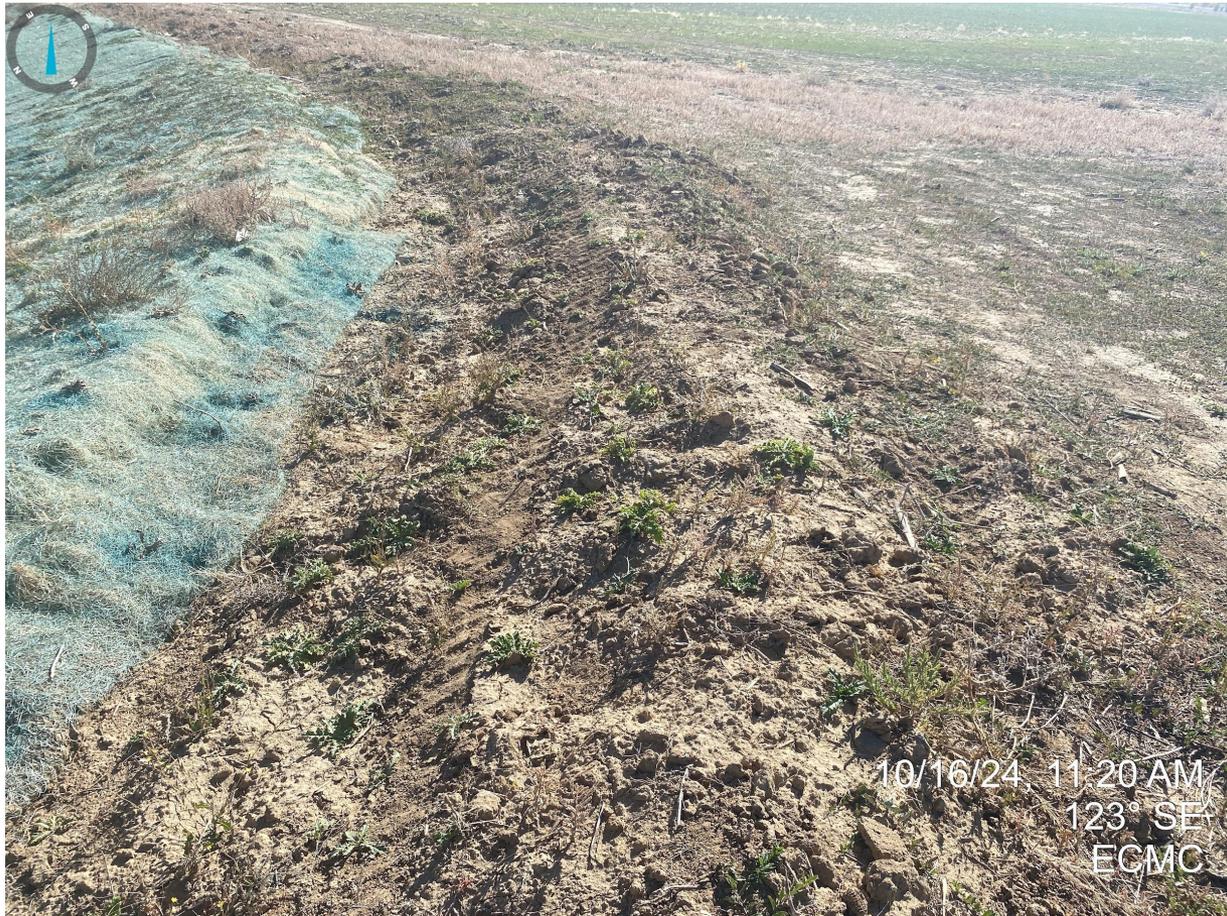
Photo 7. Evidence of Canada thistle (CO List B Noxious Weed) observed on the southern portion of the location. It was unclear if this noxious weed was managed for.

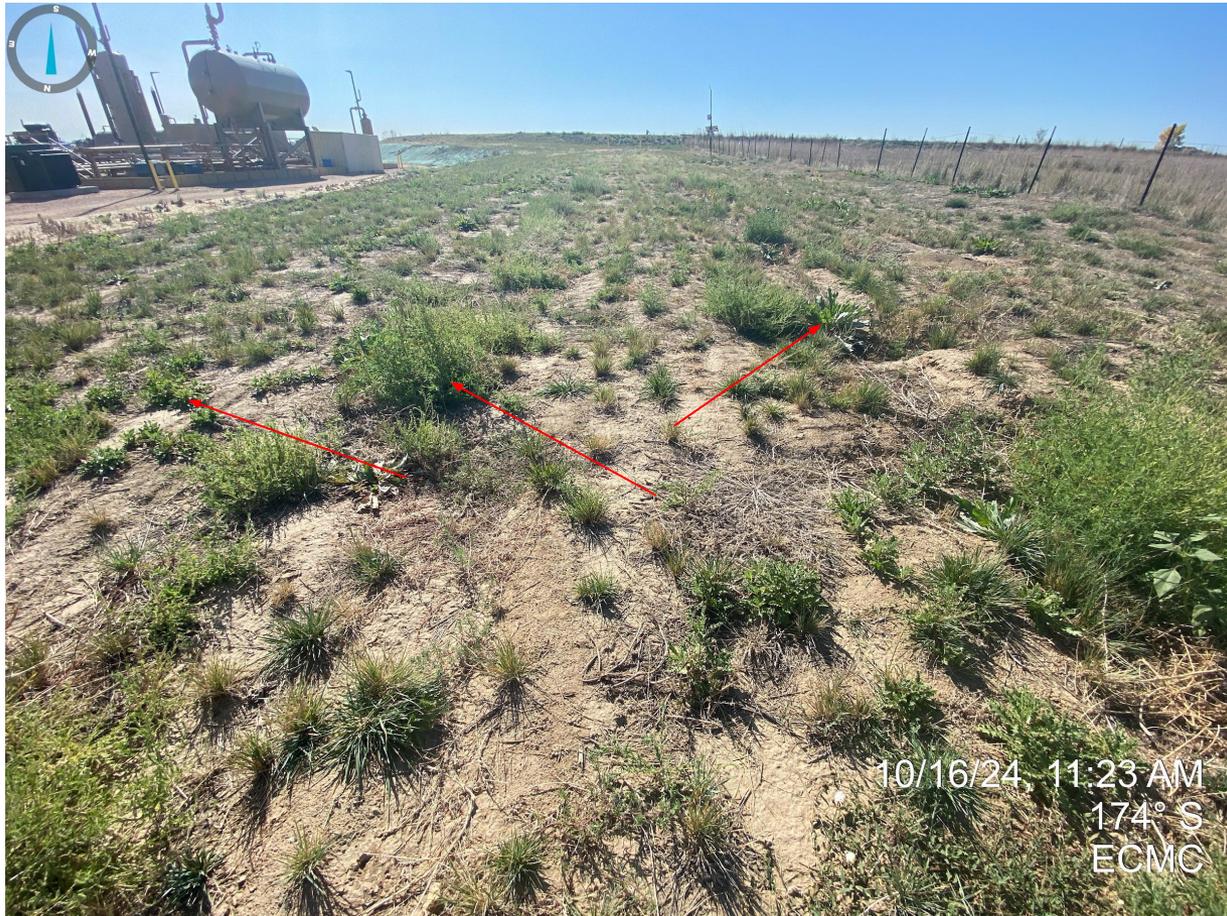
Photo 8. Evidence of noxious weed (canada thistle) and undesirable vegetation (russian thistle and curly dock) on the western portion of the location.

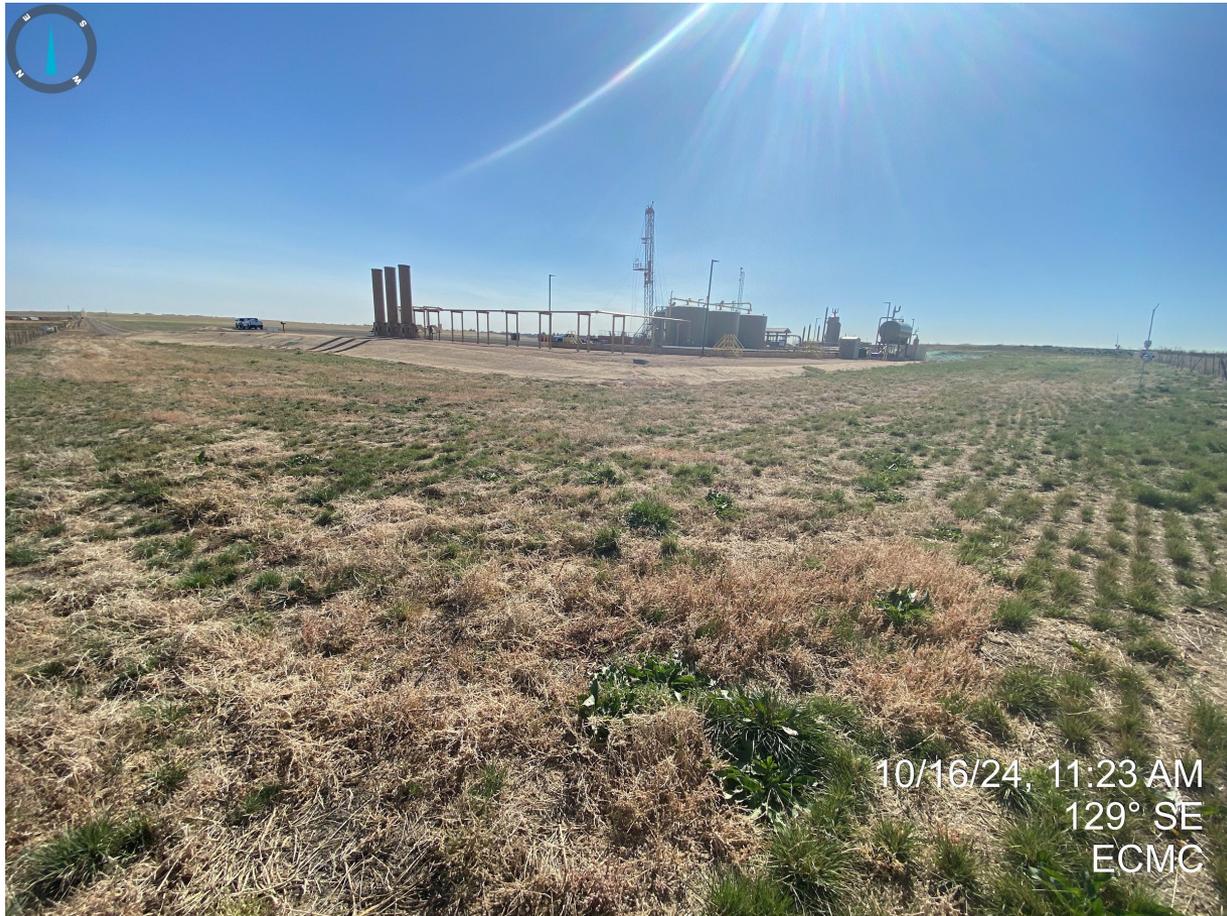
Photo 9. Facing southeast from the northwest corner of the location; see comments in Photo 8.

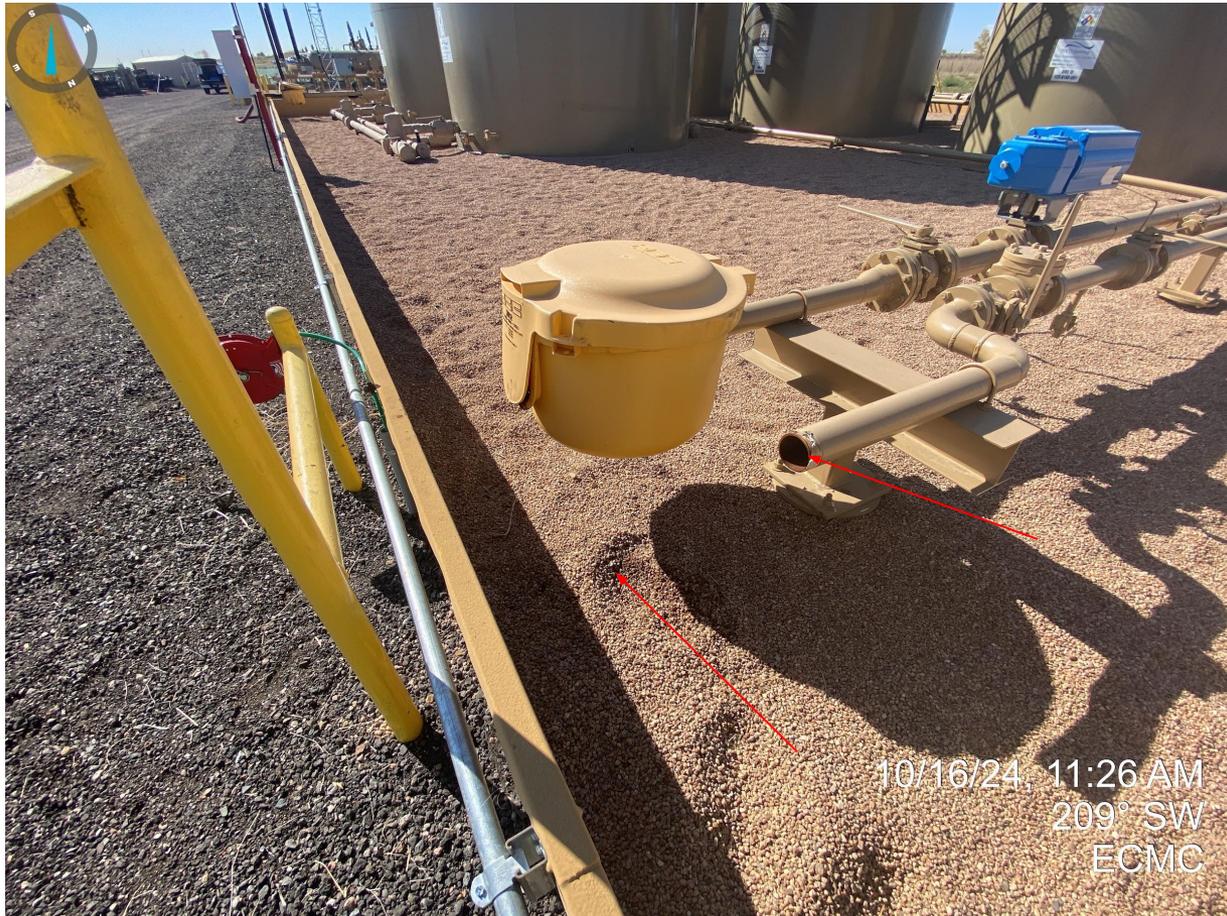
Photo 10. Stained soils and no observed bull plug at loadout line.

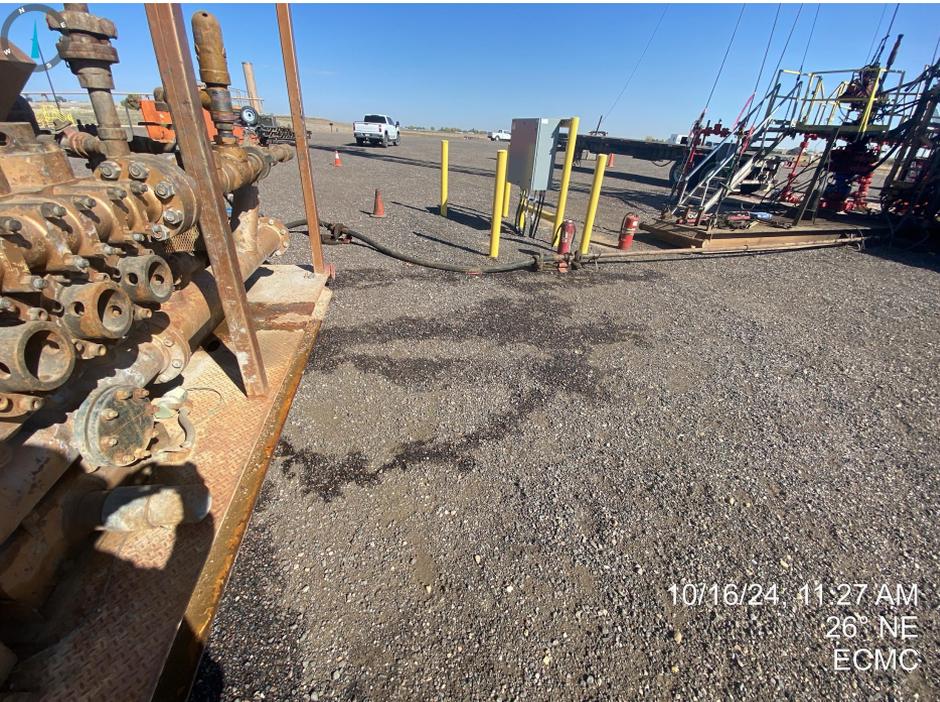
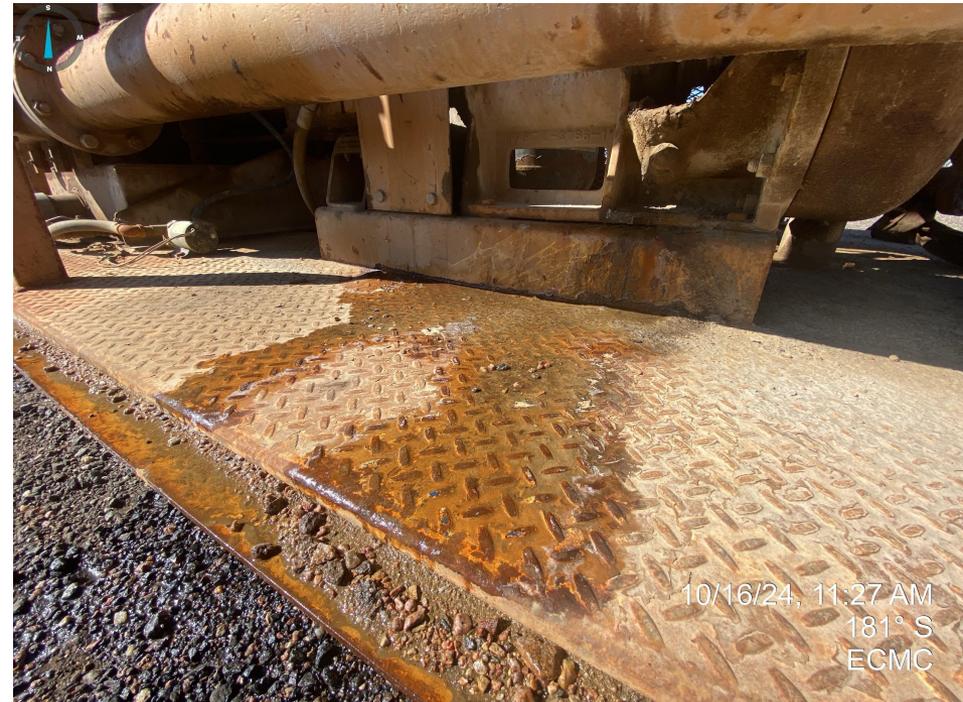
Photos 11 & 12. Unknown fluid leak at pump/motor next to one of the wellheads.

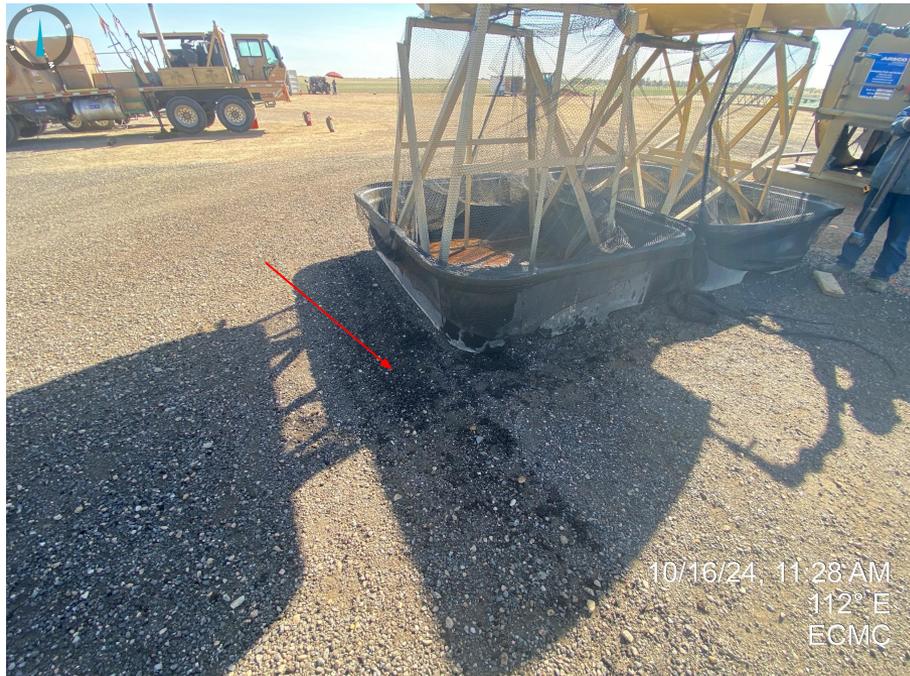
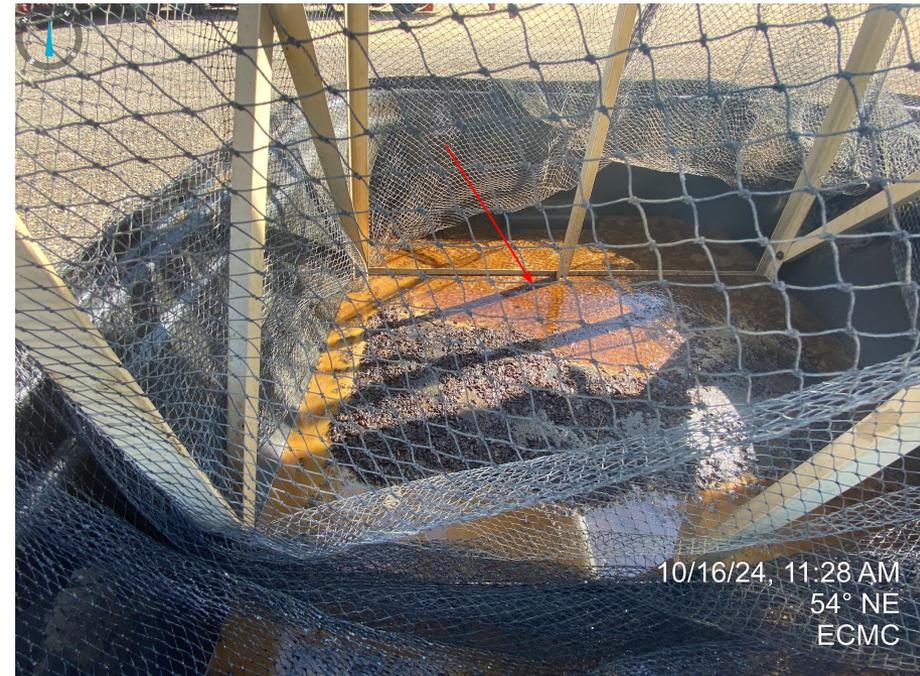
Photos 13 & 14. Netting appears to have been shaken out and reinstalled around the secondary containment. The debris that fell off of the netting appears to have mixed with the unknown contents within the secondary containment. All debris/material outside of the secondary containment, and the unknown contents within the secondary containment, must be properly disposed.

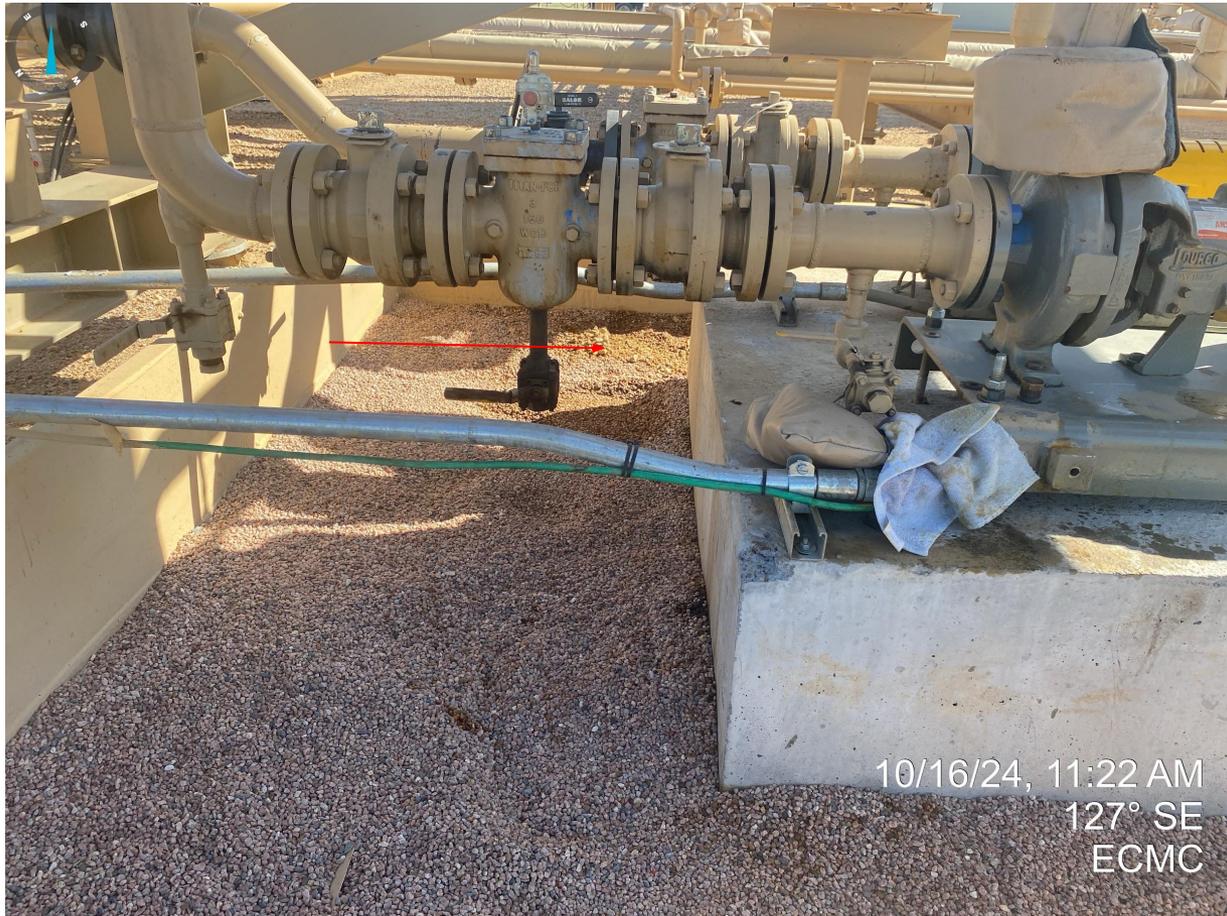
Photo 15. Stained soil observed near the western portion of the tank battery and production facilities.
