## Inspection Photos

Location Name: TEP ROCKY MOUNTAIN LLC, GM-66S96W/27SWSE

Location ID: 335398

Date: 10/23/2024

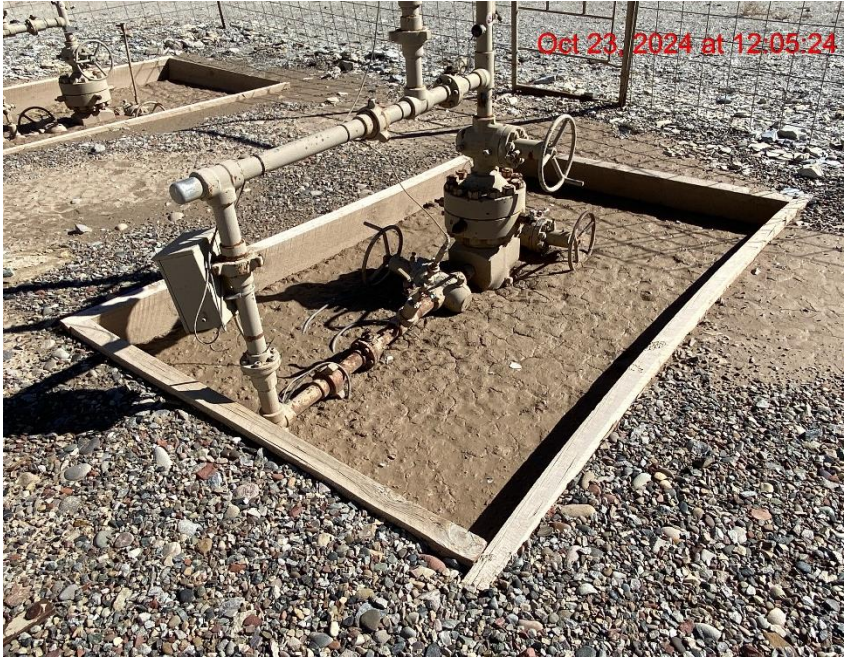
Open Wellhead Cellar/No Wildlife Egress – Photo #04428

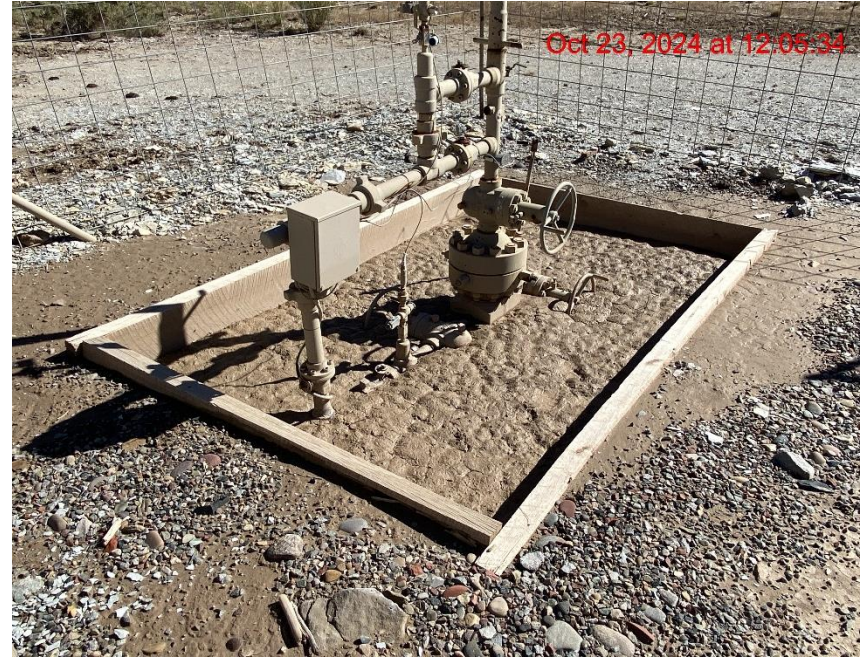
Open Wellhead Cellar/No Wildlife Egress – Photo #04429

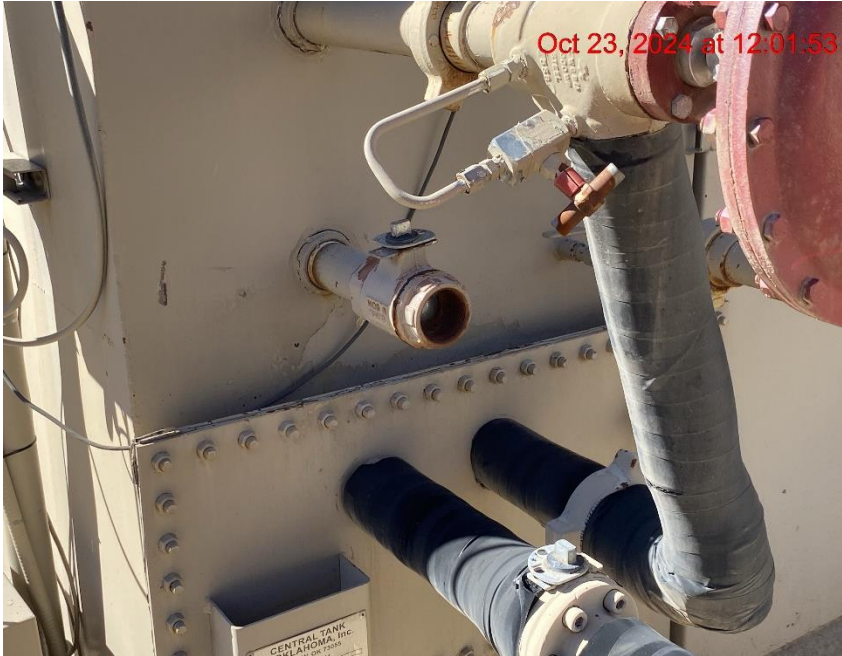
**Open-Ended Line on Separator – Photo #04421**

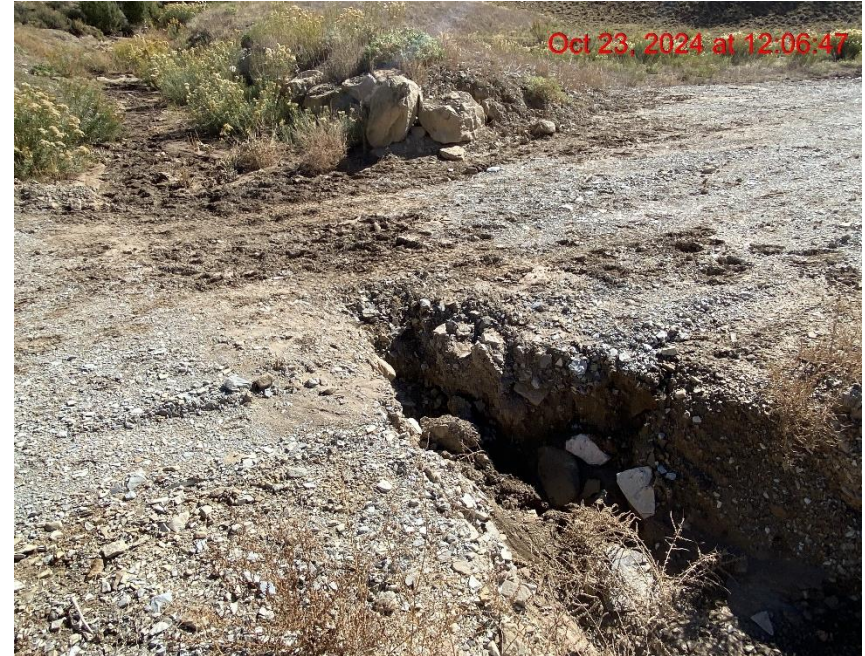
**Insufficient Erosion Control/Degradation – Photo #04430**

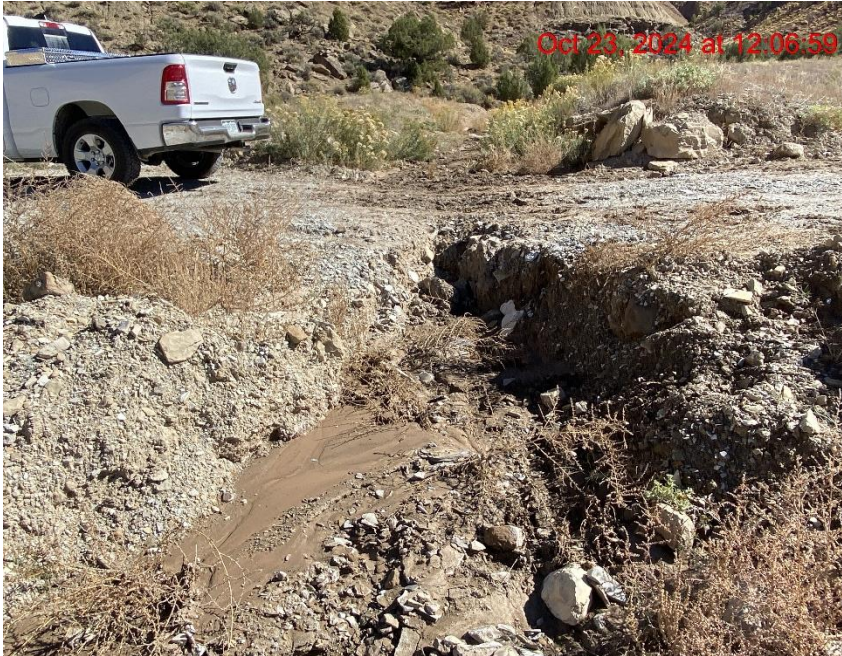
**Insufficient Erosion Control/Degradation – Photo #04431**

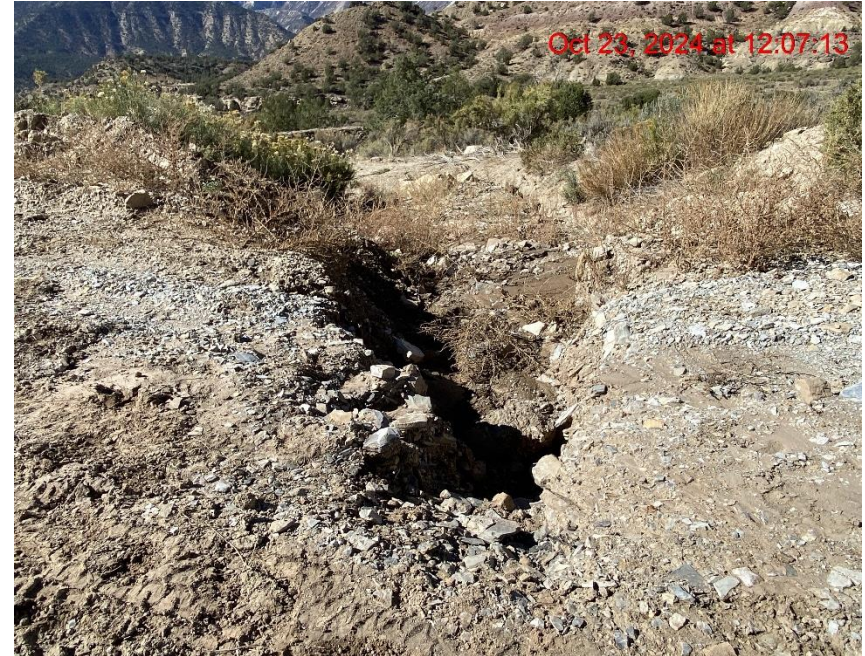
**Insufficient Erosion Control/Degradation – Photo #04432**
