**Antler Energy LLC
Federal-Chamberlin 22-1
Location ID: 312863**

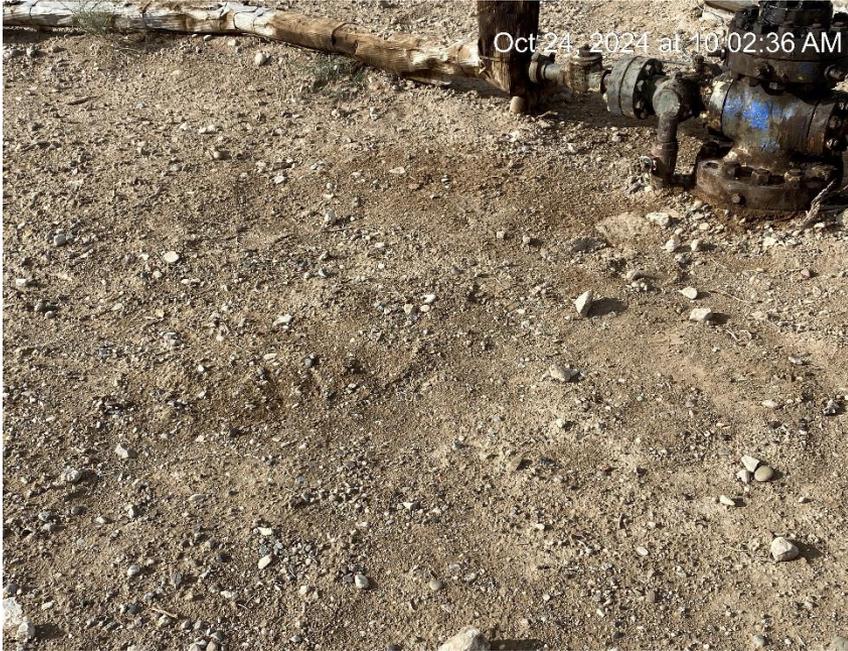
Soil staining

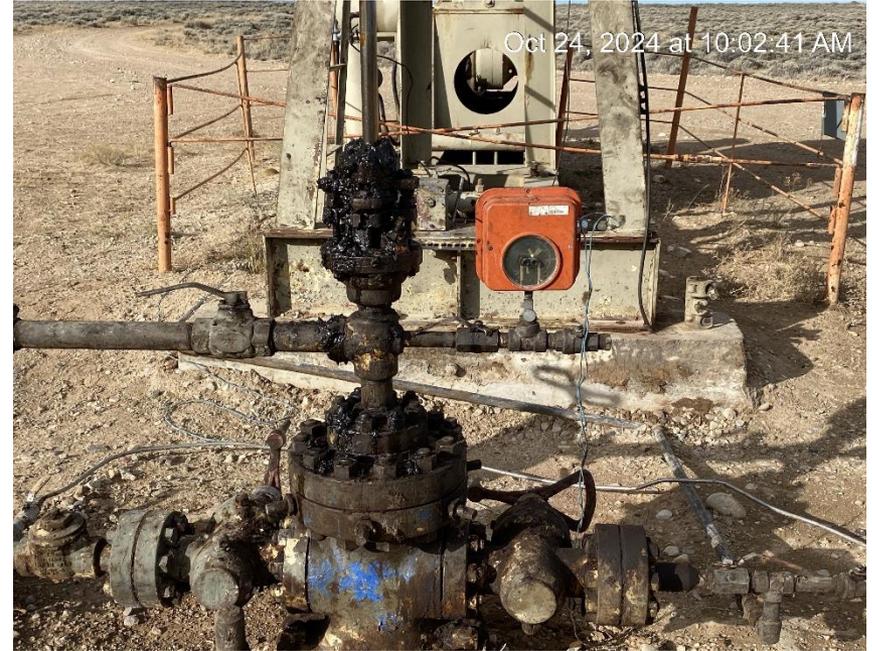
Oily waste

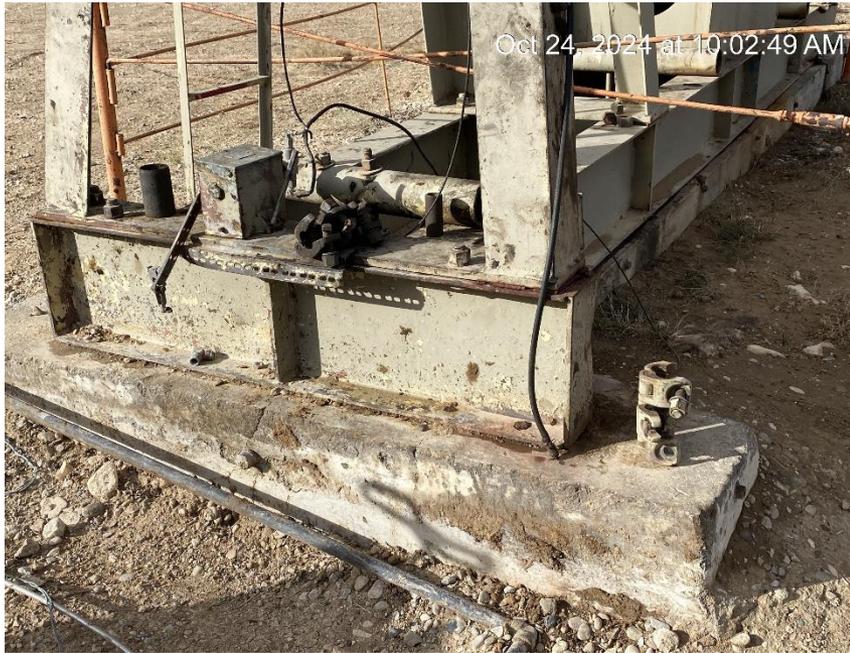
Debris

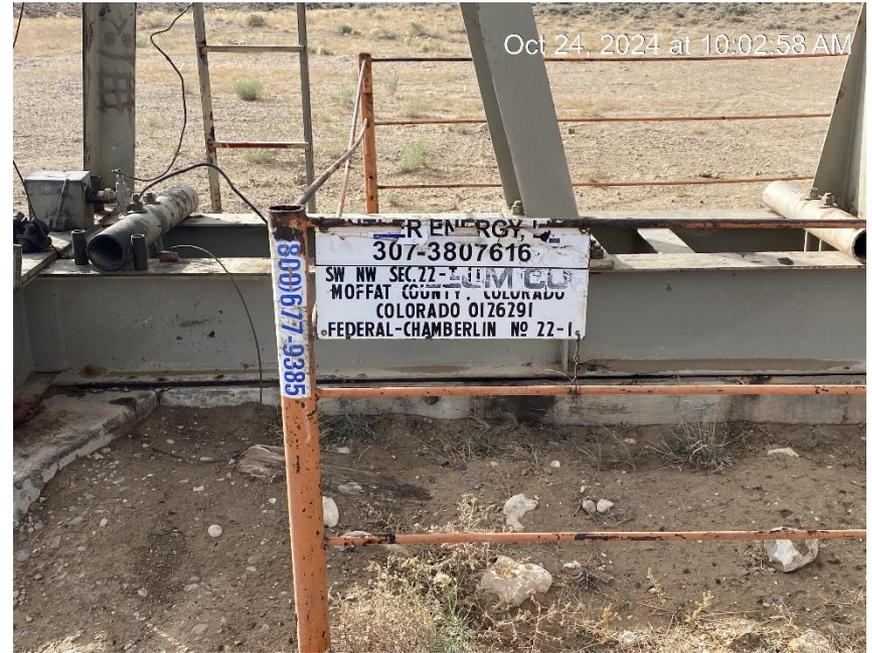
Well sign missing required information

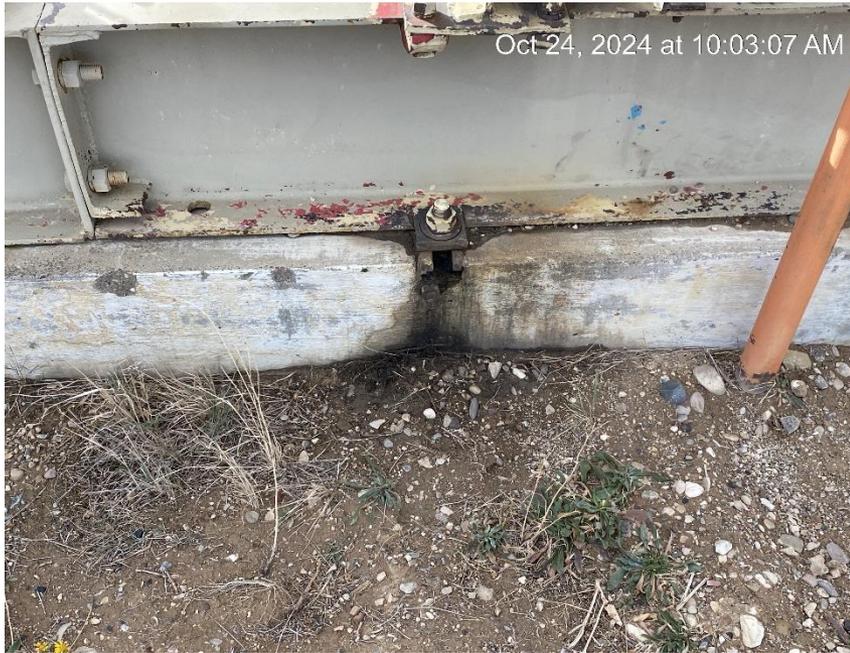
Staining

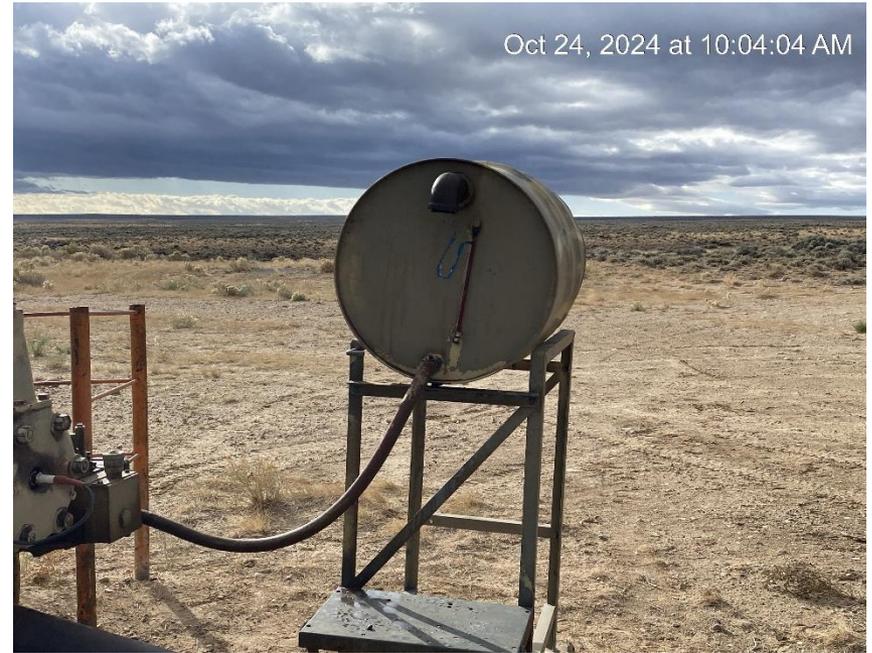
Unlabeled tank

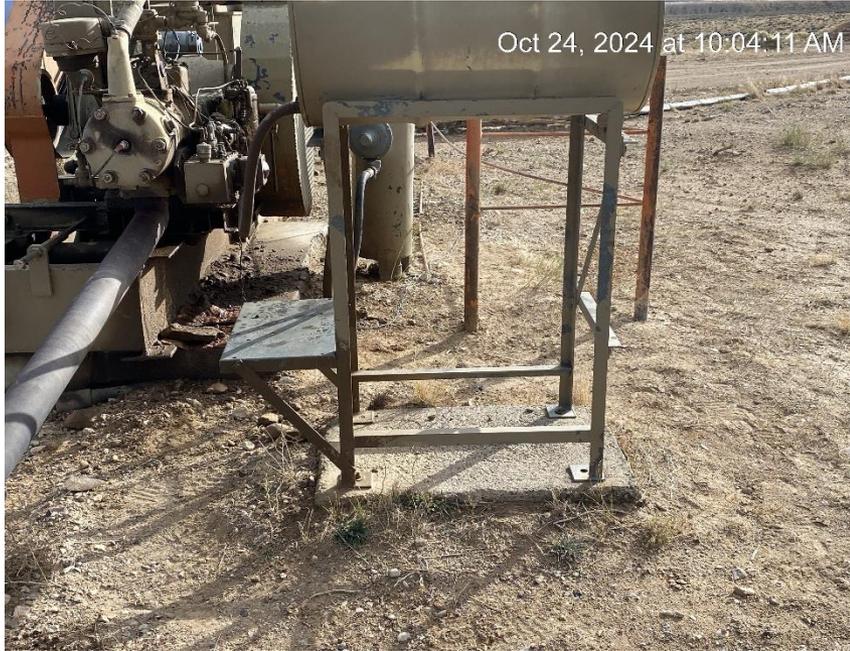
No containment

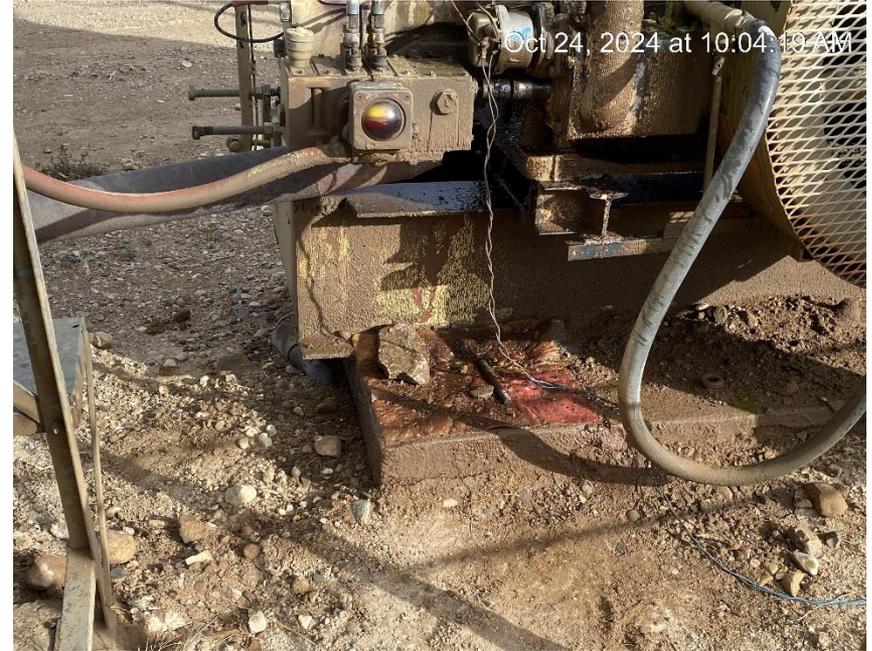
Oily waste. Stained soil

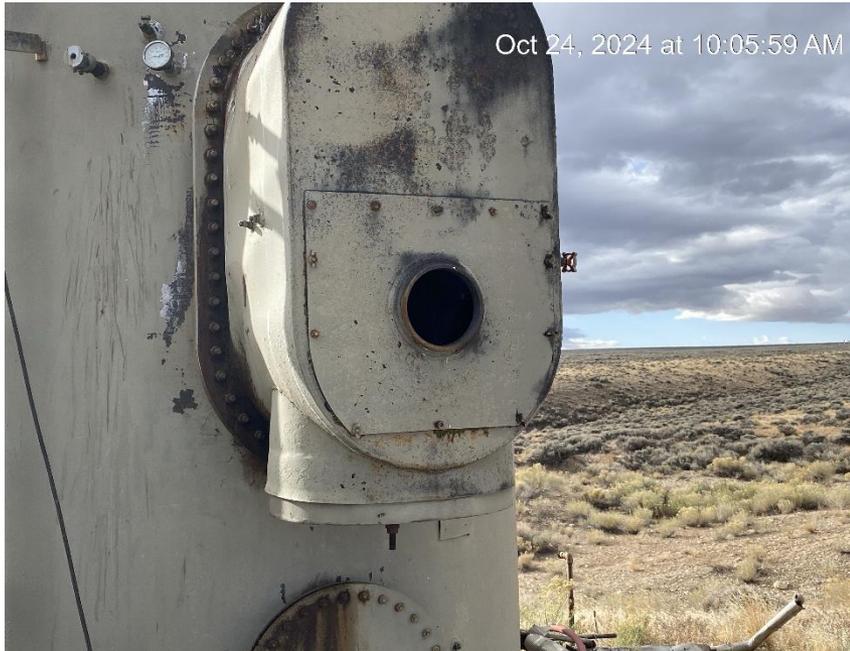
Open to wildlife

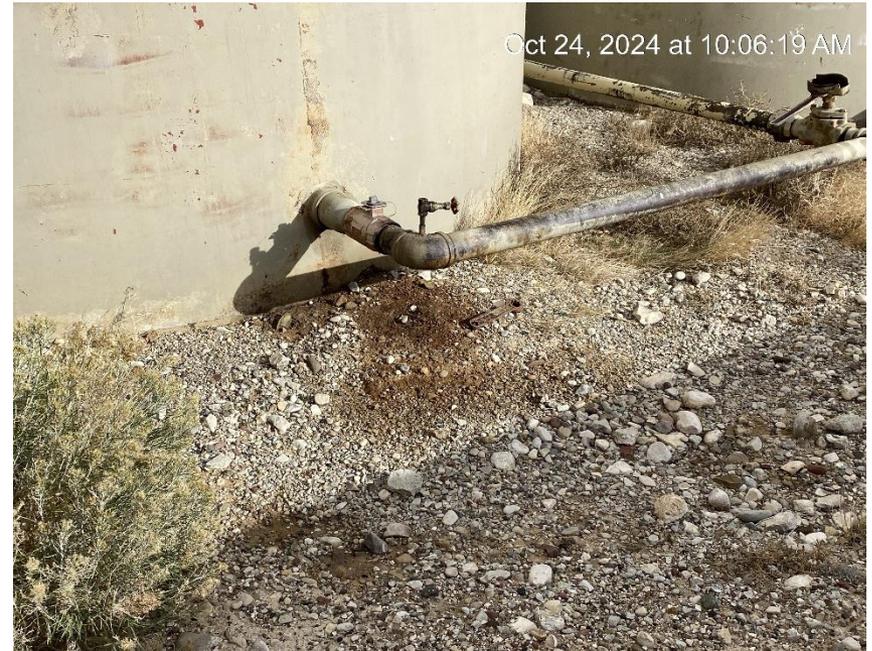
Stained soil

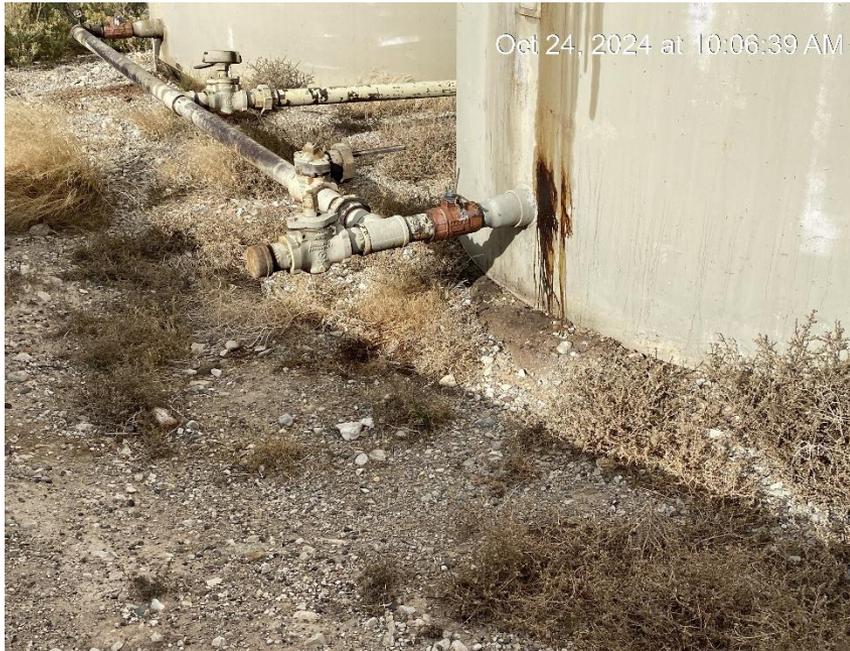
Stained soil

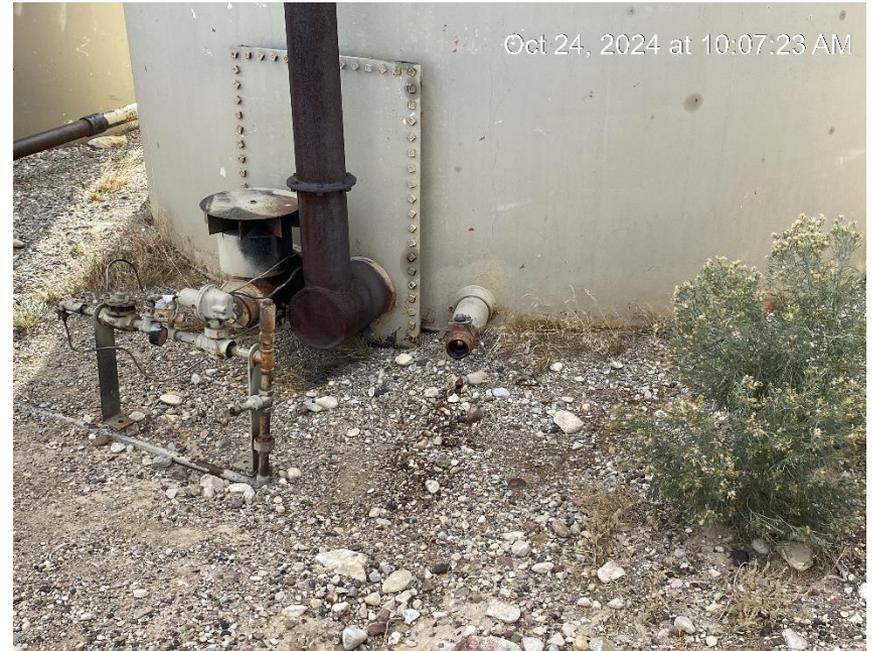
Open end tank valve. Stained soil.

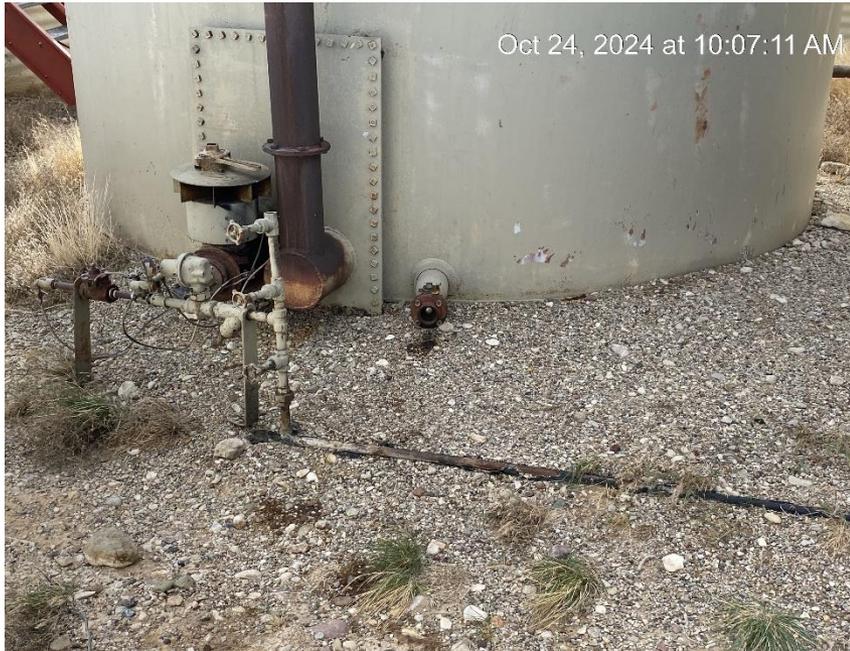
Open end tank valve. Stained soil.

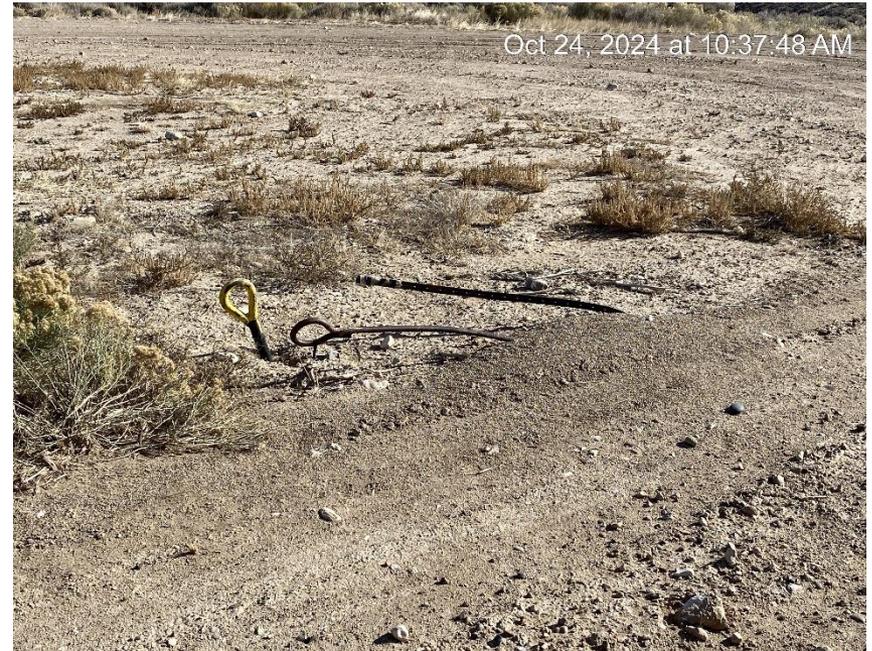
Unmarked anchors
