Inspection Photos

Location: TEP ROCKY MOUNTAIN LLC CHEVRON-65S97W/16SESW

Location ID: 324330

Date: 10/24/2024

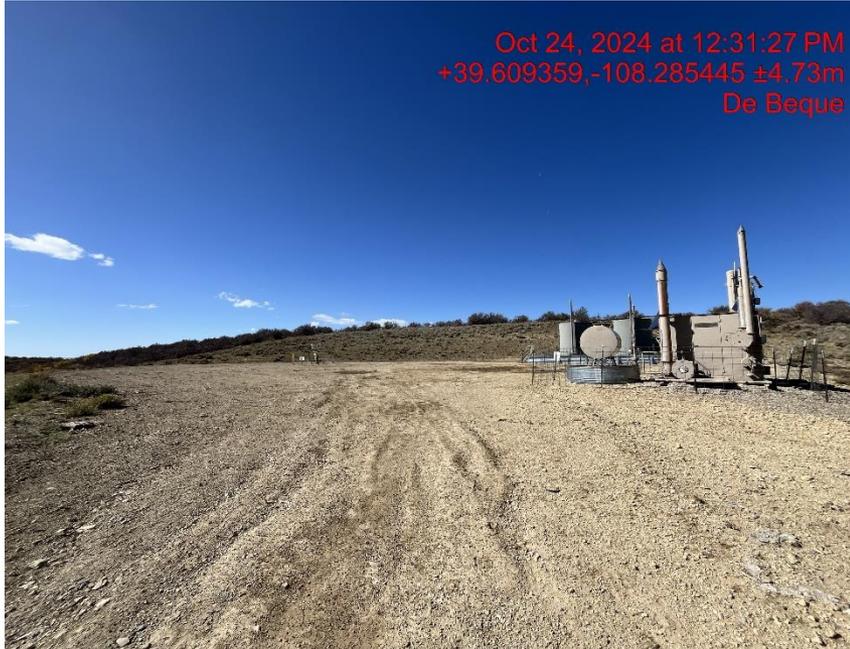
Photo # 7640 Entrance to location

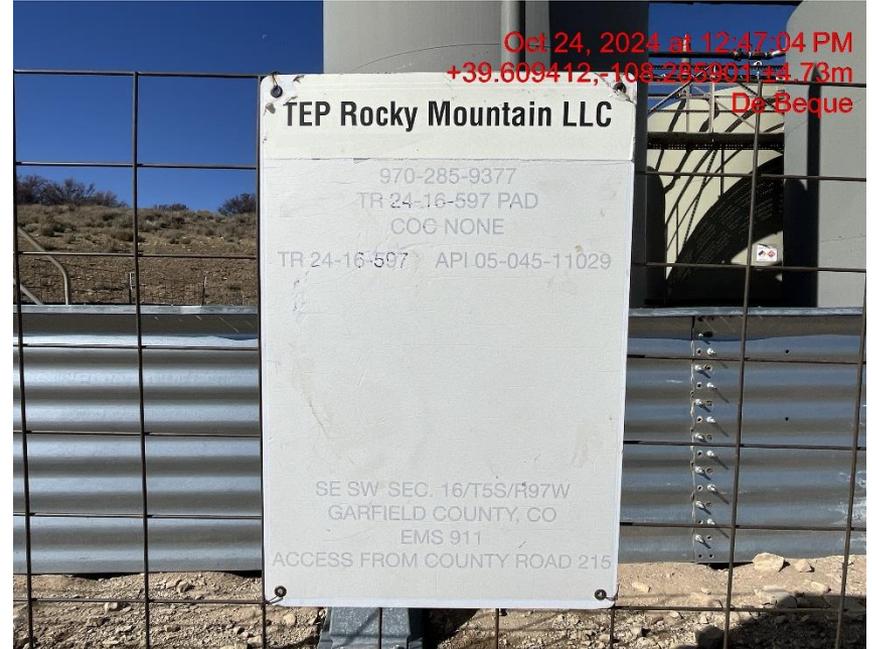
Photo # 7958 Location

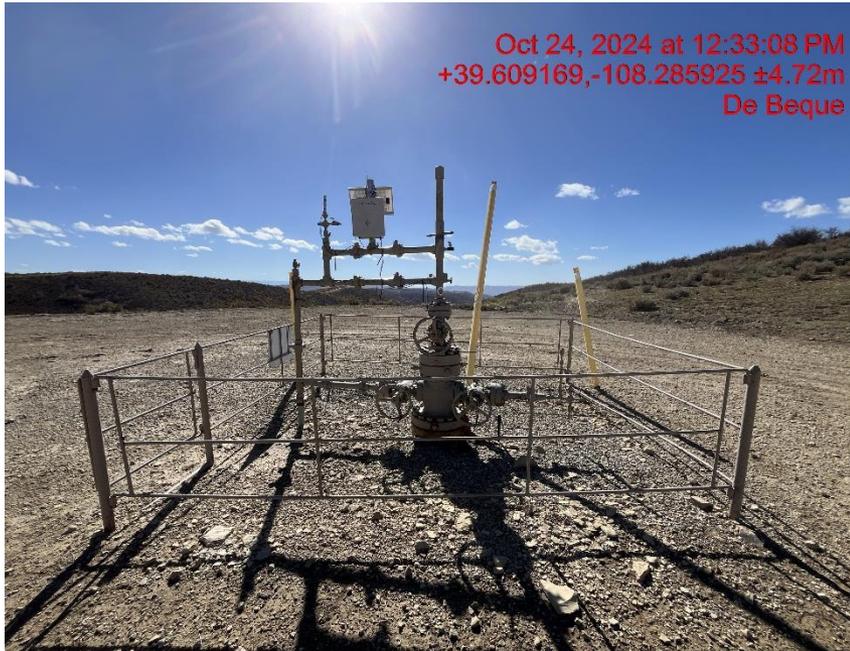
Photo # 7942 Location

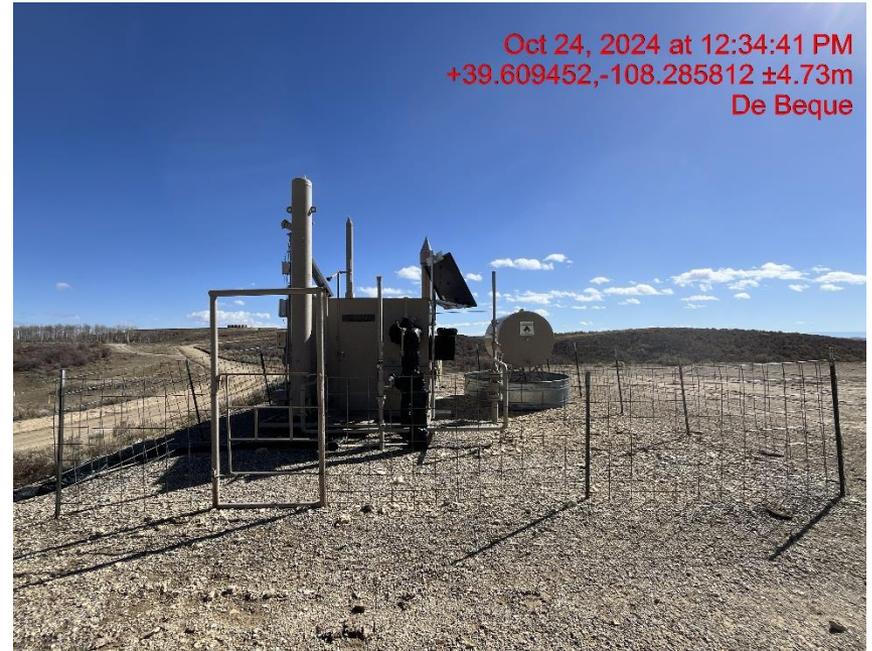
Photo # 7944 Location

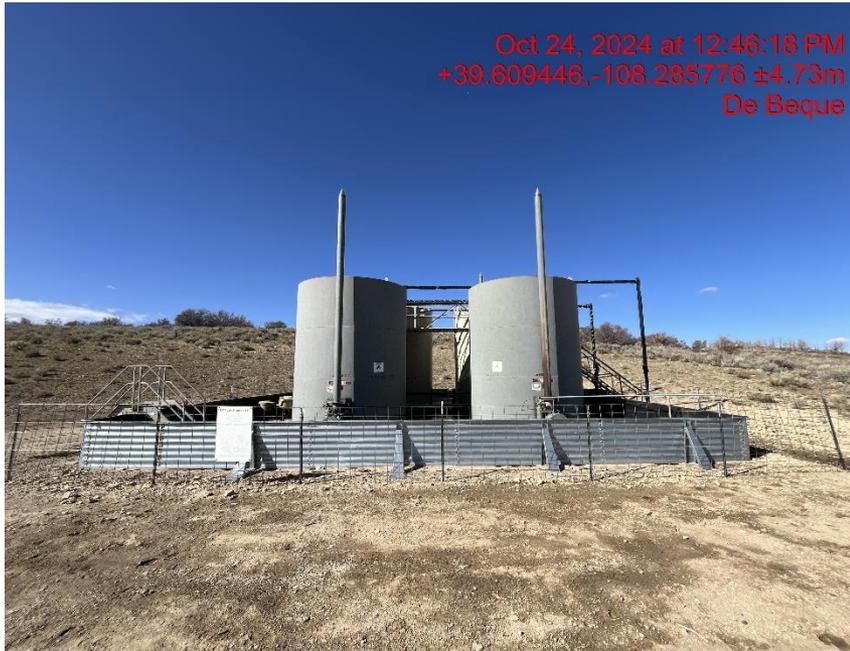
Photo # 7956 Location

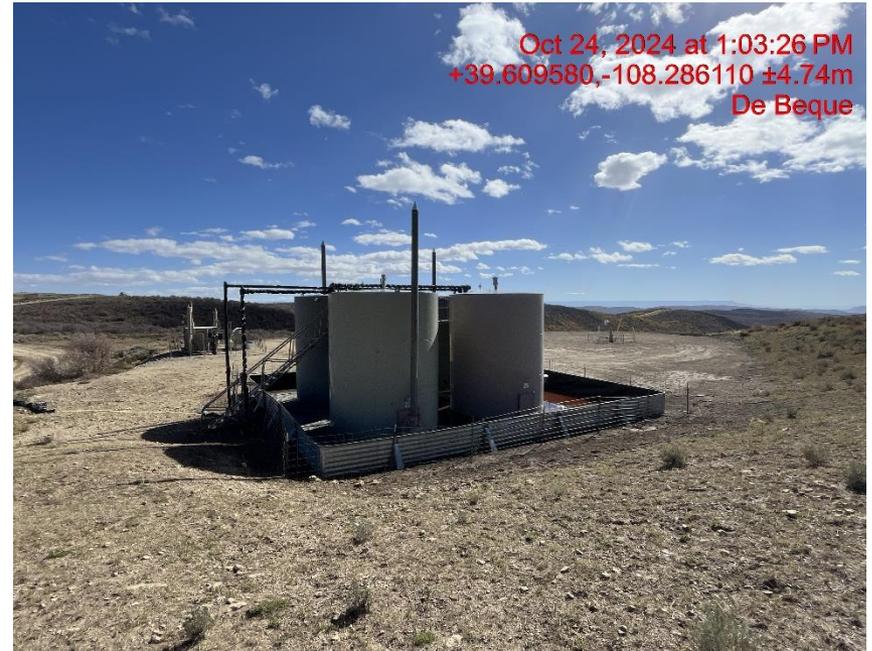
Photo # 7981 NW corner of location

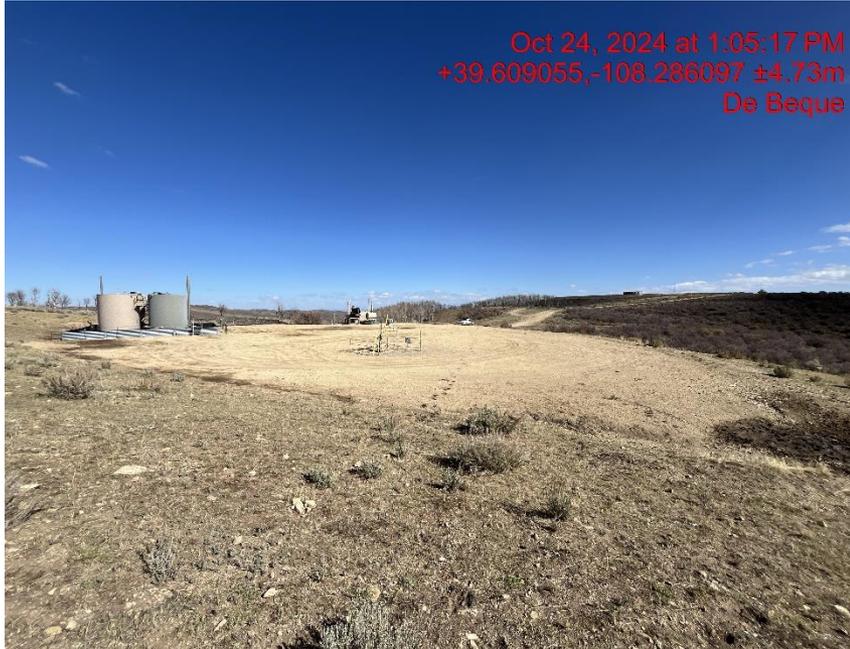
Photo # 7982 SW corner of location

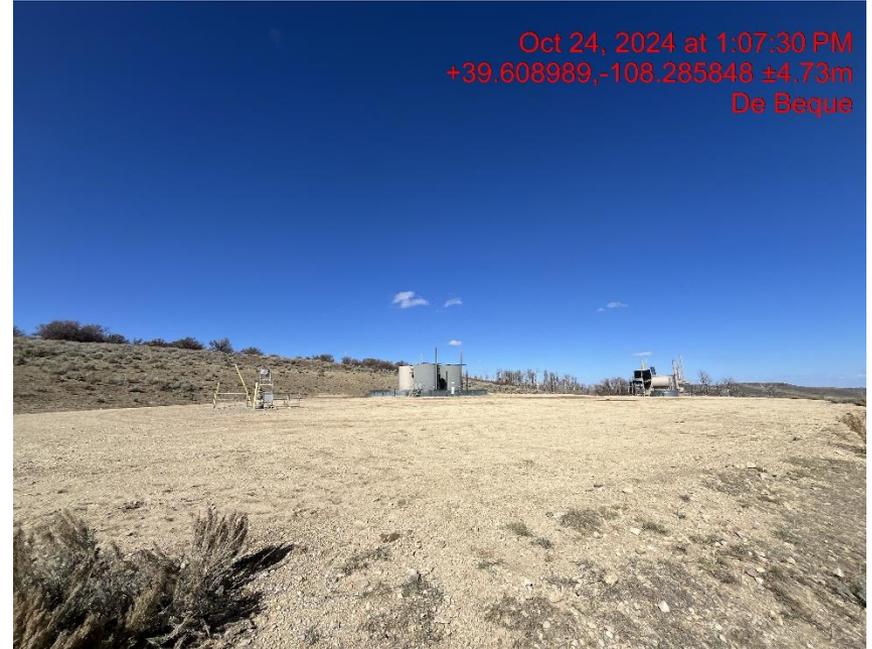
Photo # 7983 SE corner of location

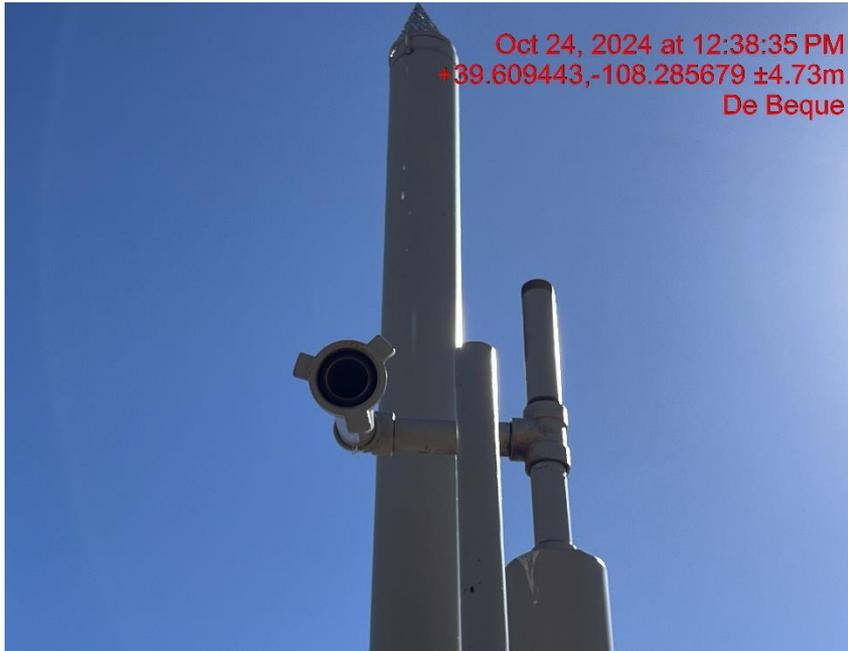
Photo # 7950 Wildlife hazard

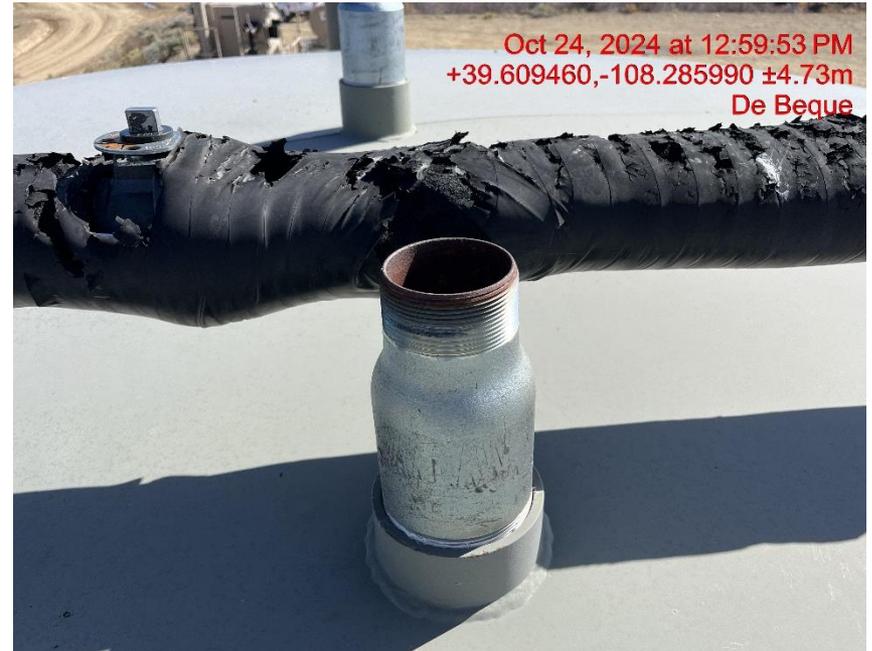
Photo # 7978 Wildlife hazard

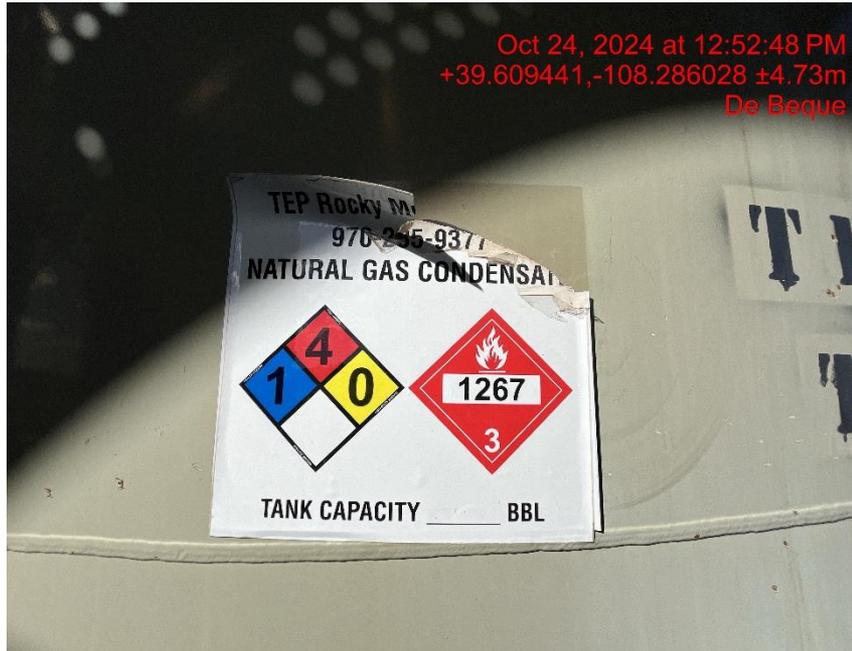
Photo # 7964 Illegible

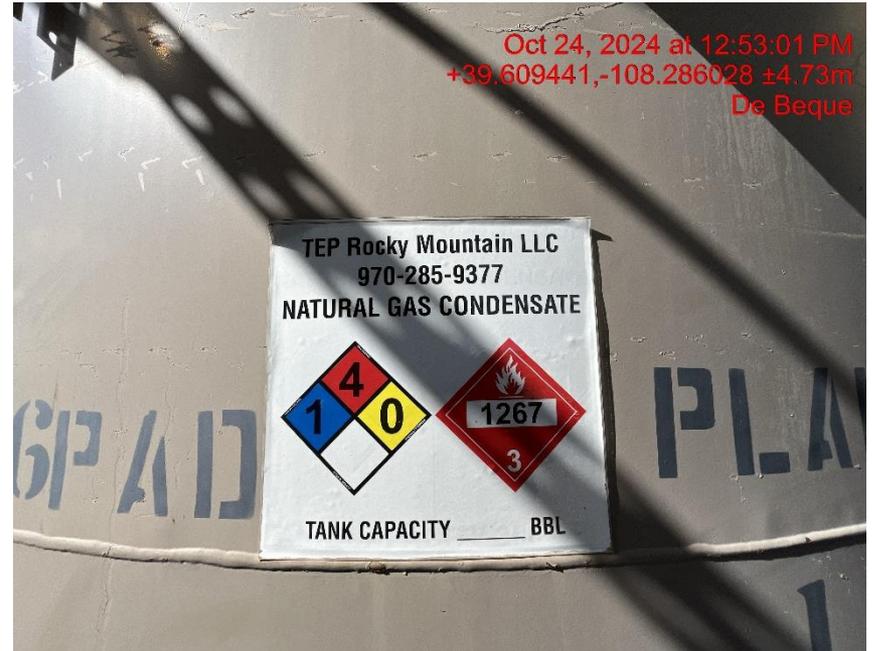
Photo # 7965 Lacking capacity

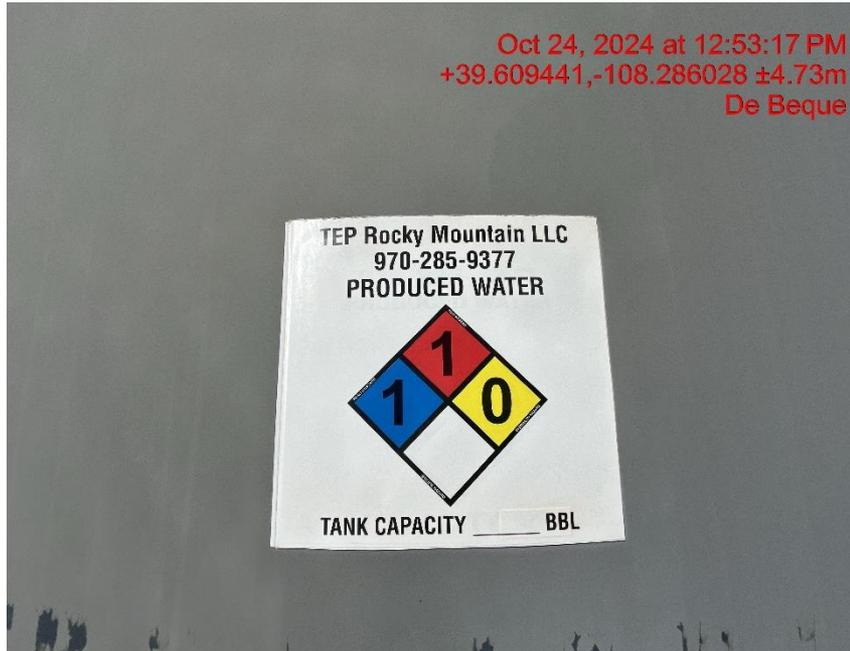
Photo # 7966 Lacking capacity

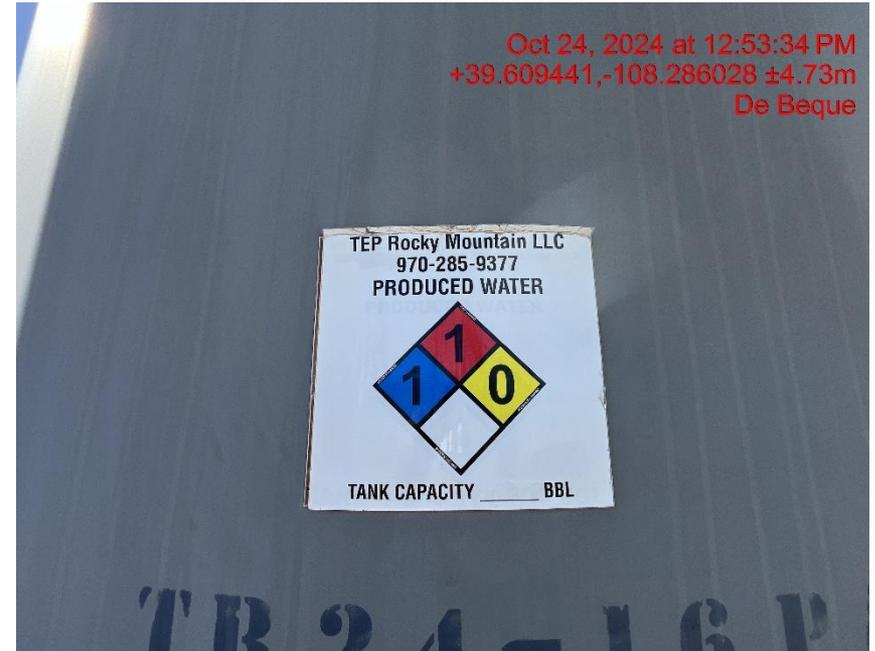
Photo # 7967 Lacking capacity

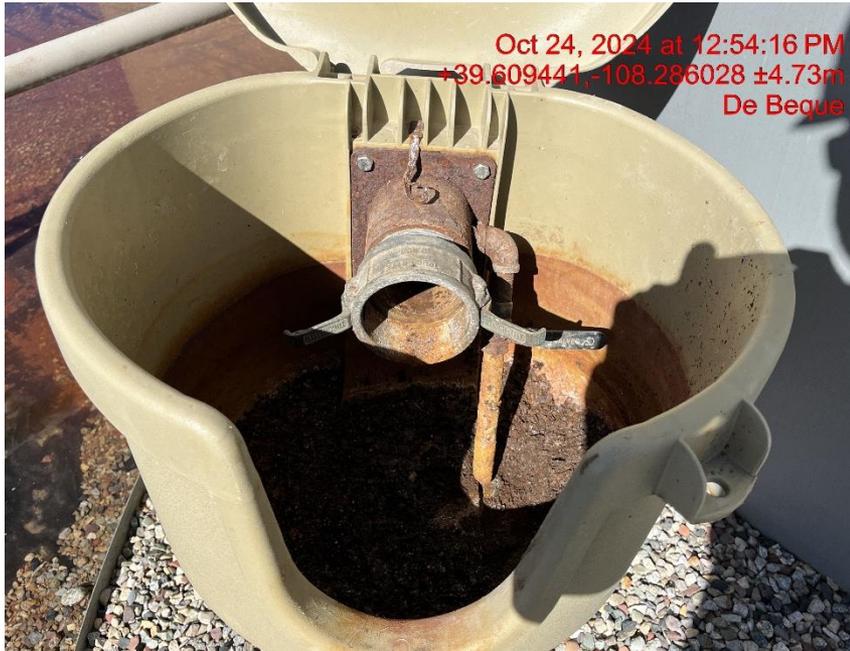
Photo # 7968 Open ended load line

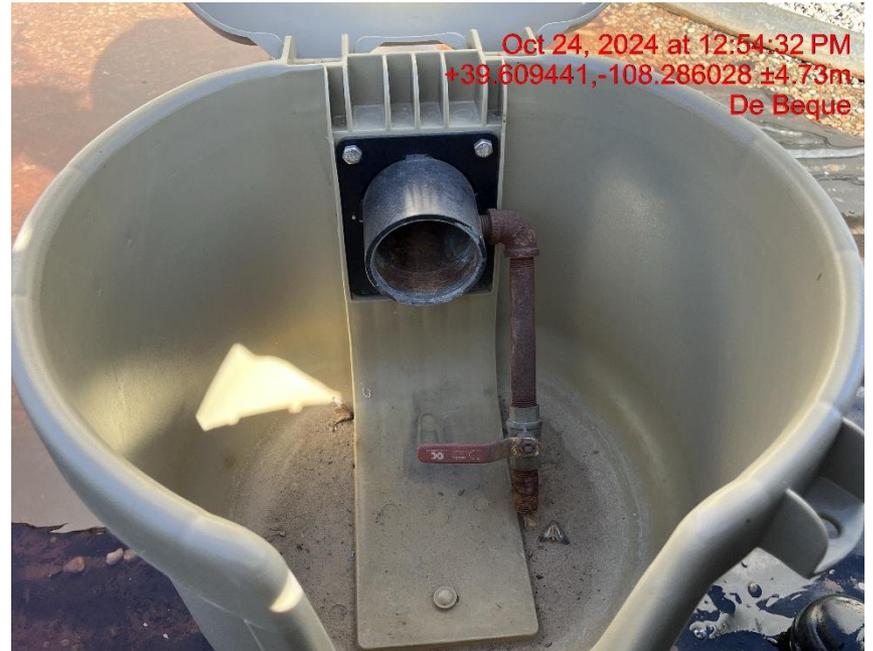
Photo # 7969 Open ended load line

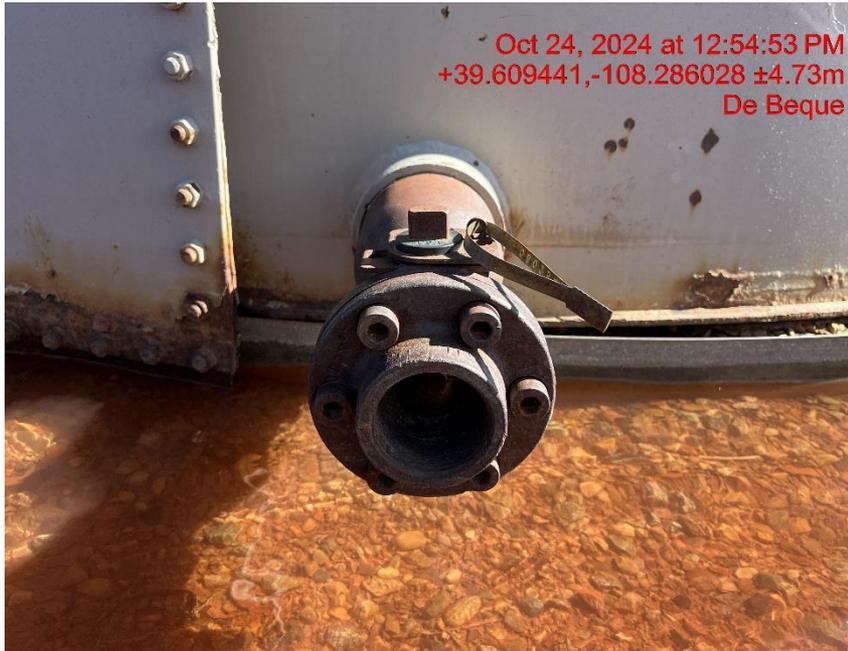
Photo # 7970 Open ended load line

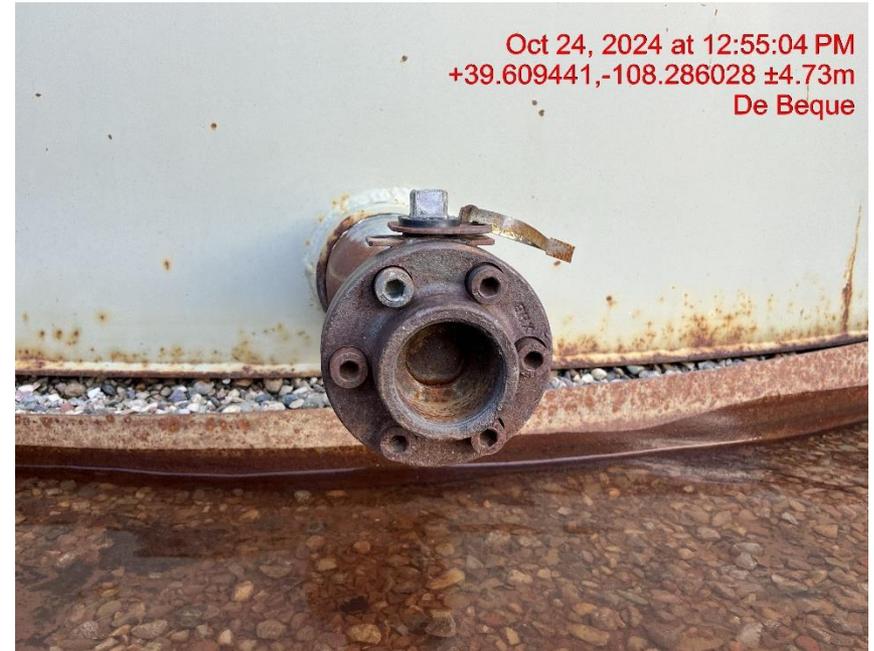
Photo # 7971 Open ended load line

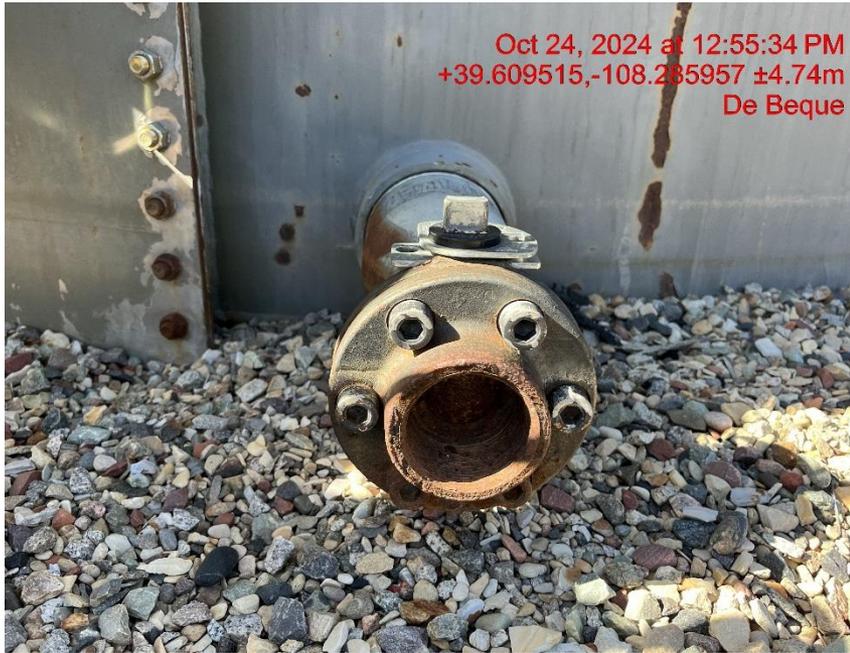
Photo # 7972 Open ended load line

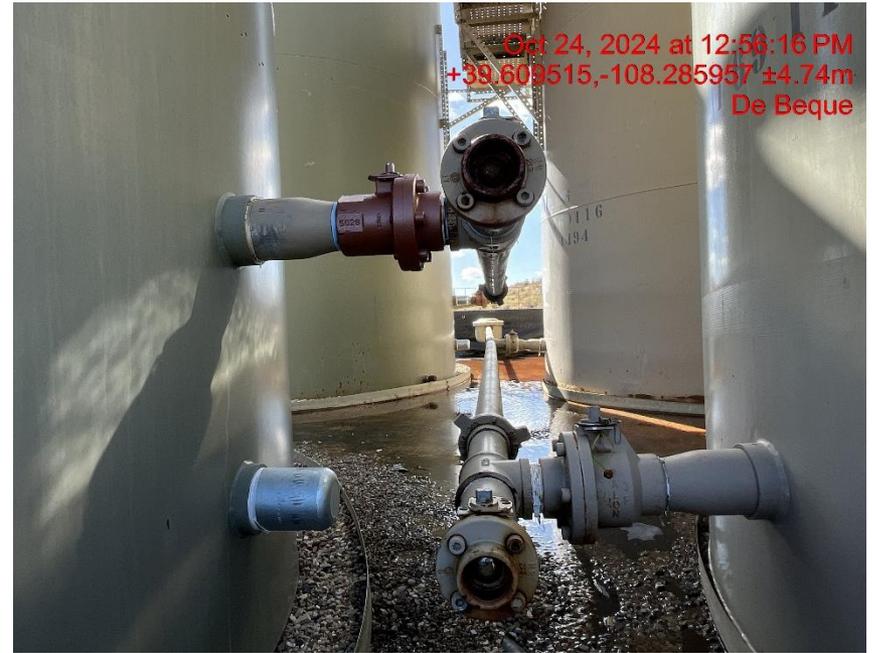
Photo # 7974 Open ended load lines
