Inspection Photos

Location Name: TEP ROCKY MOUNTAIN LLC, GM/34-4

Location ID: 334896

Date: 10/24/2024

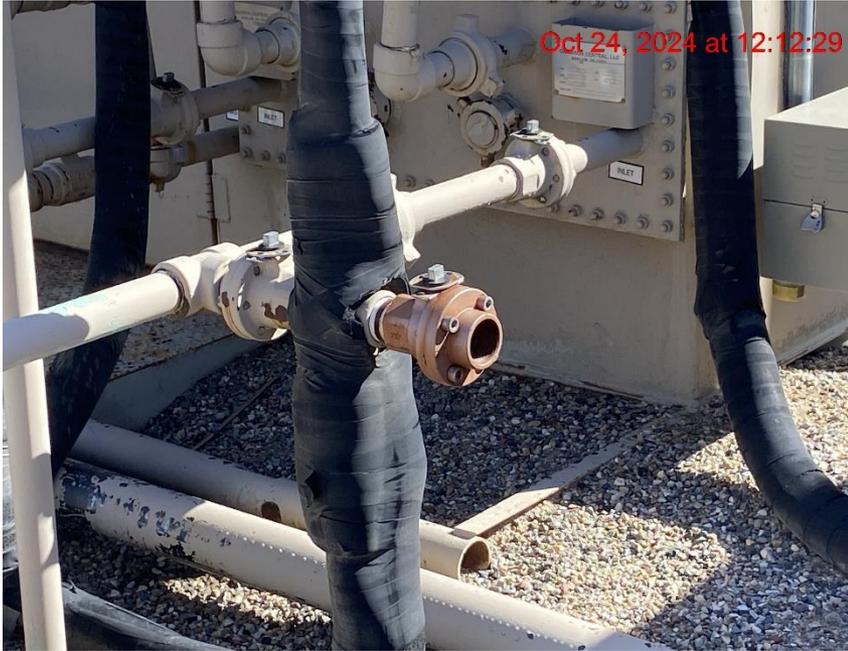
Open-Ended Line – Photo #04479

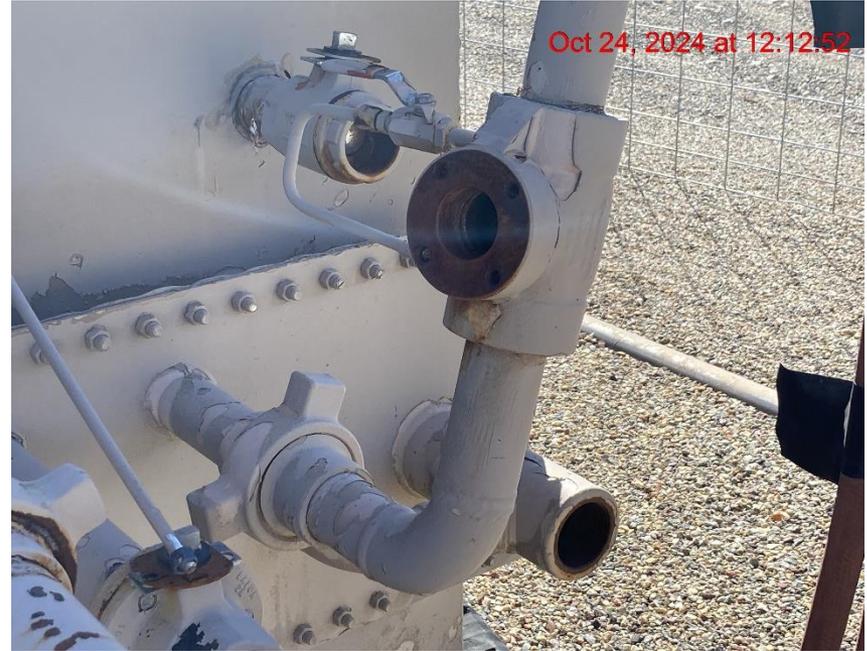
Open-Ended Lines – Photo #04481

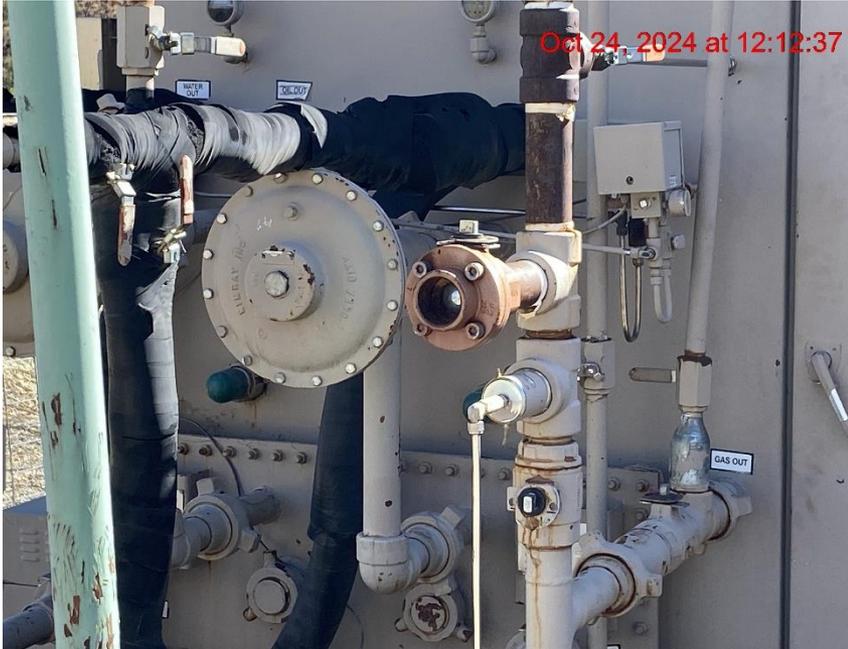
Open-Ended Line – Photo #04480

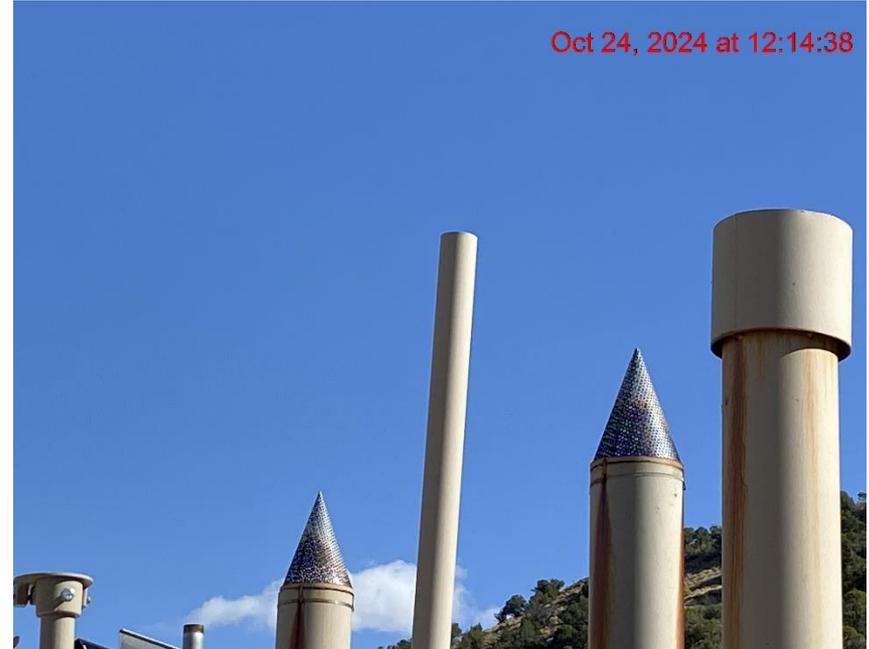
Open-Ended Vent Line – Photo #04483

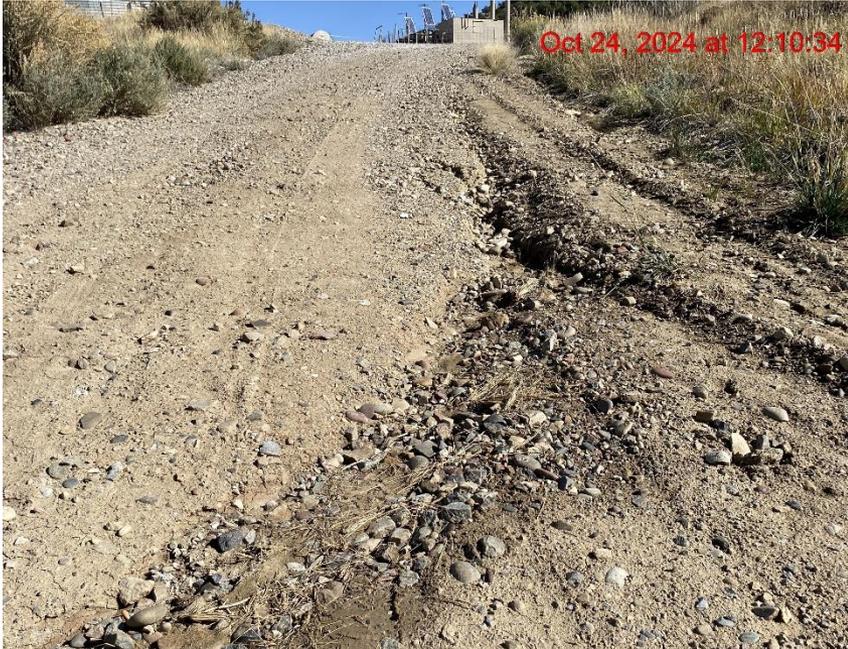
Insufficient Erosion Control – Photo #04473

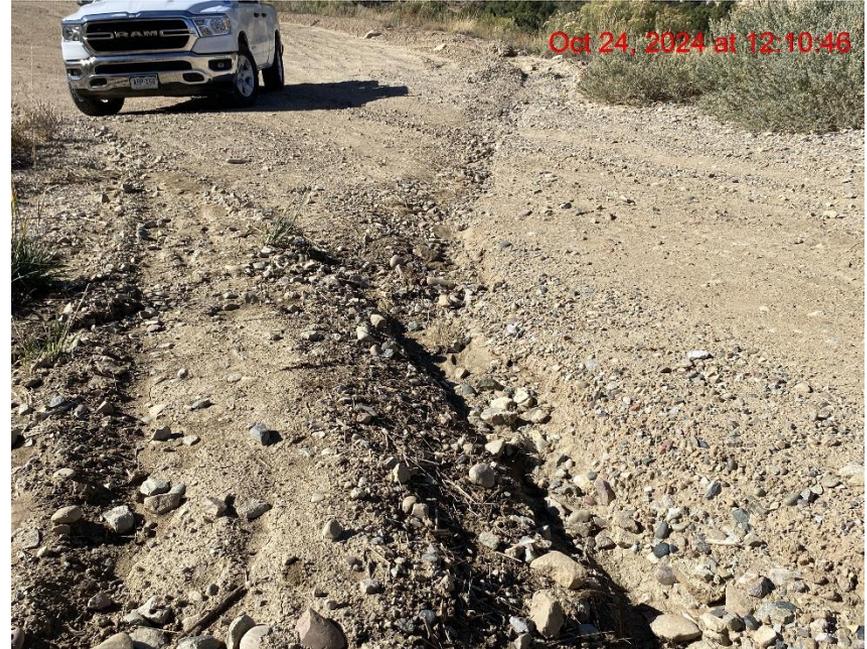
Insufficient Erosion Control – Photo #04474

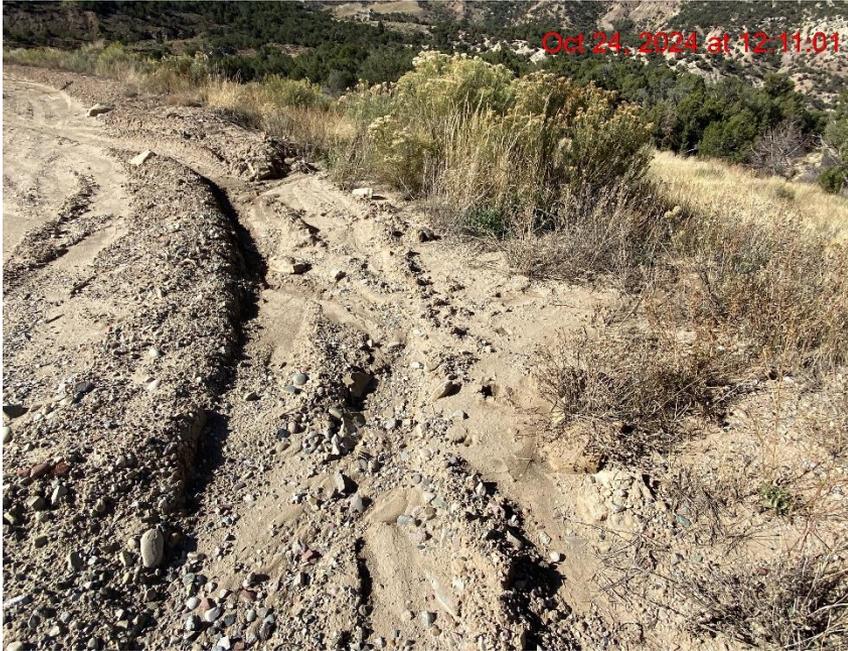
Transport of Sediment Offsite – Photo #04475

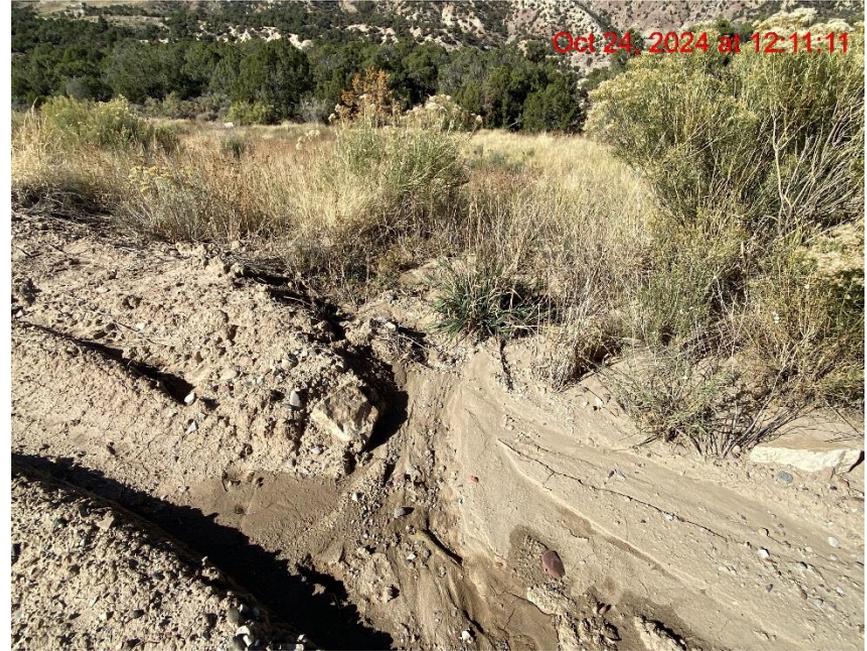
Transport of Sediment Offsite – Photo #04476
