Inspection Photos

Location: TEP ROCKY MOUNTAIN LLC CHEVRON-65S97W/22NENW

Location ID: 324361

Date: 10/24/2024

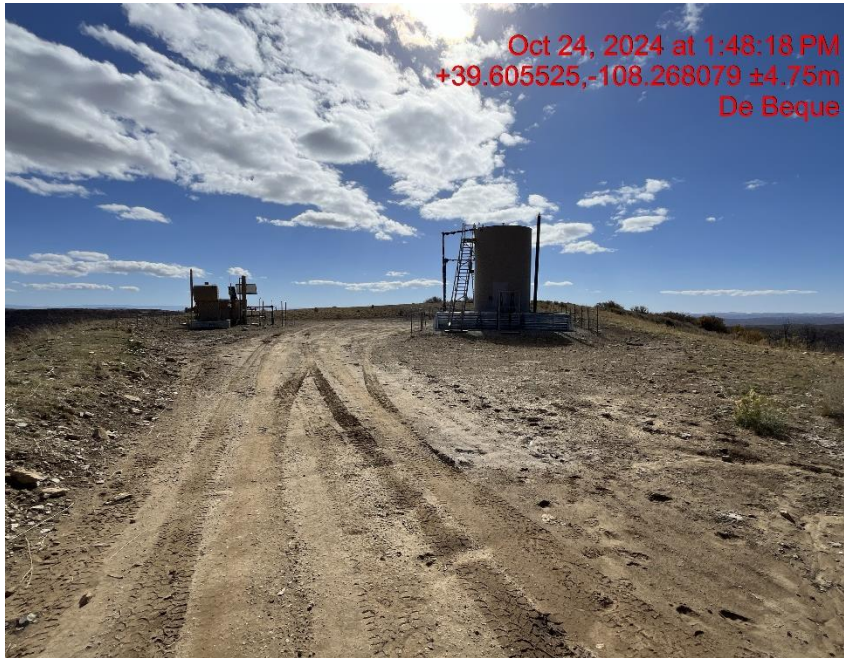
Photo # 7099 Entrance to location

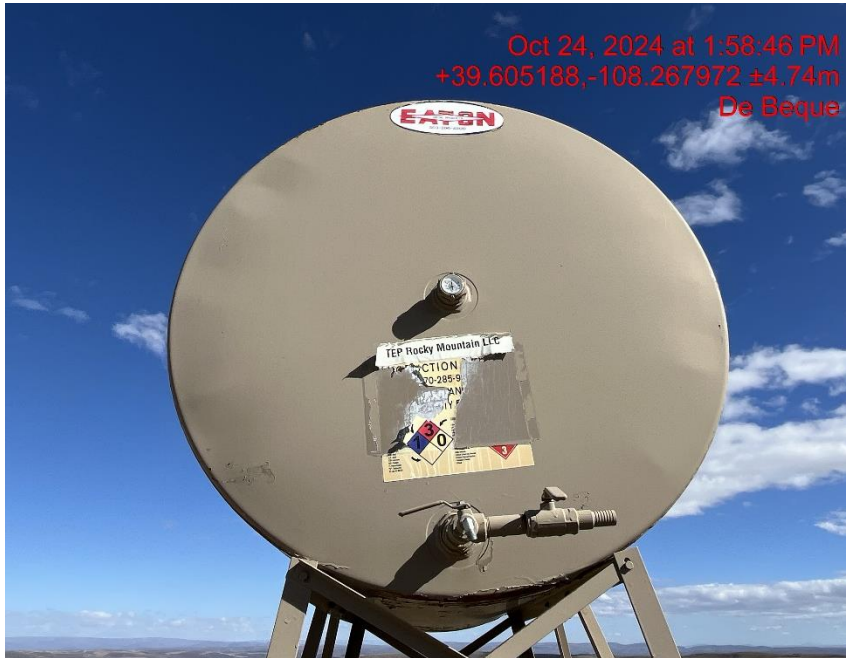
Photo # 8009 Lacking required information

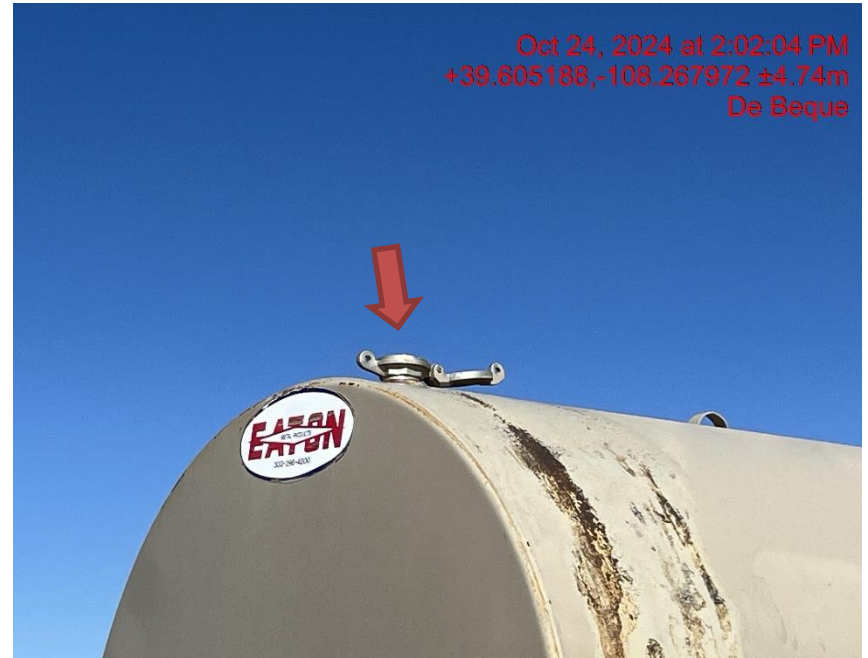
Photo # 8012 Wildlife hazard

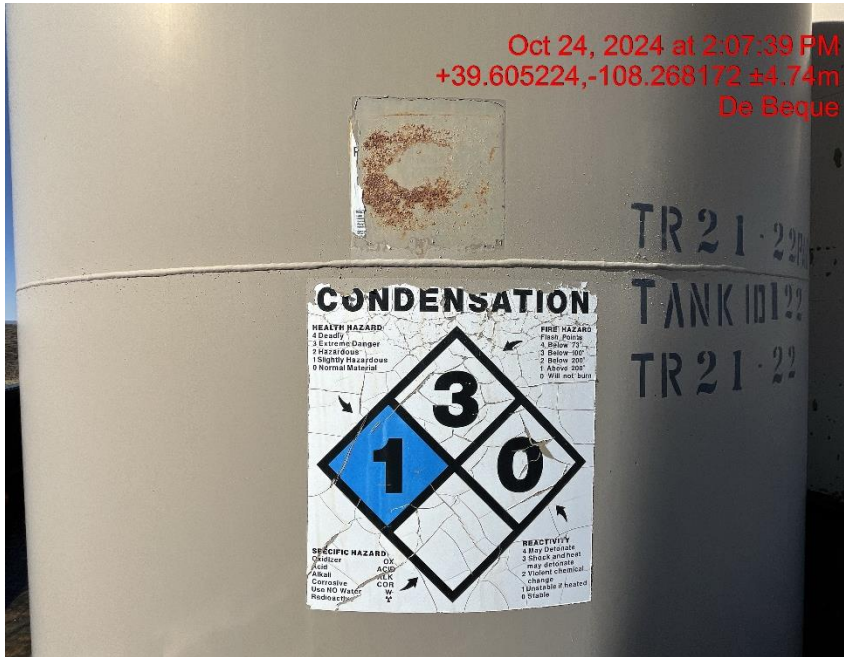
Photo # 8022 Lacking required information

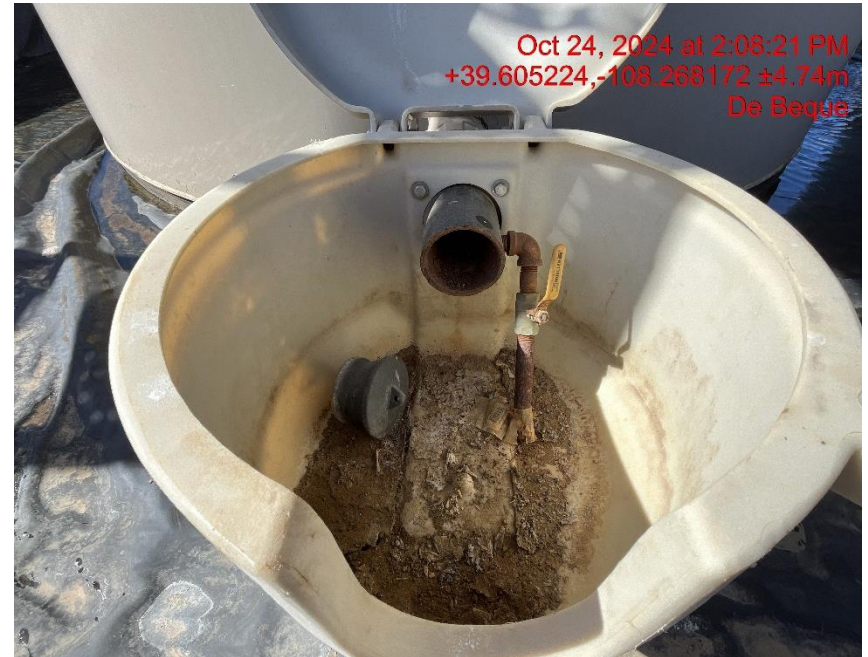
Photo # 8023 Open ended load line

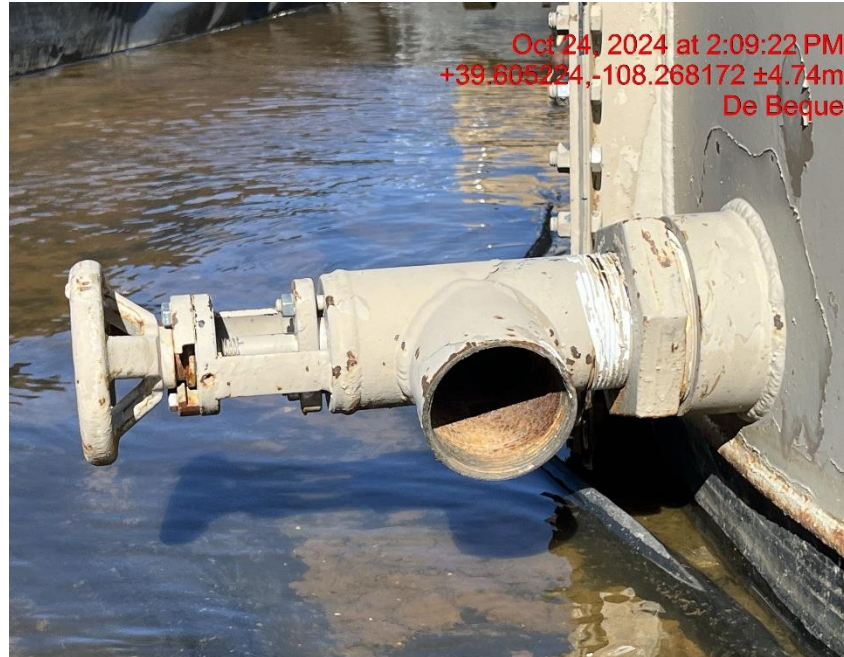
Photo # 8025 Open ended load line
