## Inspection Photos

Location Name: TEP ROCKY MOUNTAIN LLC KP 24-23 Pad

Location ID: 324439

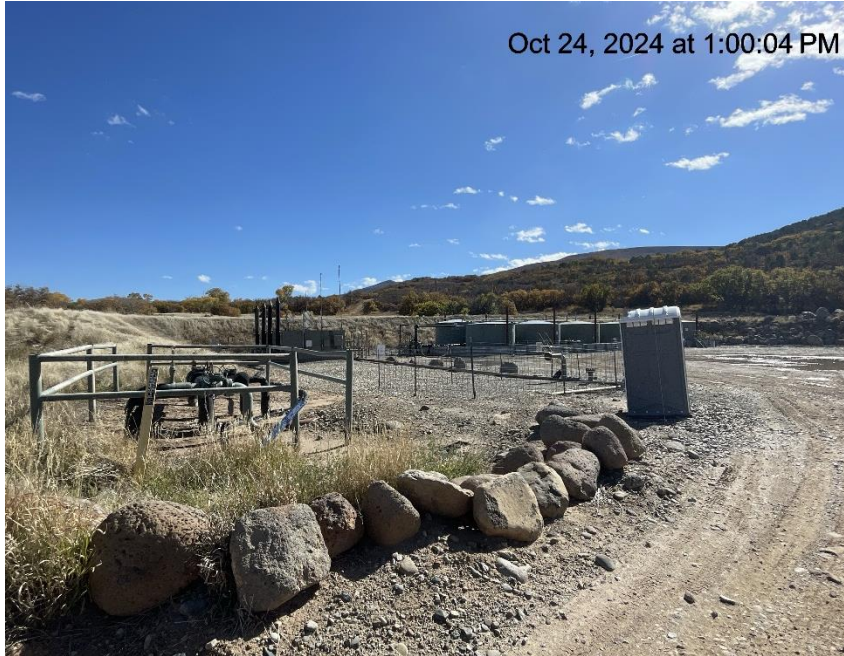
Photo # 7153 From entrance to location

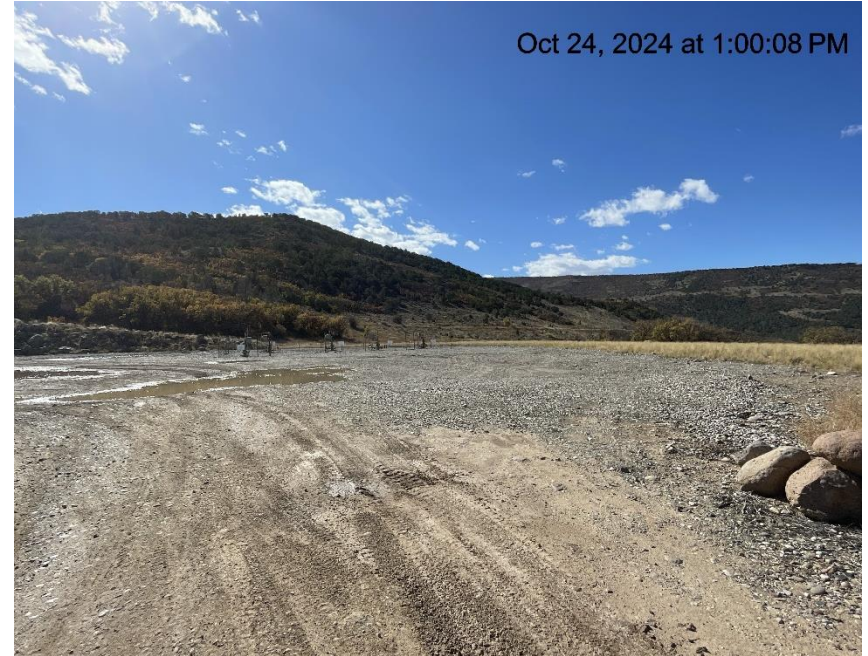
Photo # 7154 From entrance to location

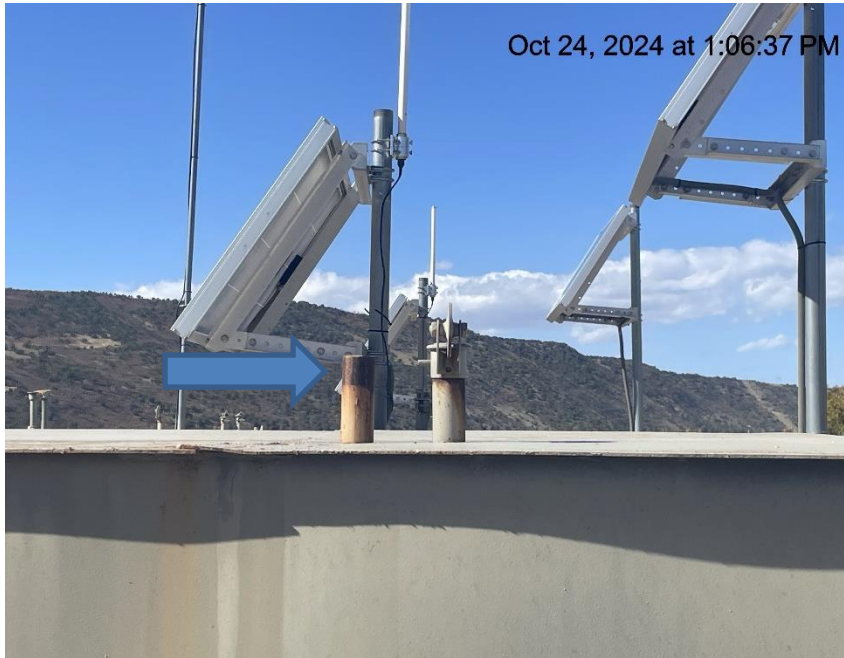
**Photo # 7161 Rupture disc vent line on separator does not comply with CECMC pressure safety device rules**

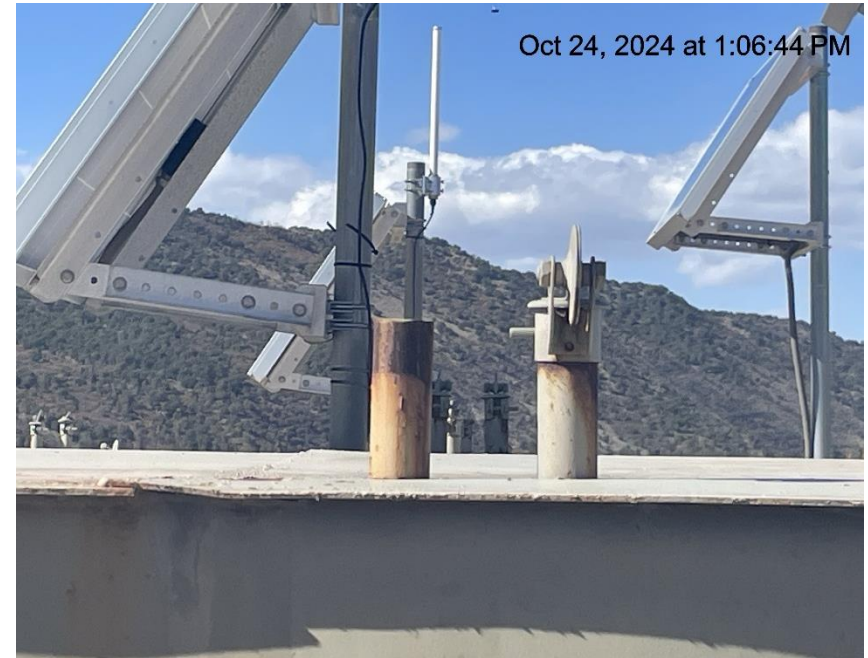
**Photo # 7162 Rupture disc vent line on separator does not comply with CECMC pressure safety device rules**

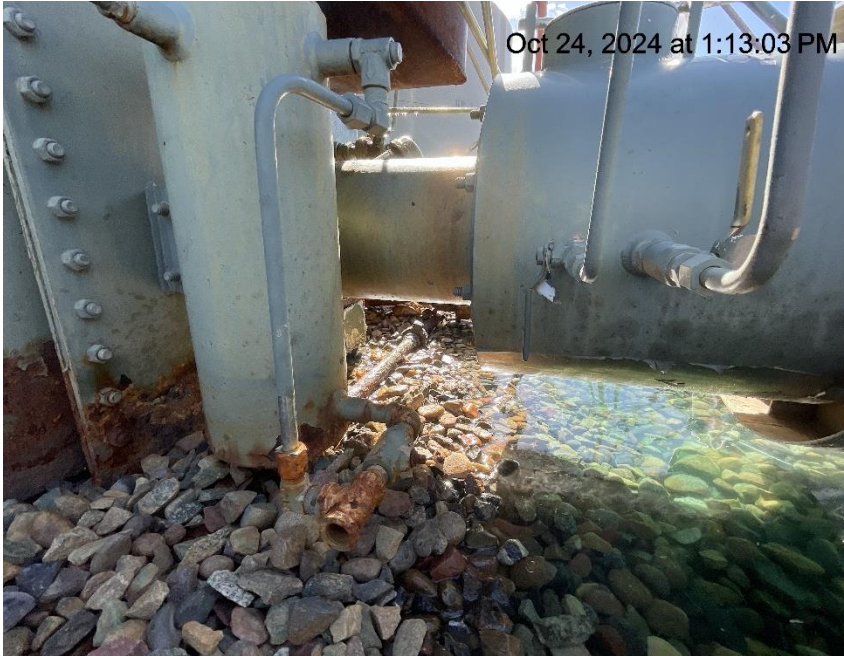
**Photo # 7163 PRV vent line does not comply with CECMC pressure safety device rules**

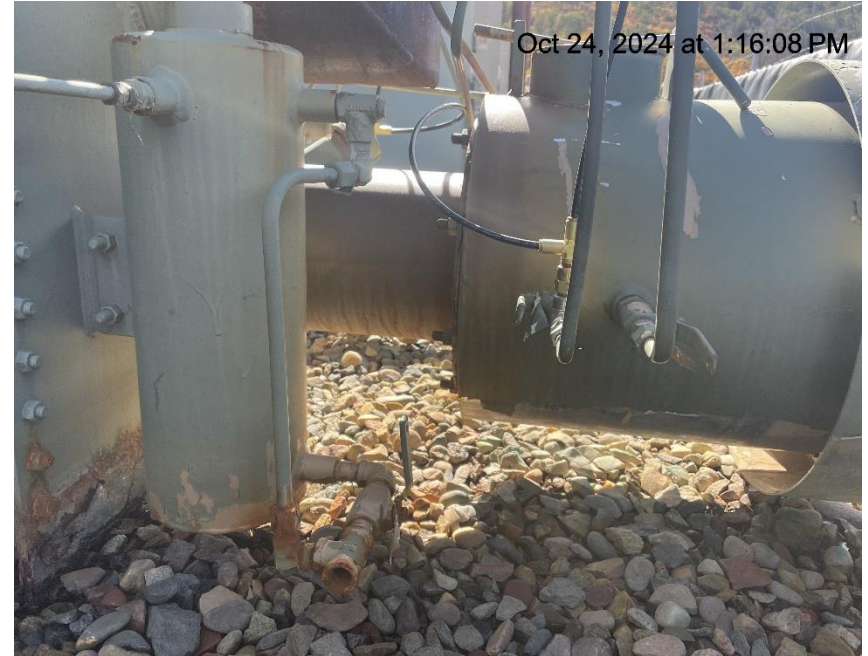
**Photo # 7164 PRV vent line does not comply with CECMC pressure safety device rules**

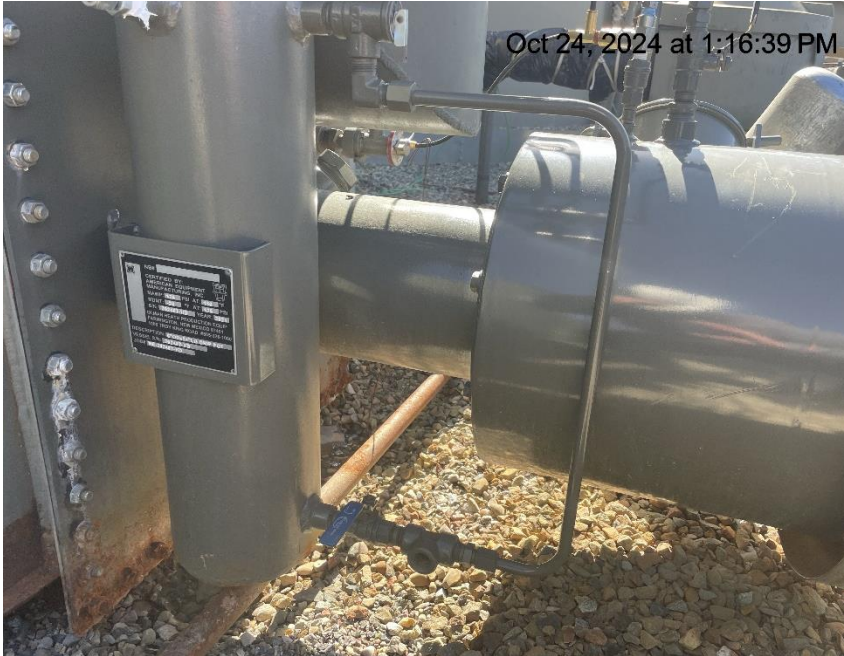
**Photo # 7165 PRV vent line does not comply with CECMC pressure safety device rules**

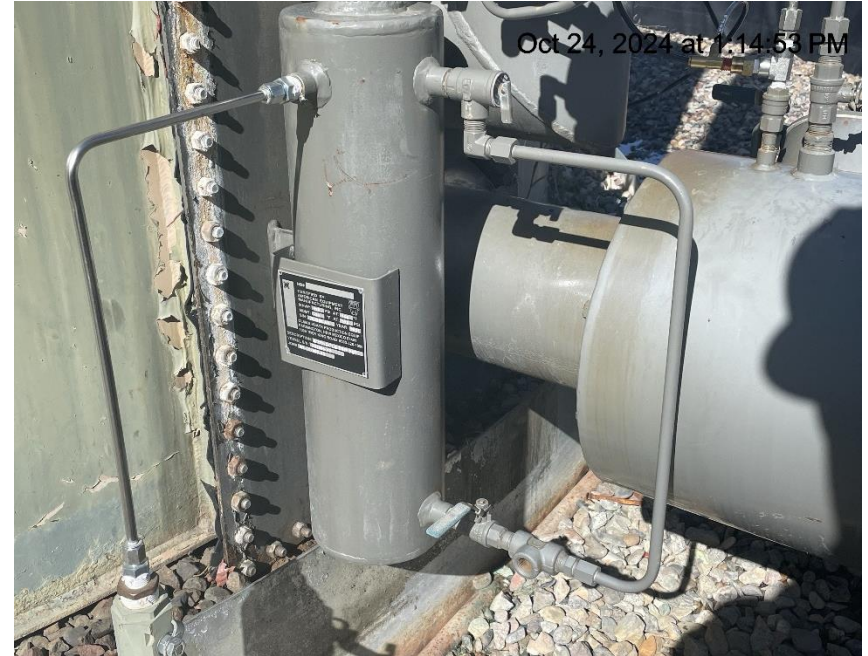
**Photo # 7166 PRV vent line does not comply with CECMC pressure safety device rules**

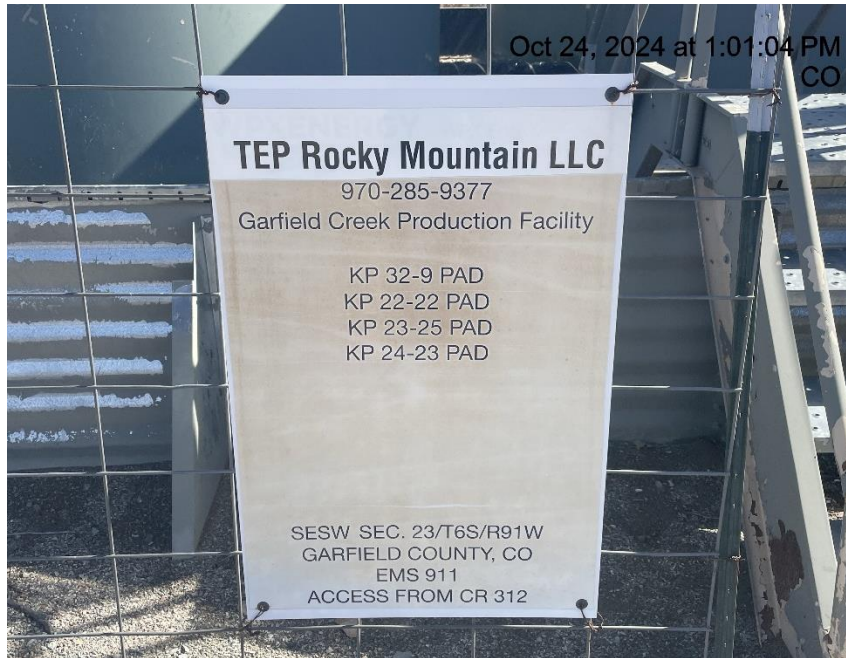
**Photo # 7167 Battery sign does not comply with CECMC rules**

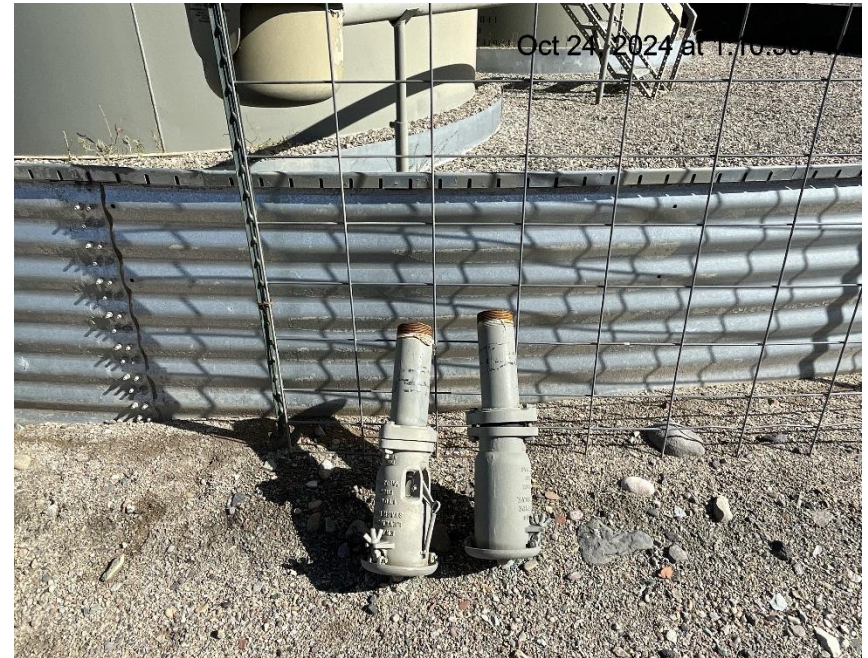
**Photo # 7168 Debris**
