Inspection Photos
Location Name: CHAMPLIN 485 AMOCO #1
Location ID: 320071

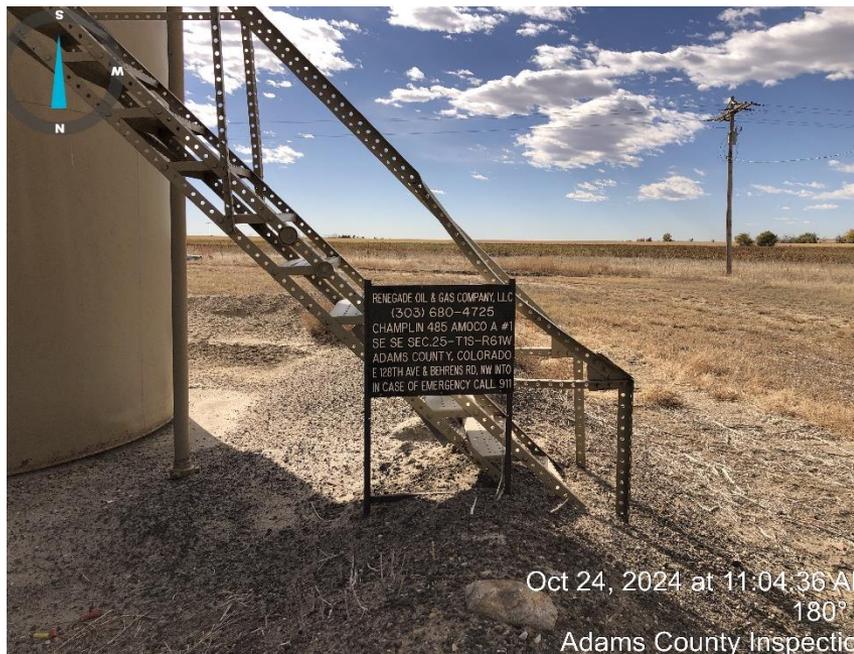
Photo #1 Location sign.

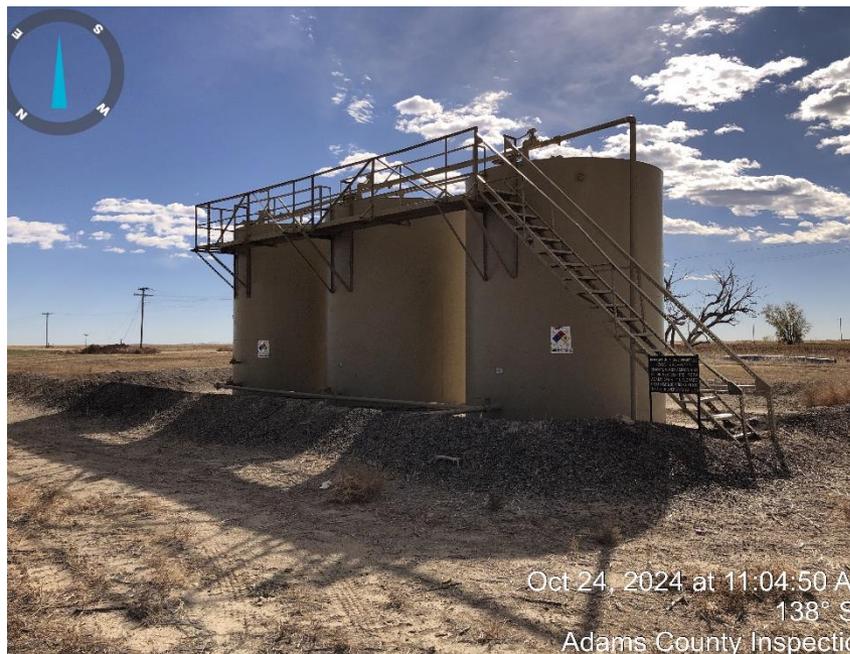
Photo # 2 Tanks (crude oil).

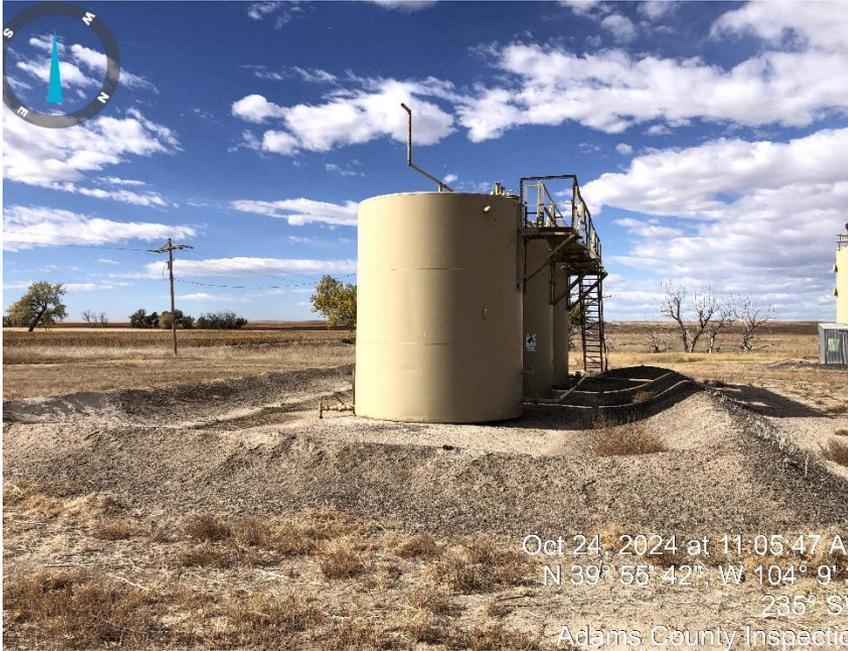
Photo #3 Tanks (crude oil) & weeds with in berm.

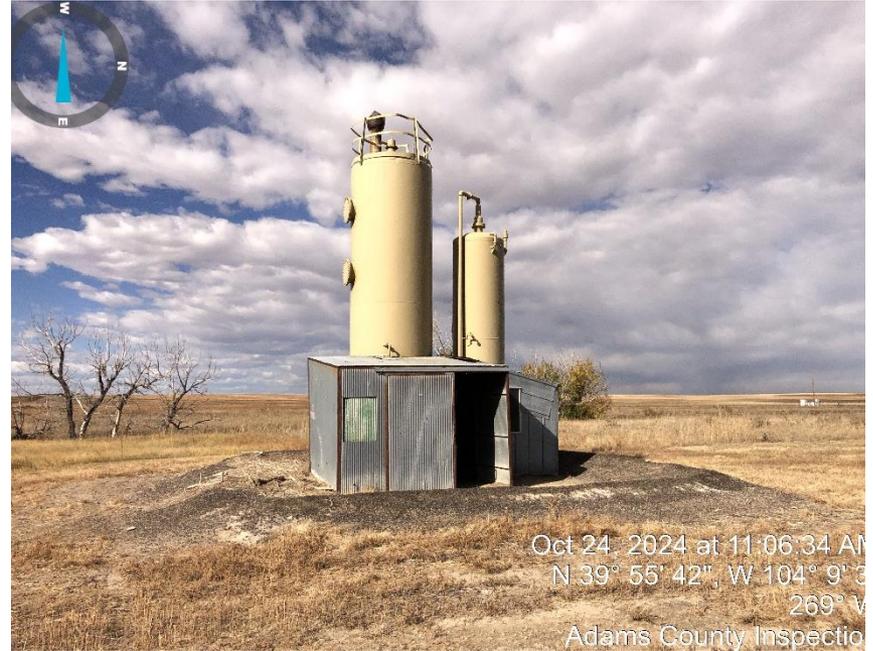
Photo #4 Vertical Separators.

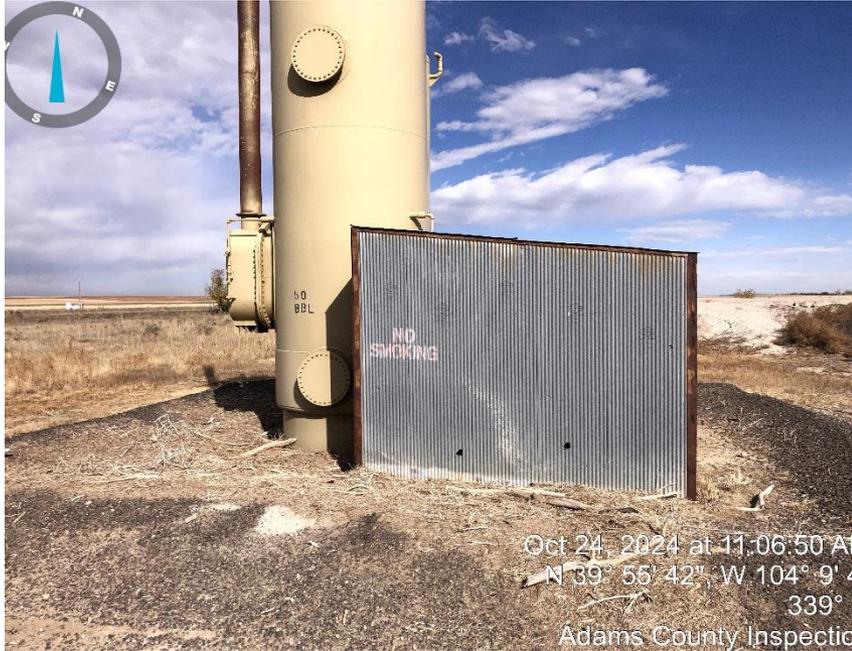
Photo #5 Debris around separator house.

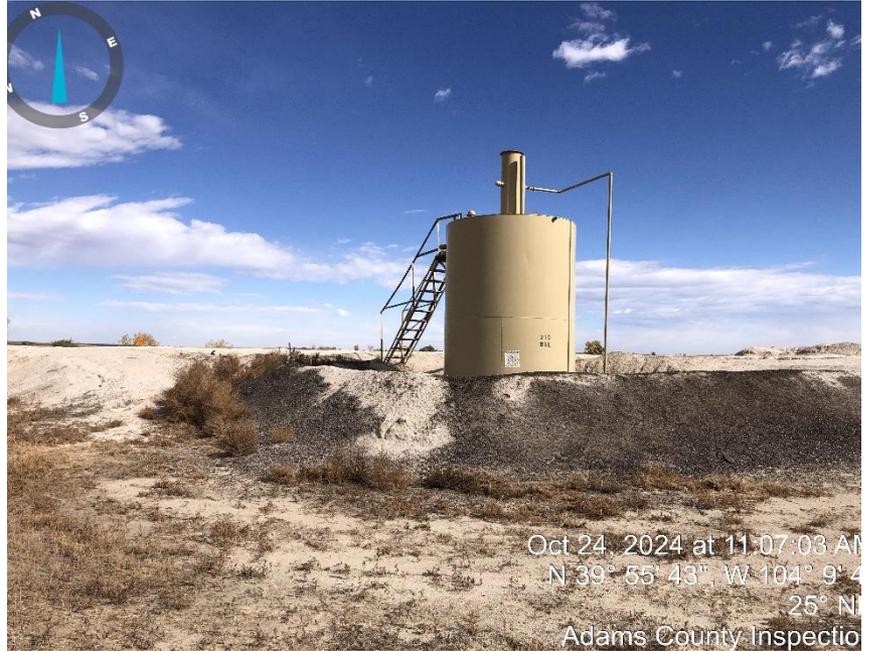
Photo #6 P/W tank, weeds on berm & NFPA placard faded and needs replaced .

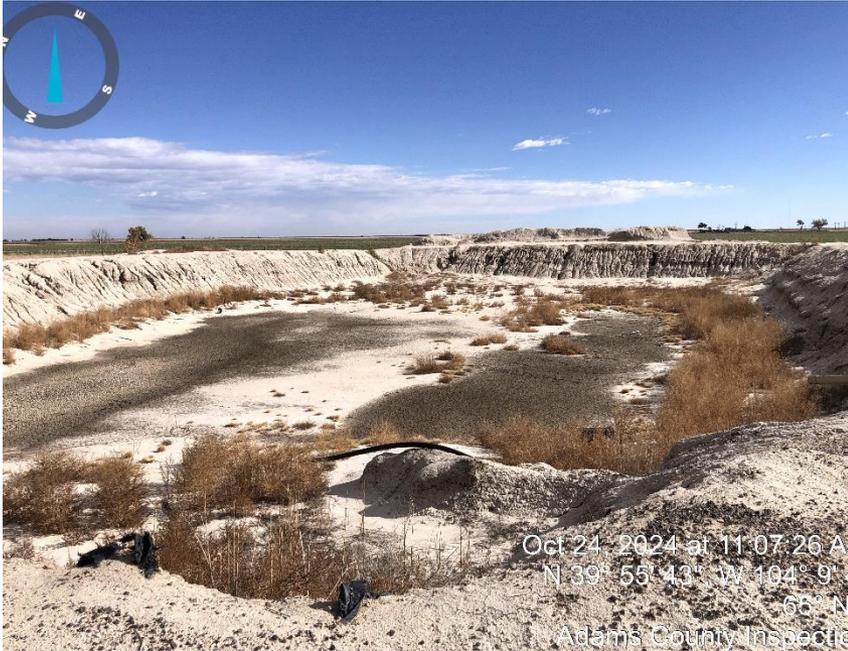
Photo #7 Facility pit. Weeds with in pit and large reels in pit.

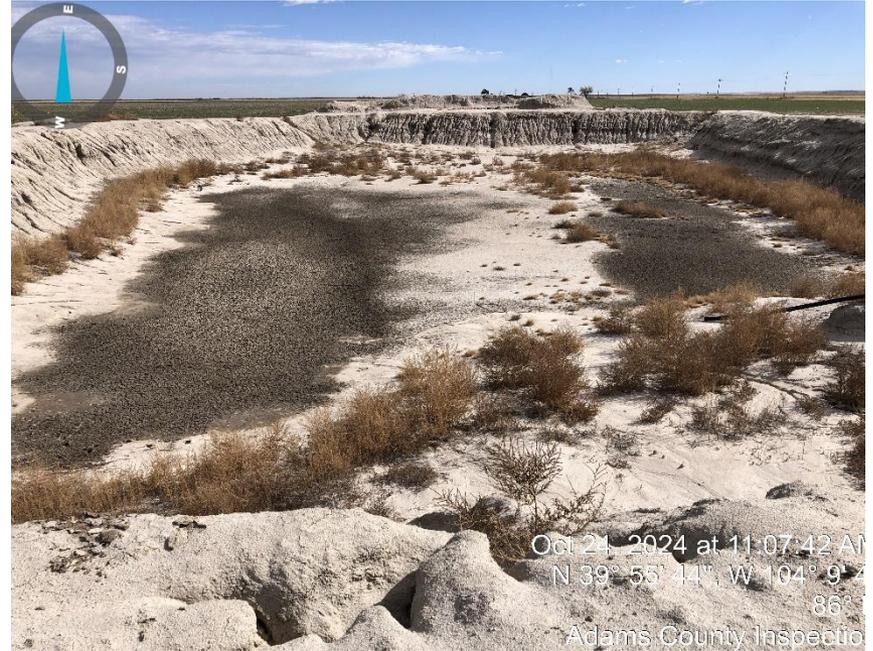
Photo #8 Facility pit. Weeds with in pit and large reels in pit)

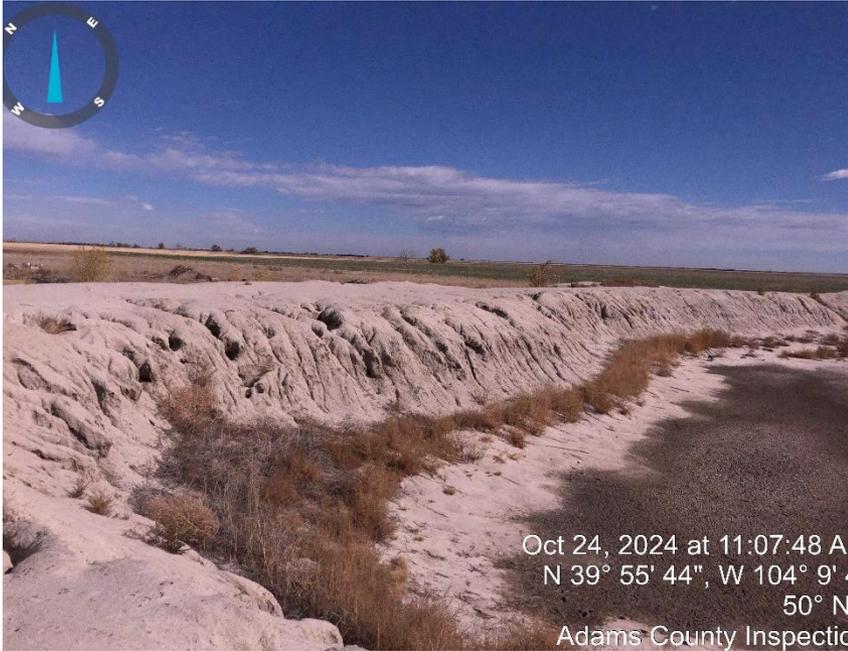
Photo #9 Facility pit. Weeds with in pit and large reels in pit.

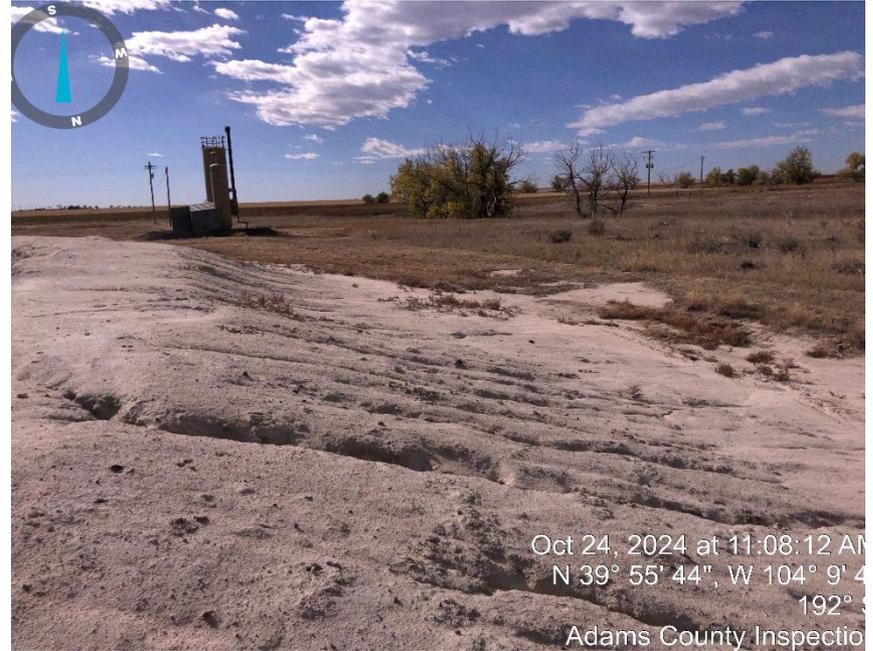
Photo #10 no BMPs in place to prevent berm sediment from leaving location.

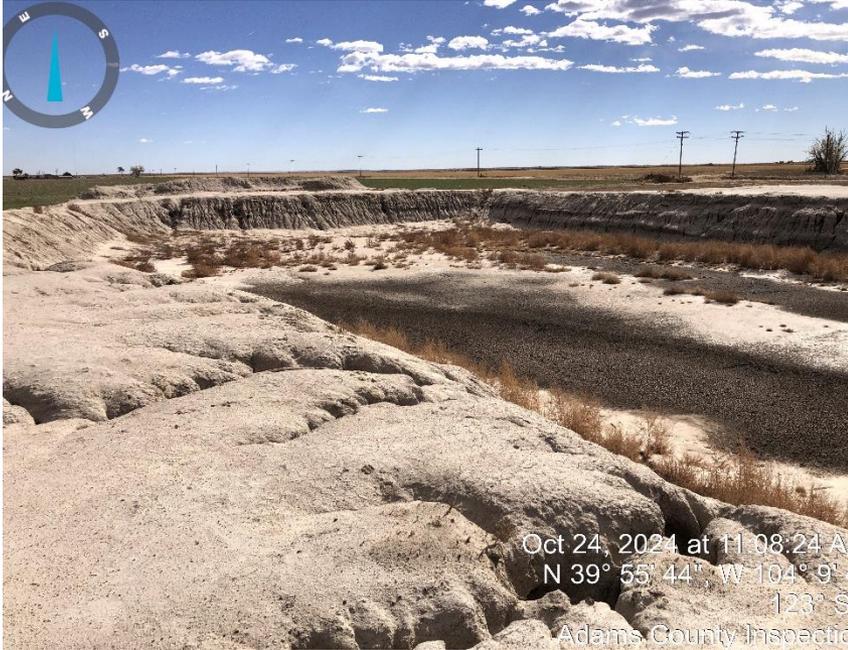
Photo #11 Facility pit. Weeds with in pit and large reels in pit.

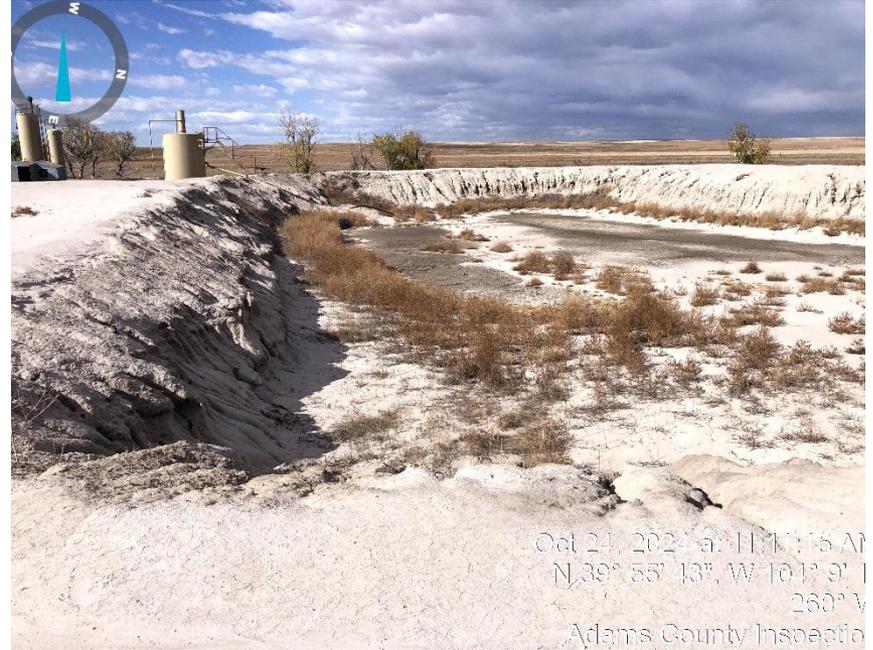
Photo #12 Facility pit. Weeds with in pit and large reels in pit.

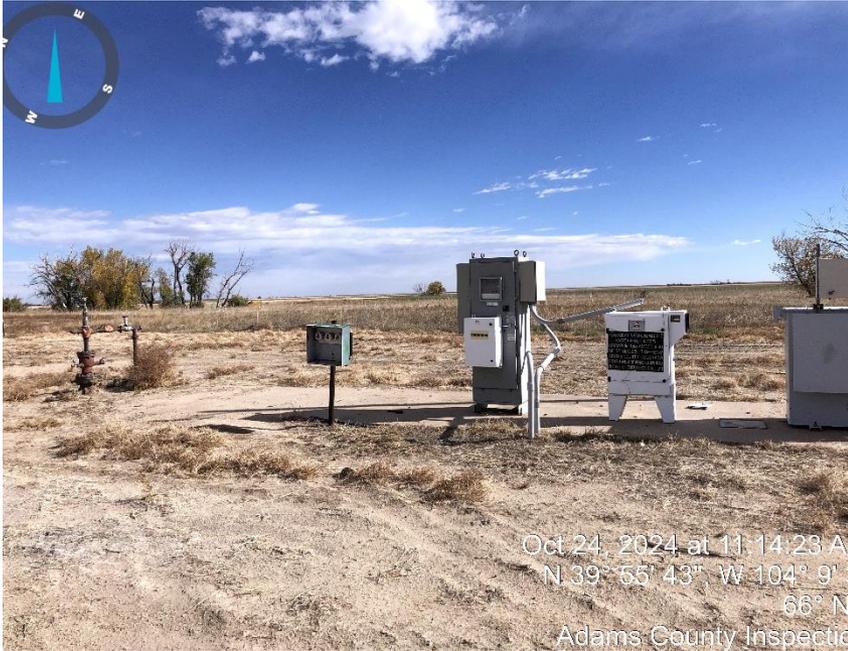
Photo #13 Electrical equipment.

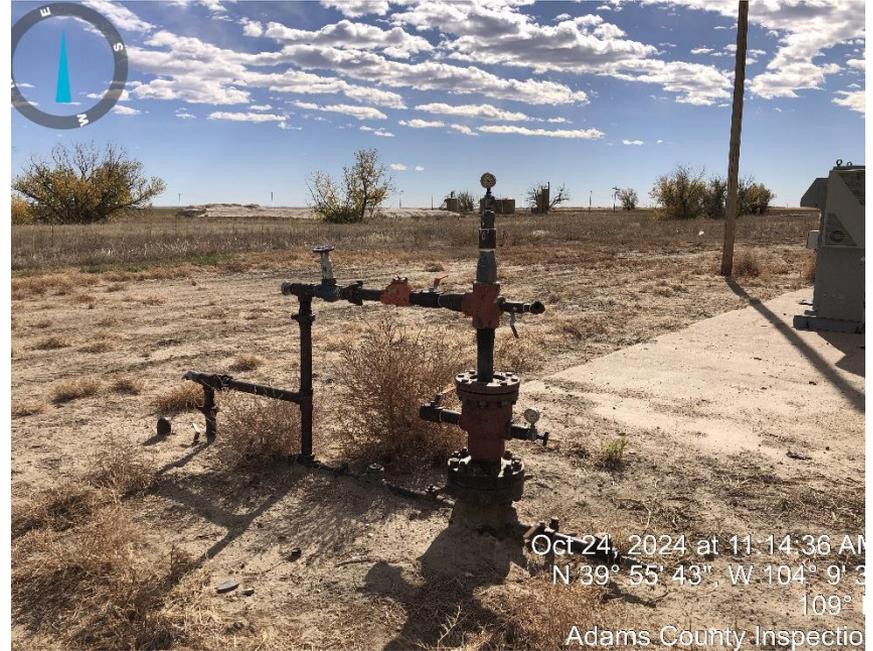
Photo #14 Well head, no sign on well head & weeds around well head.
