Inspection Photos

ID: 478058

Operator: OGRIS OPERATING LLC

Inspection Date: 10/28/2024

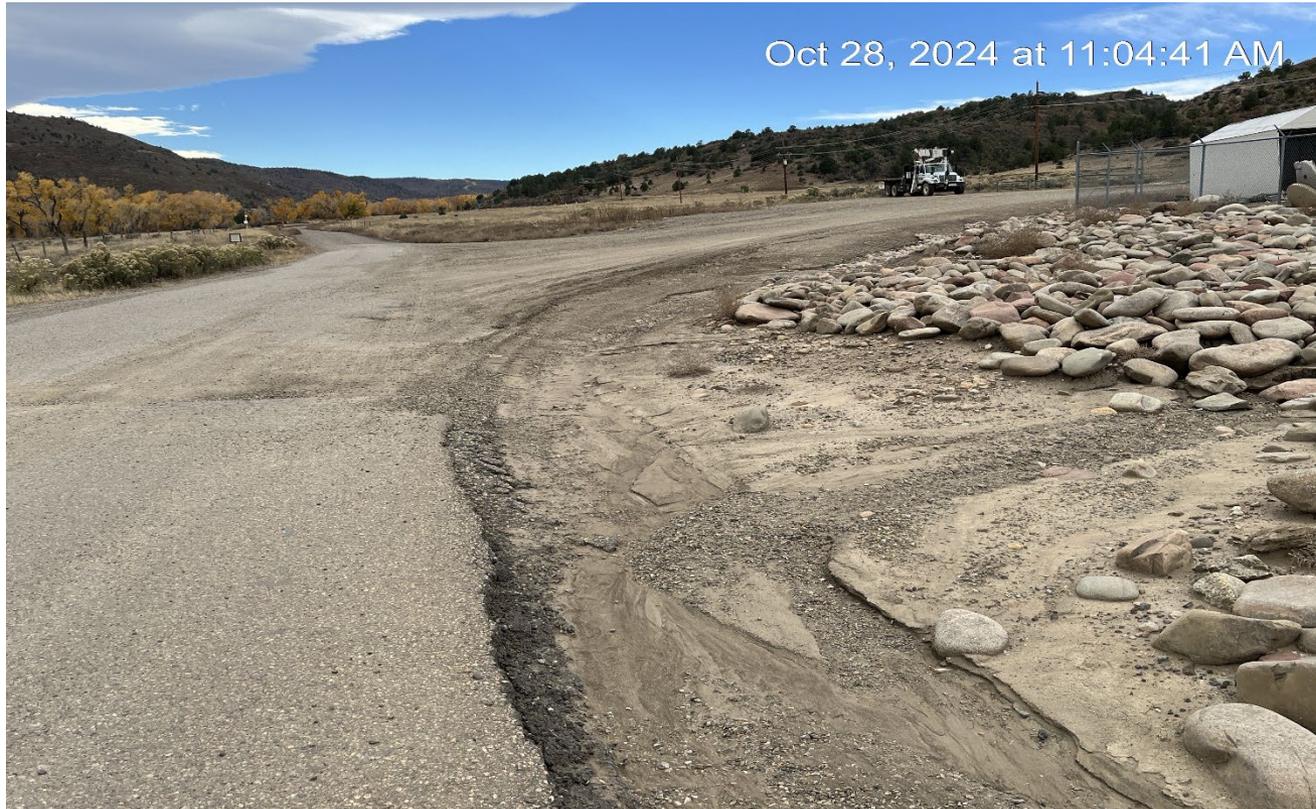
Photo 1. Facing southwest along the main road to the production facility.

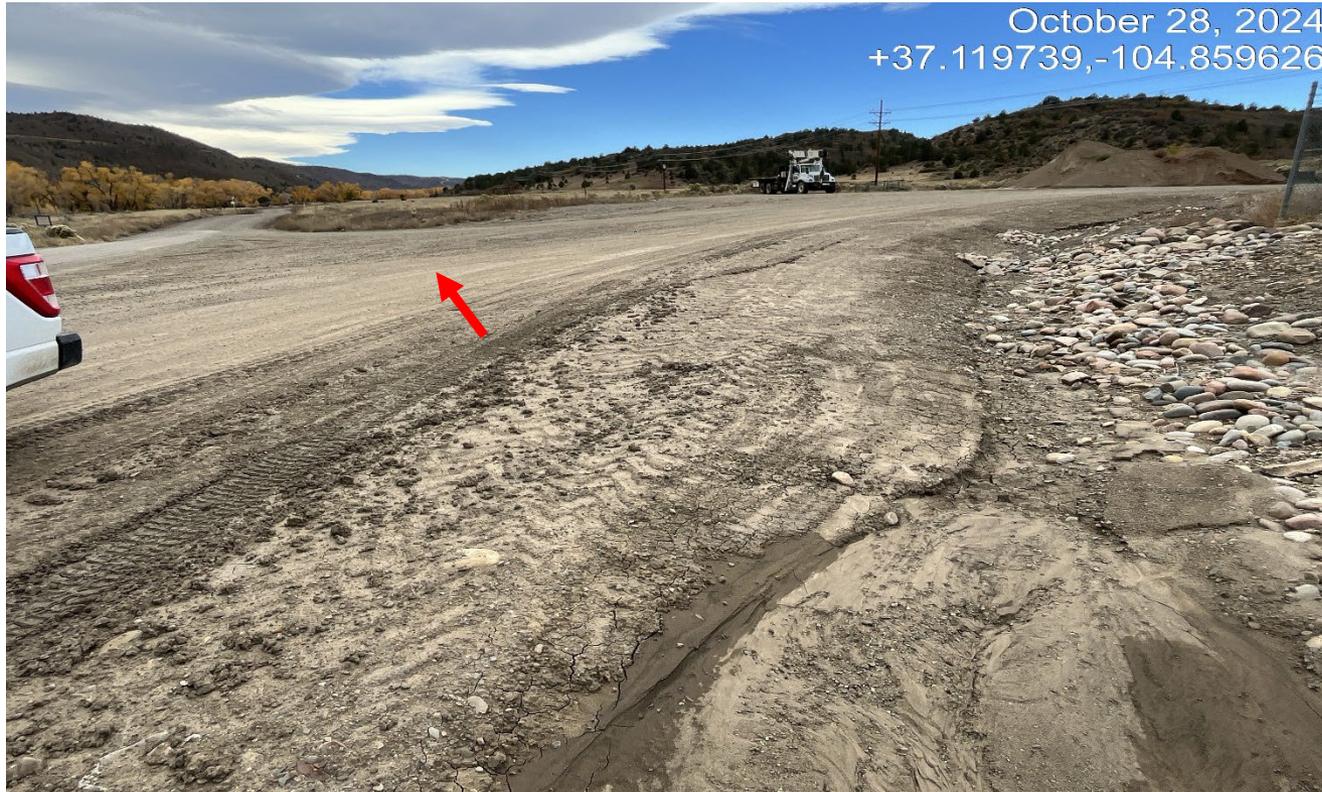
Photo 2. Facing southwest toward the access road adjacent to the main road. BMP's need to be installed to prevent sediment transport onto the road. A berm or track pad or other BMP is needed at the area of red arrow.

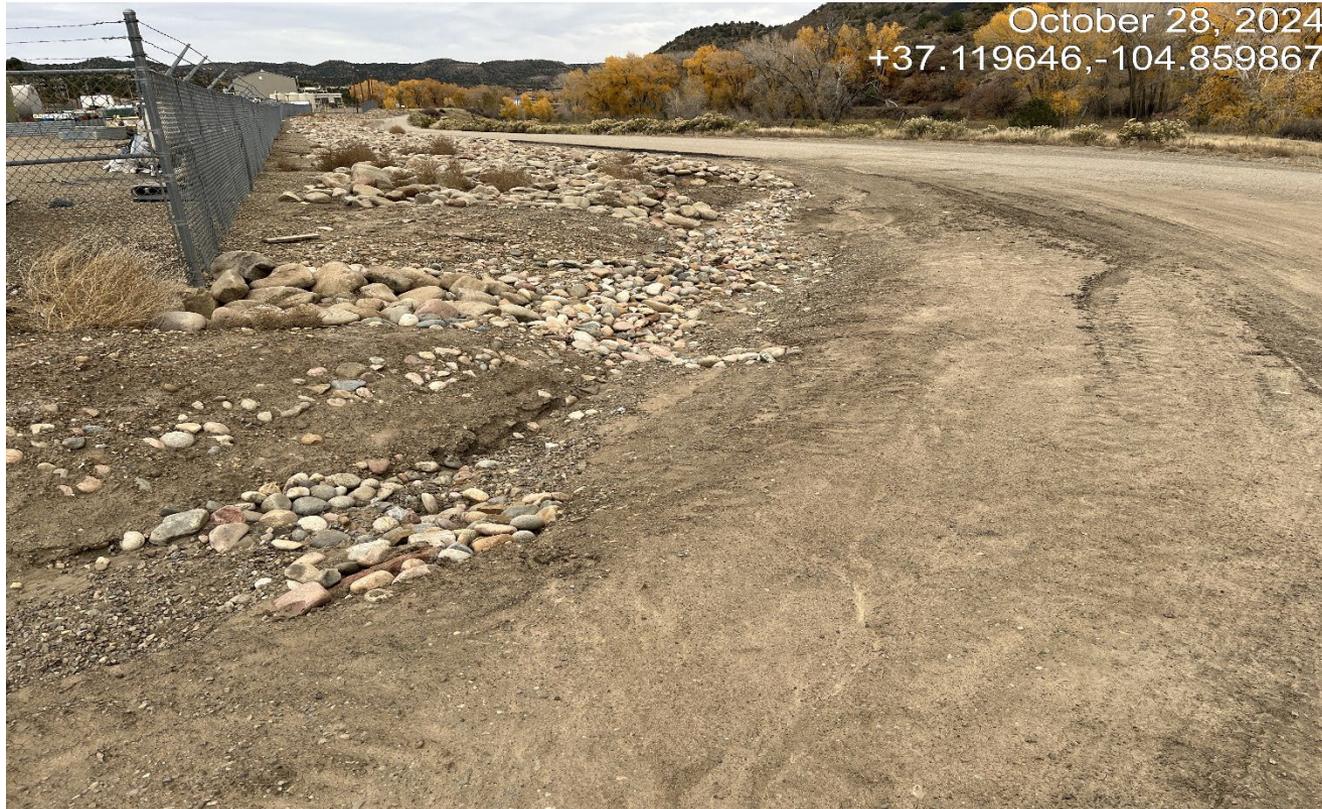
Photo 3. Facing back toward the main public road. There are rock check dams that have already filled in with sediment. A larger sediment catch may be better to prevent sediment transport onto the road. Also, round rock does not lock together and can easily be displaced.

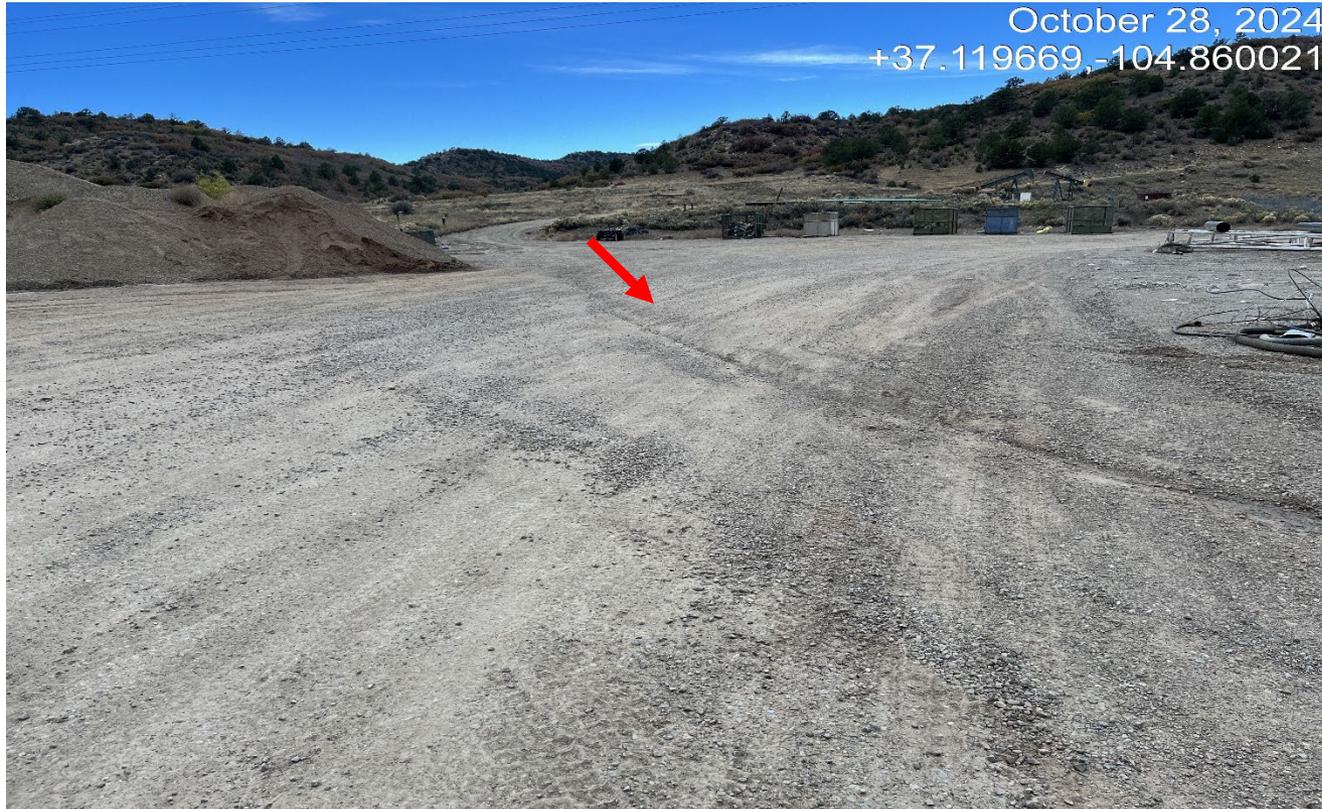
Photo 4. Facing west. It appears stormwater is flowing cross the location contributing to stormwater erosion in previous photos.

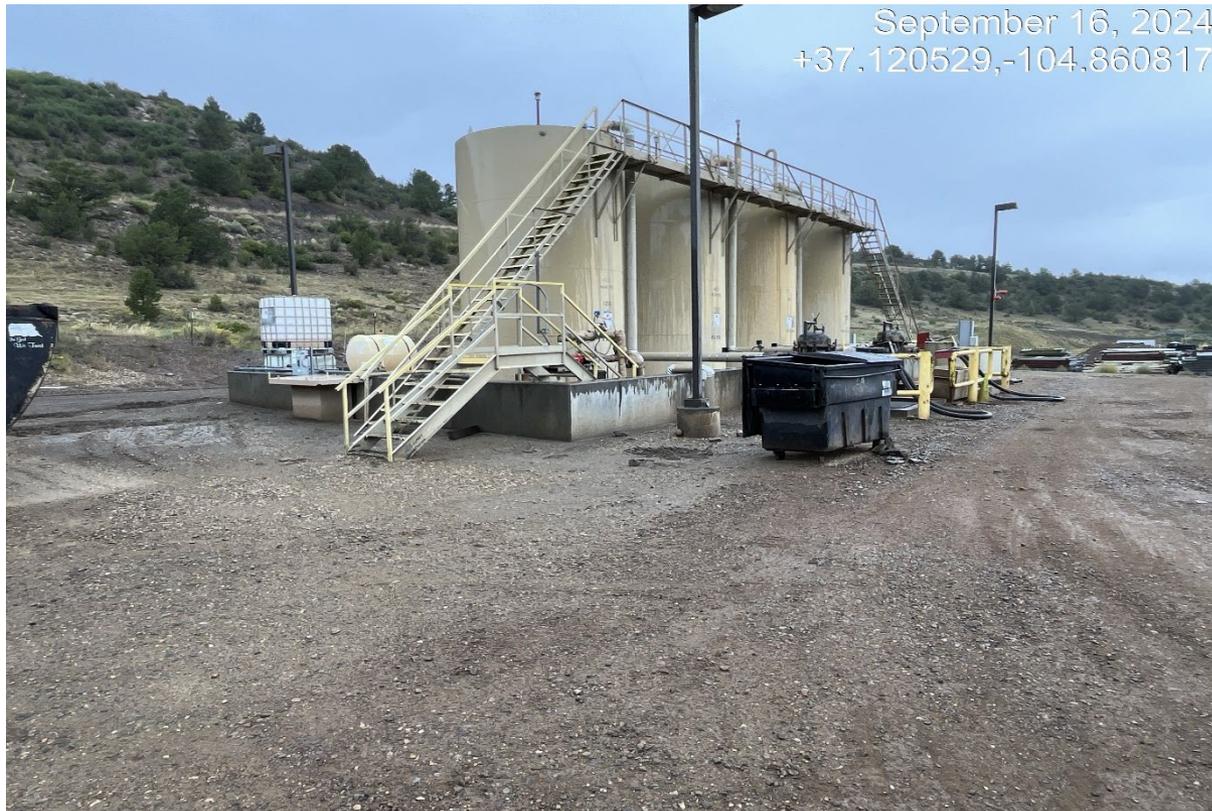
Photo 5. Facing northwest toward the tank battery.

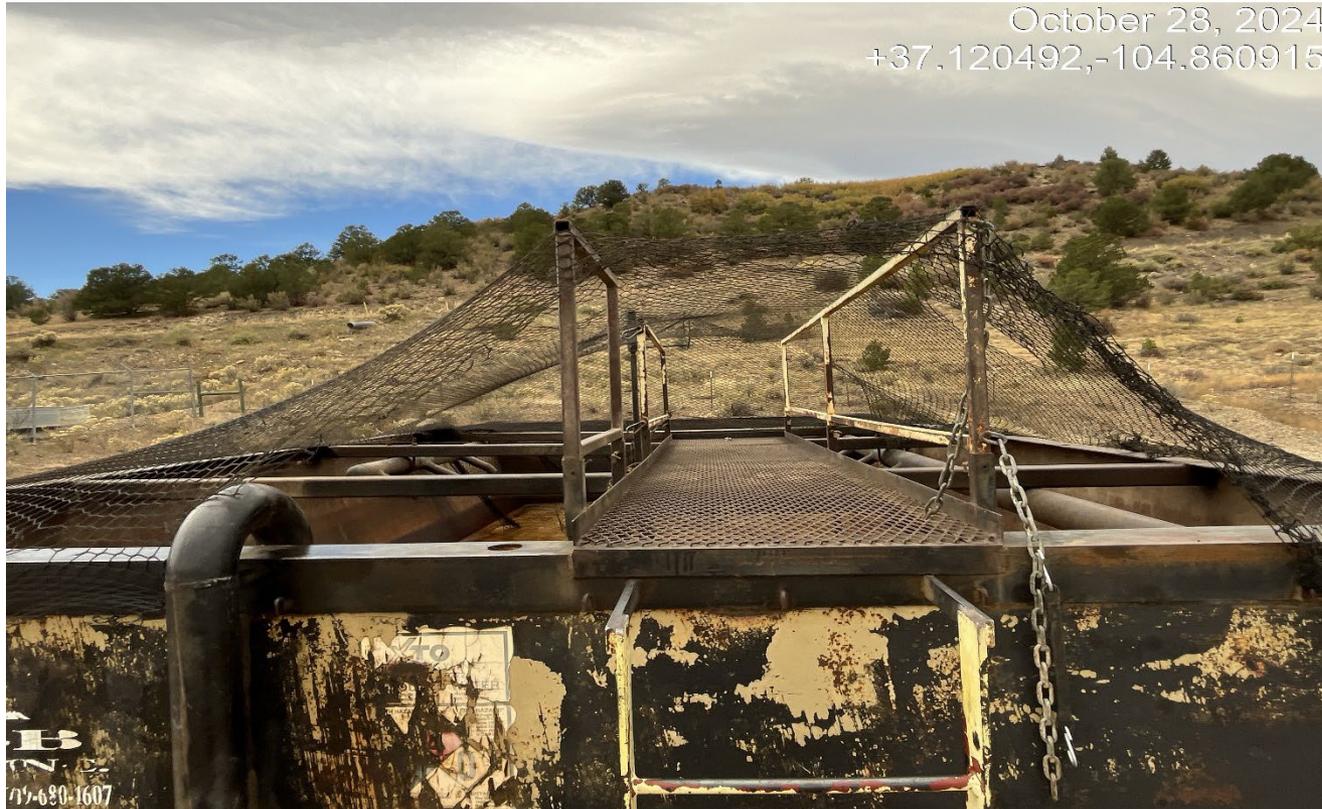
Photo 6. The netting on the open top tank does not cover the entire open top tank. Previous CA was not completed.

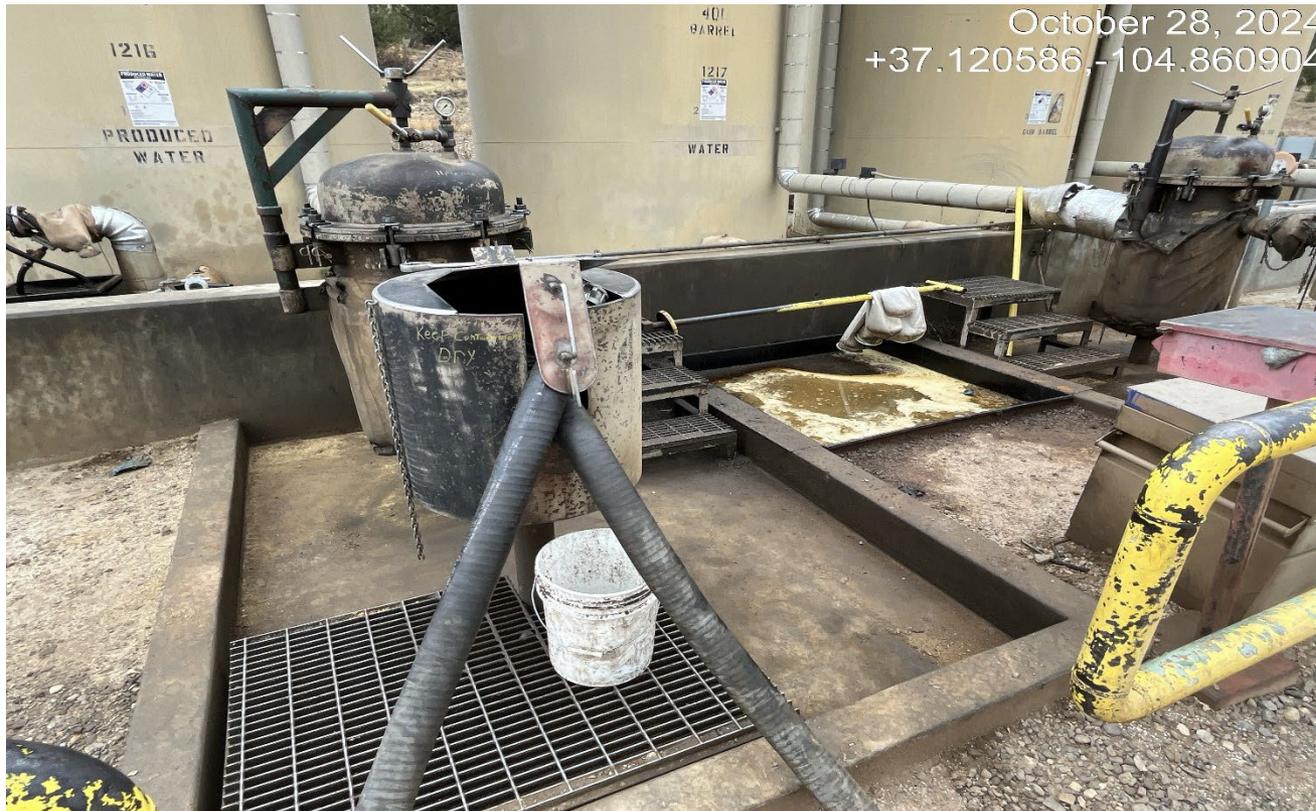
Photo 7. There is oily fluids in the secondary containment. Additionally netting must be installed to prevent wildlife entry. Previous CA was not completed.

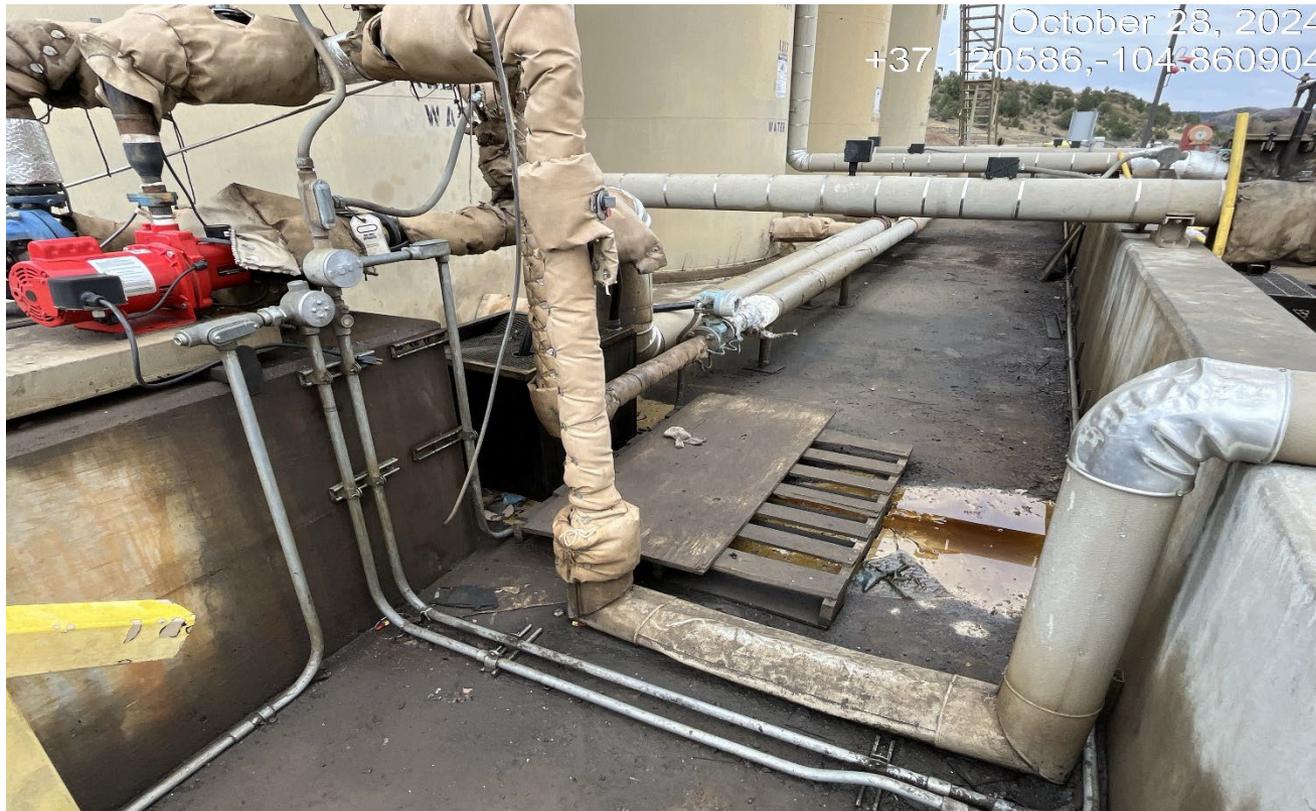
Photo 8. There is oily fluid inside the tank containment area that needs to be cleaned up.

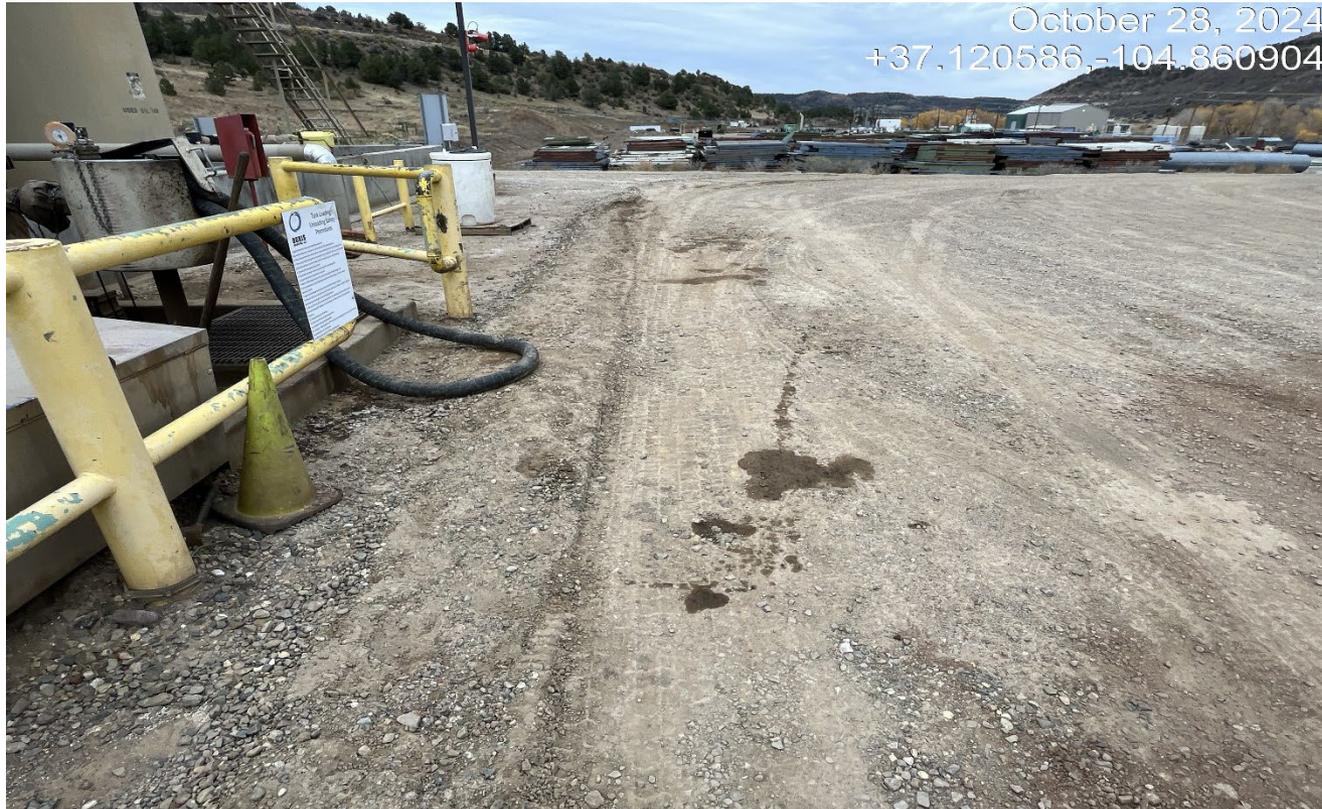
Photo 9. Facing toward the tank battery. There is still oil stained soils where trucks connect to the hoses.

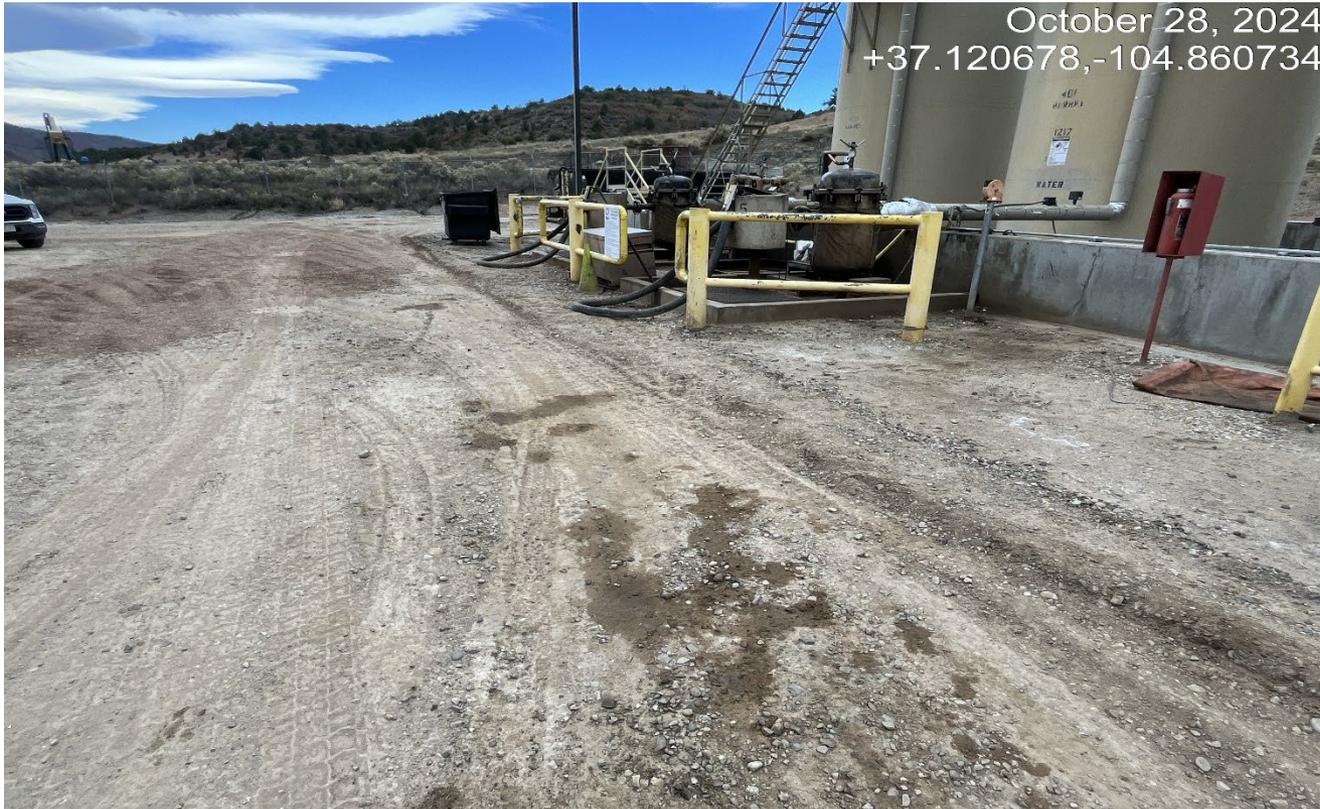
Photo 10. Facing toward the tank battery. There are oil stained soils that need to be cleaned up. Previous CA was not completed.
