Inspection Photos

ID: 333545

Operator: OGRIS OPERATING LLC

Inspection Date: 10/28/2024

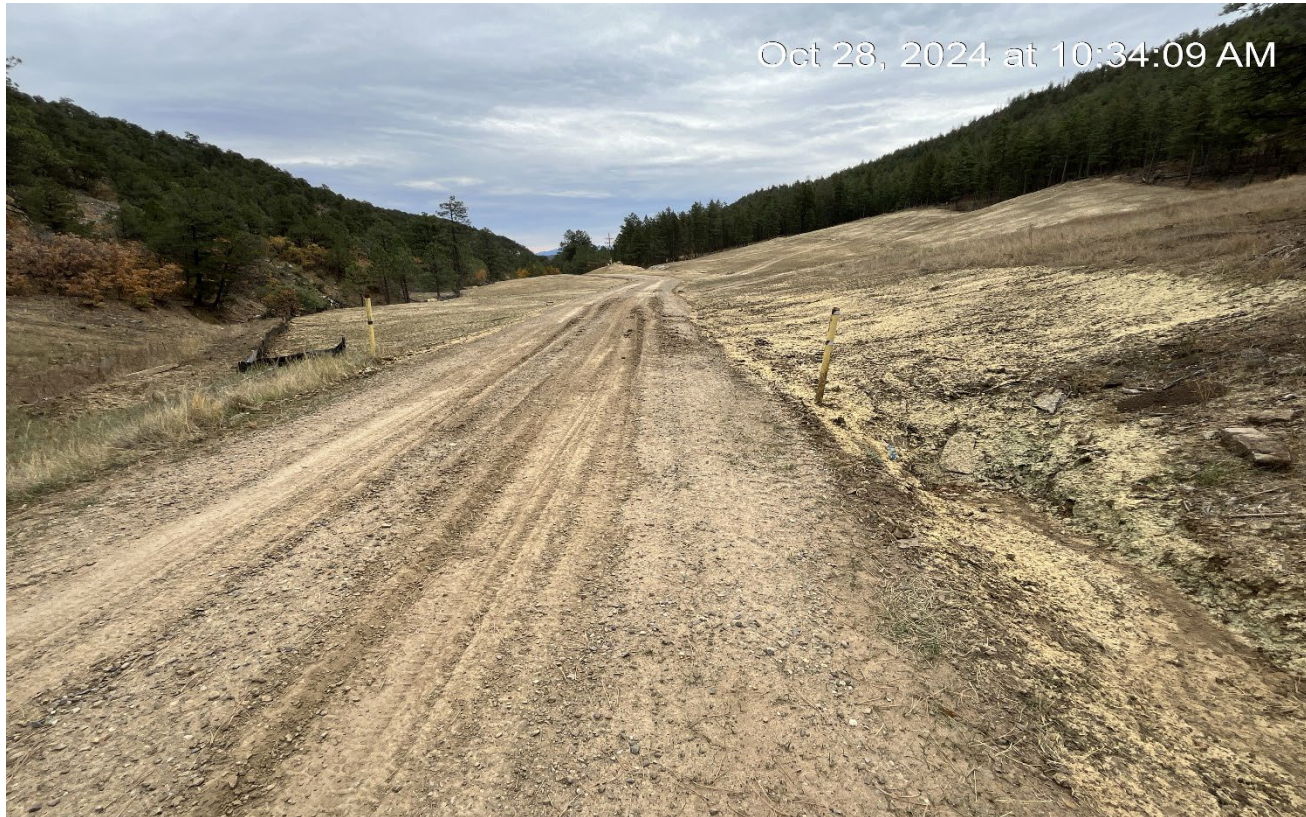
Photo 1. Facing east along the access road.

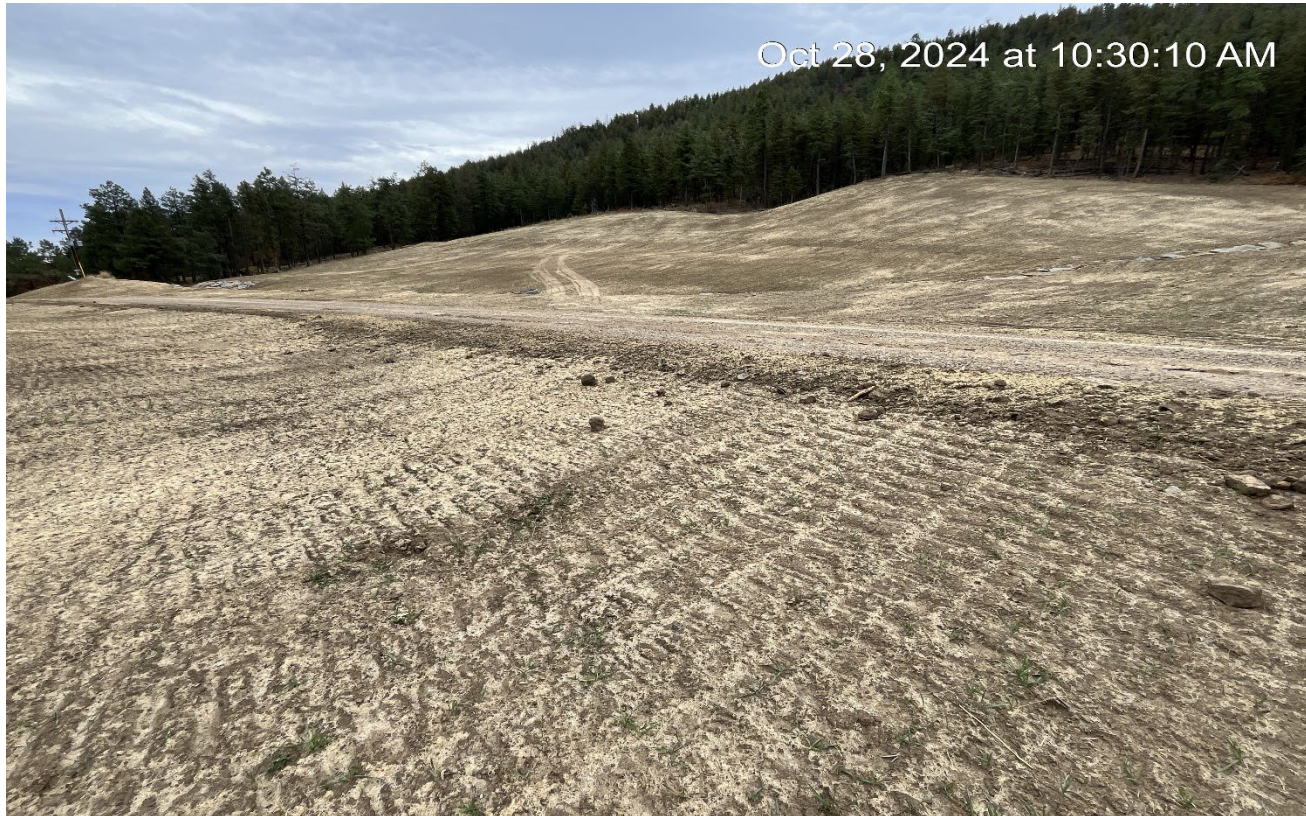
Photo 2. Facing southeast. The location has been recontoured and reclaimed. Soils have been tracked and lightly hydromulched.

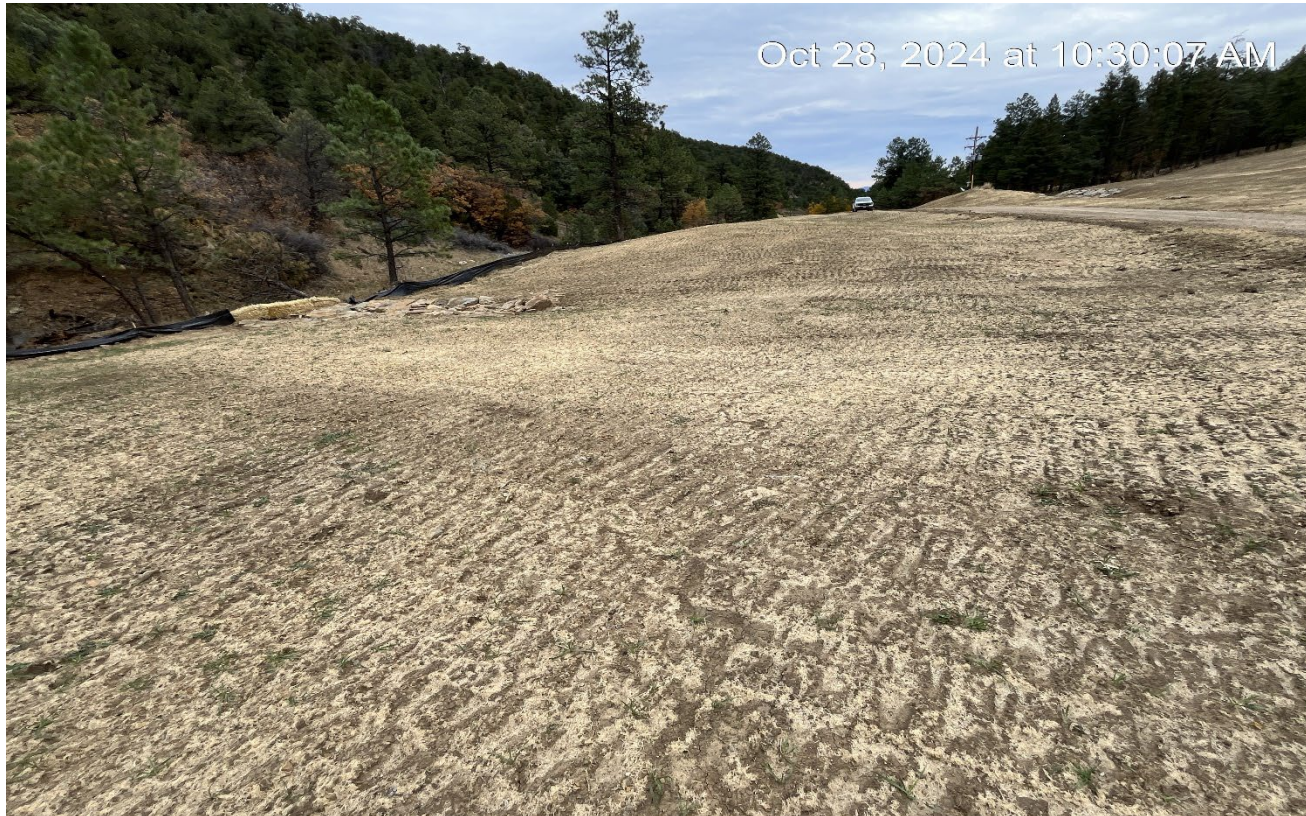
Photo 3. Facing east at the north side of the location.

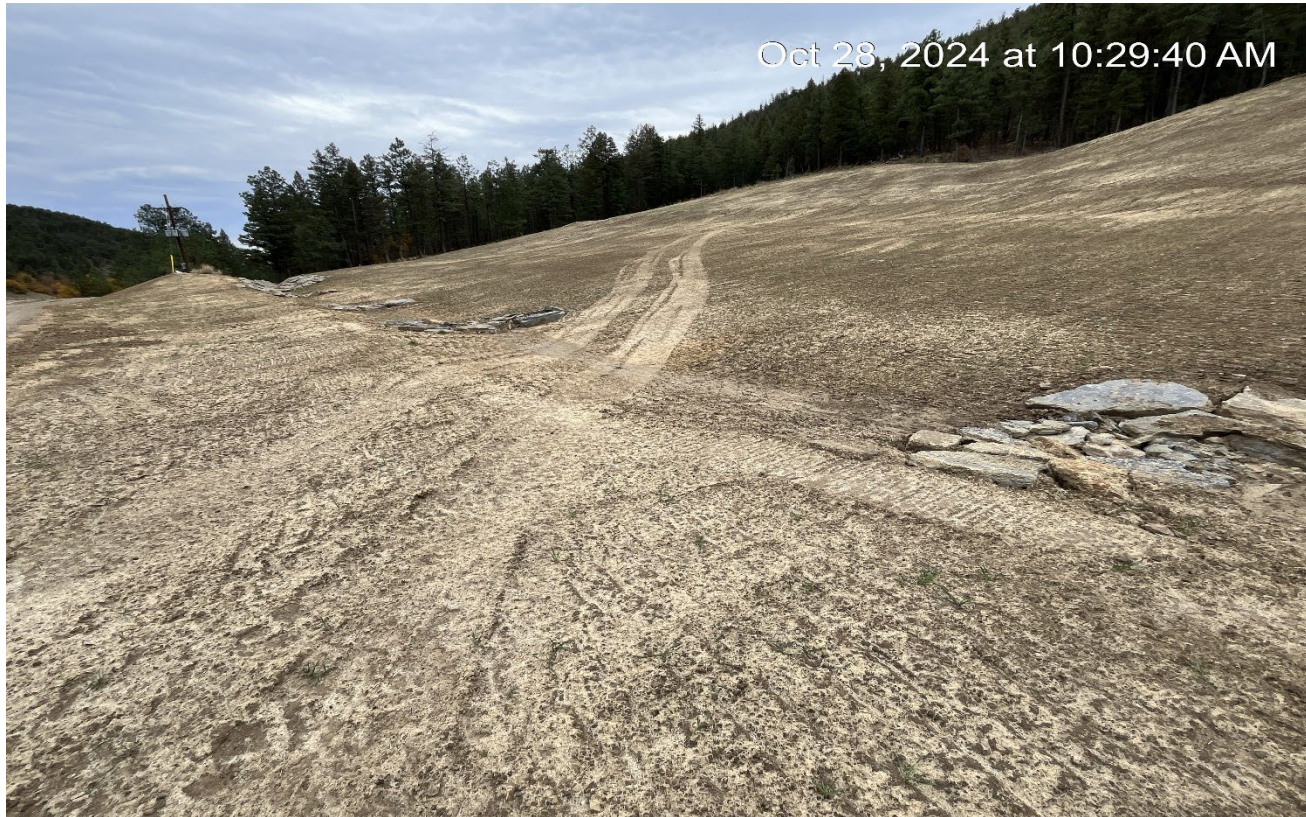
Photo 4. Facing east at the center of the location. A berm was installed with rock dams.

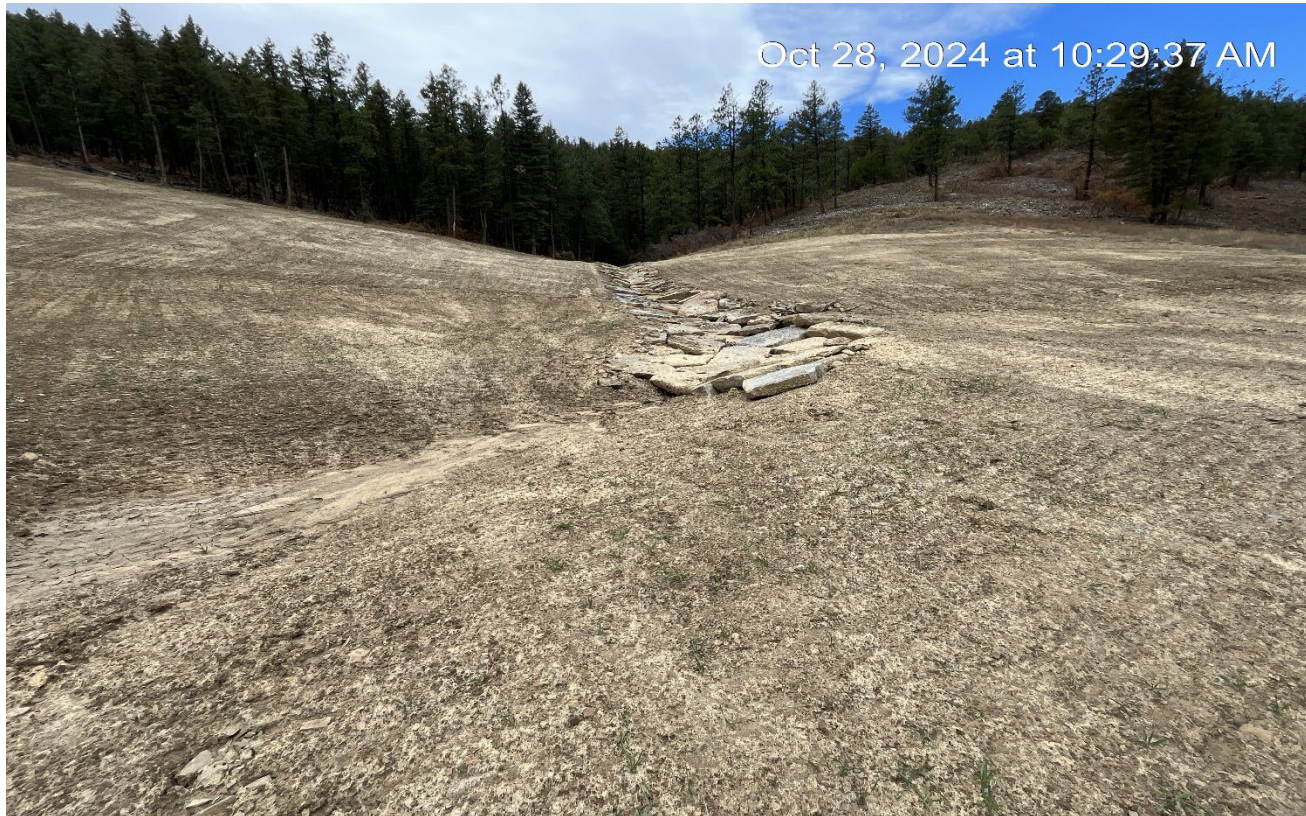
Photo 5. This drainage was stabilized with rock rip/rap for stormwater run-on..

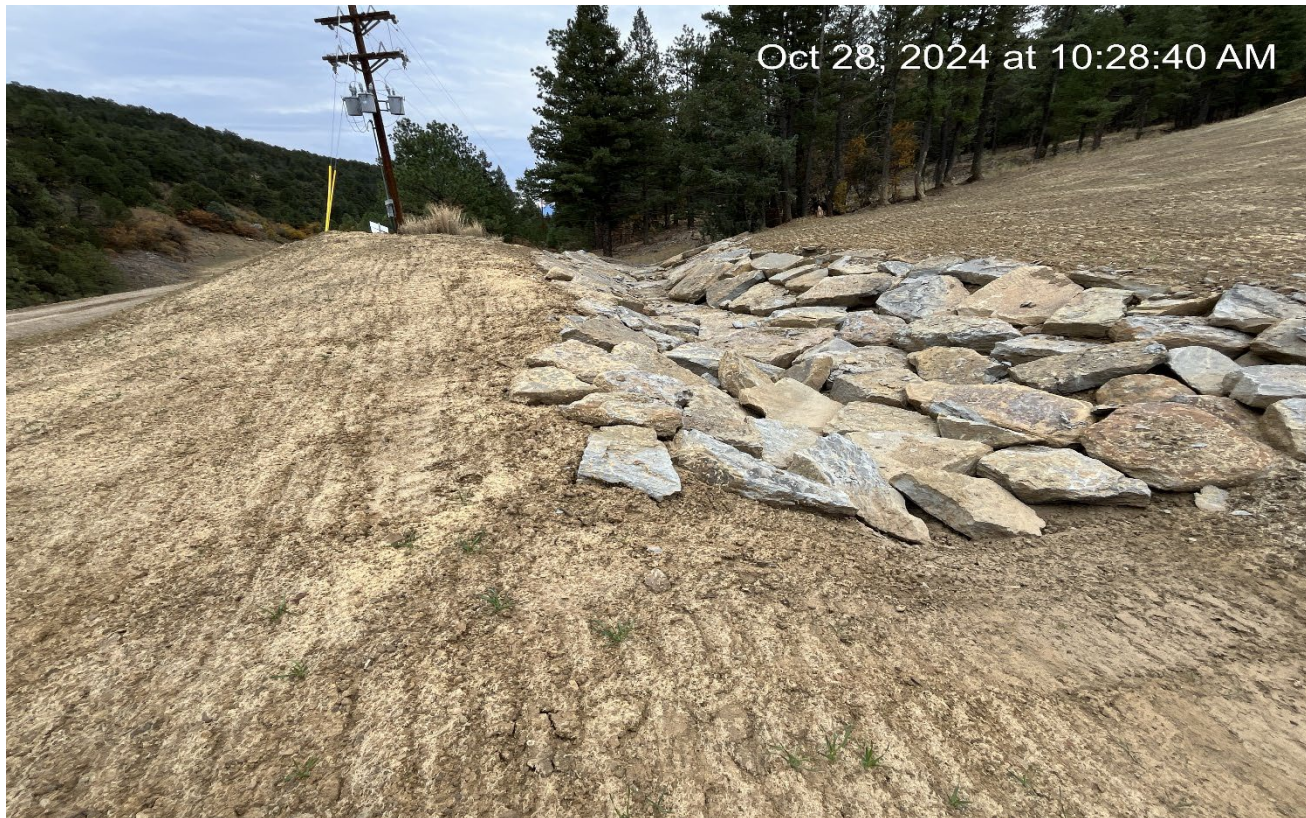
Photo 6. Facing toward the east side of the location. This rip/rap outlet appears to have too much rip/rap and may affect drainage as it appears to be slightly higher grad.

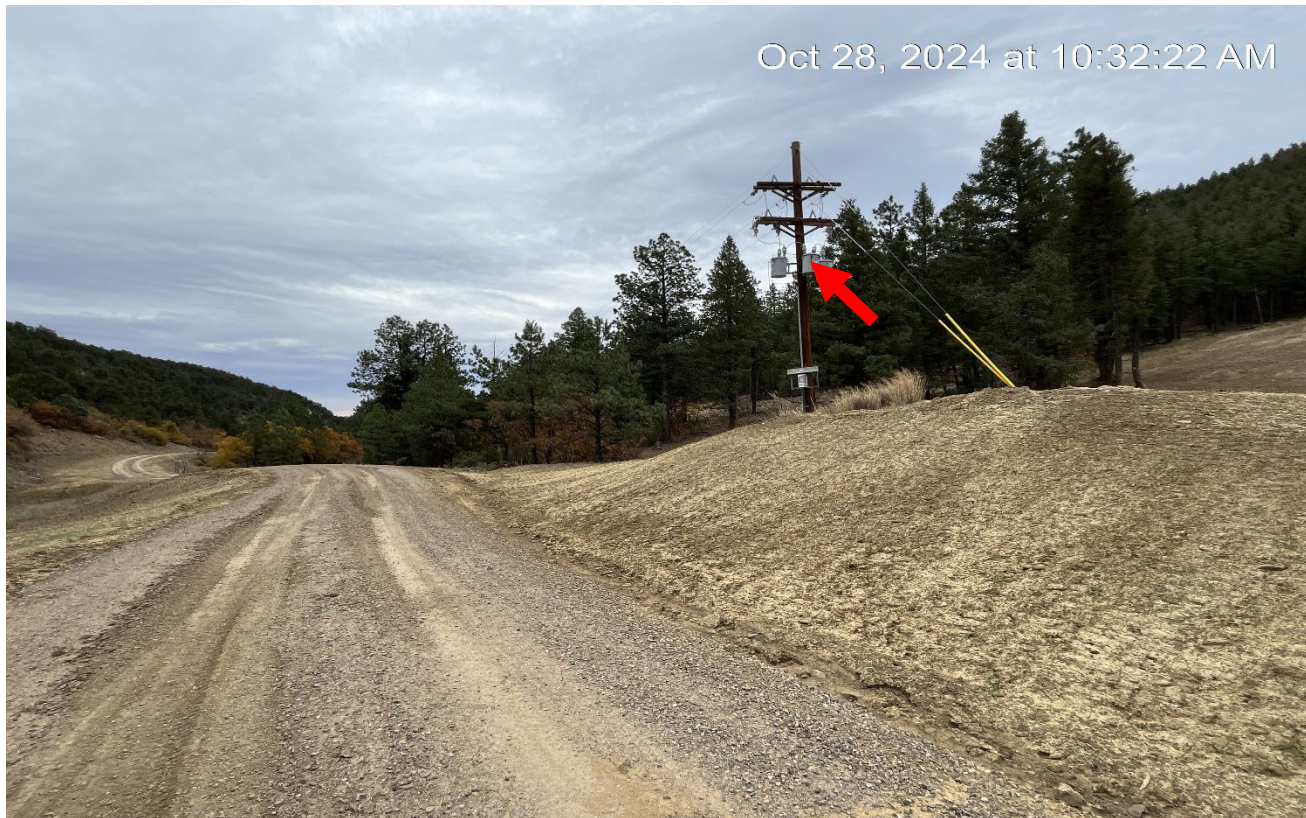
Photo 7. This electric utility line needs to be removed by coordinating removal with utility company.

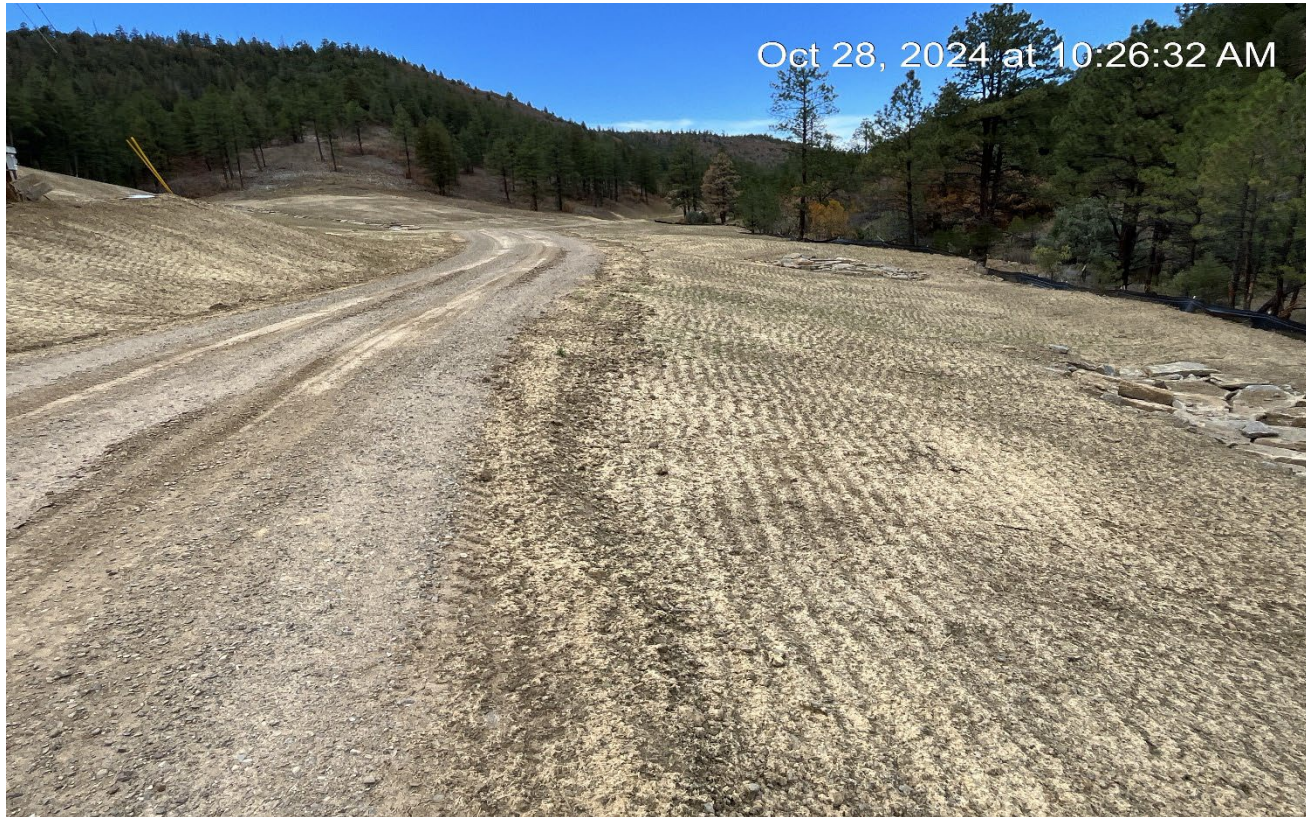
Photo 8. Facing back west at the reclaimed location..
