**Caerus Piceance – QB Energy**  
**Piceance Creek Unit-62S97W 10NWSE**  
**Location ID: 335947**

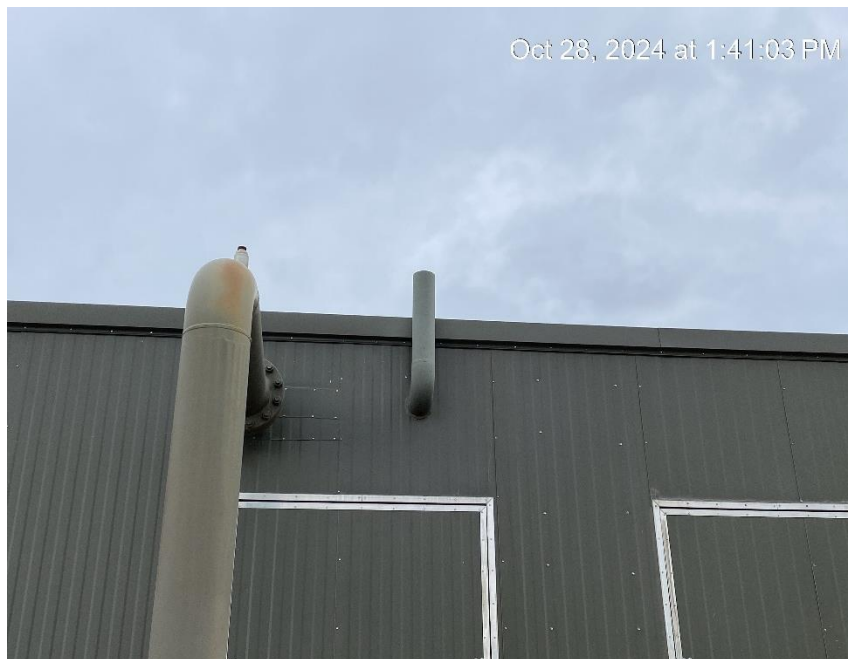
**Vent cap missing**

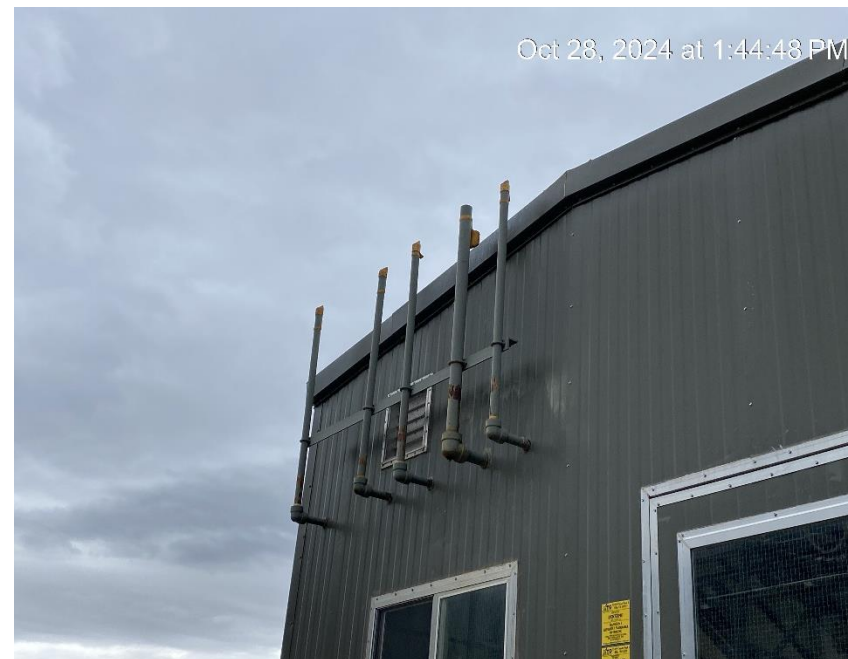
**Vent cap not in place**

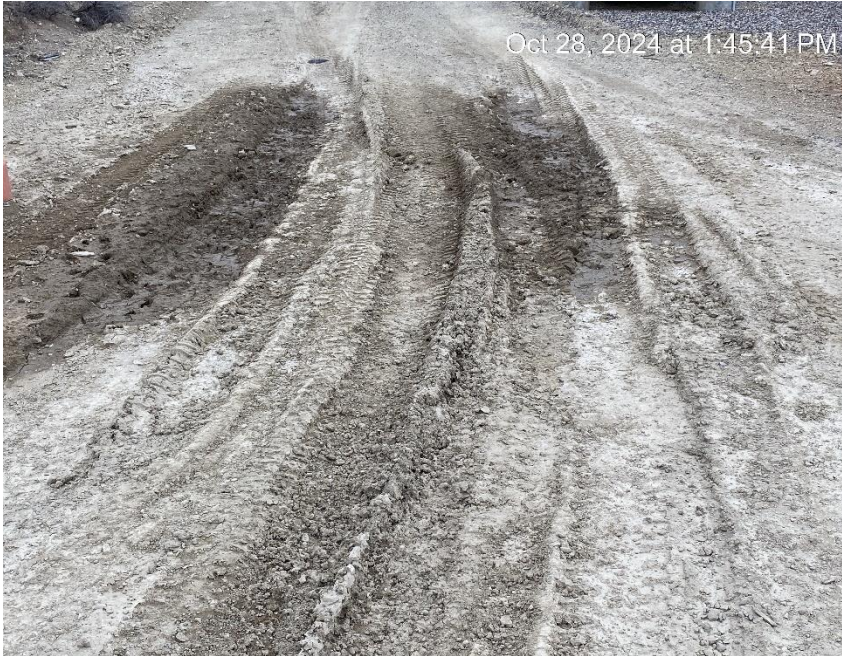
**Vehicle tracking**

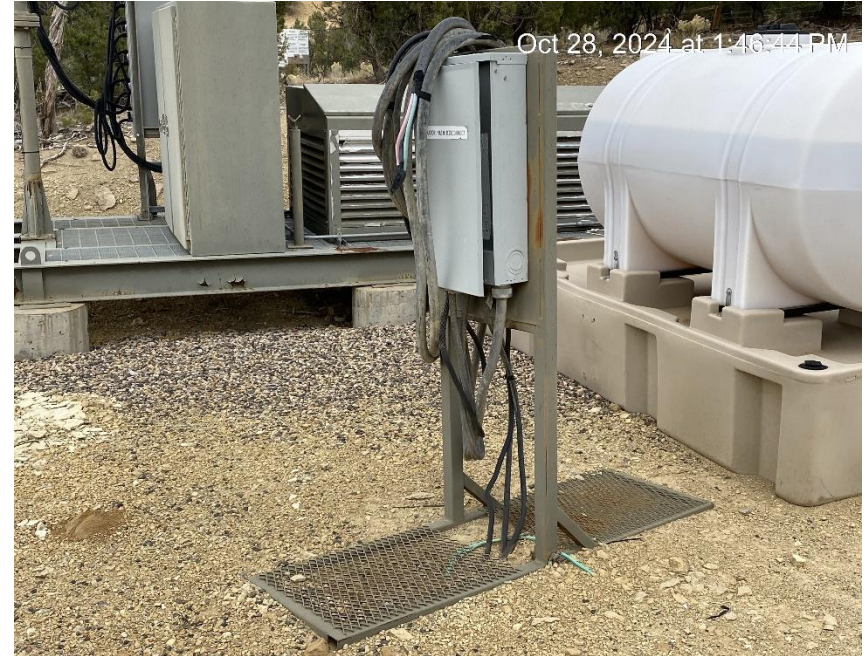
**Debris? Unused equipment?**

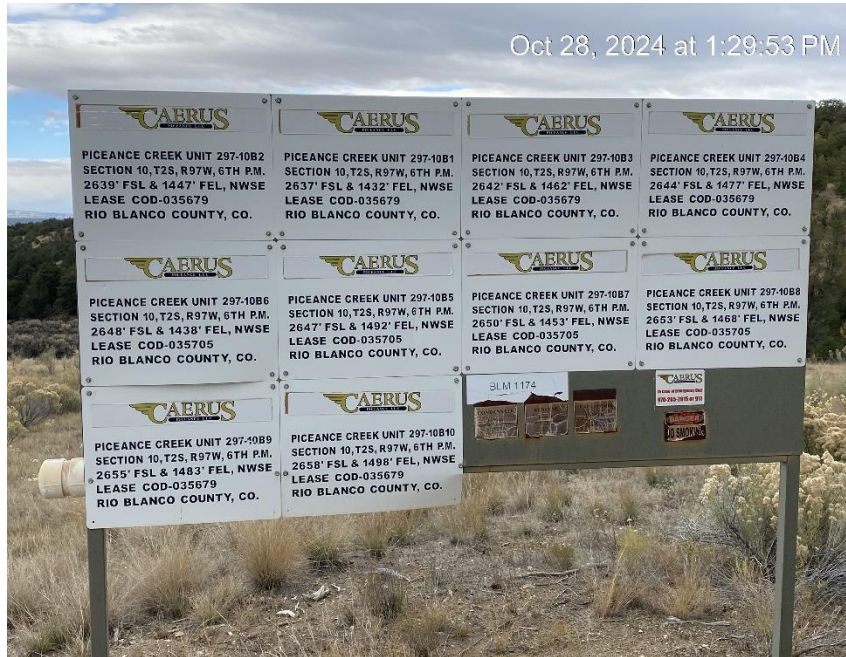
As location signs are replaced additional information is required

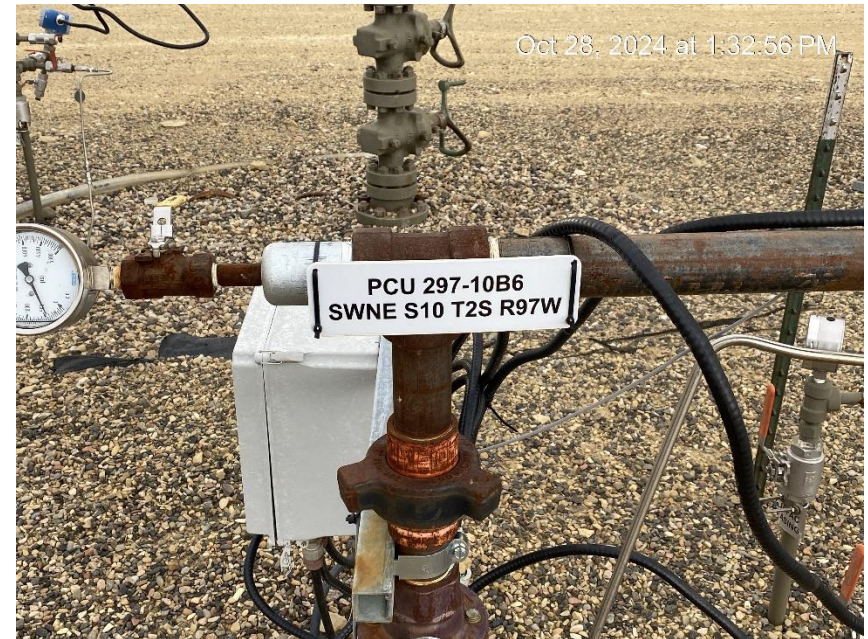
Well sign missing required information
