Inspection Photos

Location Name: TEP ROCKY MOUNTAIN LLC SNYDER A Pad

Location ID: 311651

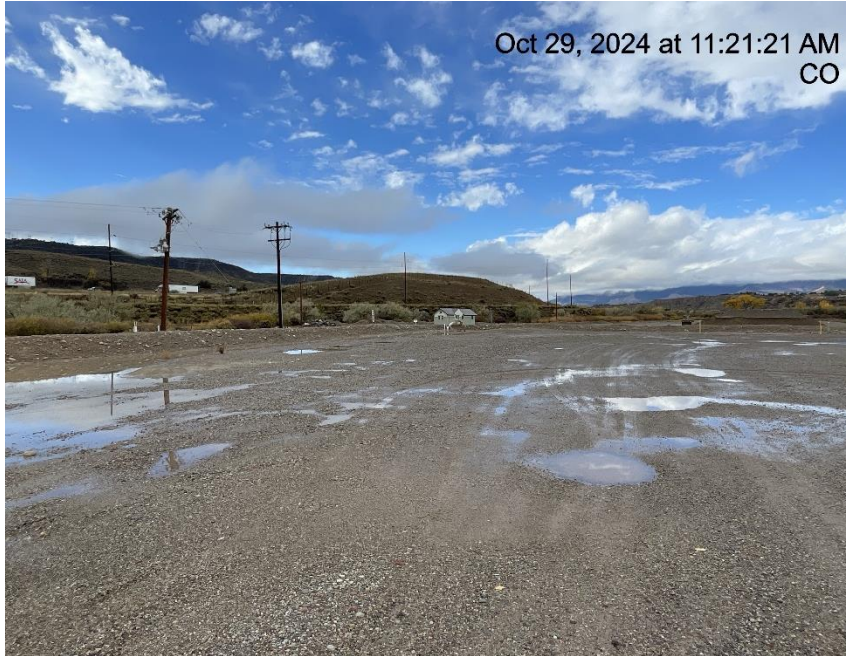
Photo # 7978 From entrance to location

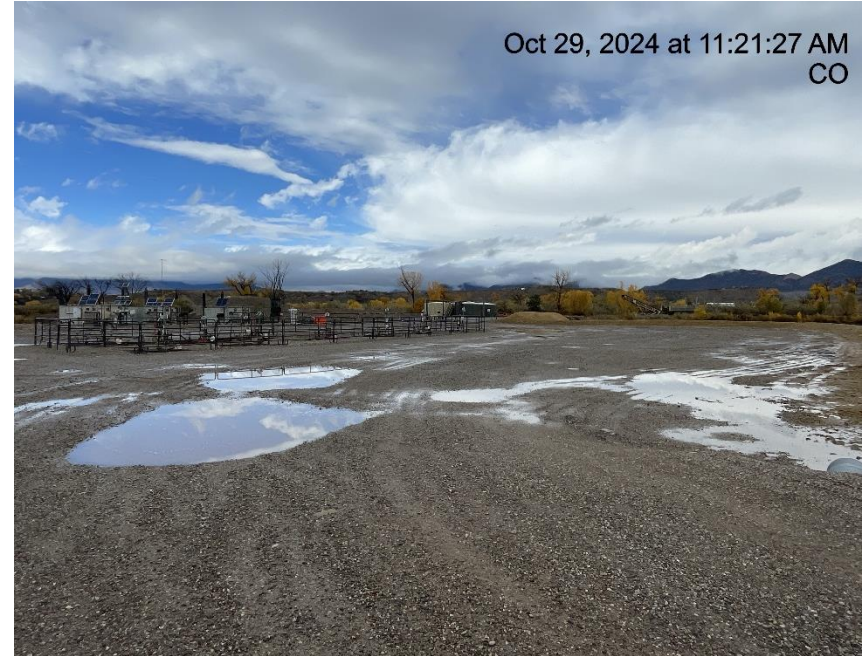
Photo # 7979 From entrance to location

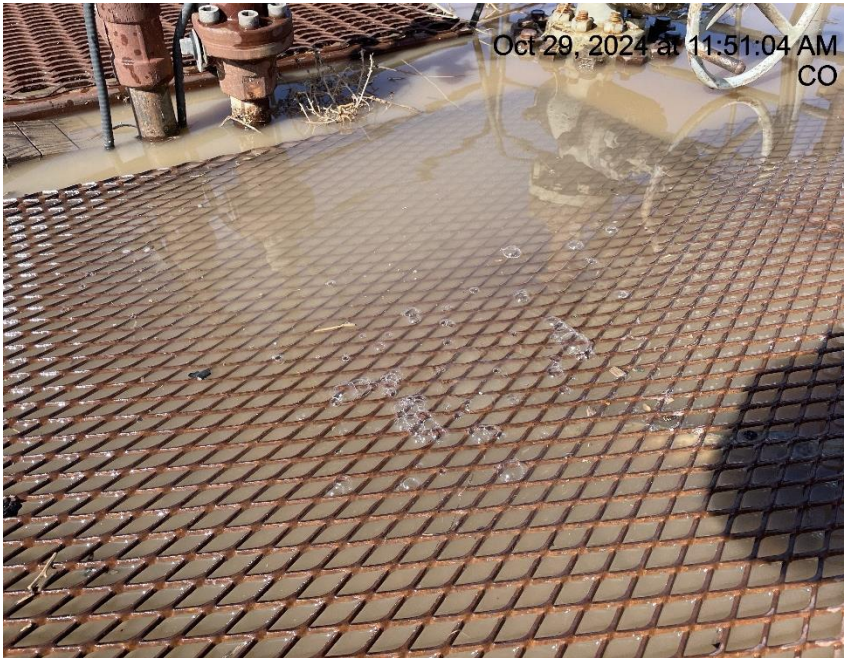
Photo # 7986 Possible wellhead leak/gas bubbling up near wellhead through water in cellar (A11 well)

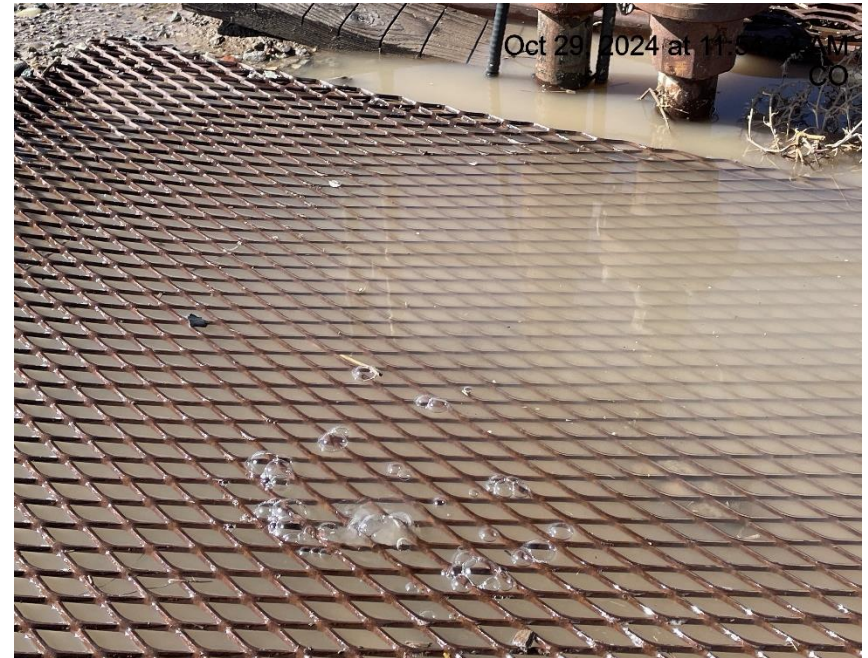
Photo # 7987 Possible wellhead leak/gas bubbling up near wellhead through water in cellar (A11 well)

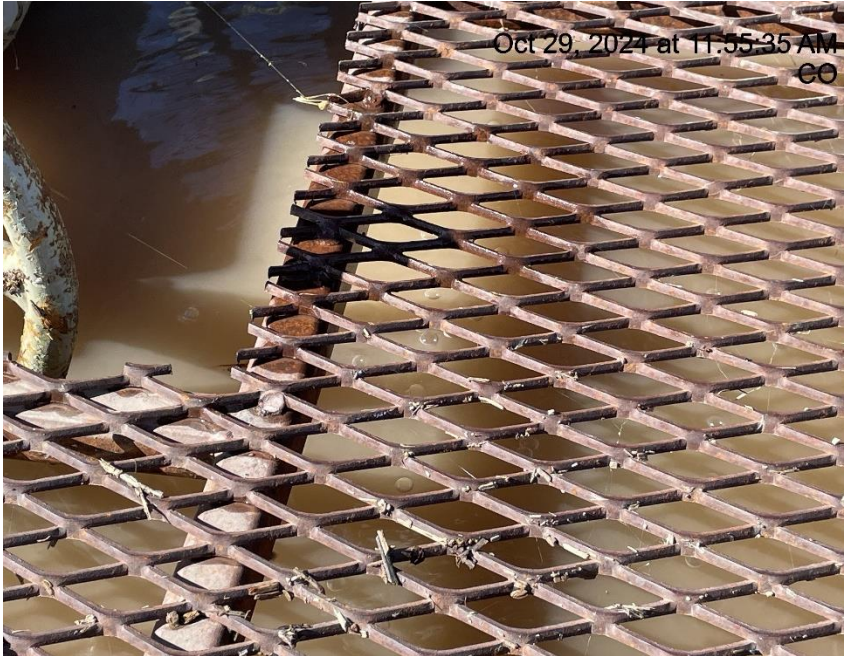
Photo # 7988 Possible wellhead leak/gas bubbling up near wellhead through water in cellar (A9 well)

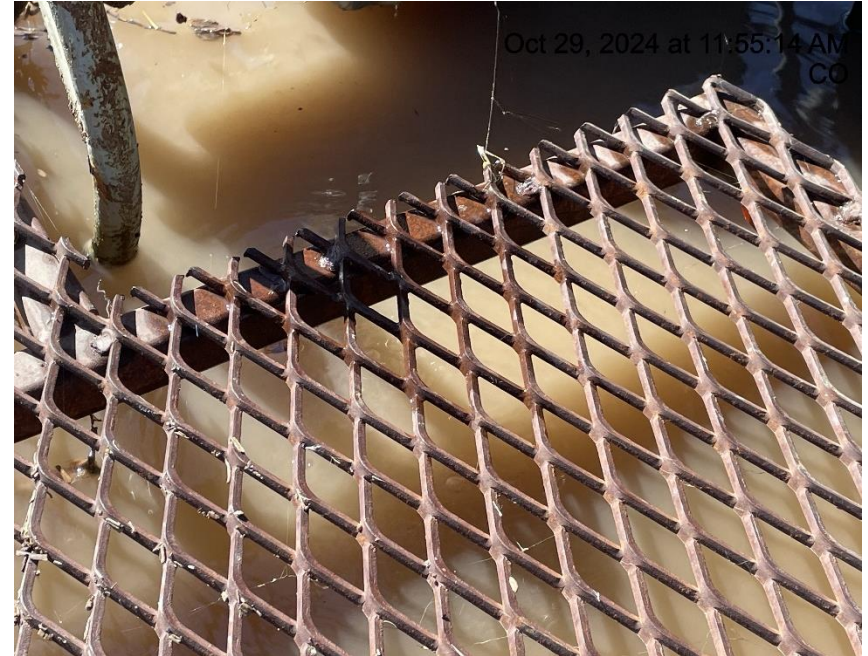
Photo # 7989 Possible wellhead leak/gas bubbling up near wellhead through water in cellar (A9 well)

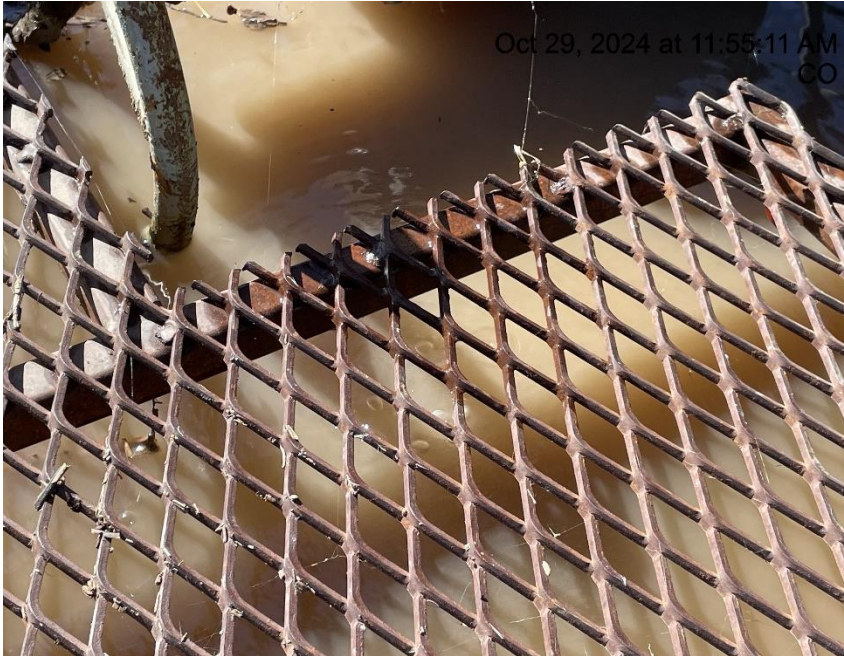
Photo # 7990 Possible wellhead leak/gas bubbling up near wellhead through water in cellar (A9 well)

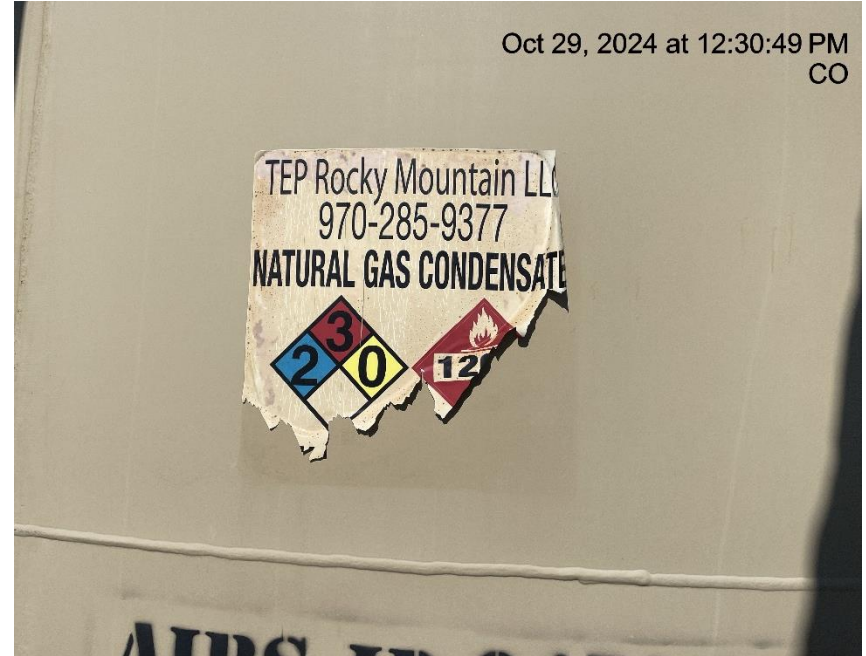
Photo # 7991 Tank label damaged
