Storm Water Management and Erosion control
Location Name: TEP ROCKY MOUNTAIN LLC FEDERAL RMV 169-18 Pad
Location ID: 335604

Location Overview: Location is within High Priority/Density Habitat areas. Location is approximately 7 yards from a creek/drainage that contributes to the Colorado River.

Section/Township/Range: 18 6S94W

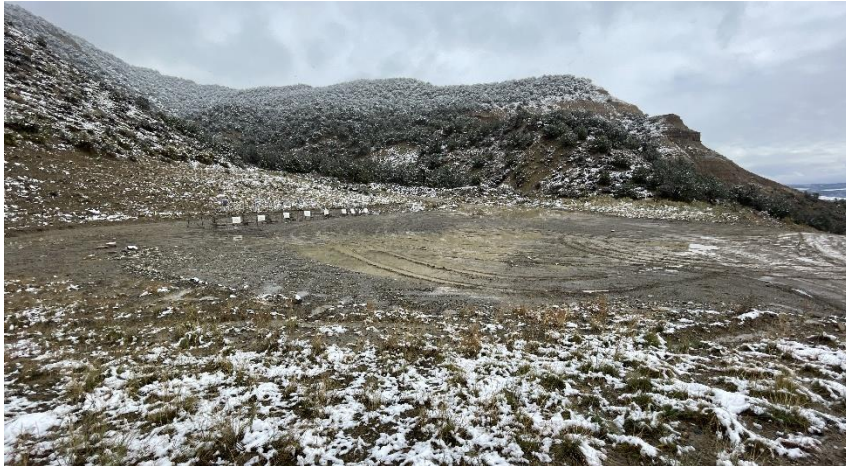
North West corner of location.

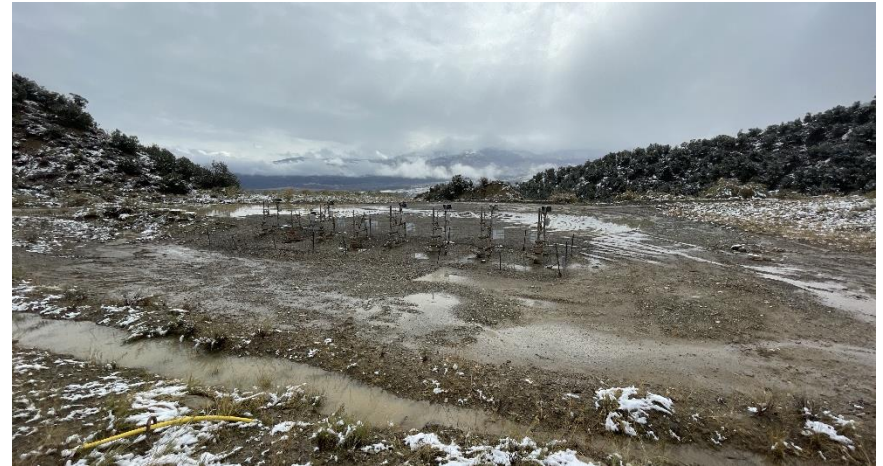
North East corner of location.

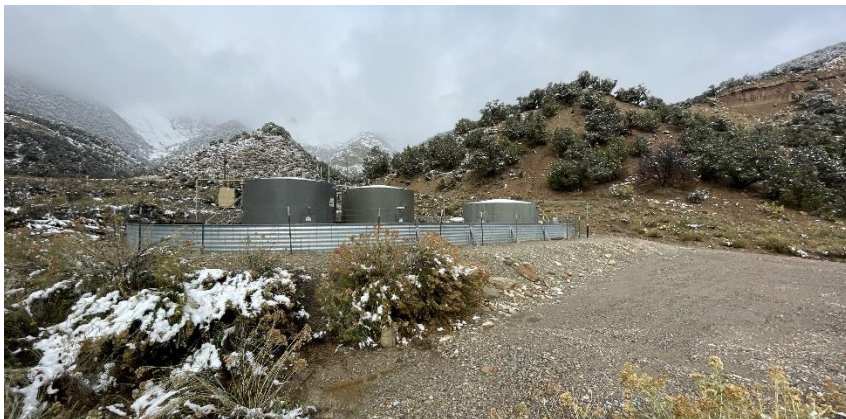
South West corner of location.

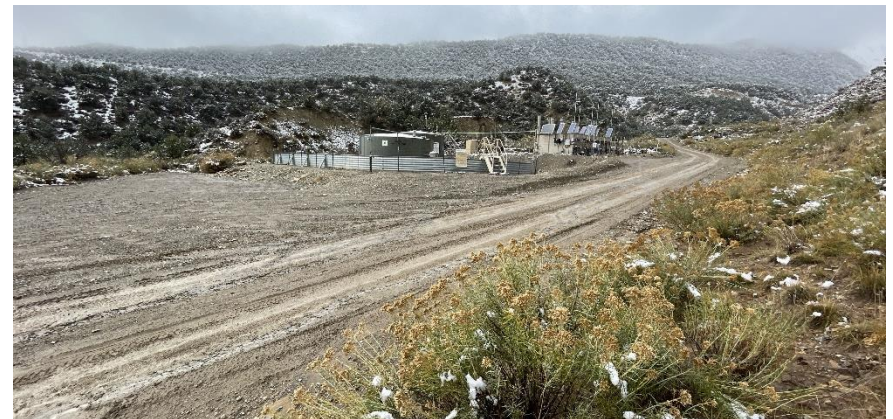
South East corner of location.

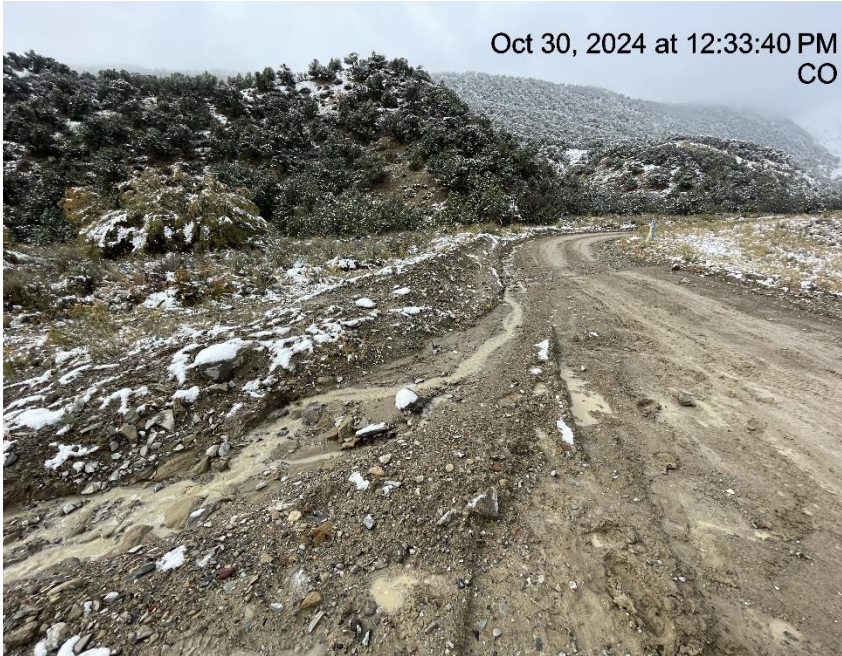
Photo # 8404 Sediment laden stormwater running off lease road into a vegetated area/insufficient BMP's

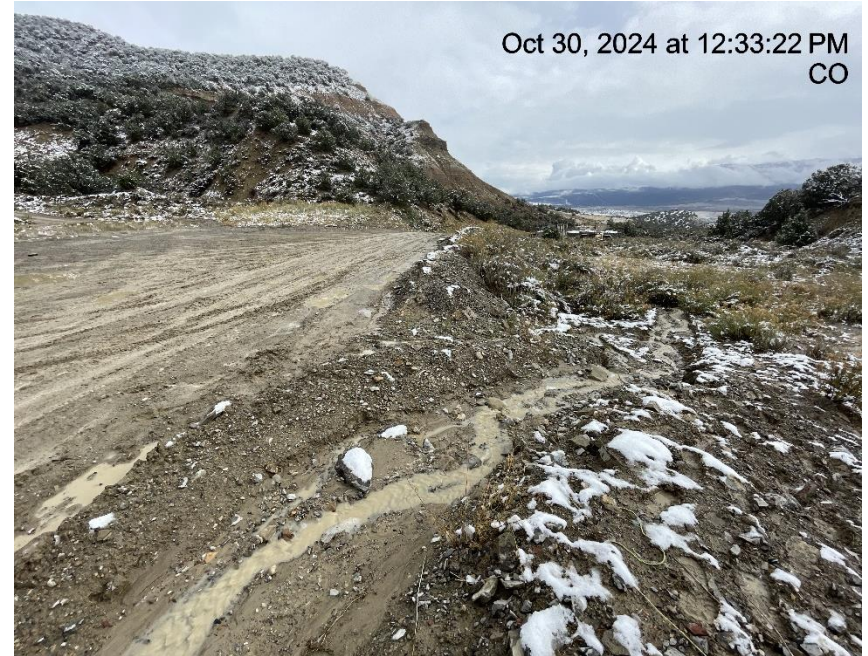
Photo # 8405 Sediment laden stormwater running off lease road into a vegetated area/insufficient BMP's

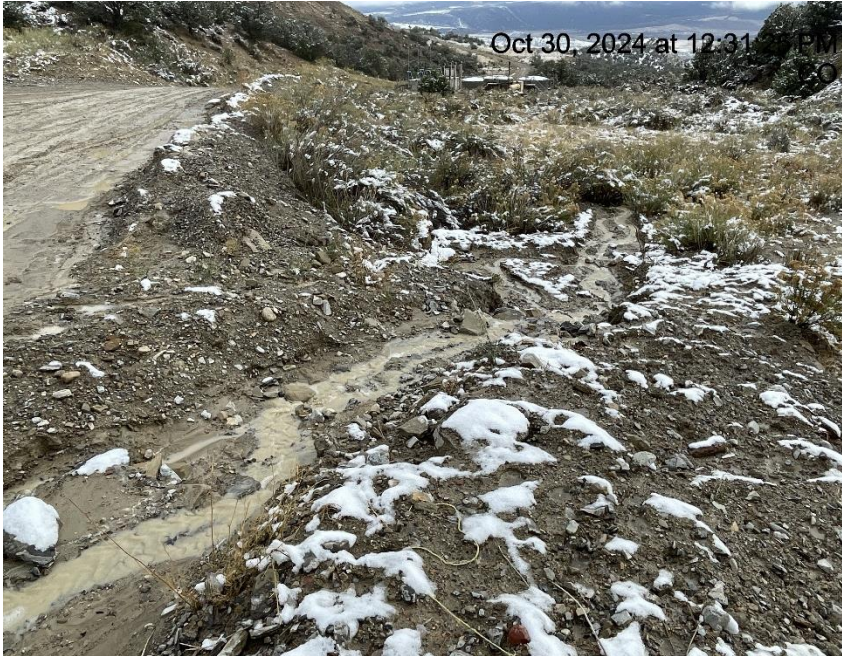
Photo # 8406 Sediment laden stormwater running off lease road into a vegetated area/insufficient BMP's
