## Inspection Photos

Location: TEP ROCKY MOUNTAIN LLC BOSELY-67S96W/23SWNW

Location ID: 334721

Date: 10/30/2024

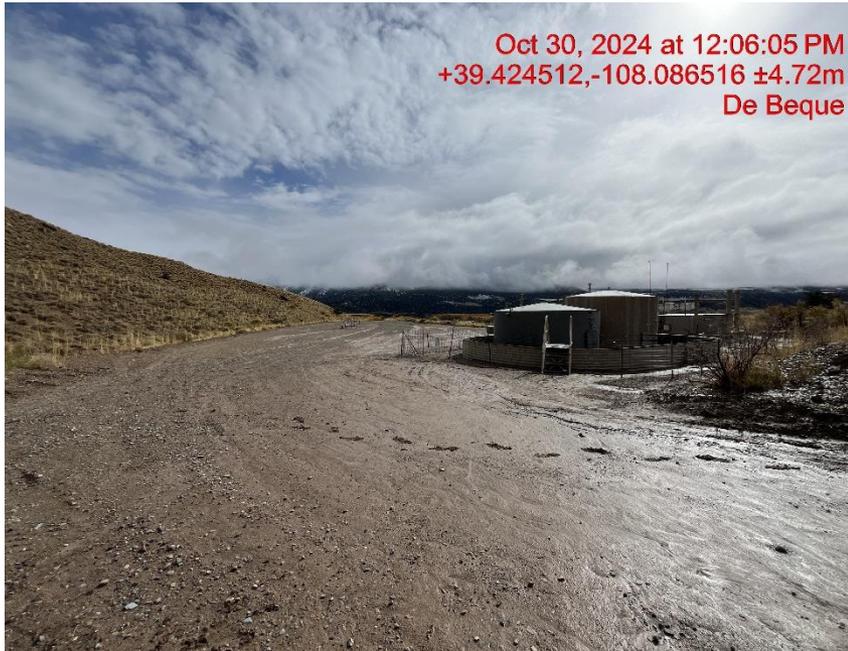
Photo # 8338 Entrance to location

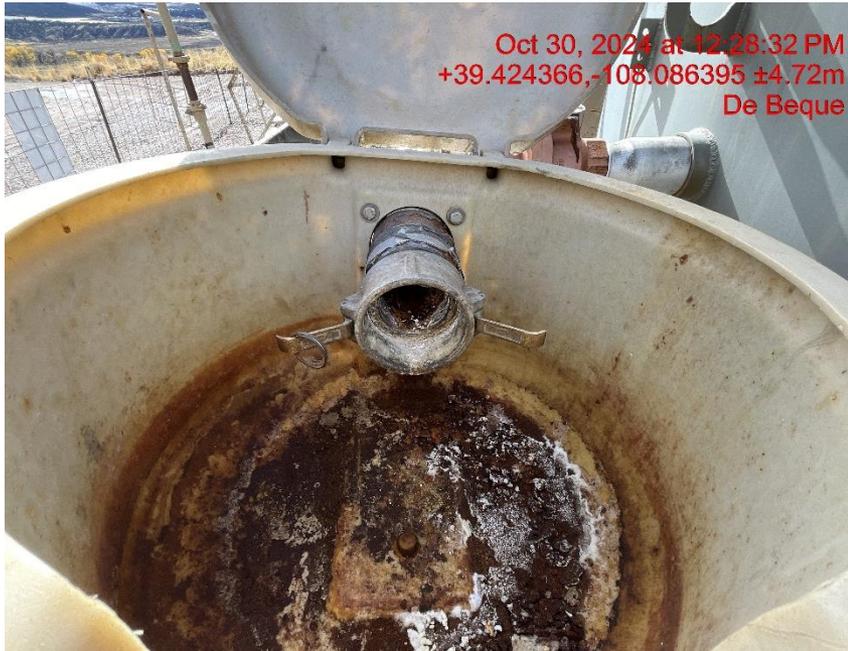
**Photo # 8353 Open ended load line**

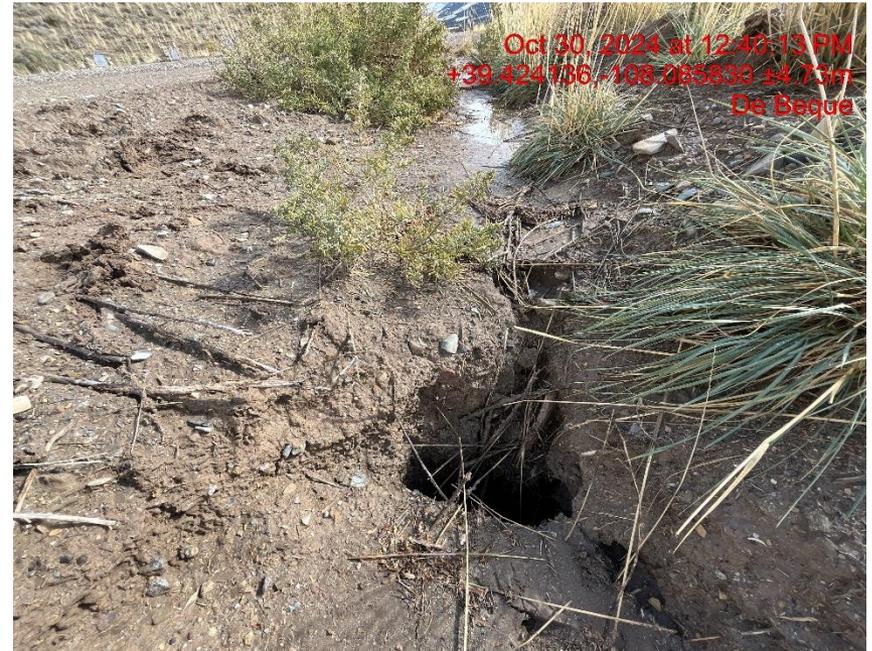
**Photo # 8366 Tunnel erosion in ditch, is also a wildlife/personal safety hazard**

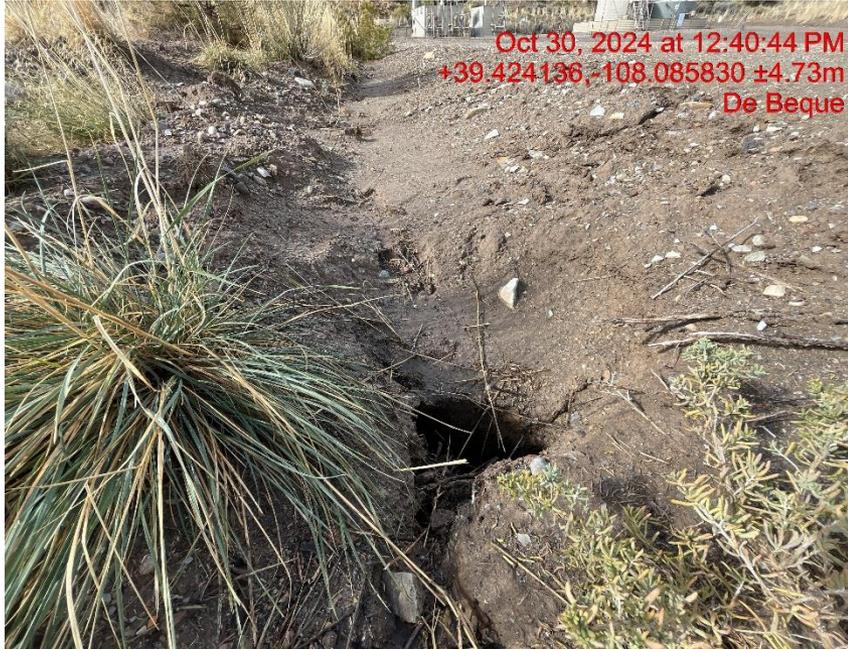
**Photo # 8368 Tunnel erosion in ditch, is also a wildlife/personal safety hazard**

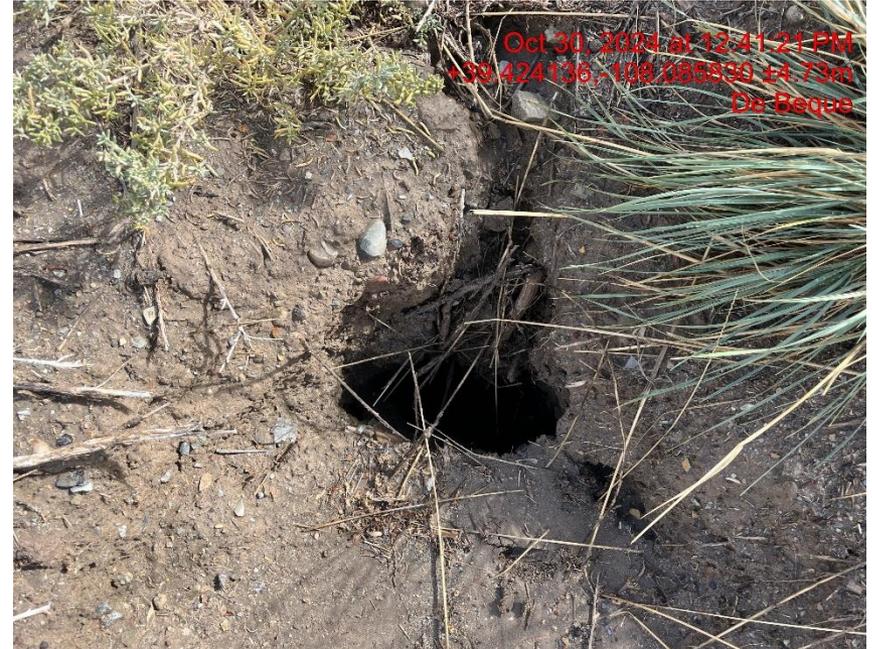
**Photo # 8369 Tunnel erosion in ditch, is also a wildlife/personal safety hazard**
