Inspection Photos

Location: TEP ROCKY MOUNTAIN LLC Strait/SG 42-22

Location ID: 430567

Date: 10/30/2024

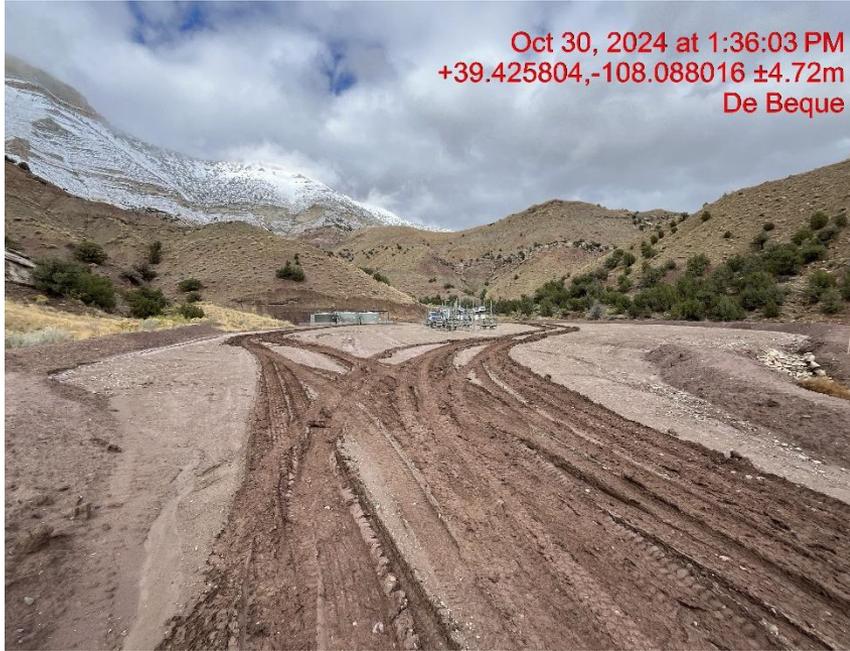
Photo # 8384 Entrance to location

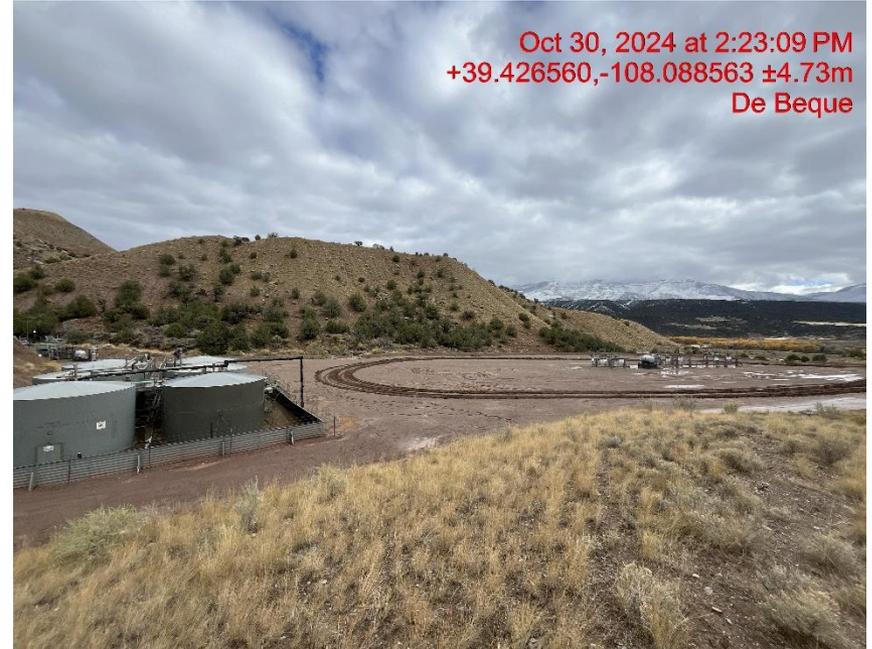
Photo # 8428 NW corner of location

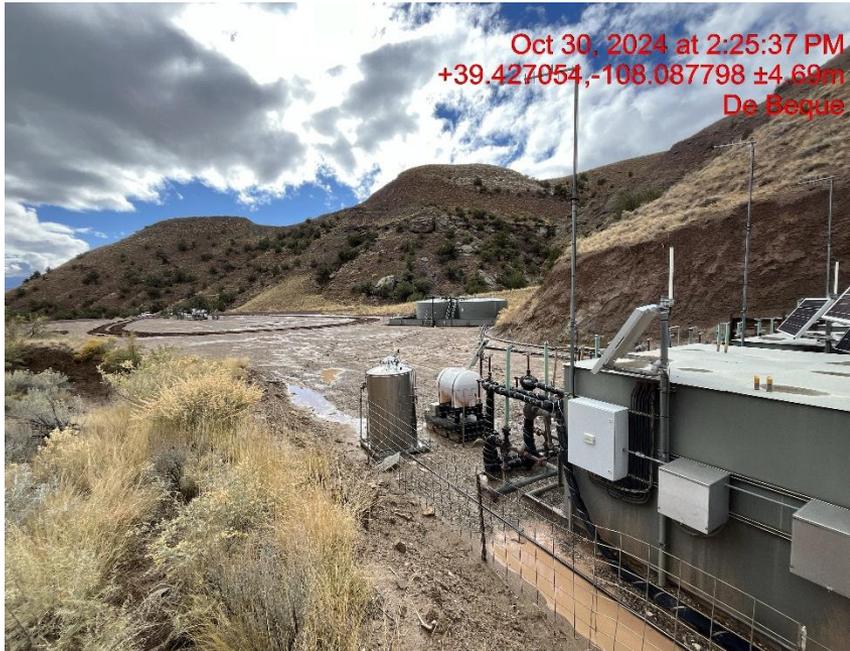
Photo # 8429 NE corner of location

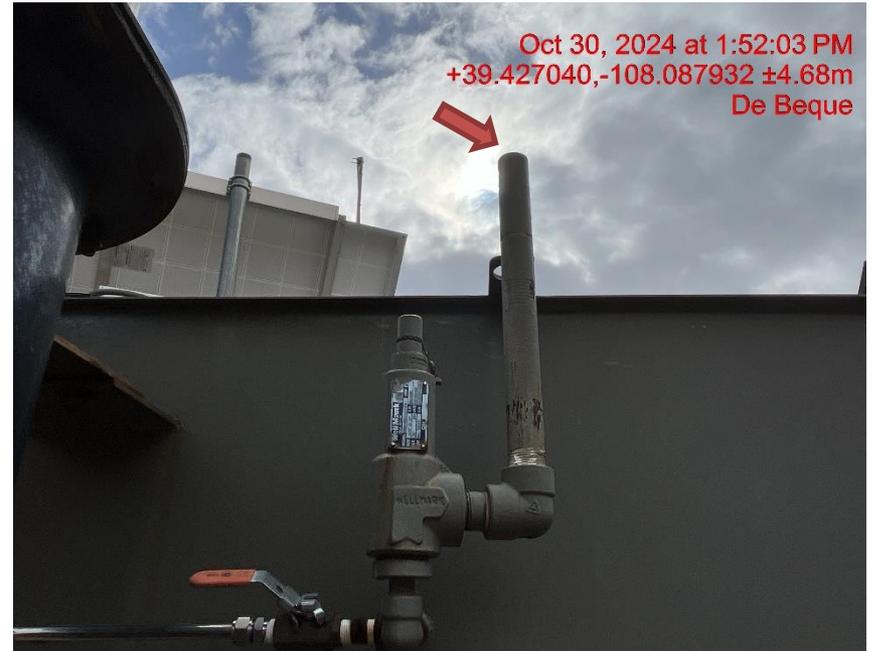
Photo # 8393 PRV vent line does not comply with CECMC pressure safety device rules

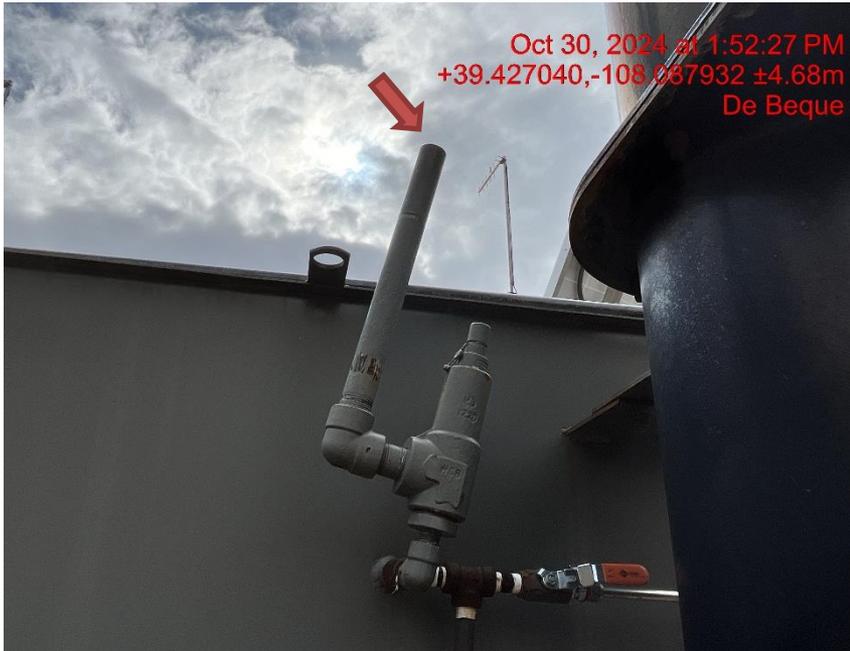
Photo # 8394 PRV vent line does not comply with CECMC pressure safety device rules

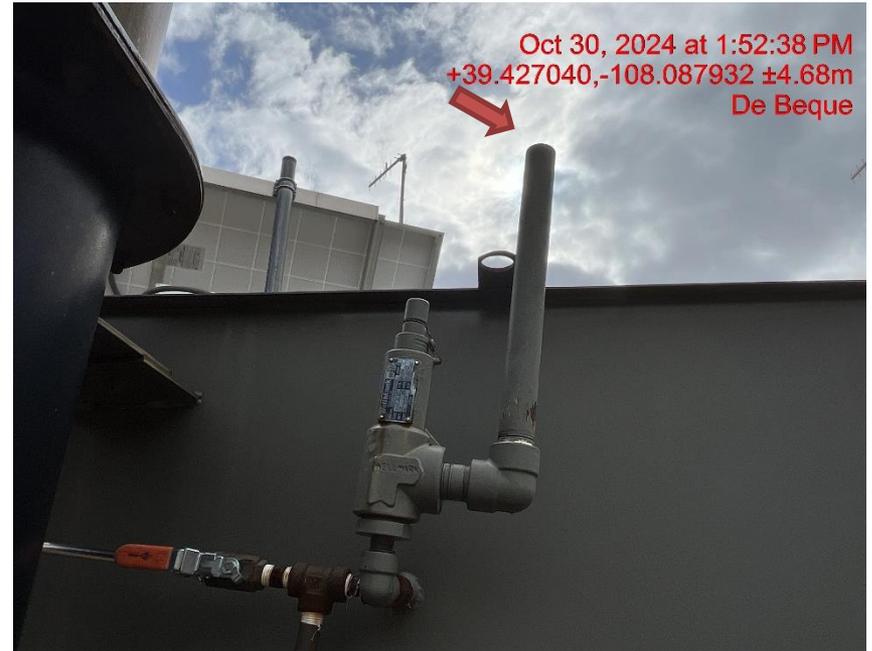
Photo # 8395 PRV vent line does not comply with CECMC pressure safety device rules

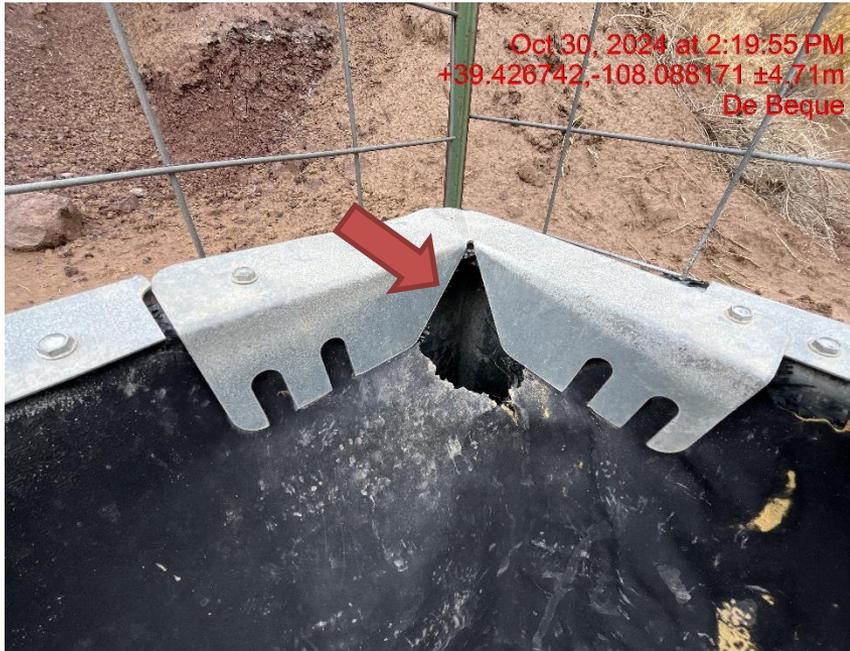
Photo # 8424 Hole in secondary containment/liner needs maintenance

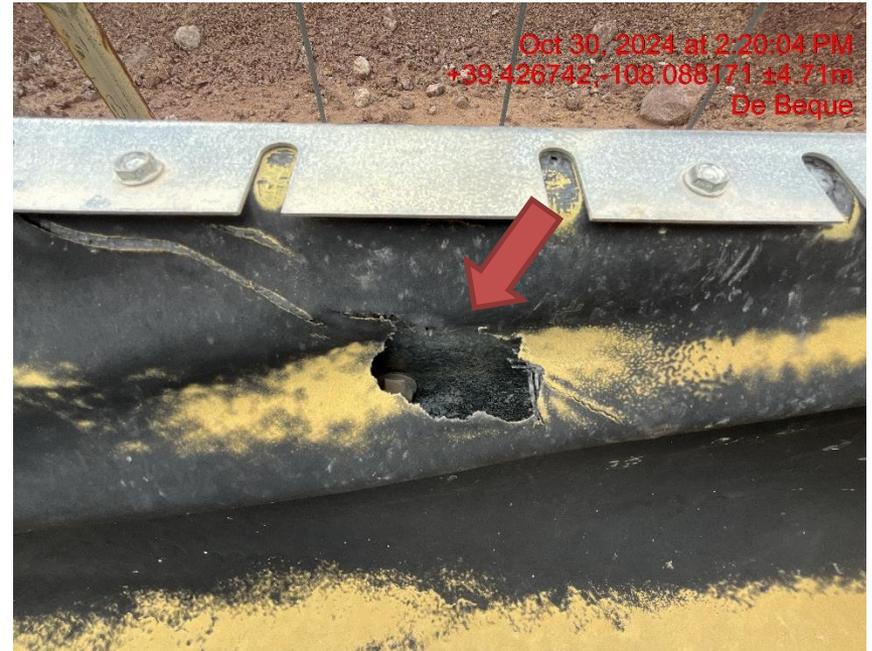
Photo # 8425 Hole in secondary containment/liner needs maintenance

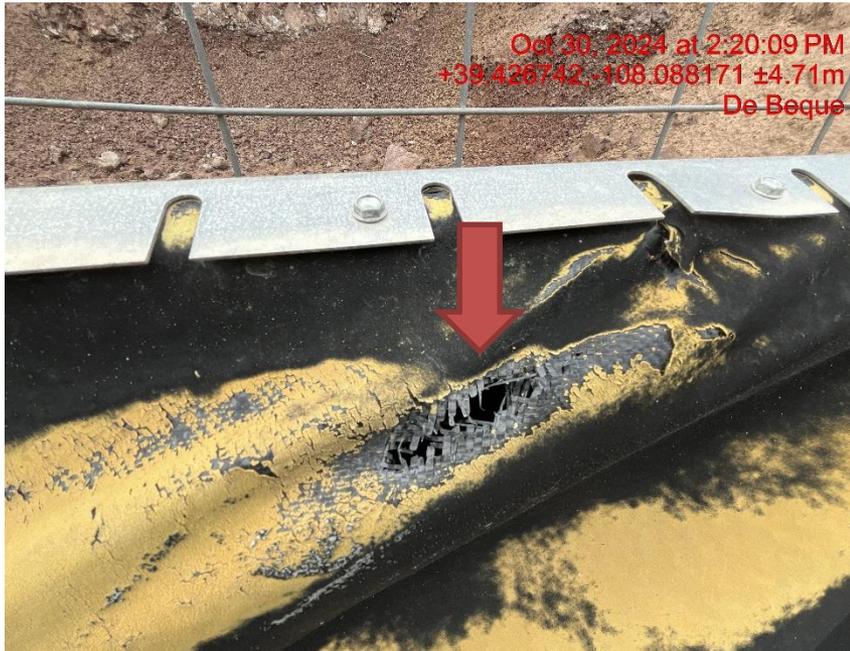
Photo # 8426 Hole in secondary containment/liner needs maintenance

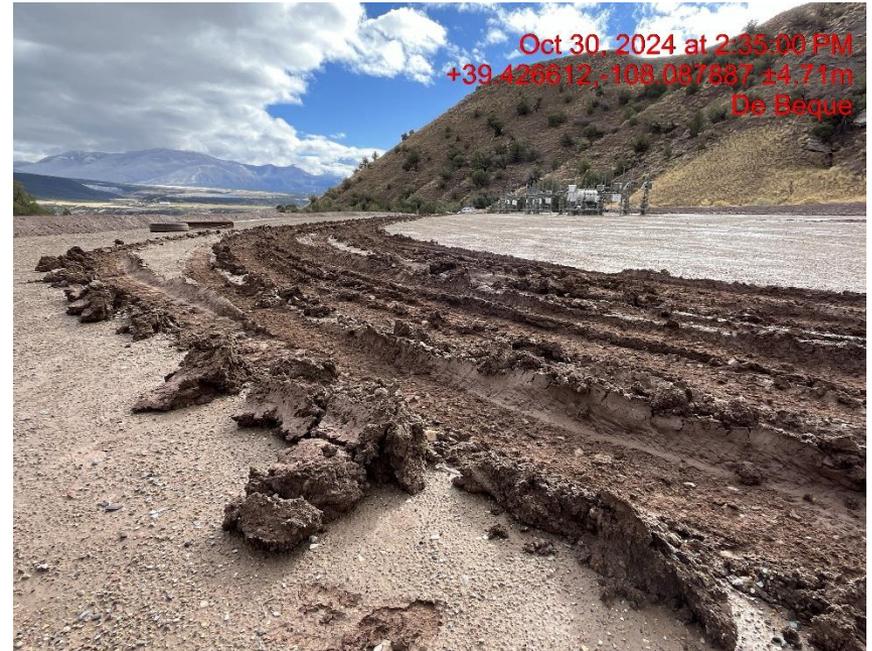
Photo # 8441 Lack of stabilization/compaction on location/insufficient tracking BMP's

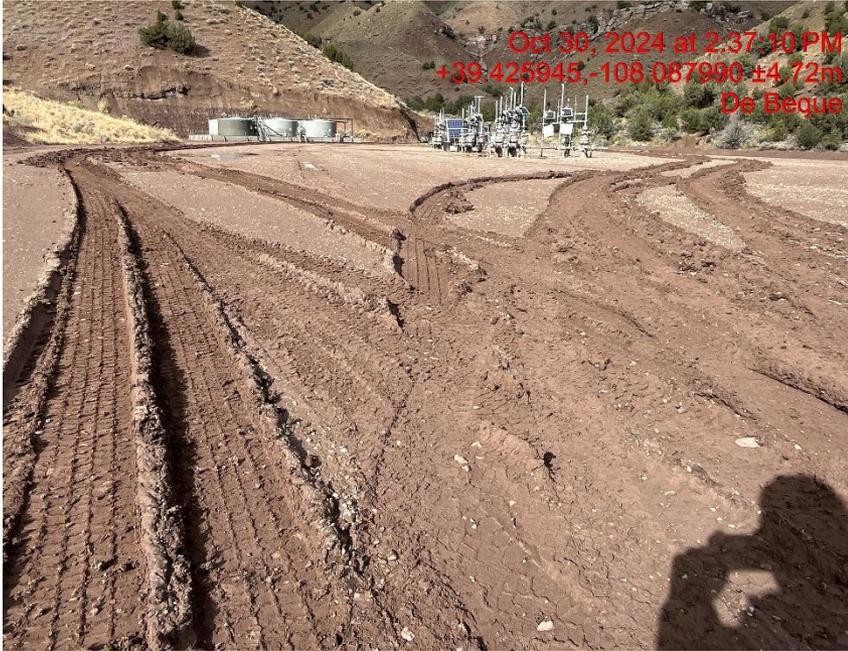
Photo # 8443 Lack of stabilization/compaction on location/insufficient tracking BMP's

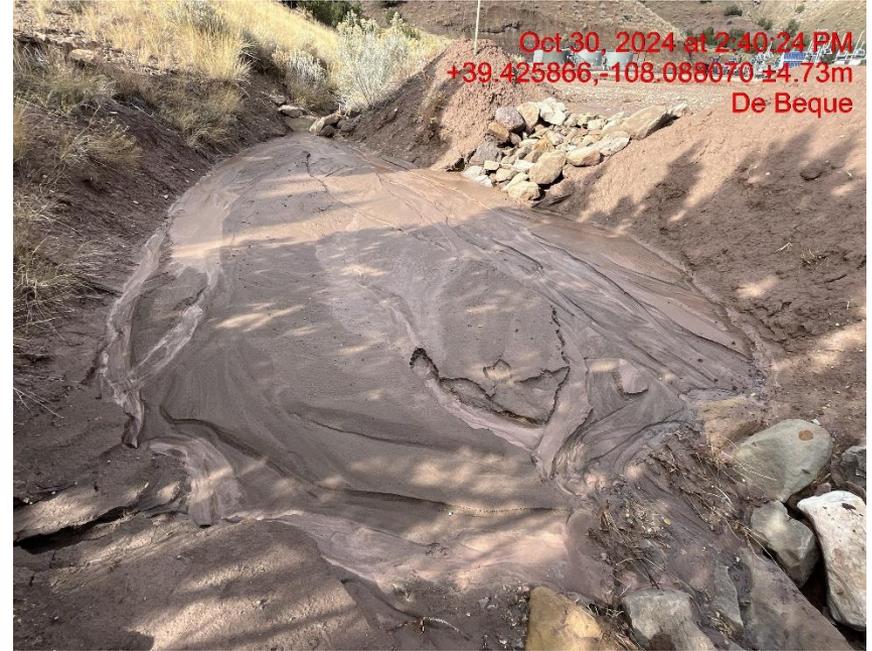
Photo # 8449 Sediment trap needs maintenance
