# Interim Reclamation and Stormwater Inspection

Date: 10/29/2024

Operator: WESTERN OPERATING COMPANY - 95620

Location ID: 312291

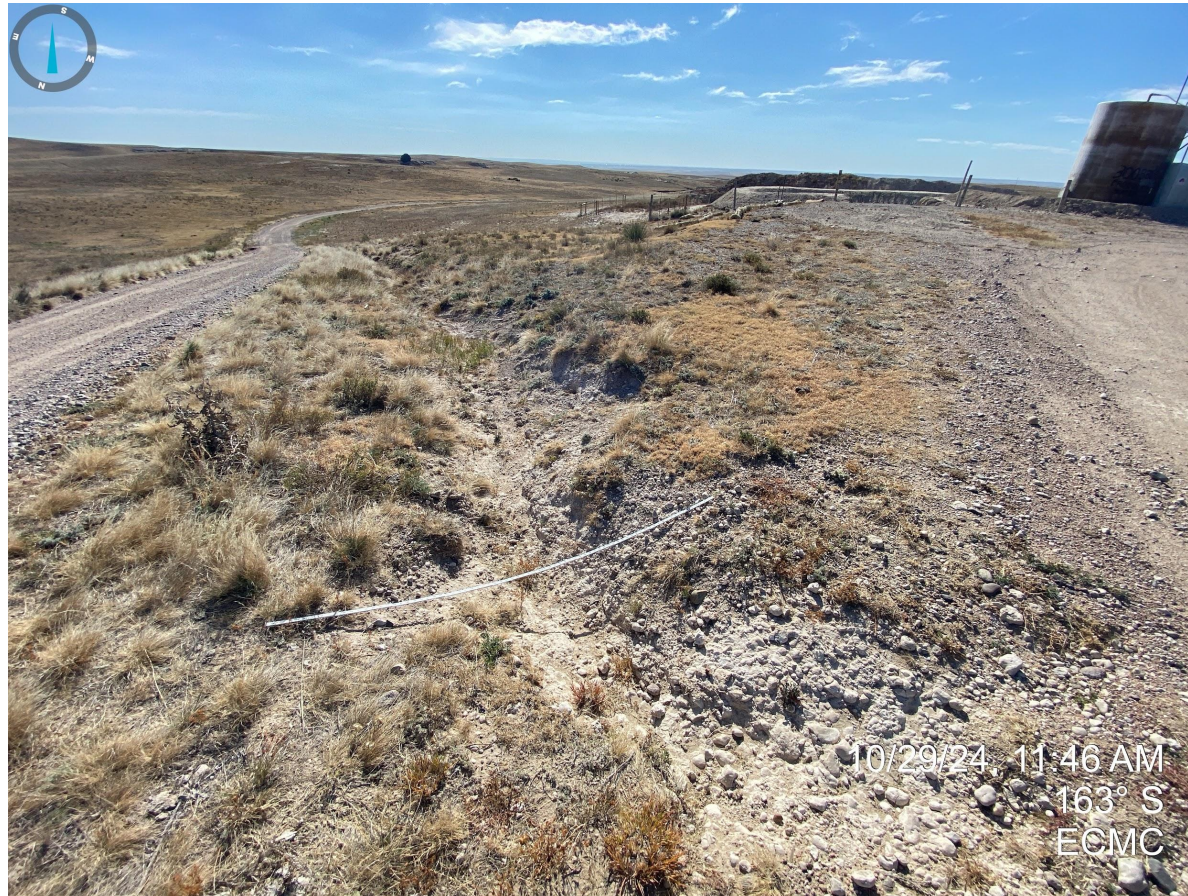
**Photo 1.** Taken north of pit. Evidence of erosion degradation, previously documented, does not appear to have been repaired/stabilized with no evidence of control measures/BMPs observed that would prevent further erosion of the production areas and access roads.

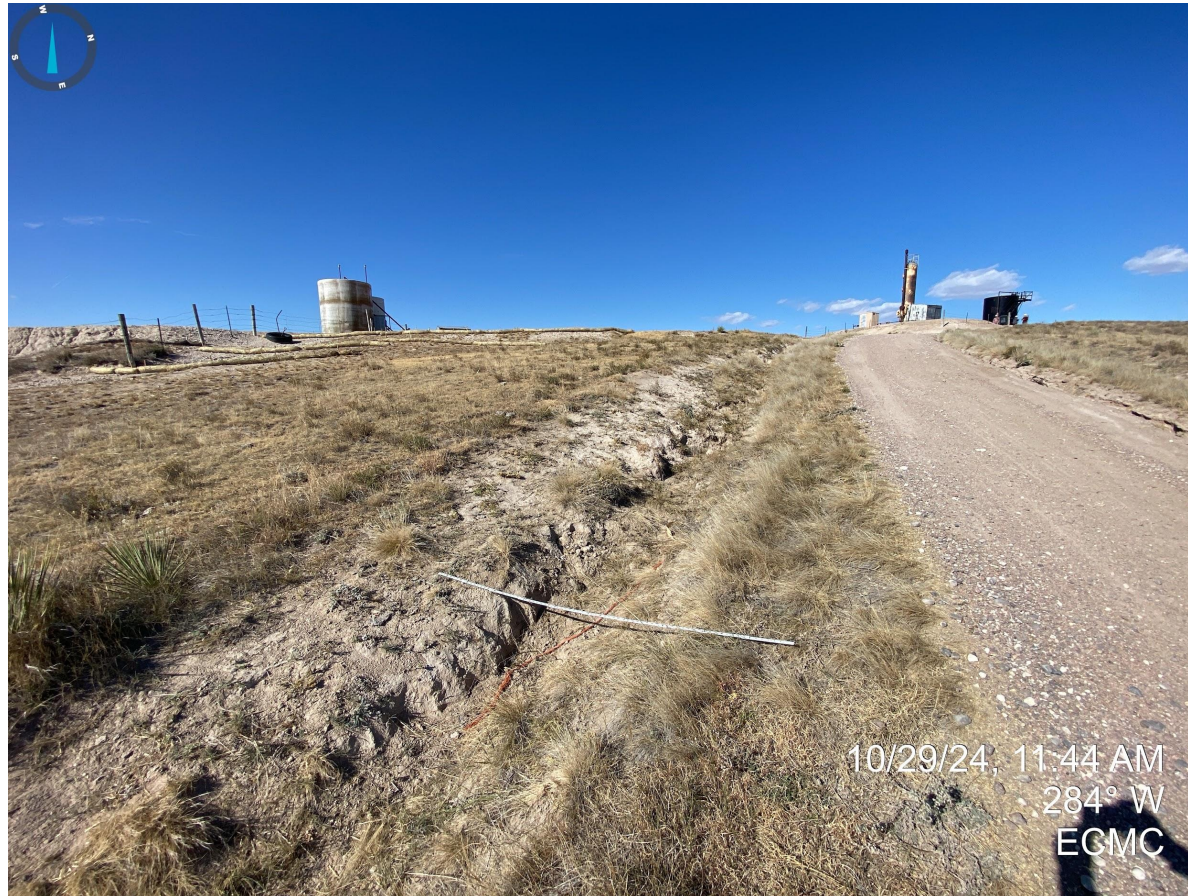
**Photo 2.** Continued from Photo 1, facing west. See comments in Photo 1.

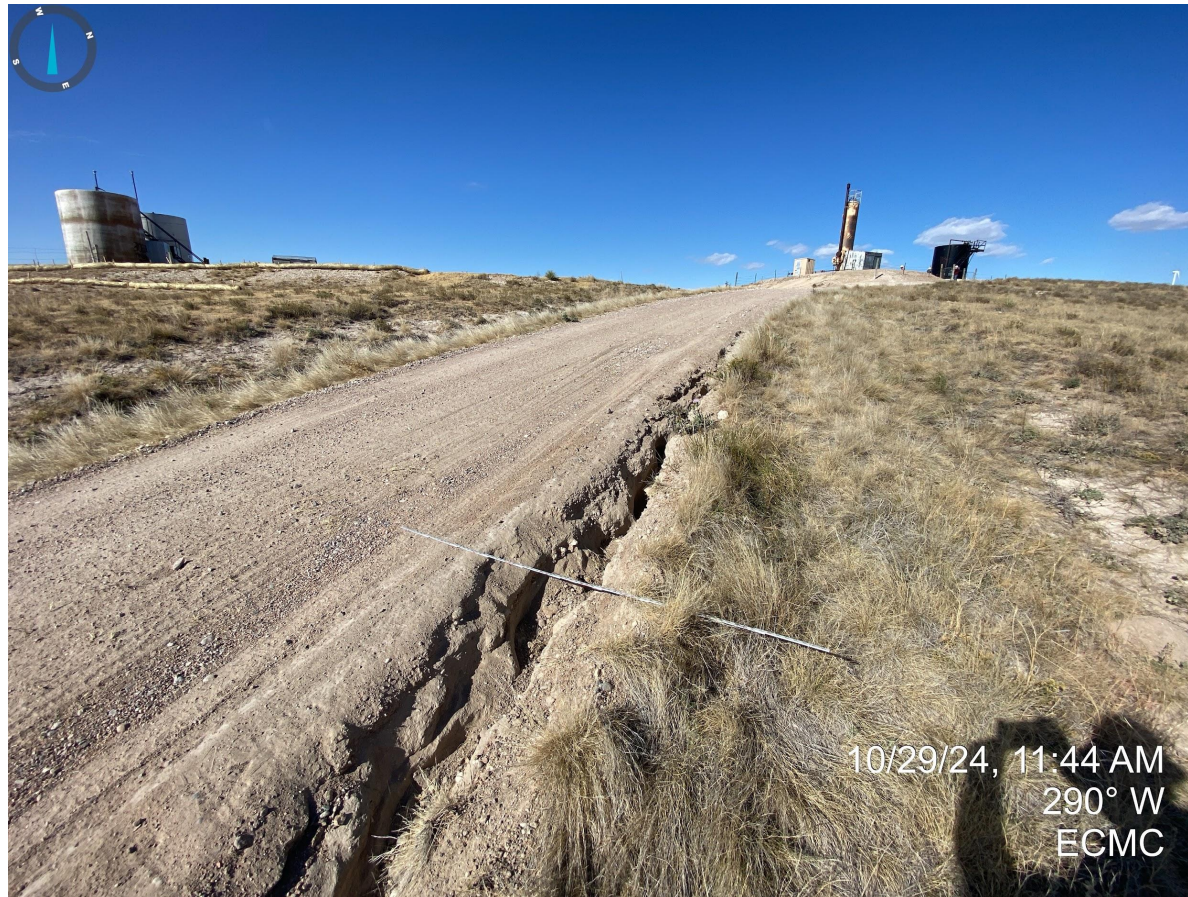
**Photo 3.** Continued from Photo 1, north side of the access road. See comments in Photo 1.

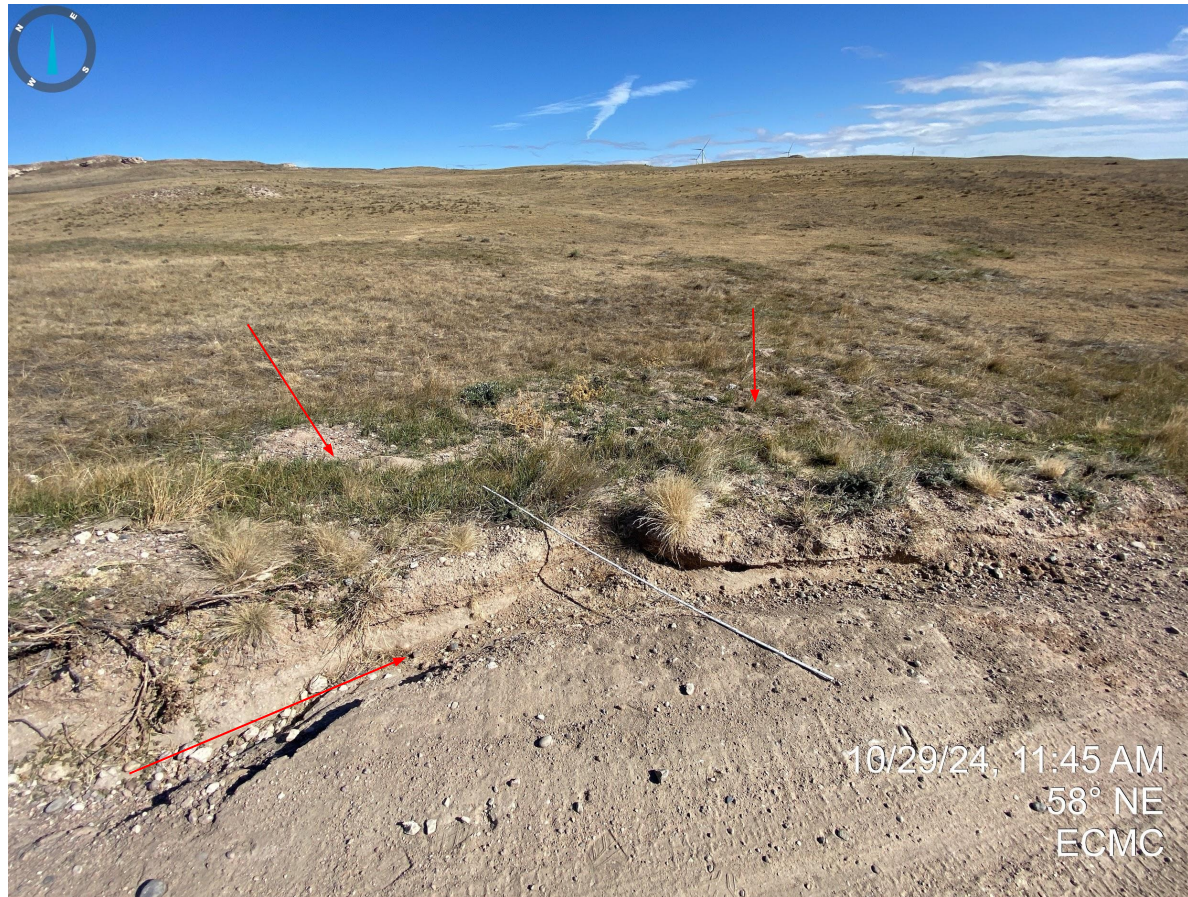
**Photo 4.** Sediment deposition and erosion degradation along the access road, east of pit.

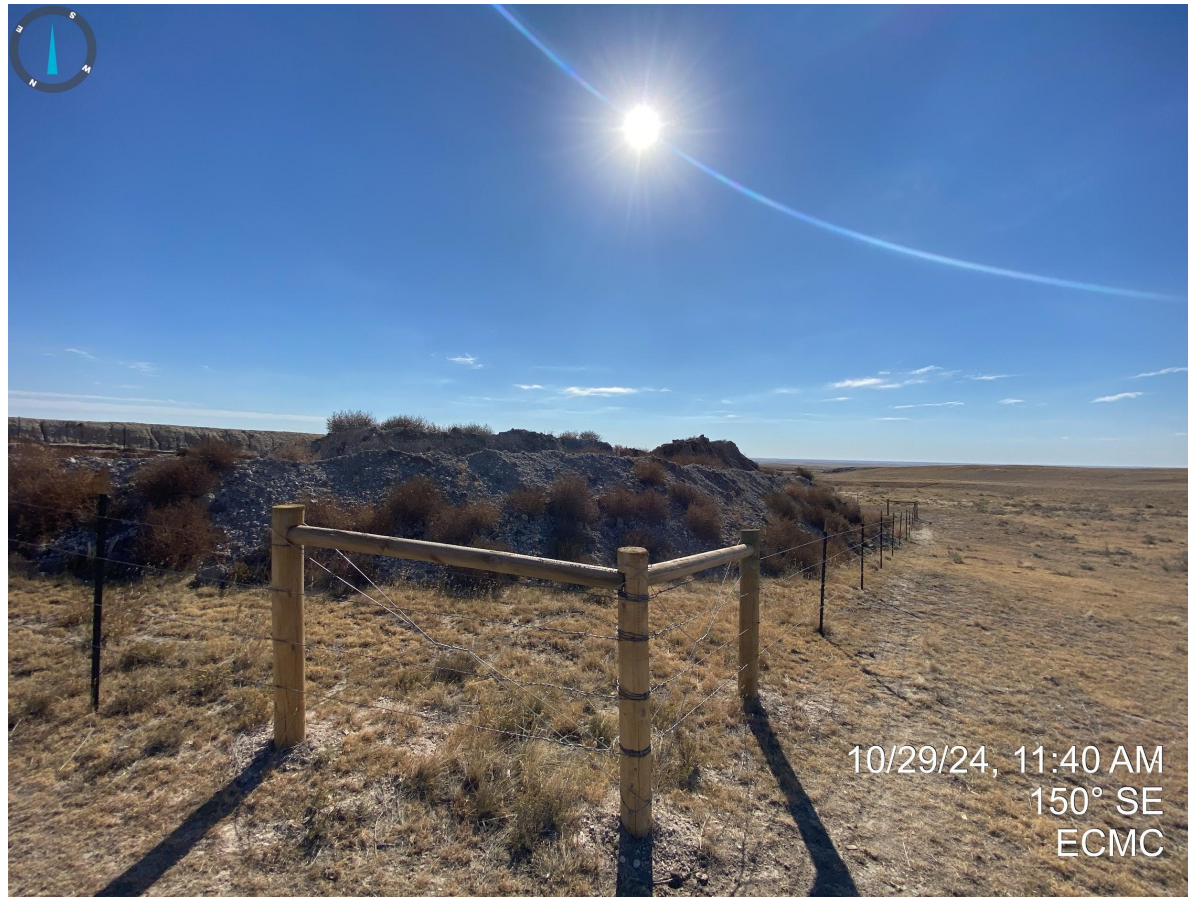
**Photo 5.** Taken from the north side of the stockpiled soils. No perimeter stormwater control measures/BMPs, or impermeable liners underneath the stockpile were observed during this inspection. Impacted soils appear to have been placed directly on top of undisturbed lands. Additionally, it does not appear that topsoil has been salvaged Per Rule 1002.b prior to stockpiling the soil on undisturbed portions of land. Undesirable vegetation observed throughout stockpiled areas.

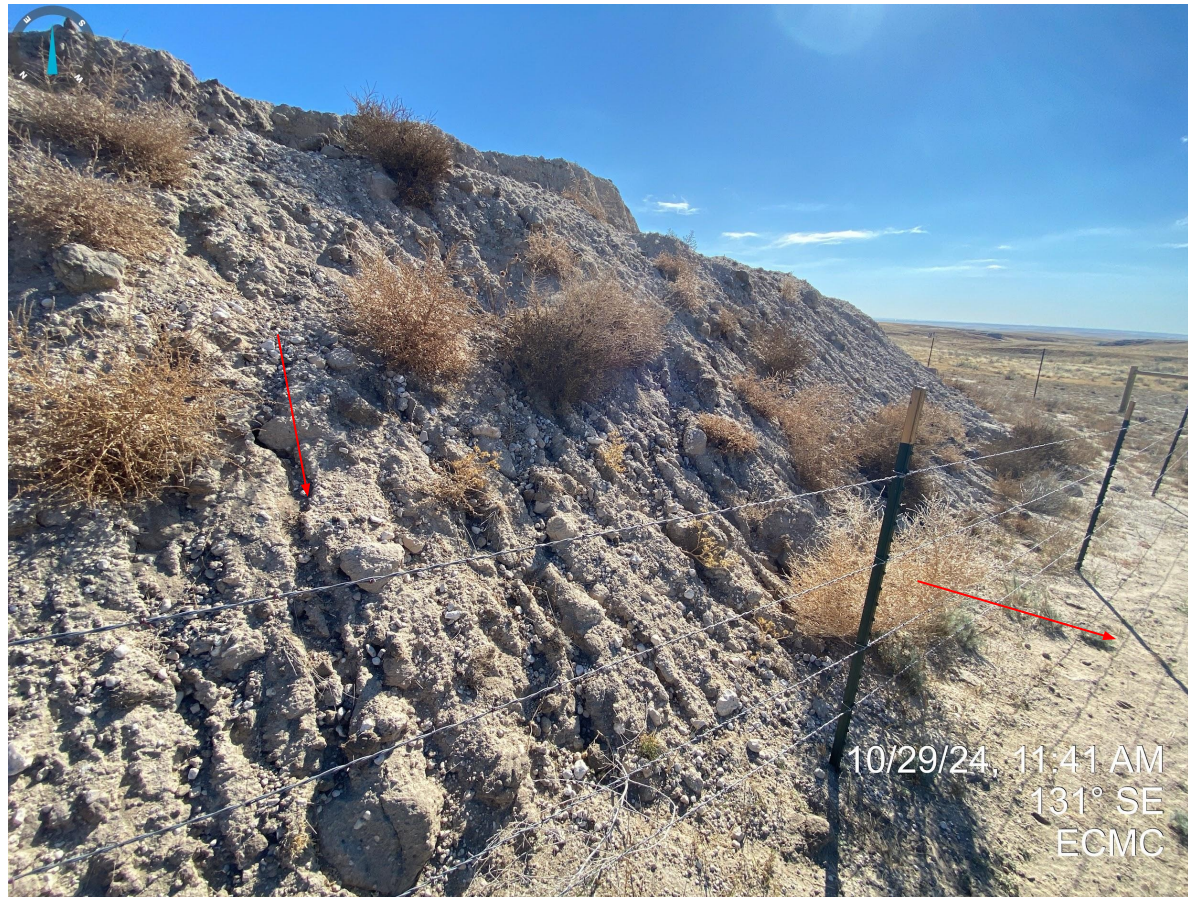
**Photo 6.** Continued from Photo 5; evidence of unstabilized soils (rill erosion) and sediment migration outside of the fenced portions. Undesirable vegetation (russian thistle) also observed.

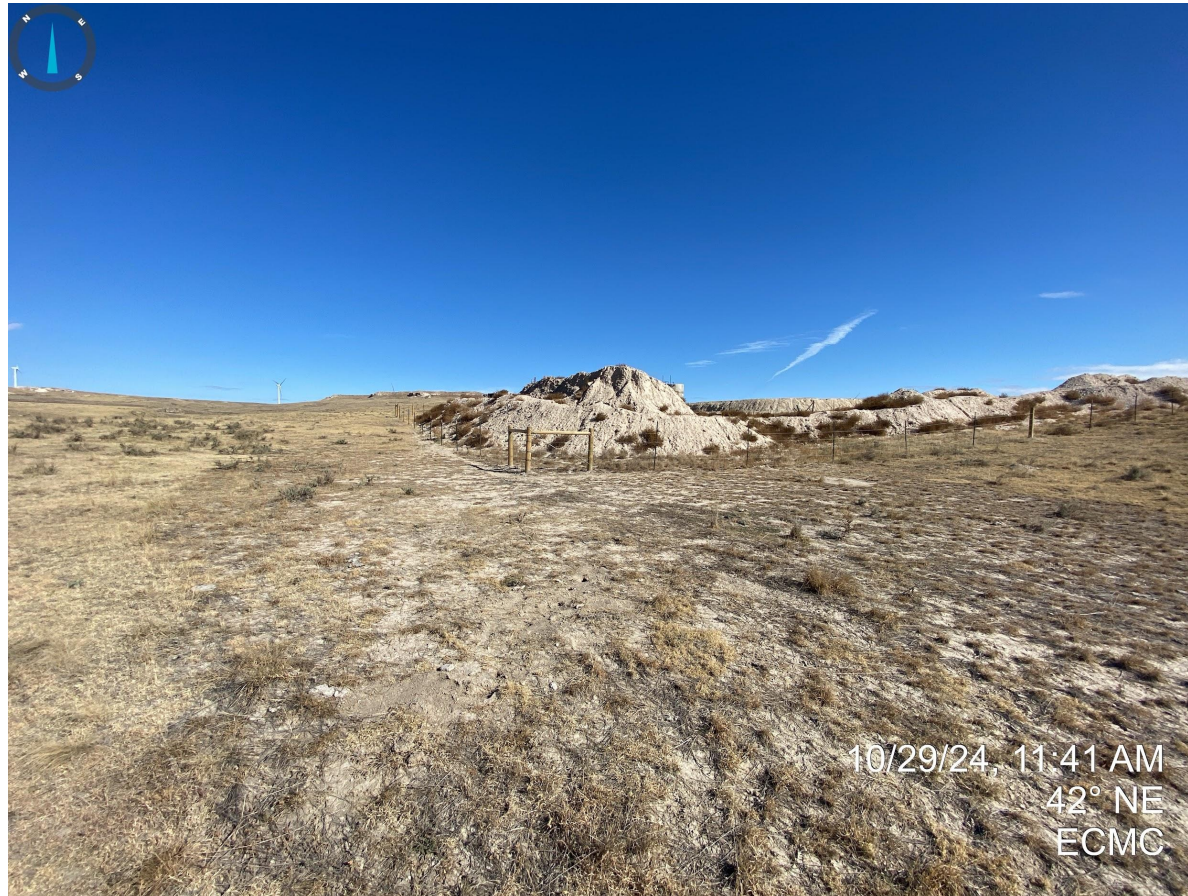
**Photo 7.** Sediment deposition resulting from unstabilized stockpiles, southwest corner of the pit.

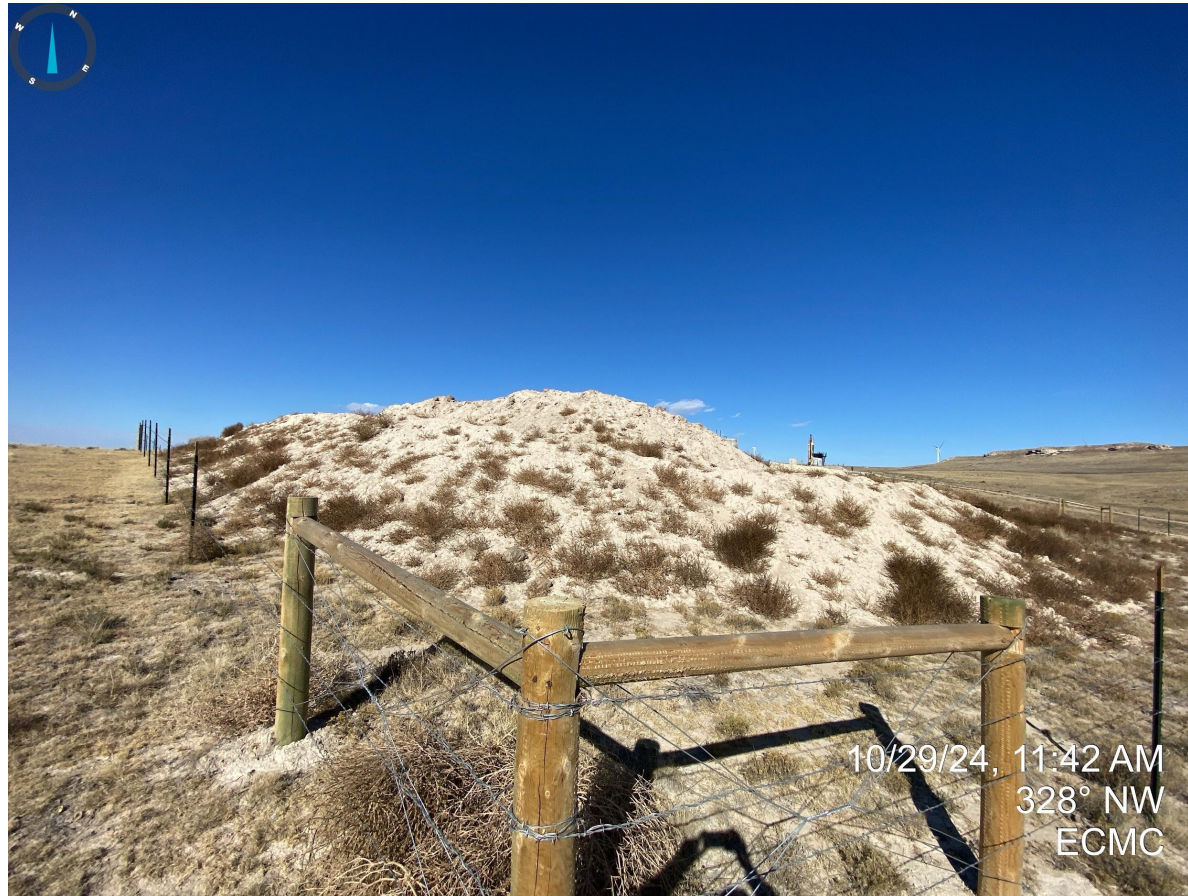
**Photo 8.** Taken from the southeast corner of the stockpiled material; see comments in Photo 5.

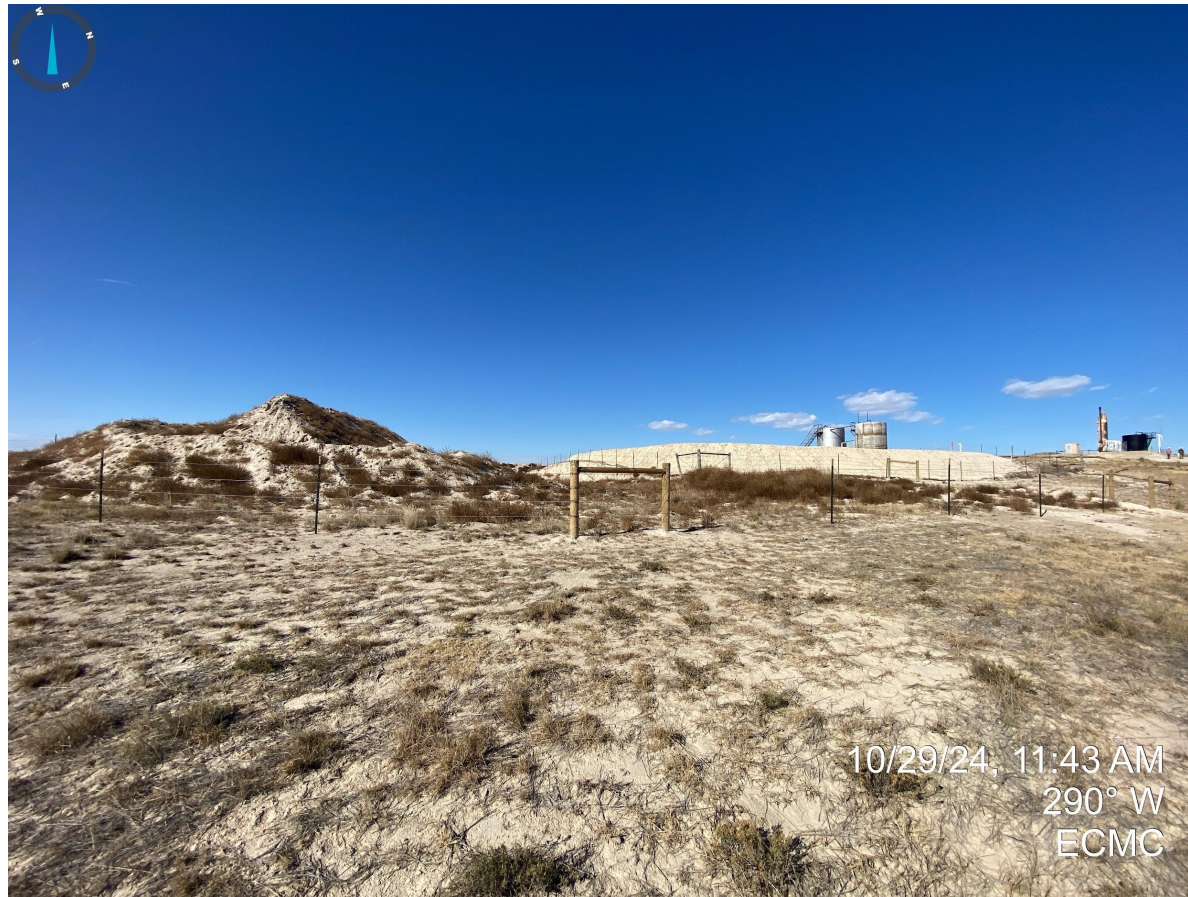
**Photo 9.** Taken southeast of the excavated area and stockpiled material; no apparent perimeter stormwater control measures and sediment deposition observed.

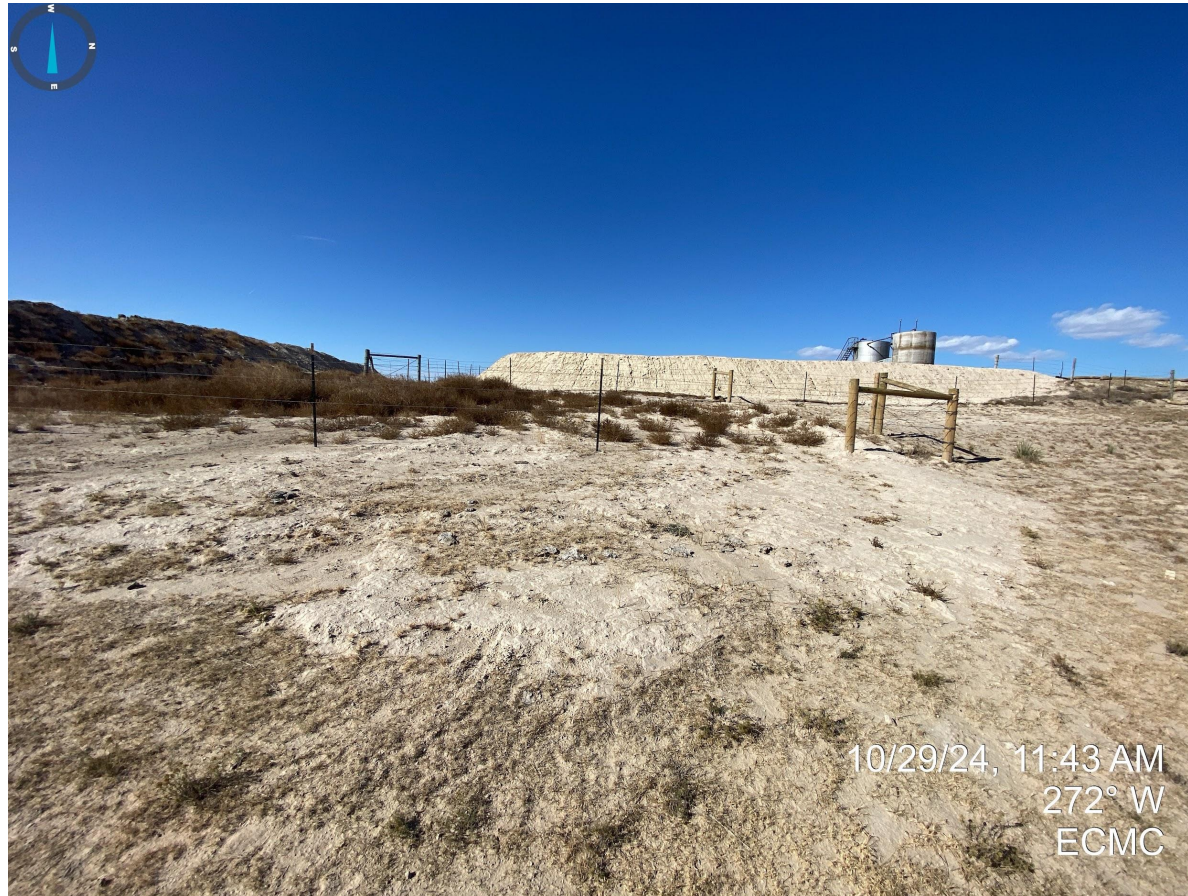
**Photo 10.** Sediment deposition resulting from unstabilized soils, southeast corner of the pit.

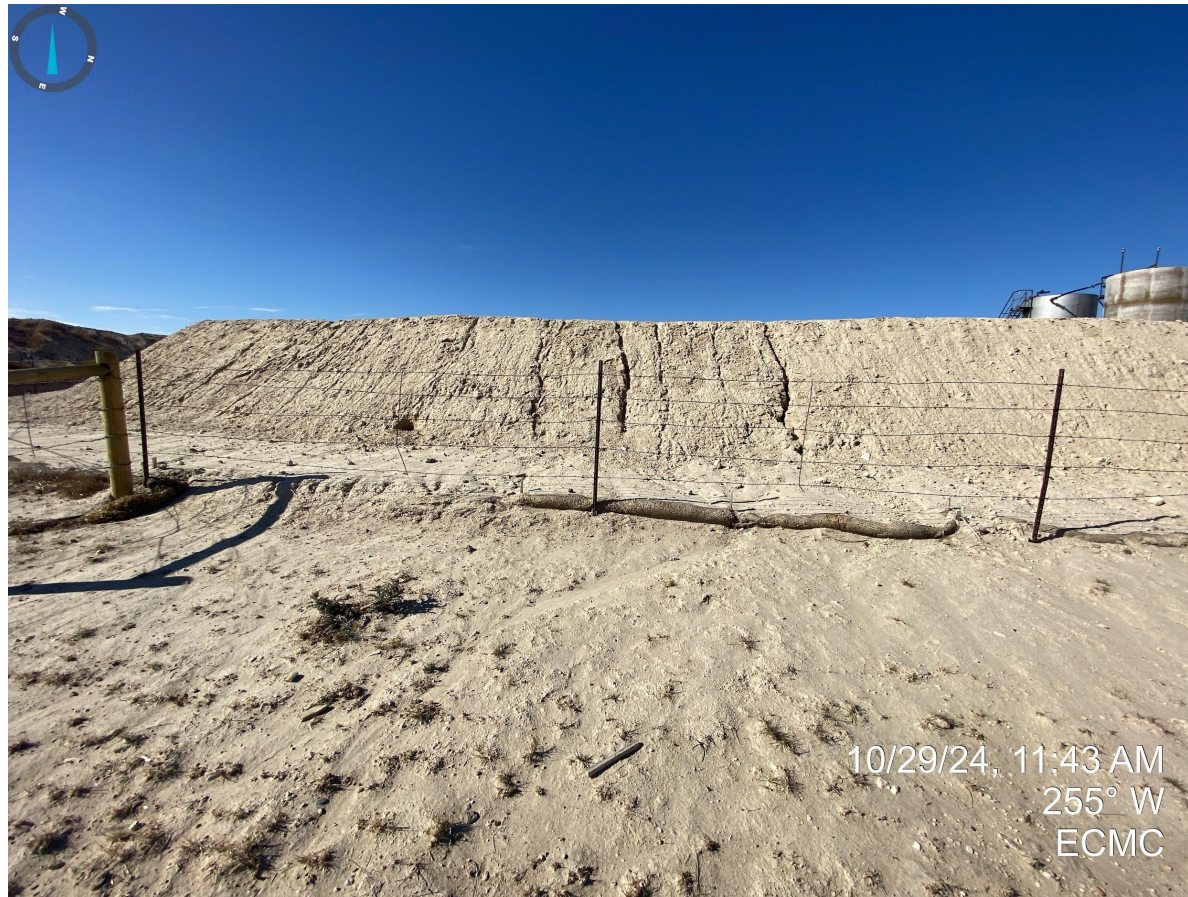
**Photo 11.** Sediment deposition resulting from unstabilized soils, eastern portion of the pit. Stormwater control measures remain inadequate at this location.

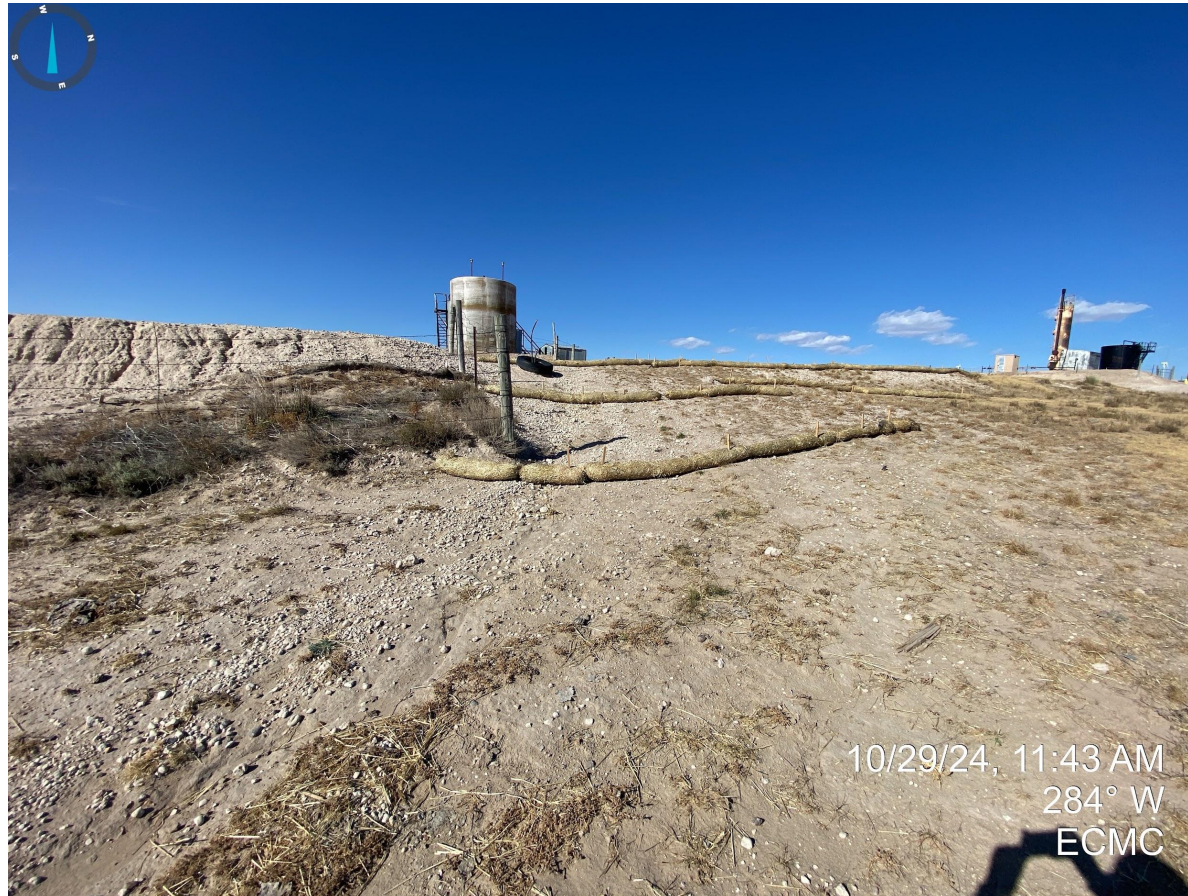
**Photo 12.** Erosion degradation occurring on the northern/eastern portion of the production areas, near the pit. Stormwater control measures appear to have been reinstalled, however, they don't not appear to be installed per good engineering practices (e.g. trenched and backfilled).

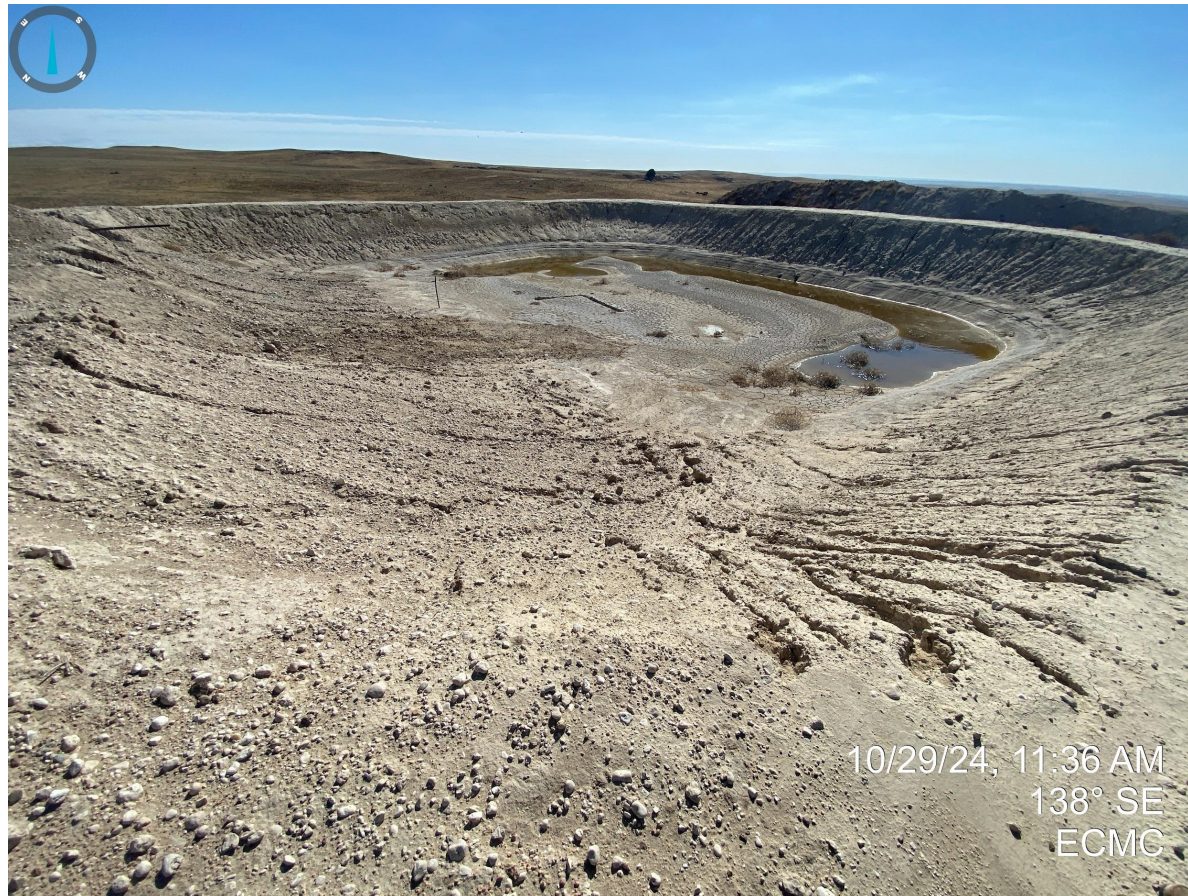
**Photo 13.** Erosion degradation observed within pit walls.

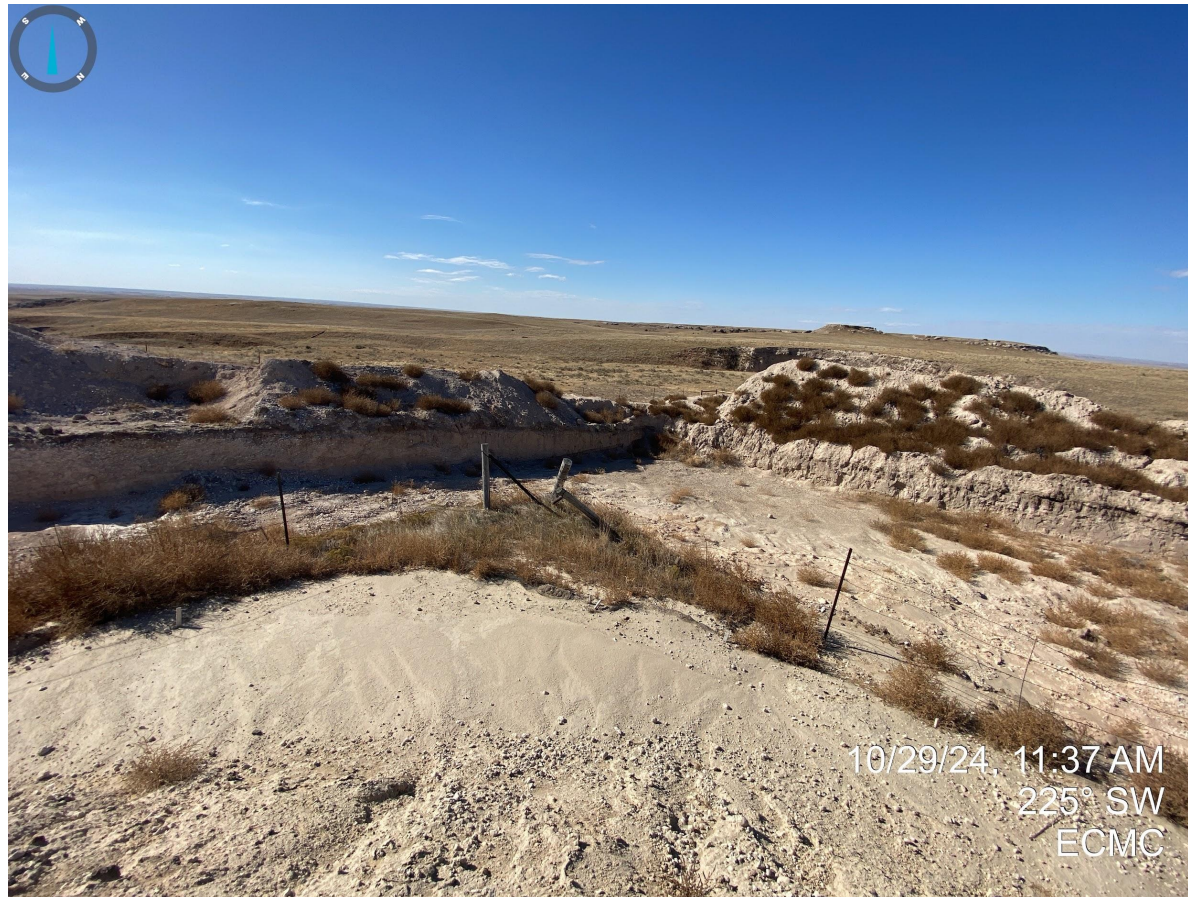
**Photo 14.** Erosion degradation and undesirable vegetation observed from the southwest corner of the pit, looking into the excavated area.

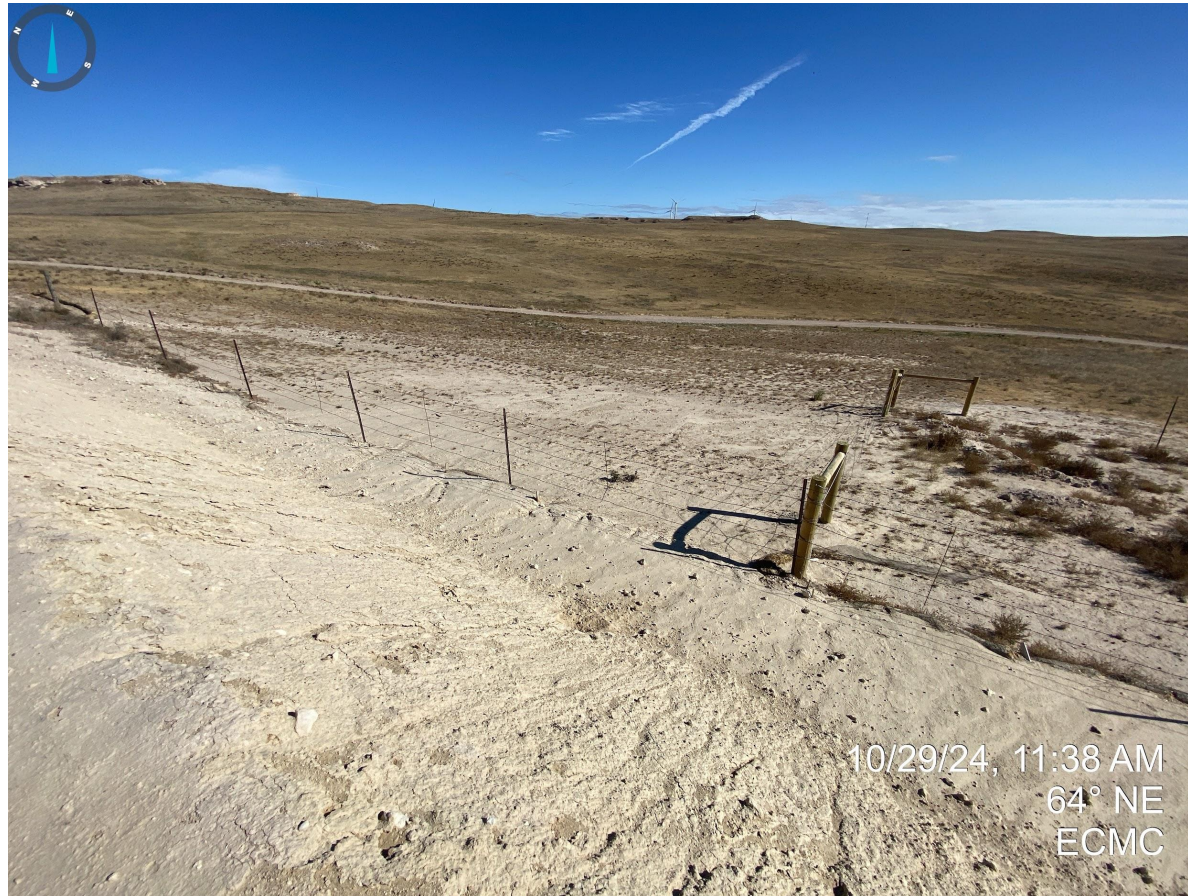
**Photo 15.** Erosion degradation on the eastern pit walls. Stormwater control measures/BMPs remain inadequate at this location.
