Construction and Stormwater Inspection

Operator: CARBON STORAGE SOLUTIONS LLC -
10786

Location ID: 487295

Inspection Photos
Location Name: Front Range 2-1
Location ID: 487295

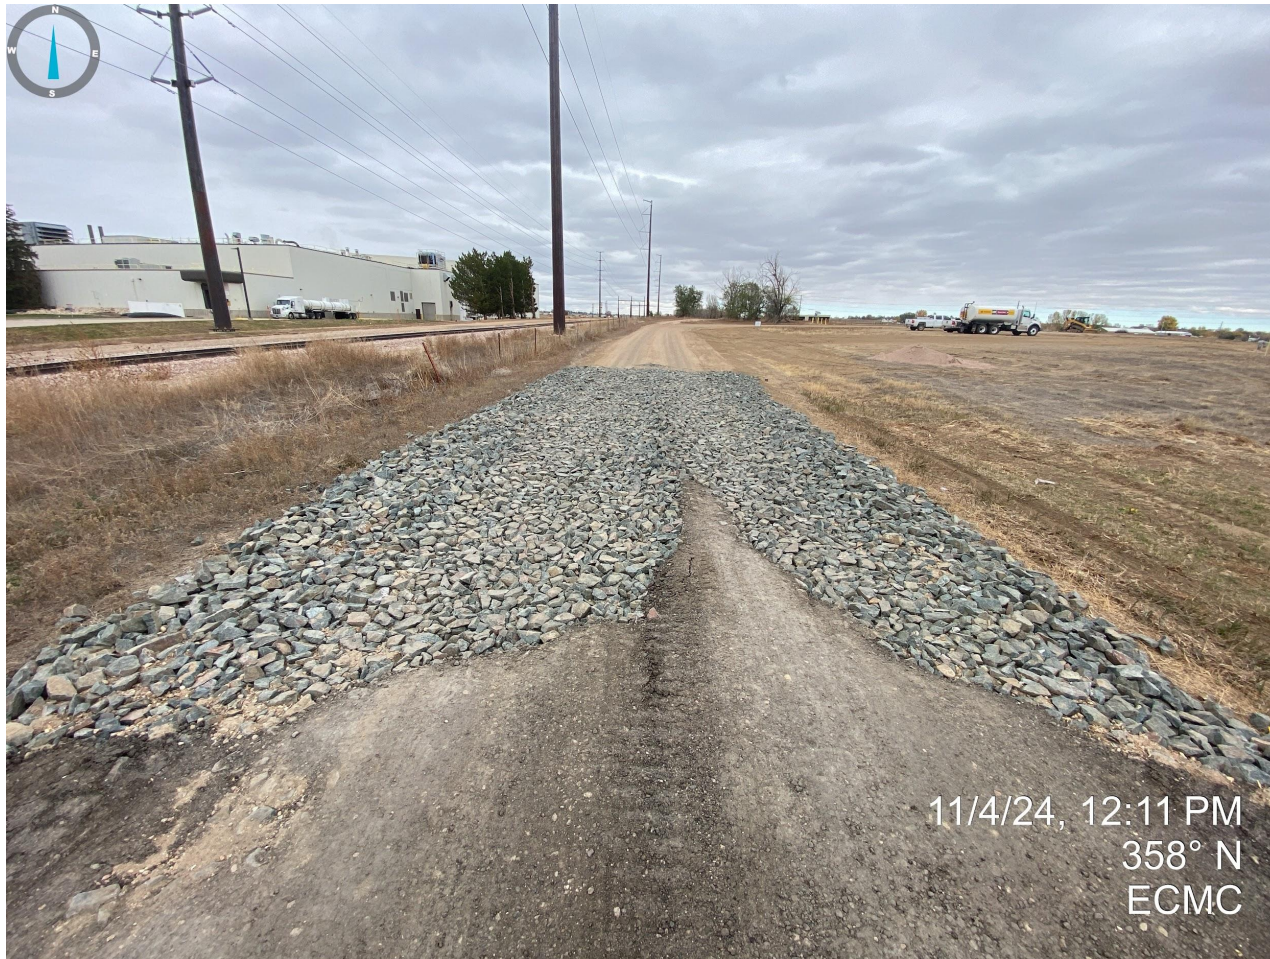
Photo 1. Tracking pad installed at the location entrance.

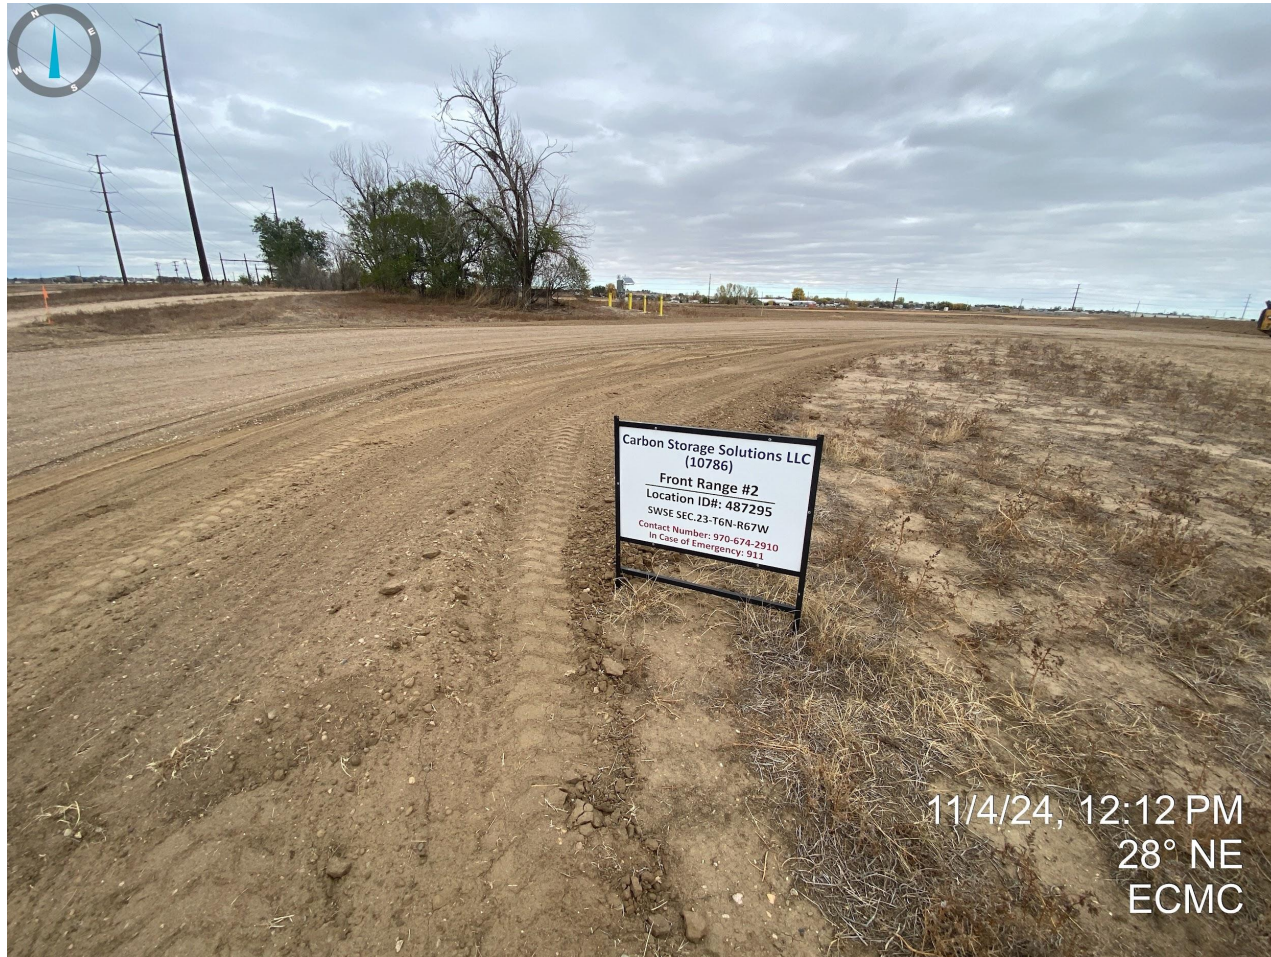
Photo 2. Location sign post at the entrance. A copy of the Form 2A was not posted in a conspicuous location at the time of this inspection; this is not in compliance with Rule 406.c.

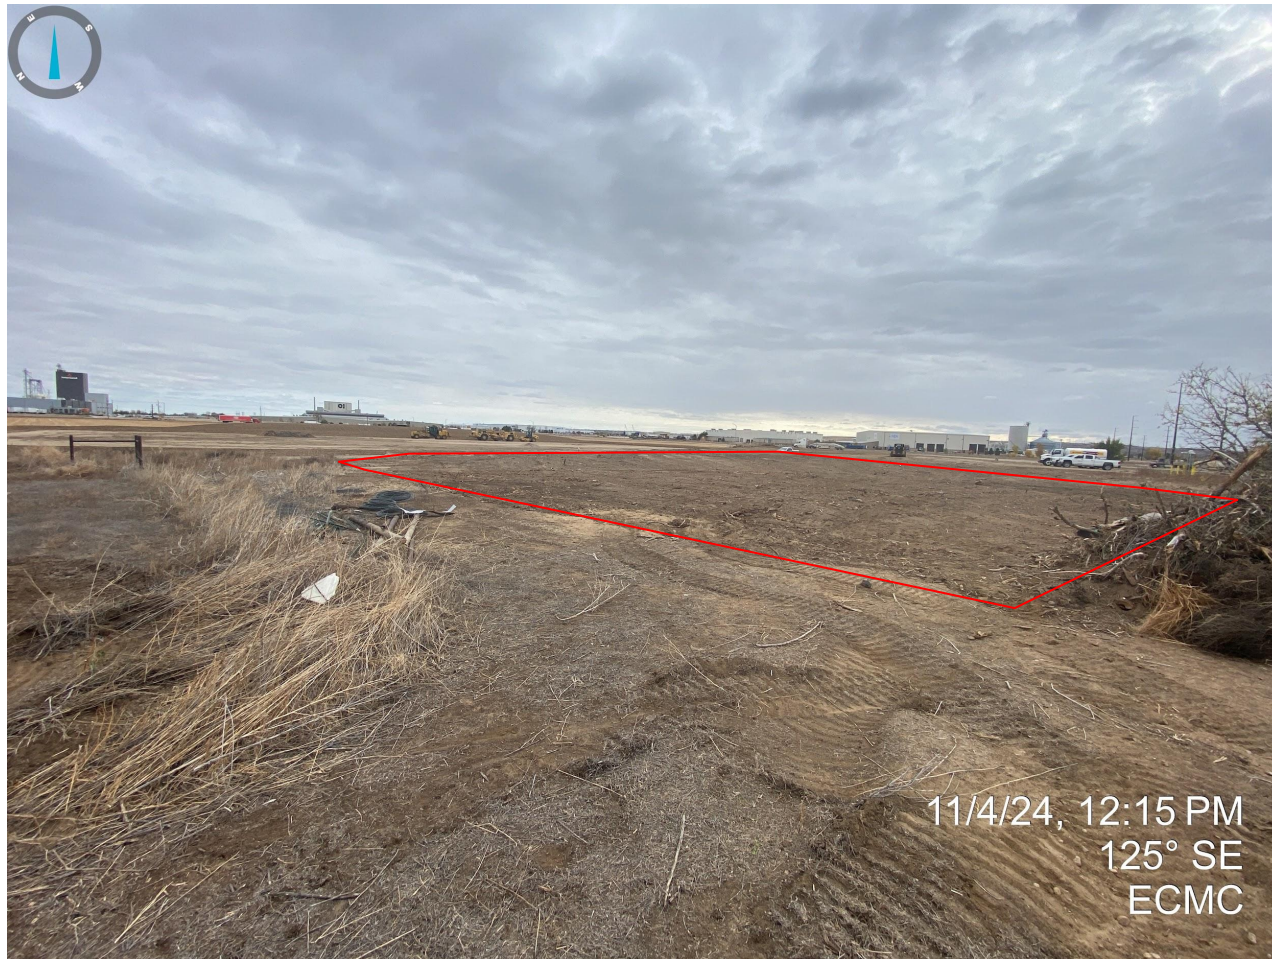
Photo 3. Facing southeast from the northwest corner of the disturbance area. It appears that the northwest portion of the disturbance area was grubbed, or cleared of vegetation (approximated by red polygon). It did not appear that topsoil had been salvaged; if the construction area/drilling pad expands, topsoil will need to be salvaged in compliance with Rule 1002.b.

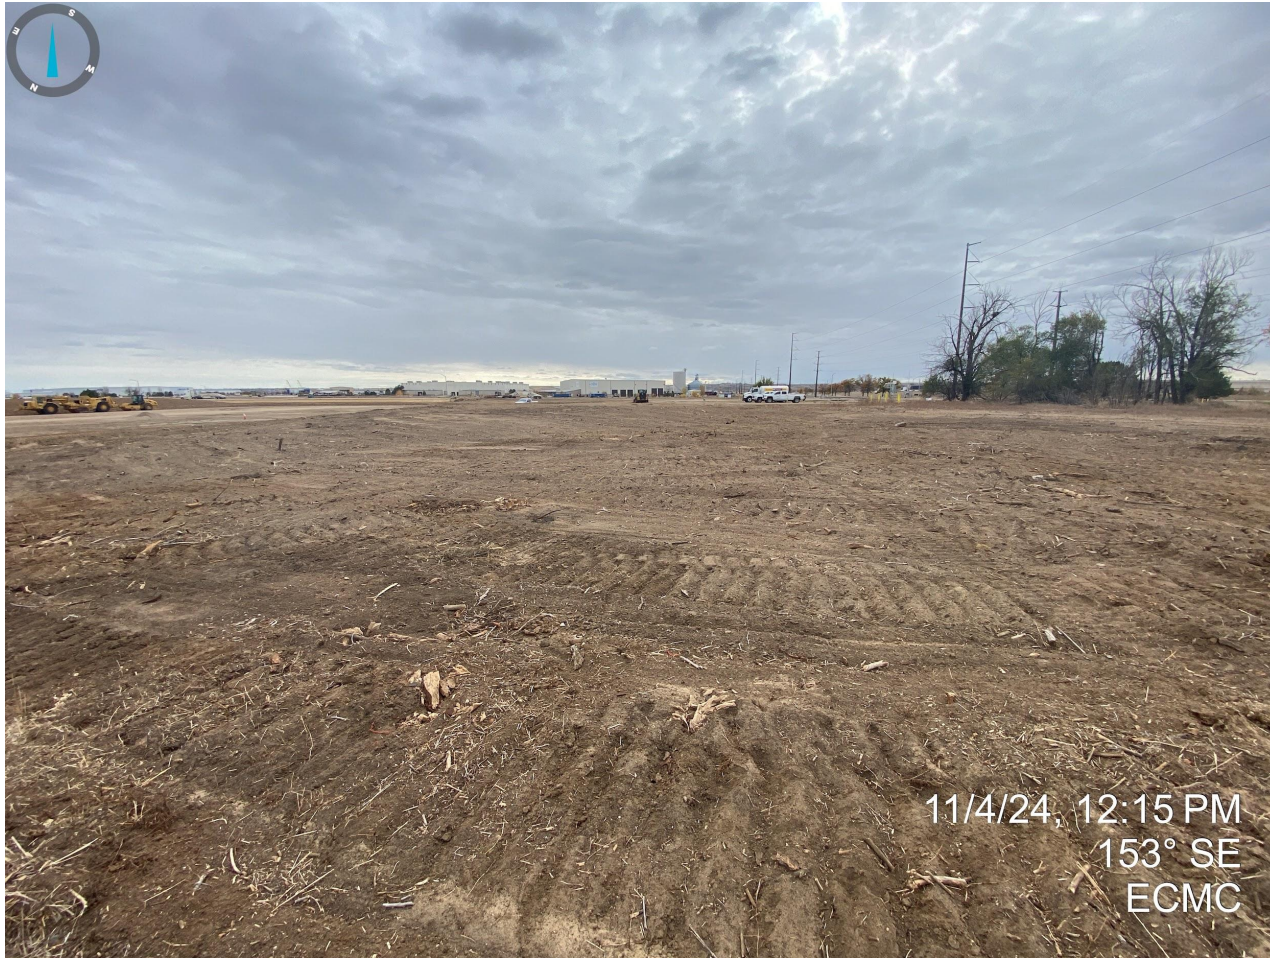
Photo 4. Continued from Photo 3, facing southeast from the eastern boundary. See comments in Photo 3.

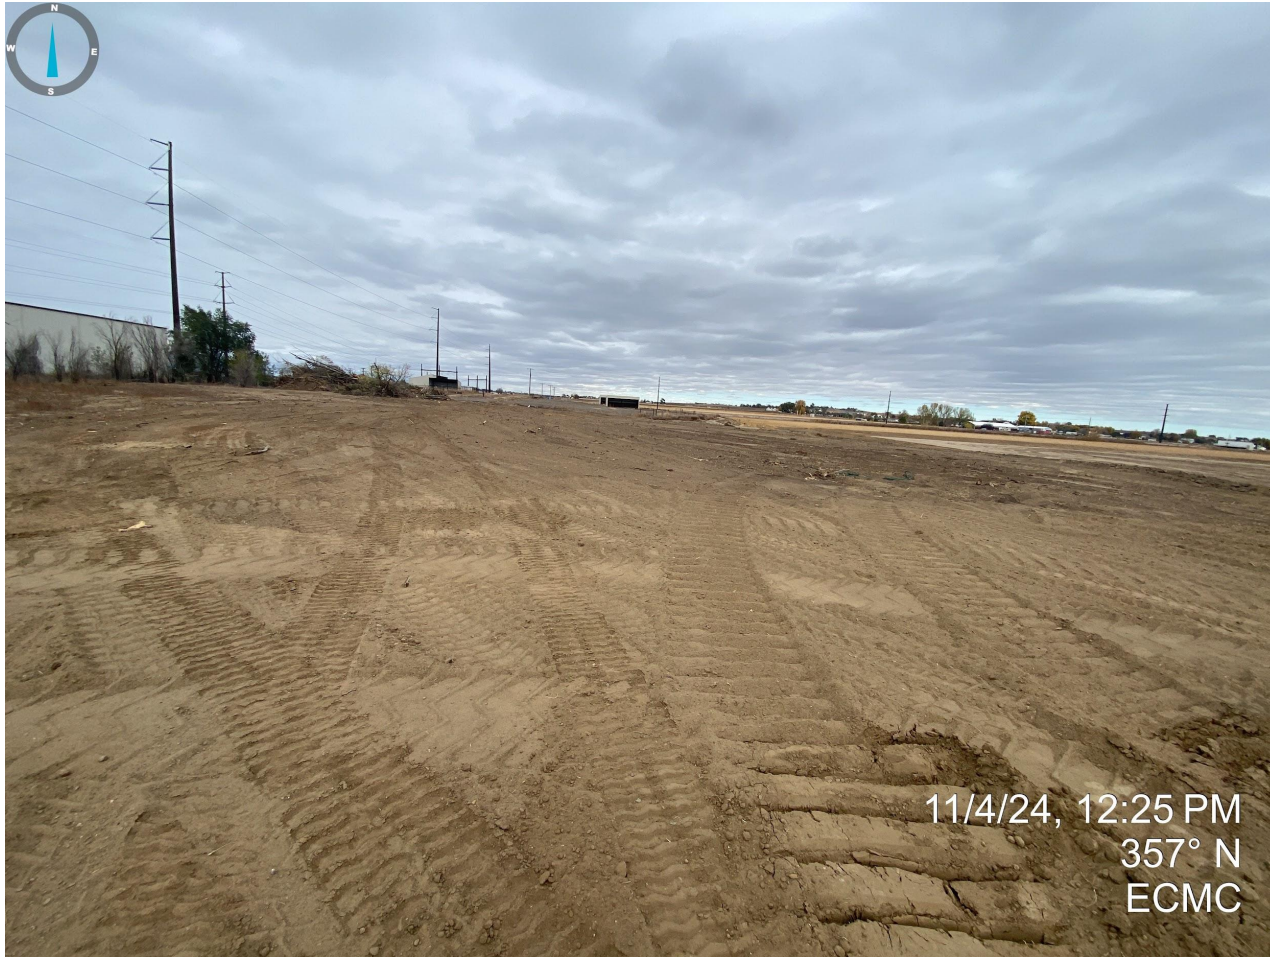
Photo 5. Continued from Photo 3, facing north from the southern boundary. See comments in Photo 3.

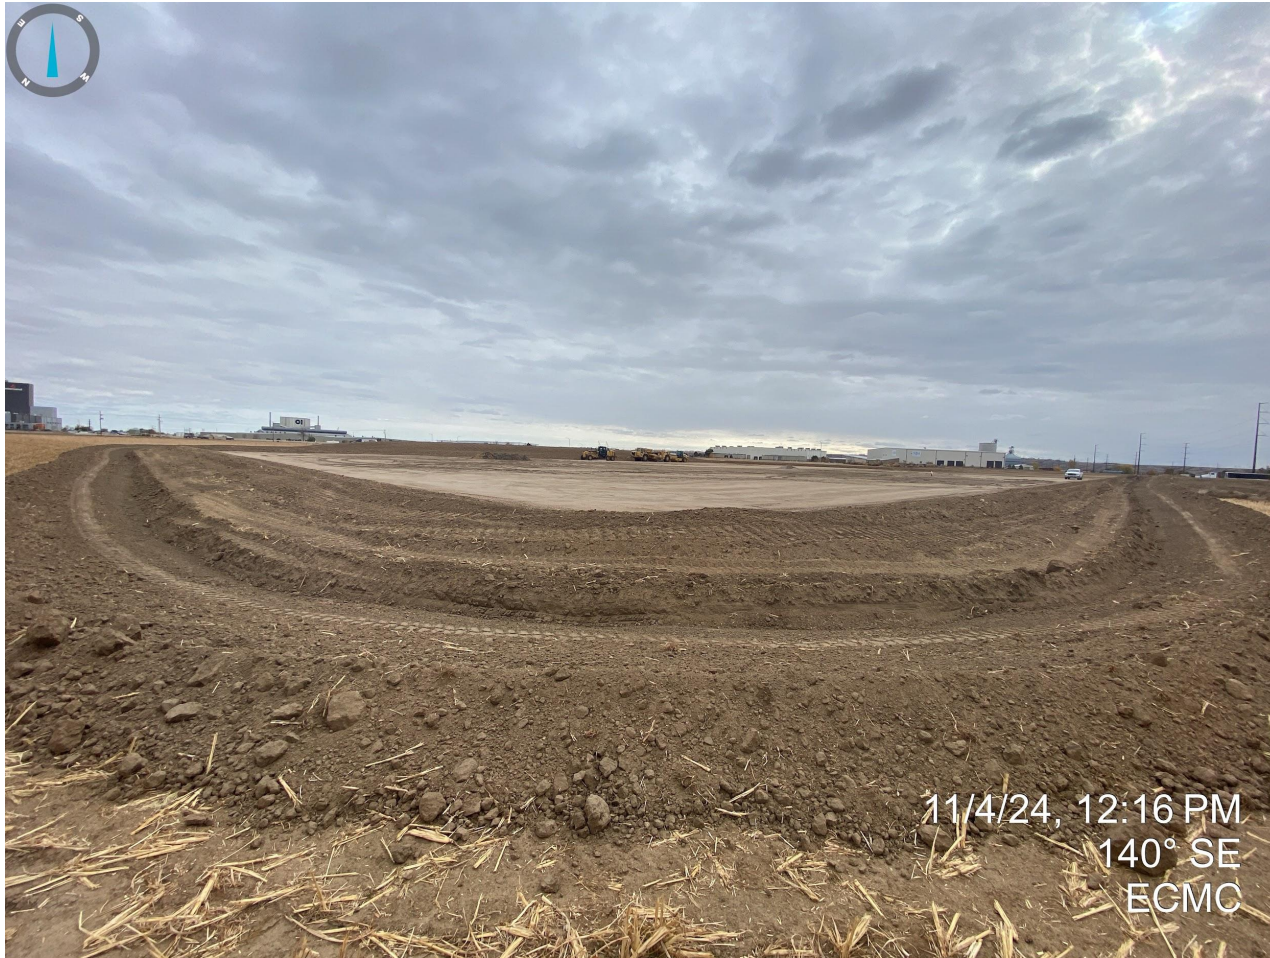
Photo 6. Facing southeast from the northwest corner of the disturbance area. Photo illustrates that a perimeter ditch and berm has been constructed around the entire drilling pad.

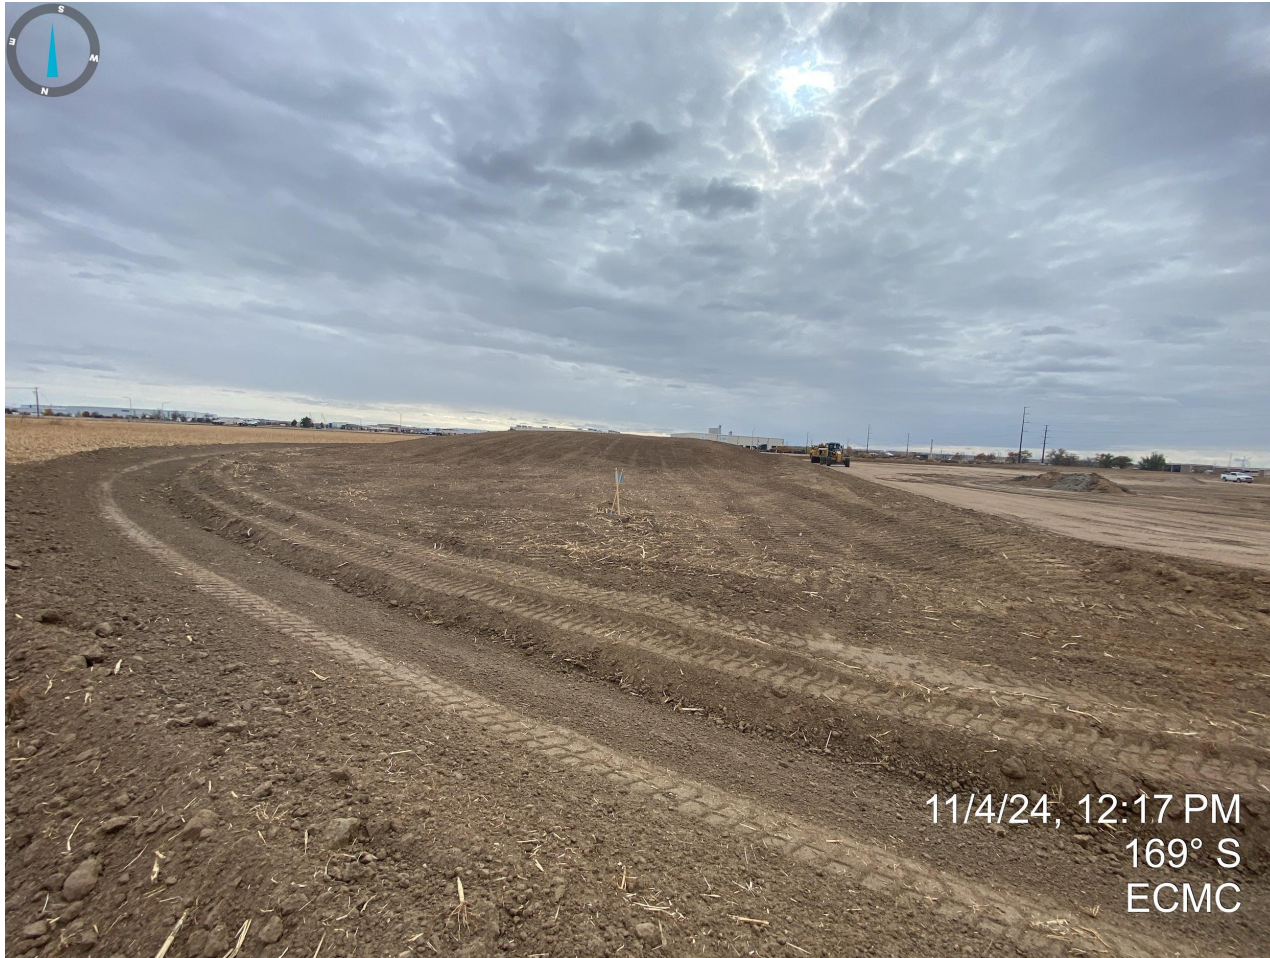
Photo 7. Taken near the northeast corner of the disturbance area, facing south. Photo illustrates a perimeter ditch and berm has been constructed. Topsoil stockpile pictured in background.

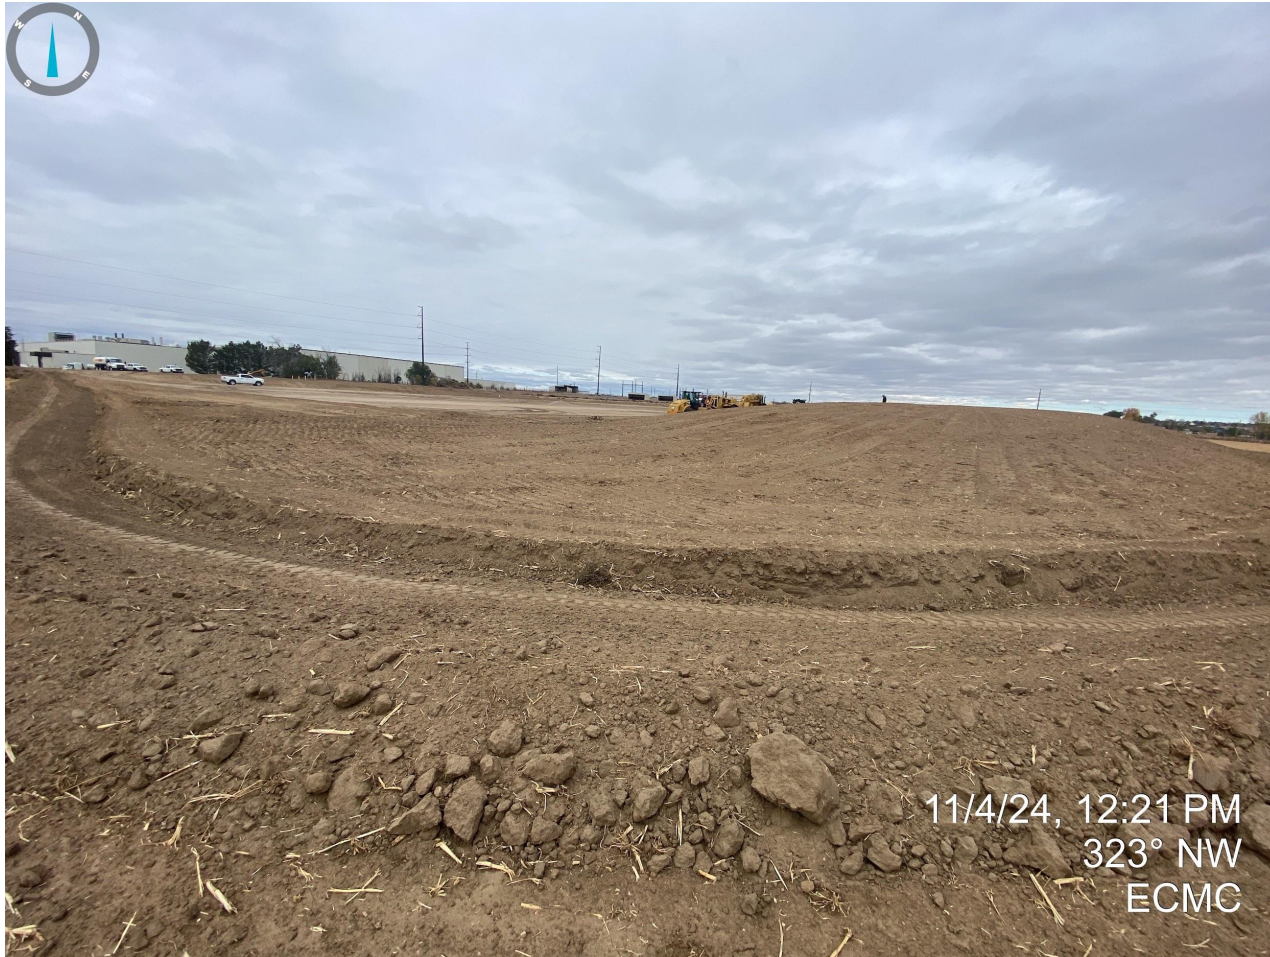
Photo 8. Taken near the southeast corner of the disturbance area, facing northwest. Photo illustrates a perimeter ditch and berm has been constructed. Topsoil stockpile pictured in background.

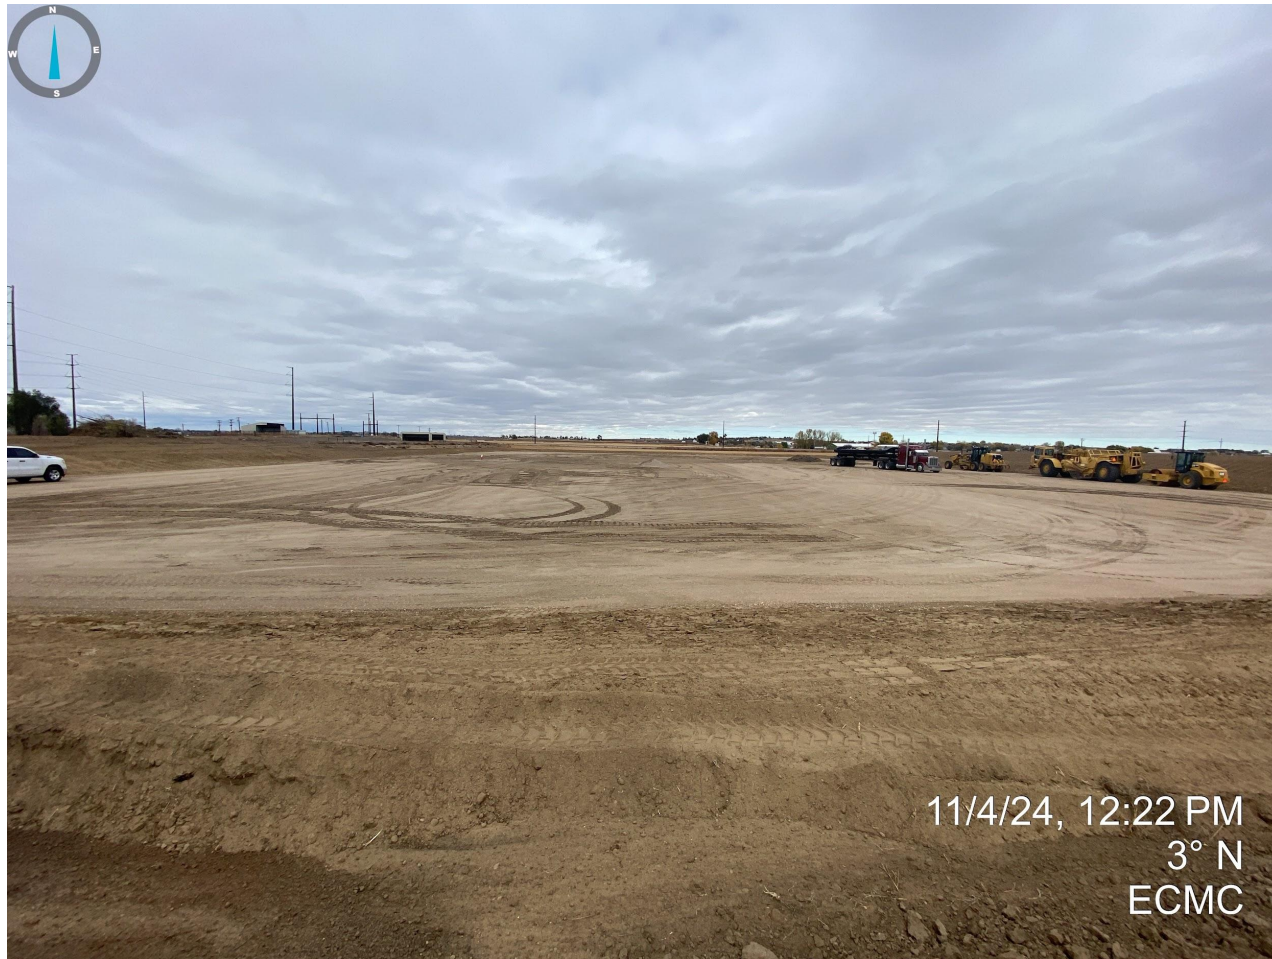
Photo 9. Taken from the southern/center portion of the disturbance area, facing north. Photo shows an overview of the drilling pad.

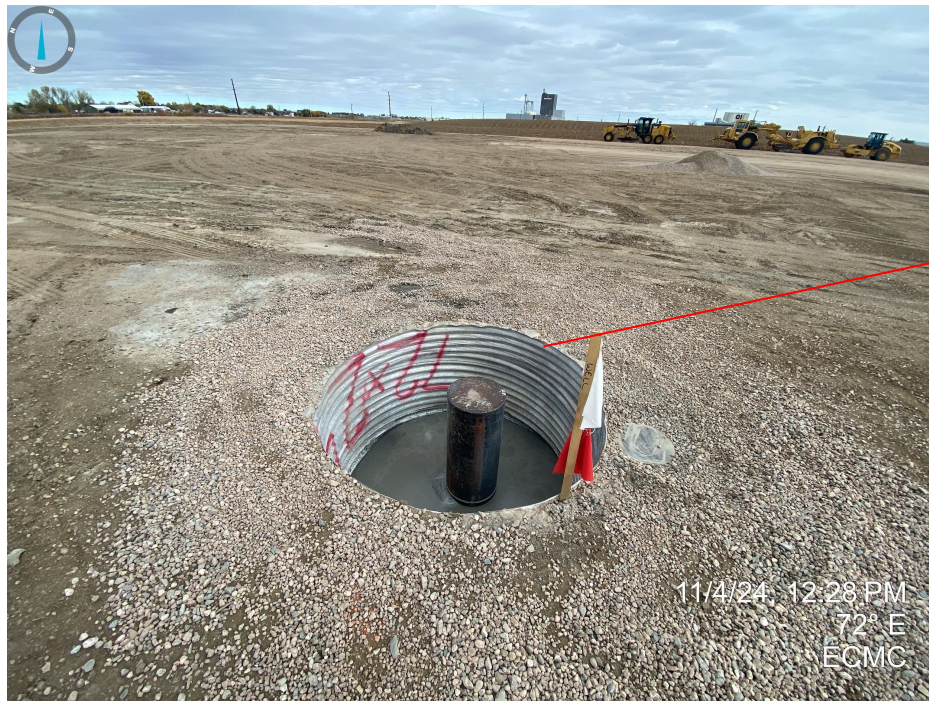
Photo 10. No wildlife exclusion device observed around the open well cellar.

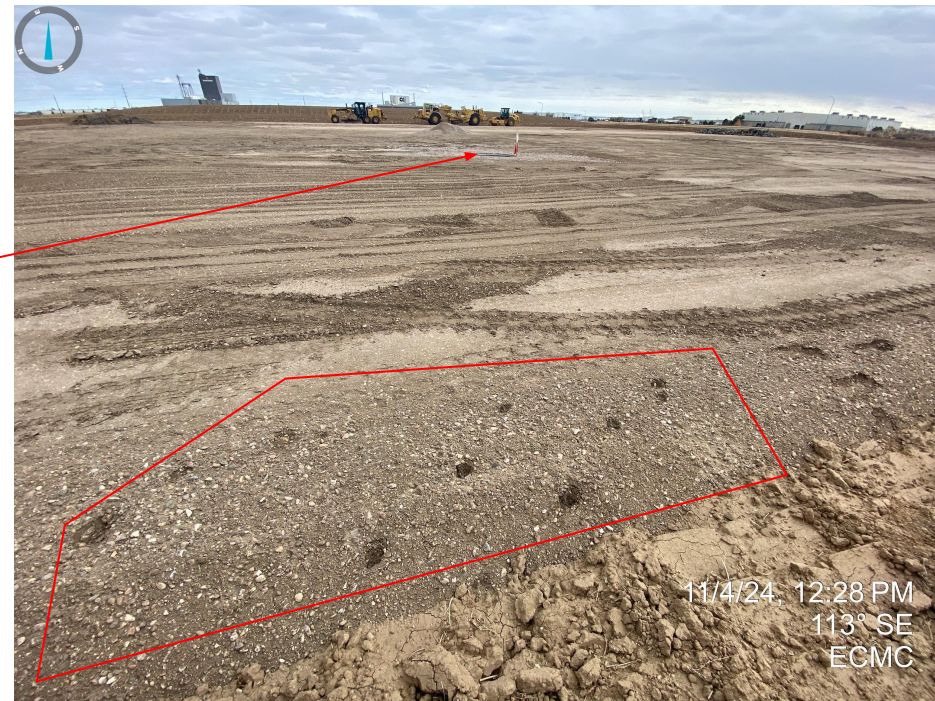
Photo 11. Wildlife tracks observed adjacent to the well cellar.

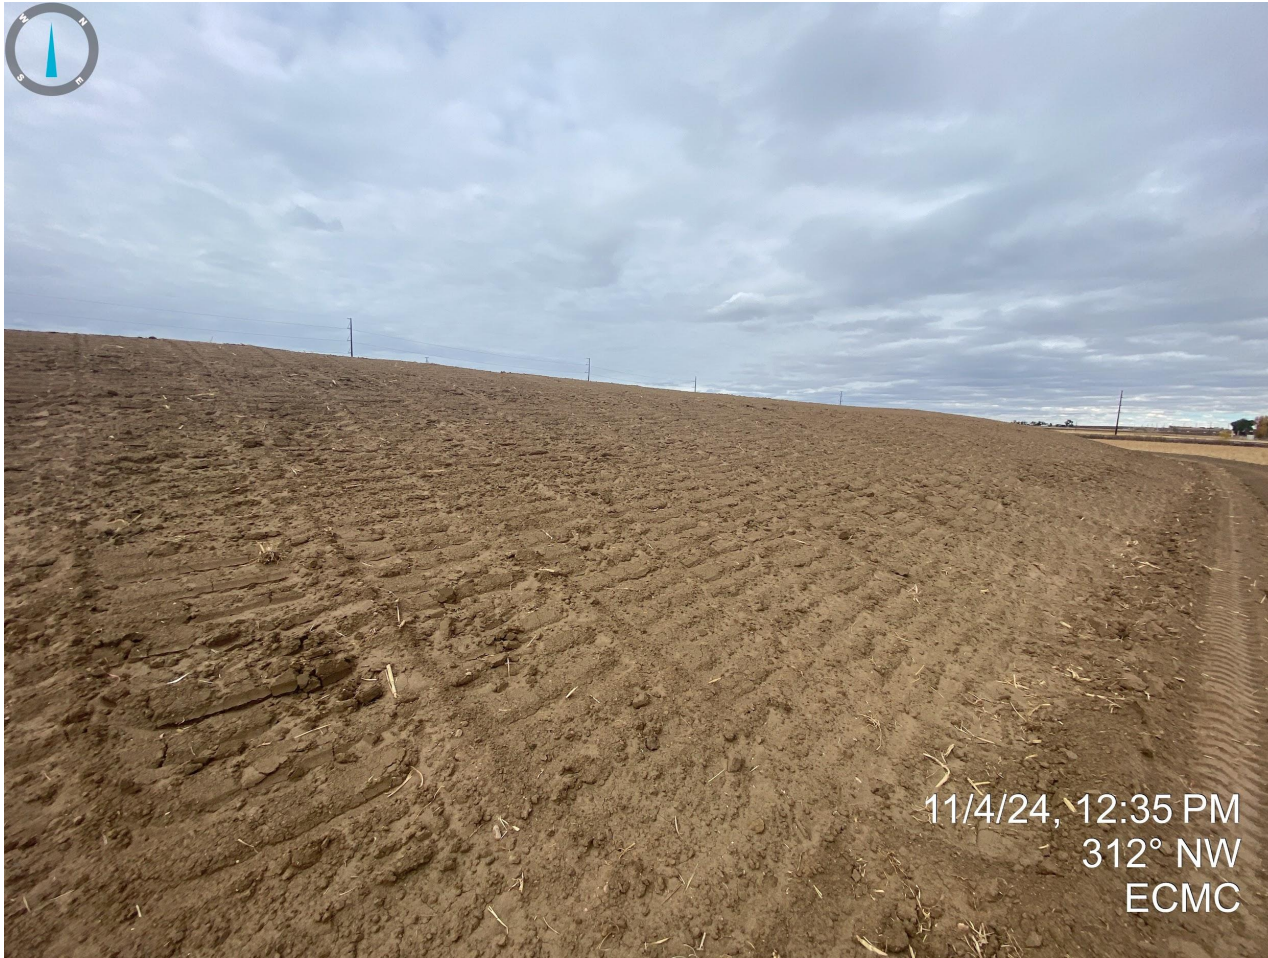
Photo 12. Eastern side of the topsoil stockpile. It appears that the stockpile has been equipment tracked for short term stabilization.

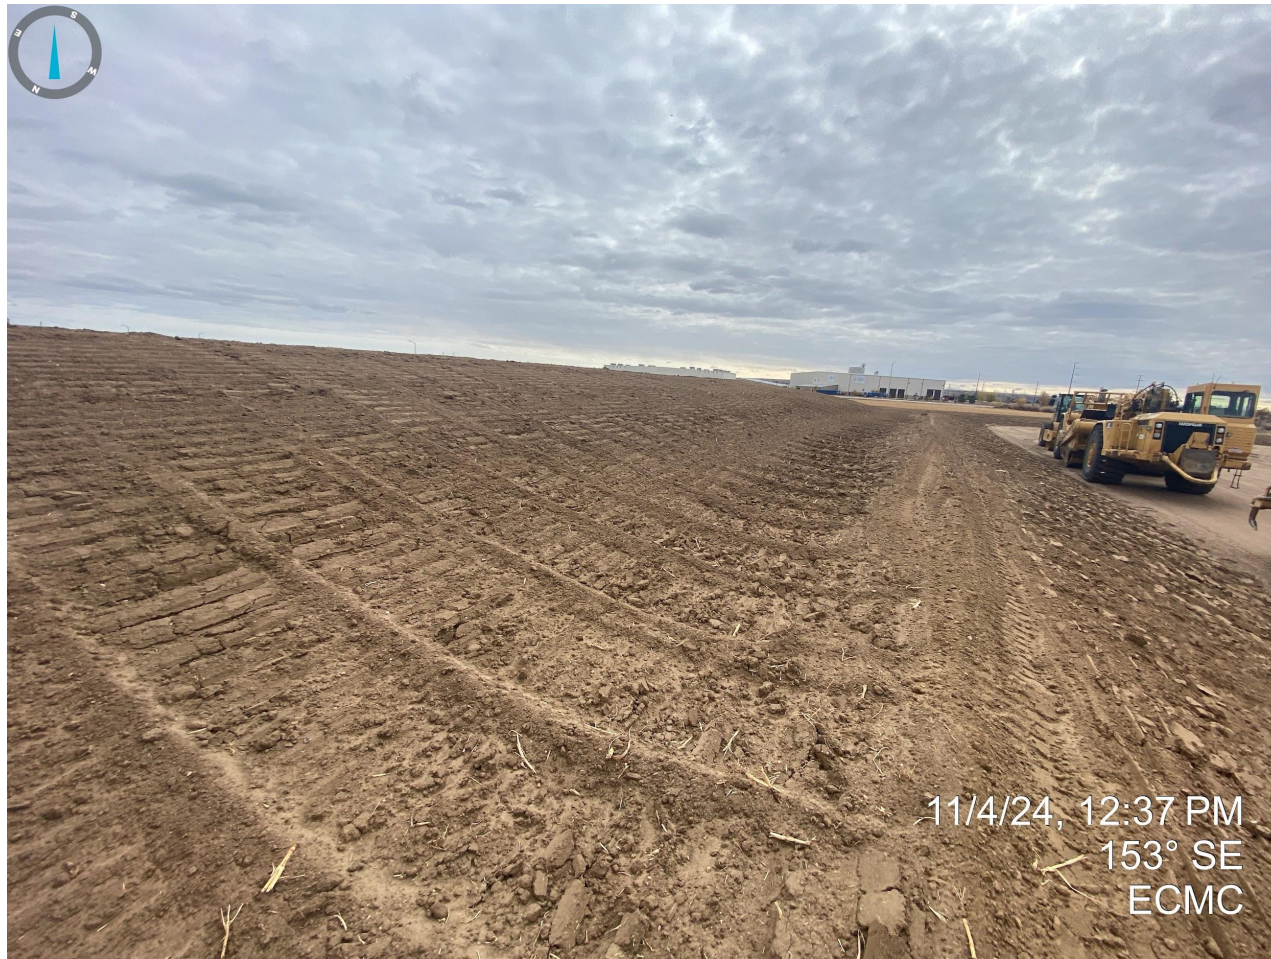
Photo 13. Western side of the topsoil stockpile. It appears that the stockpile has been equipment tracked for short term stabilization.

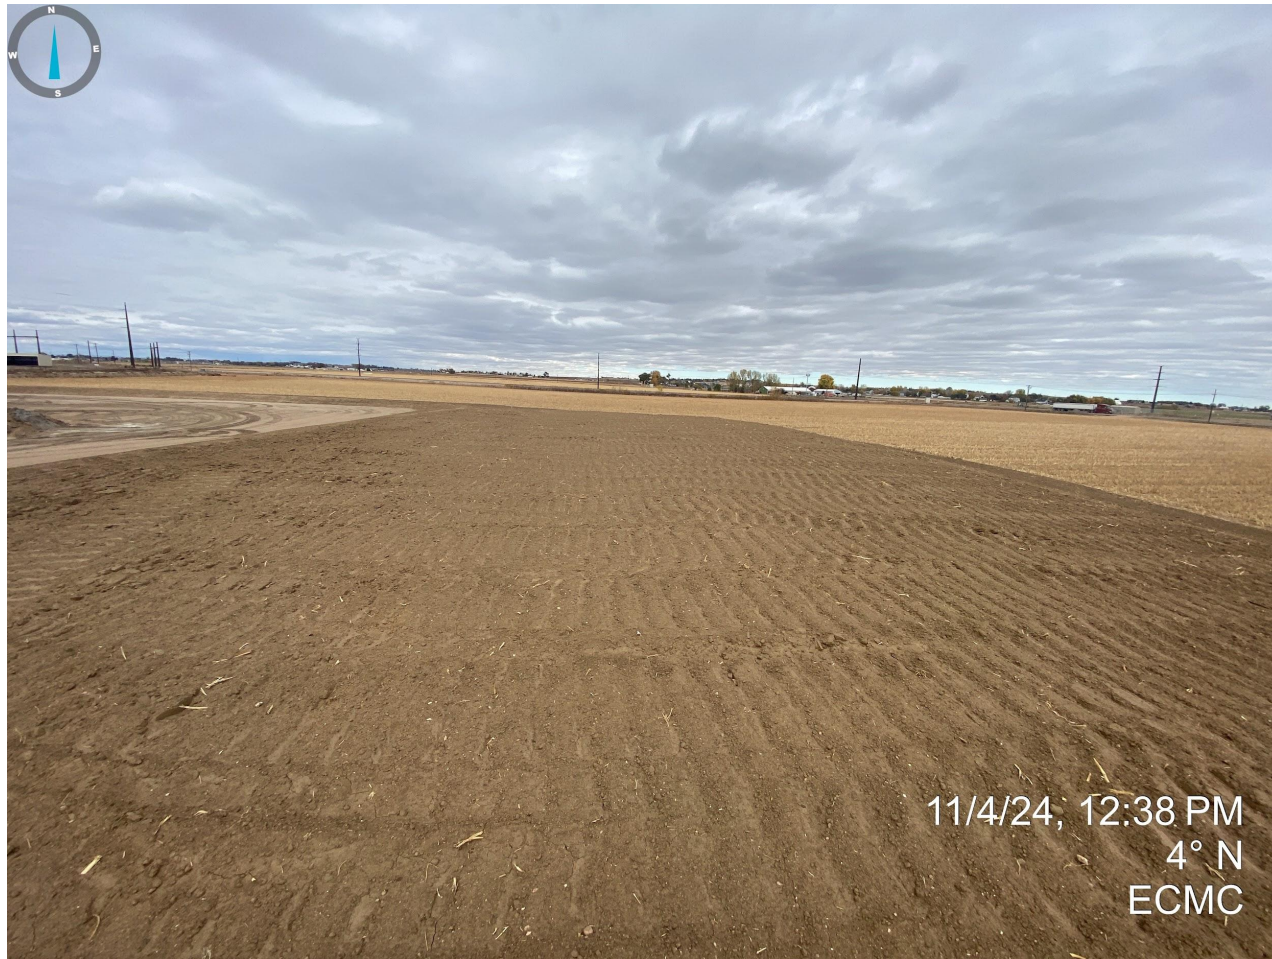
Photo 14. Top portion of the topsoil stockpile. It appears that the stockpile has been equipment tracked for short term stabilization.
